# *South Baker Creek Dam*

## 30% Design Report

### Huerfano County Water Conservancy District

AG JOB No. 18-117

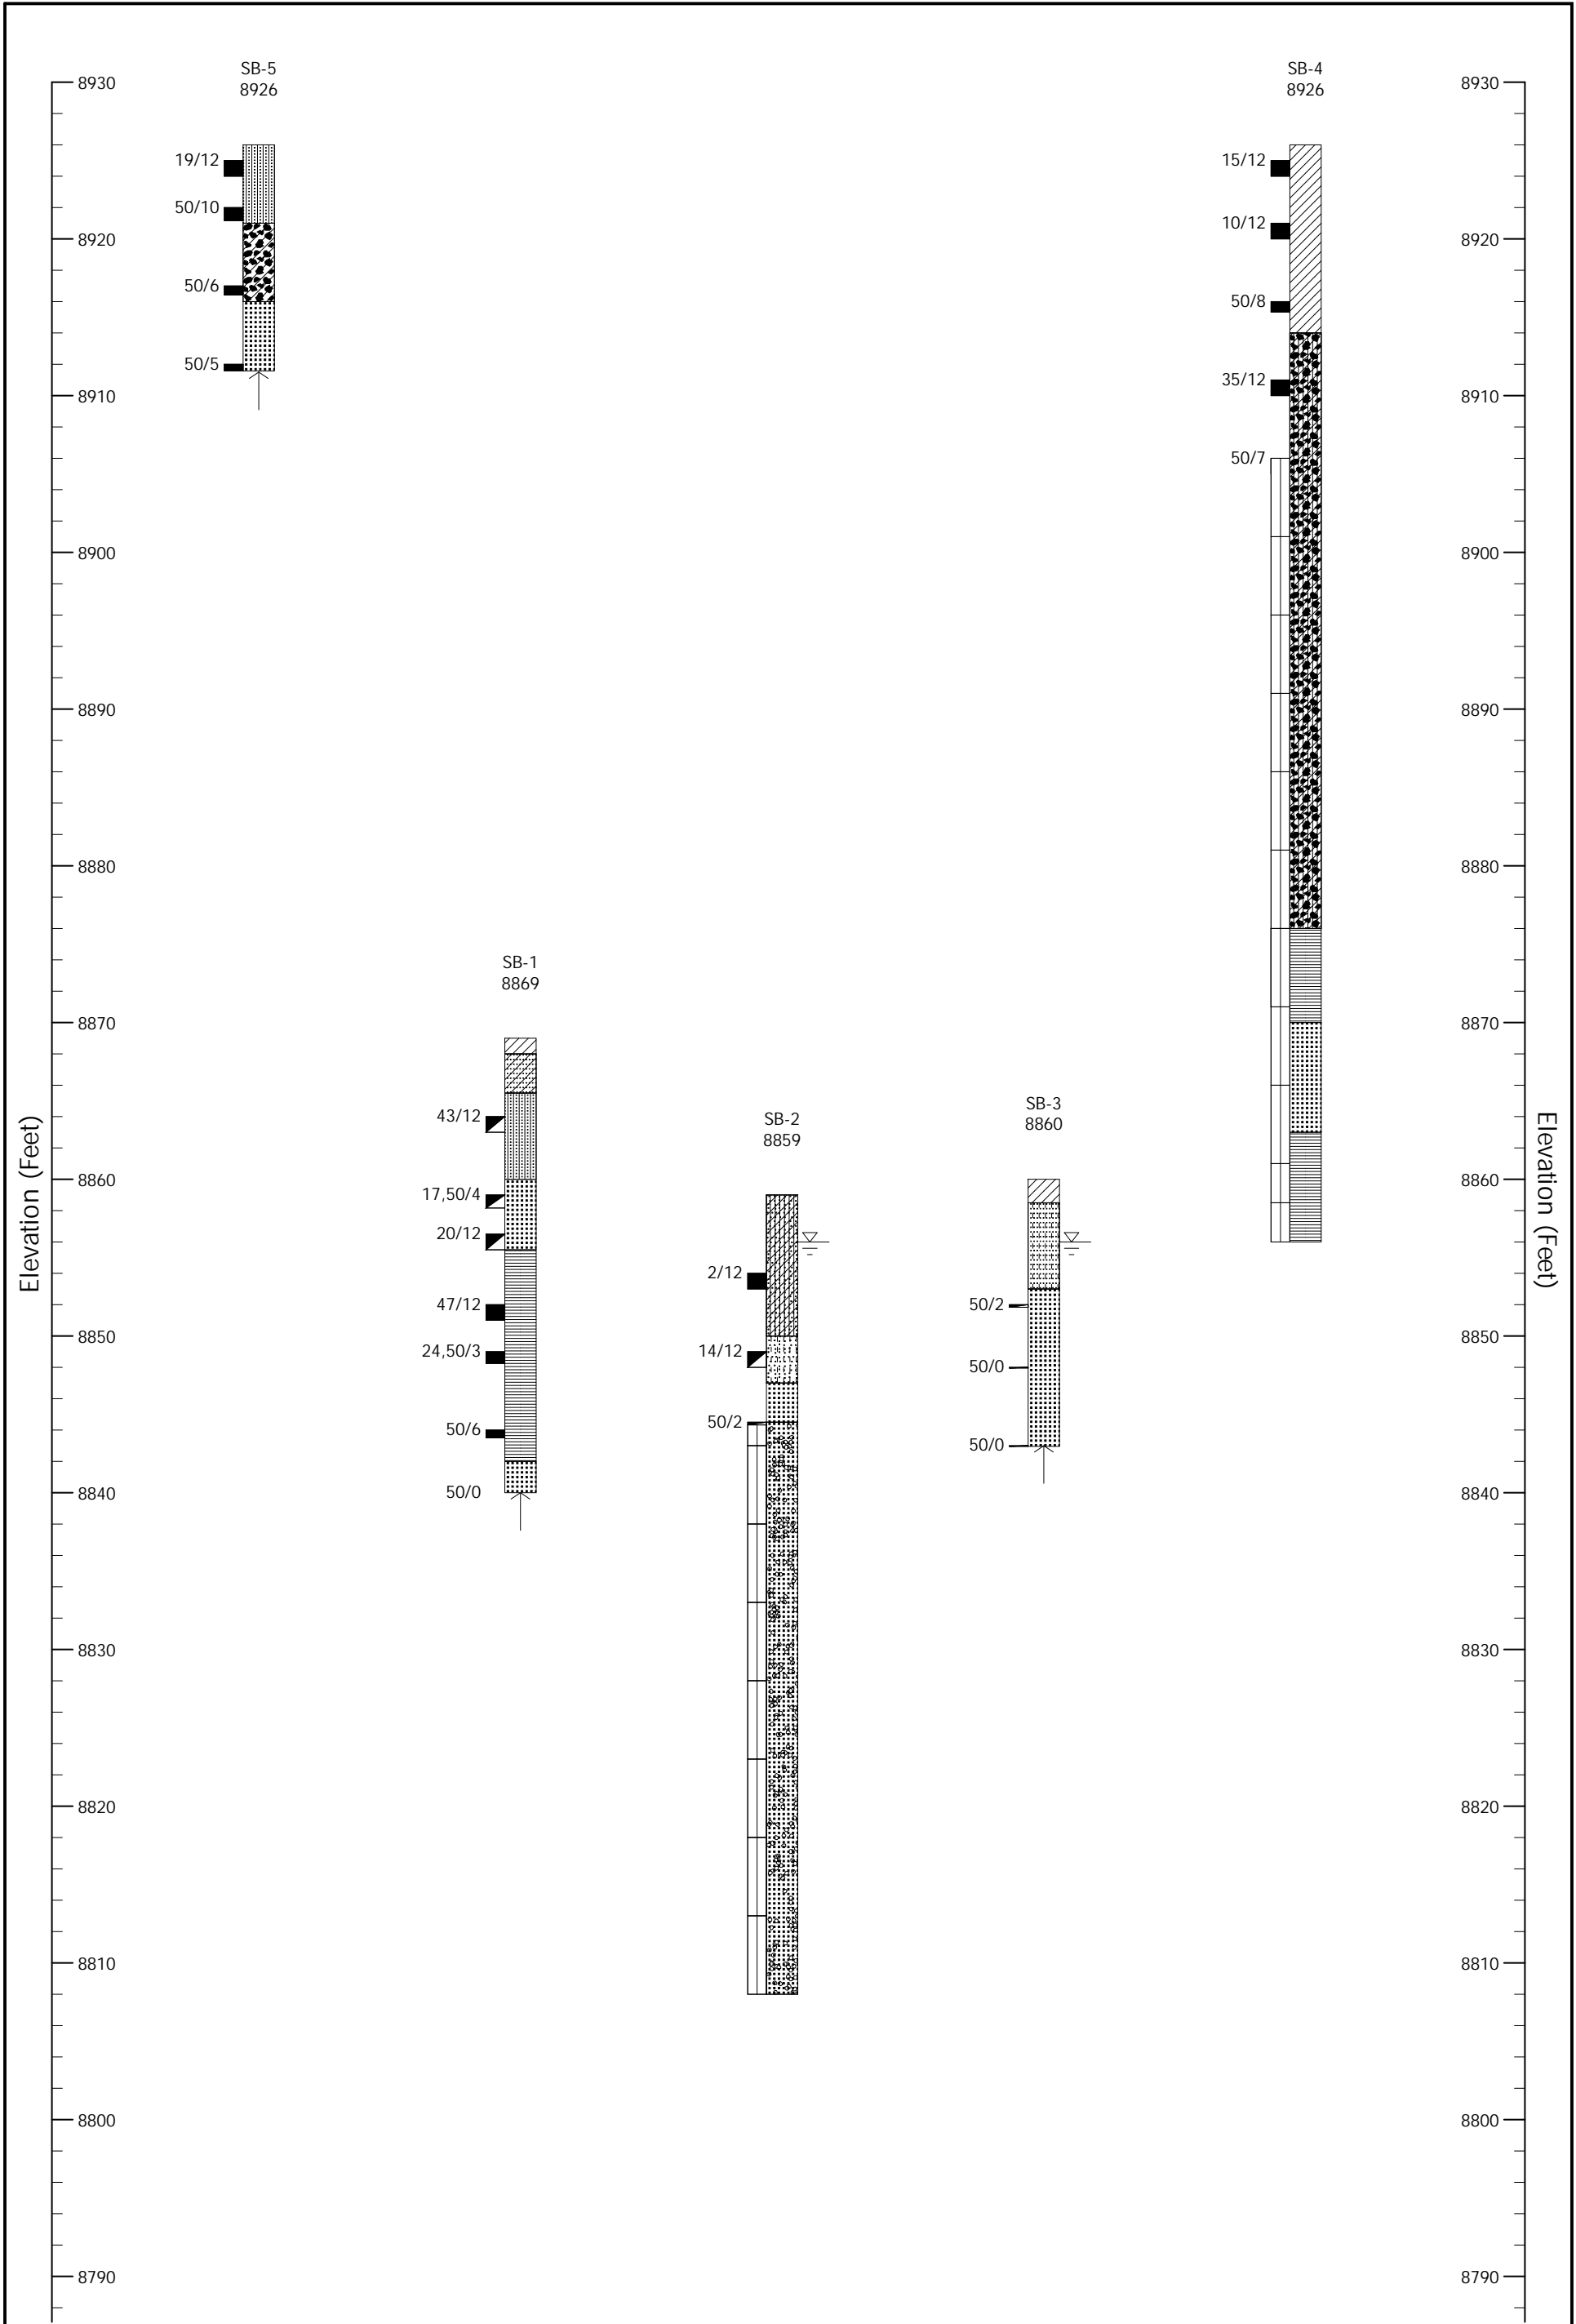
PROJECT NO:	18.117	<b>FIGURE 23</b>  South Baker Boring Logs

Borings were advanced using a CME 550 track mounted drill rig equipped with 6 inch diameter, continuous flight, hollow stem auger and HQ and NX wireline coring equipment. ODEX casing driving was used at one location. Soil and bedrock were sampled to practical auger refusal at designated intervals using a modified California sampler which is driven into the soil by dropping a 140 pound hammer through a free fall of 30 inches. The modified California sampler is a 2.5 inch outside diameter by 2 inch inside diameter device lined with thin brass tubes to recover relatively undisturbed samples. A penetration test is the procedure to drive the modified California sampler into the soil and to record the number of blows required to do so. The number of blows required for the sampler to penetrate 12 inches gives an indication of the consistency or relative density of the soil encountered. Results of the penetration tests and locations of sampling are presented on the Boring Logs profiles, Figures 12, 15, 18, 20, and 23. Individual logs are presented in Appendix A.

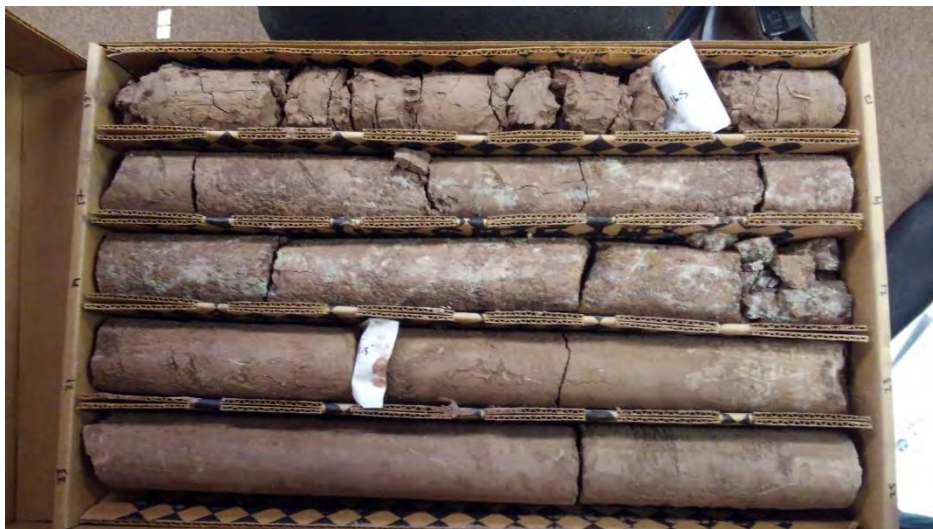
**Photo 1. LVL-5 from 15 to 25 feet.**

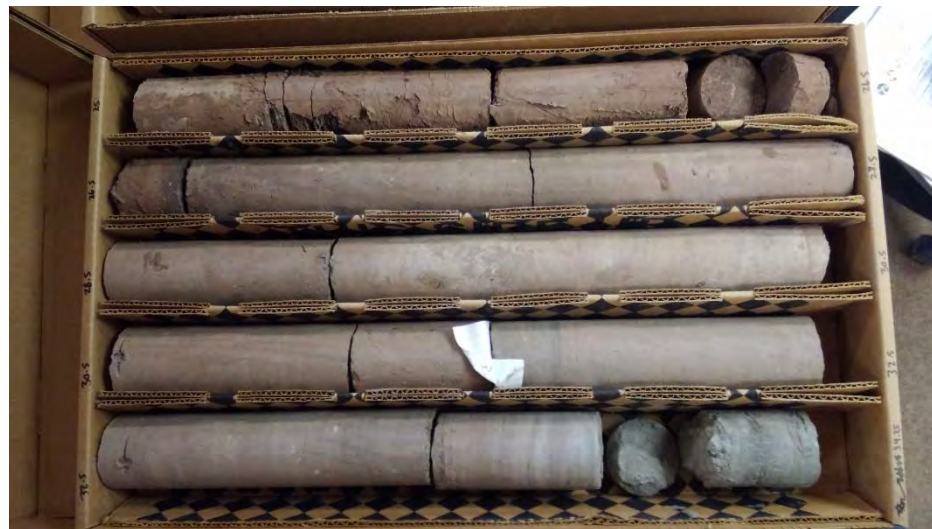
**Photo 2. LVL-5 from 25 to 34.5 feet.**

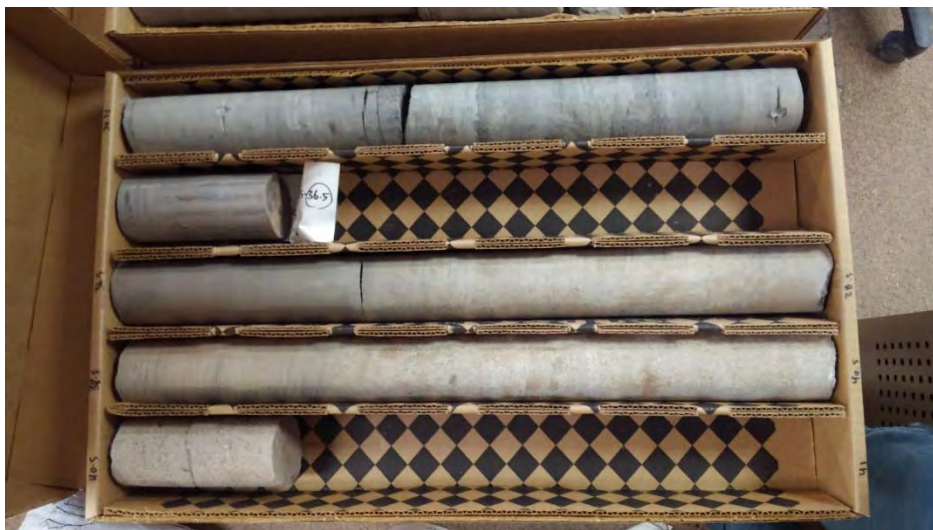
**Photo 3. LVL-5 from 34.5 to 41 feet.**

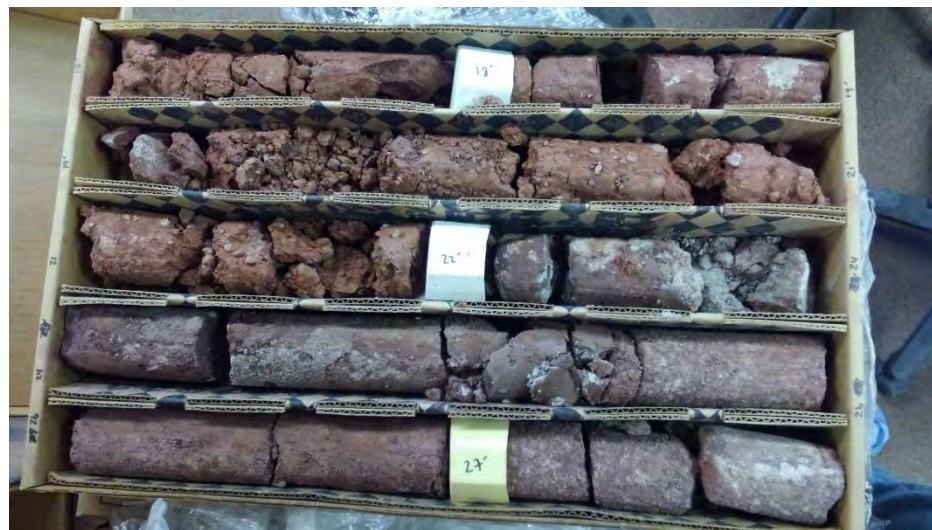
**Photo 4. B-2 from 17 to 28 feet.**

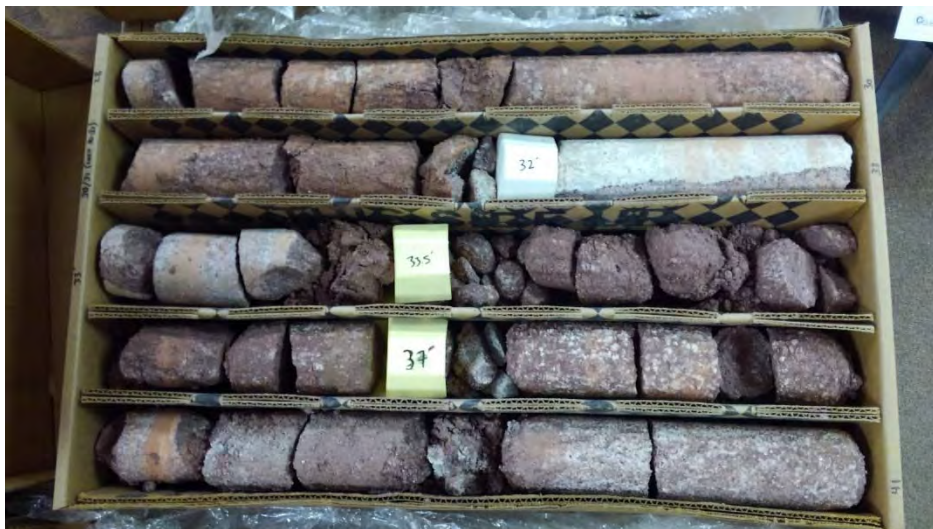
**Photo 5. B-2 from 28 to 41 feet.**

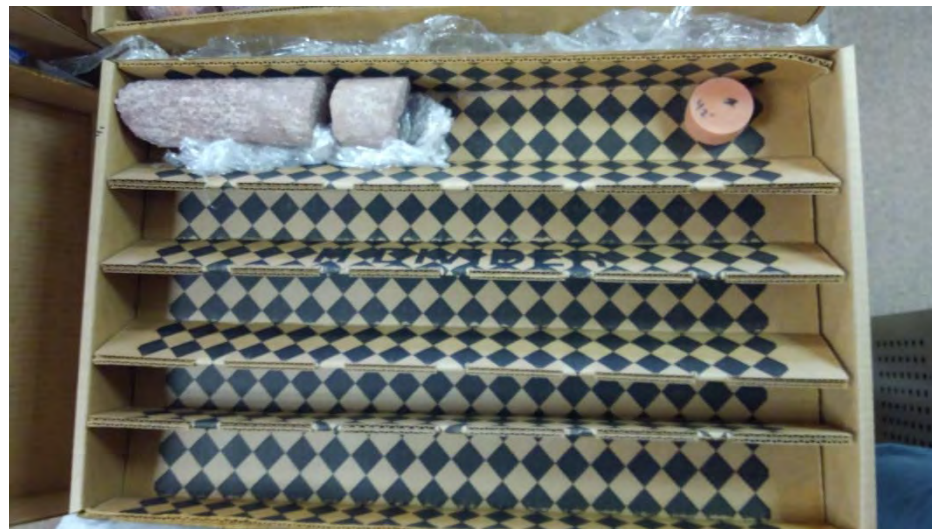
**Photo 6. B-2 from 41 to 42 feet.**

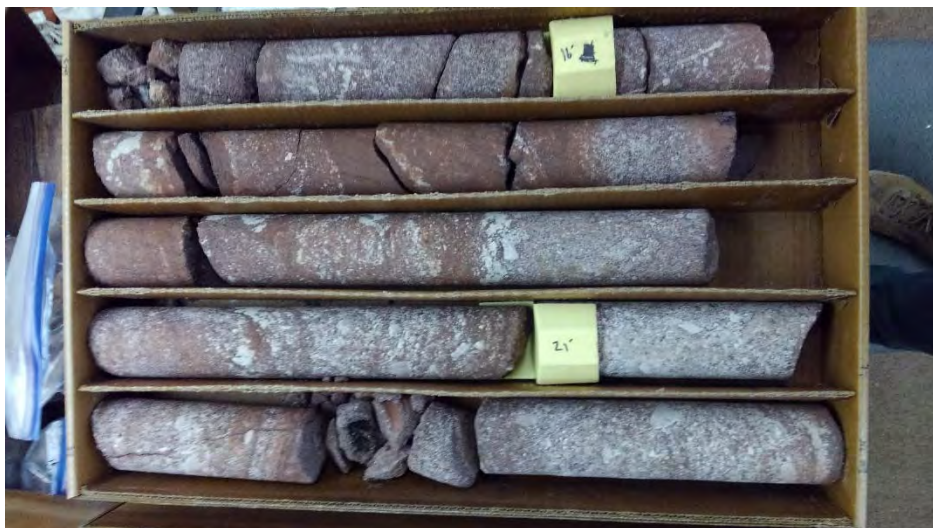
**Photo 7. SB-2 from 14.5 to 24 feet.**

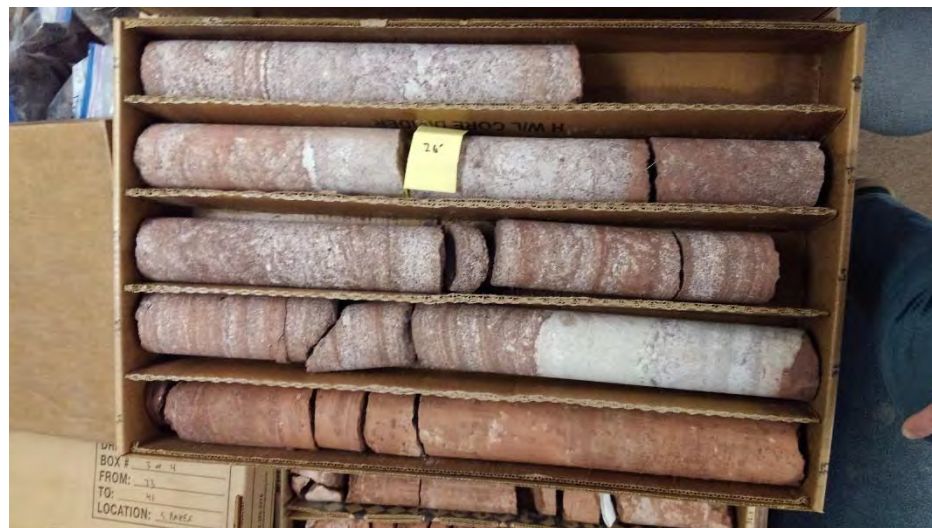
**Photo 8. SB-2 from 24 to 33 feet.**

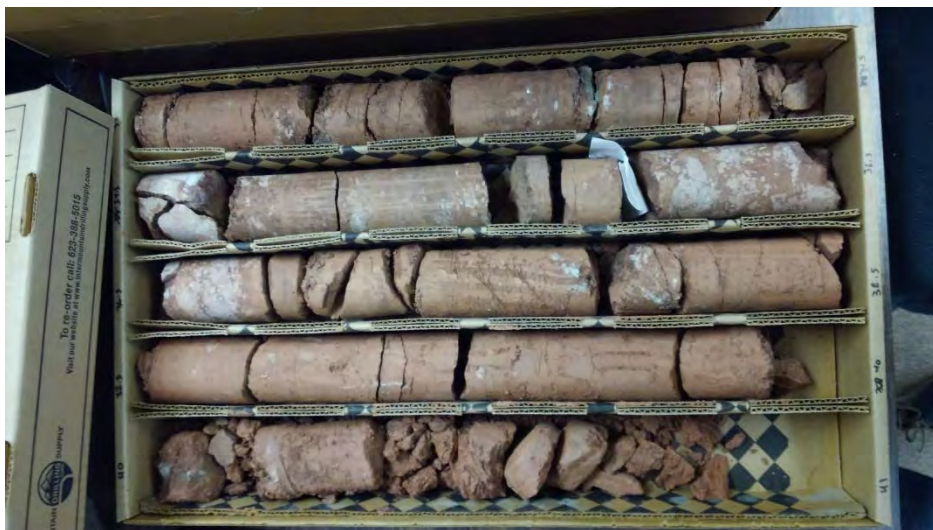
**Photo 9. SB-2 from 33 to 41 feet.**

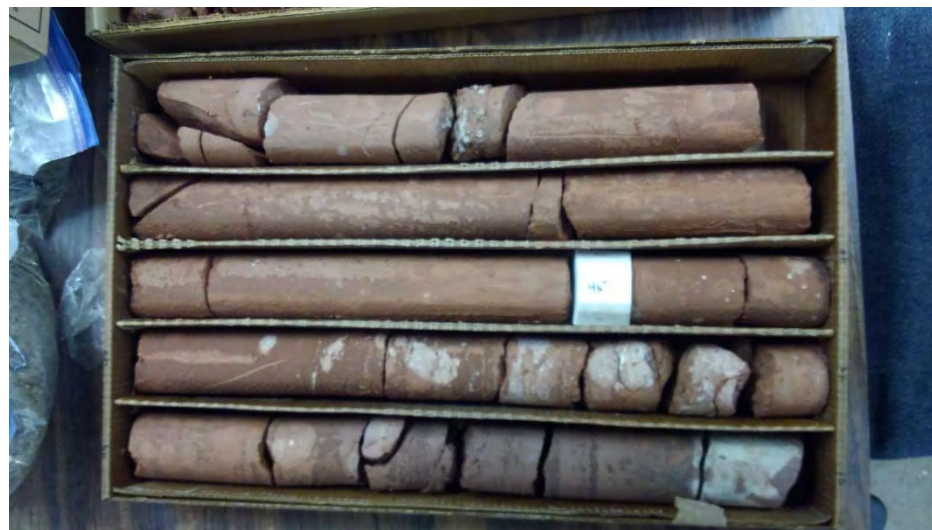
**Photo 10. SB-2 from 41 to 51 feet.**

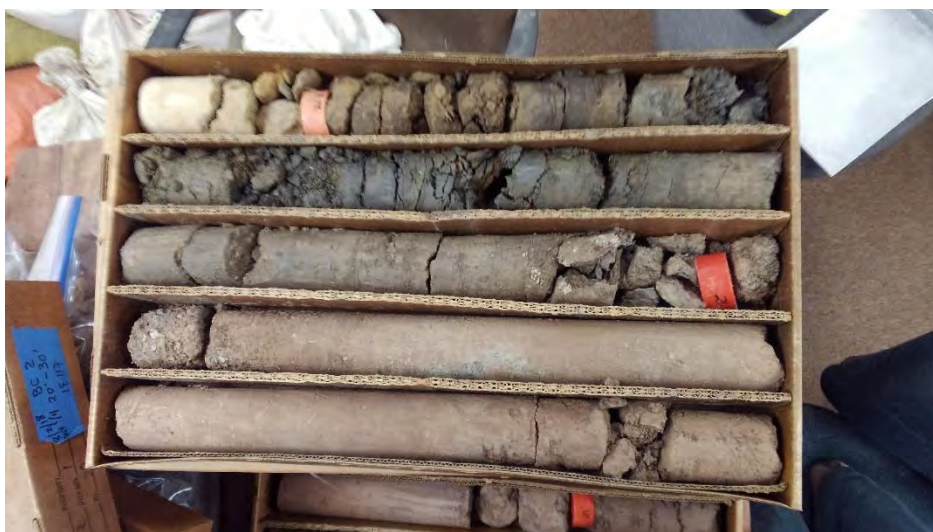
**Photo 11. BC-2 from 20 to 30 feet.**

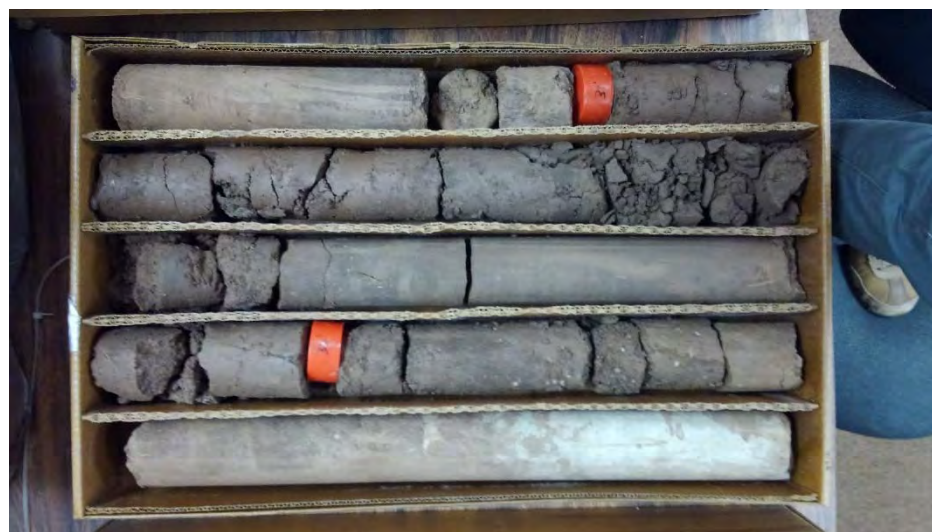
**Photo 12. BC-2 from 30 to 37.2 feet.**

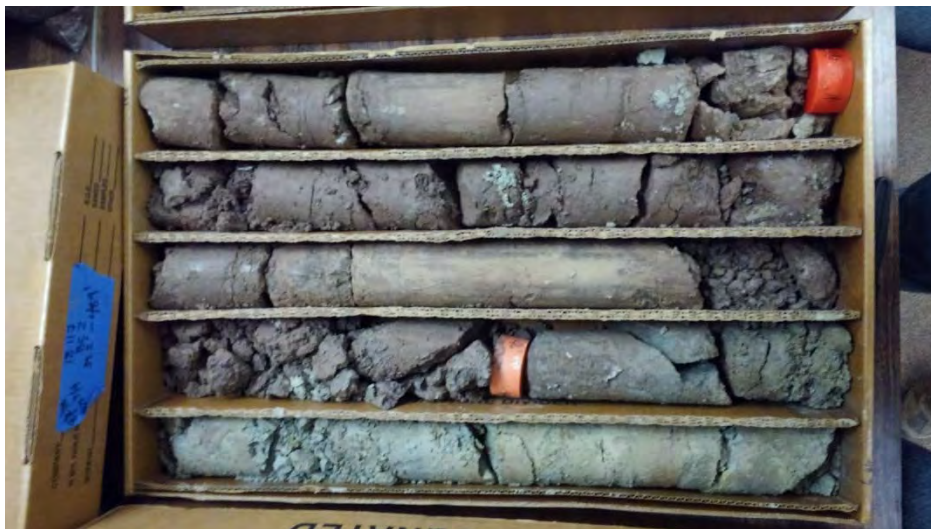
**Photo 13. BC-2 from 37.2 to 48.9 feet.**

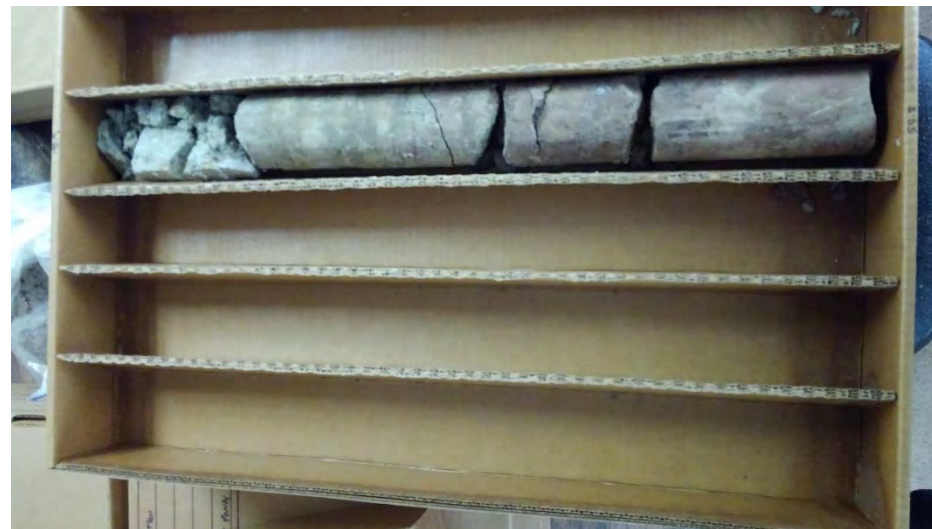
**Photo 14. BC-2 from 48.9 to 50.8 feet.**

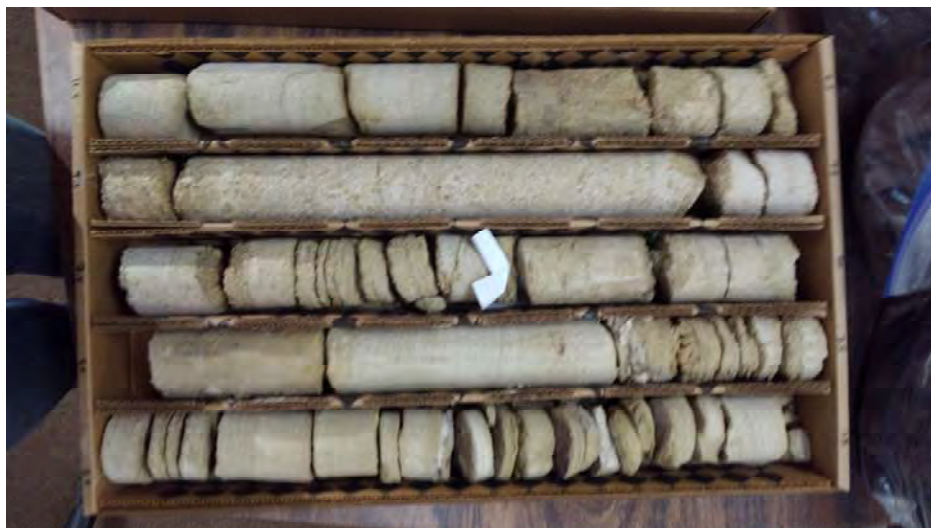
**Photo 15. LVL-3 from 1.5 to 11.5 feet.**

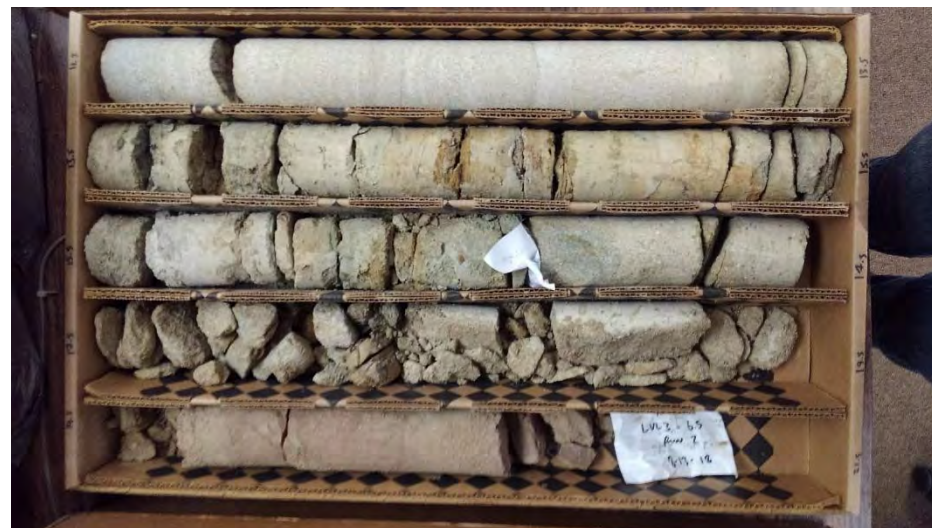
**Photo 16. LVL-3 from 11.5 to 21.5 feet.**

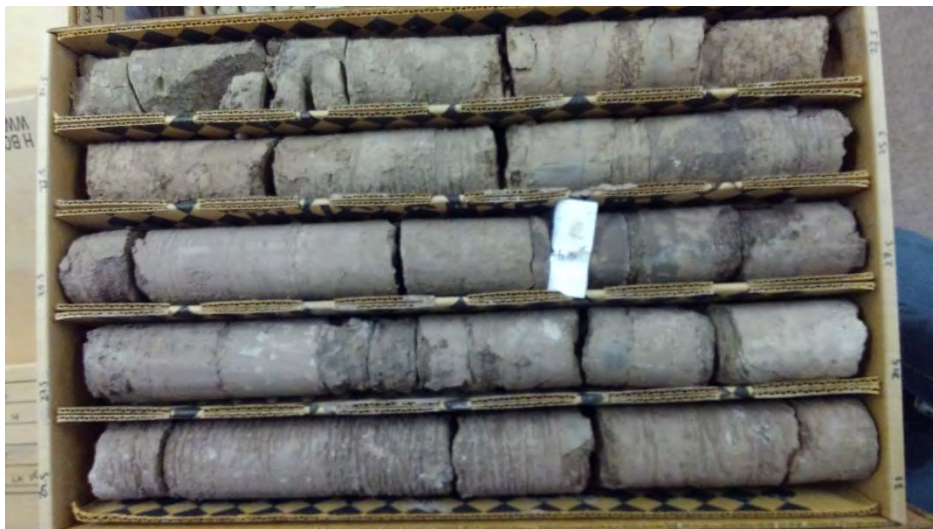
**Photo 17. LVL-3 from 21.5 to 31 feet.**

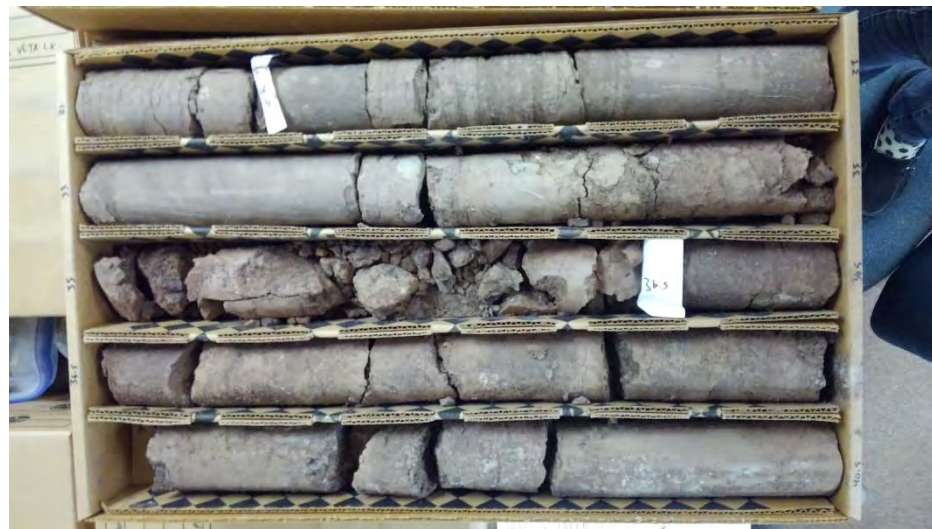
**Photo 18. LVL-3 from 31 to 40.5 feet.**

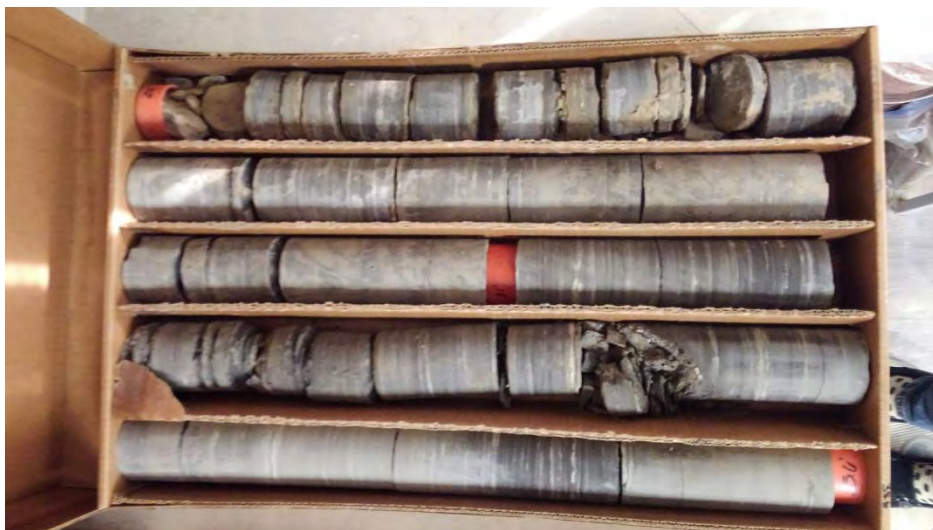
**Photo 19. MS-3 from 26 to 35.6 feet.**

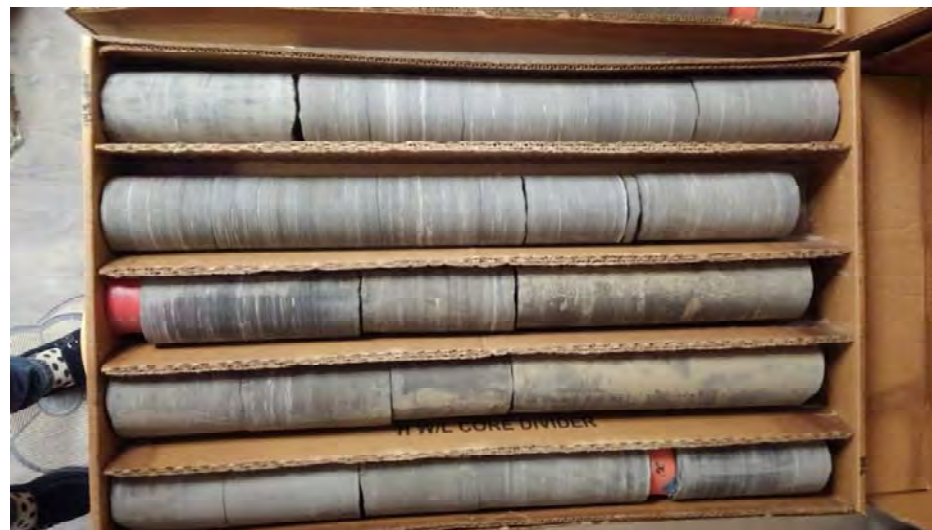
**Photo 20. MS-3 from 35.6 to 44.5 feet.**

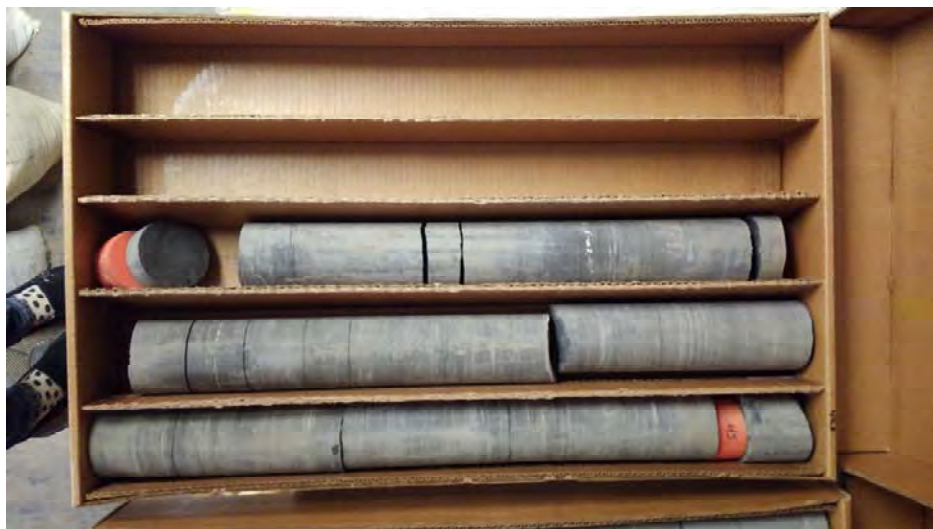
**Photo 21. MS-3 from 44.5 to 50 feet.**

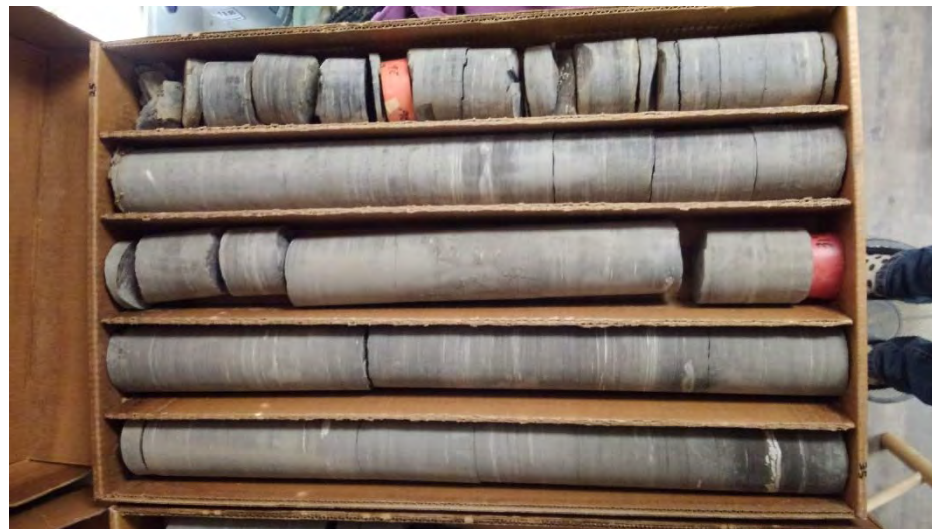
**Photo 22. MS-5 from 25 to 35 feet.**

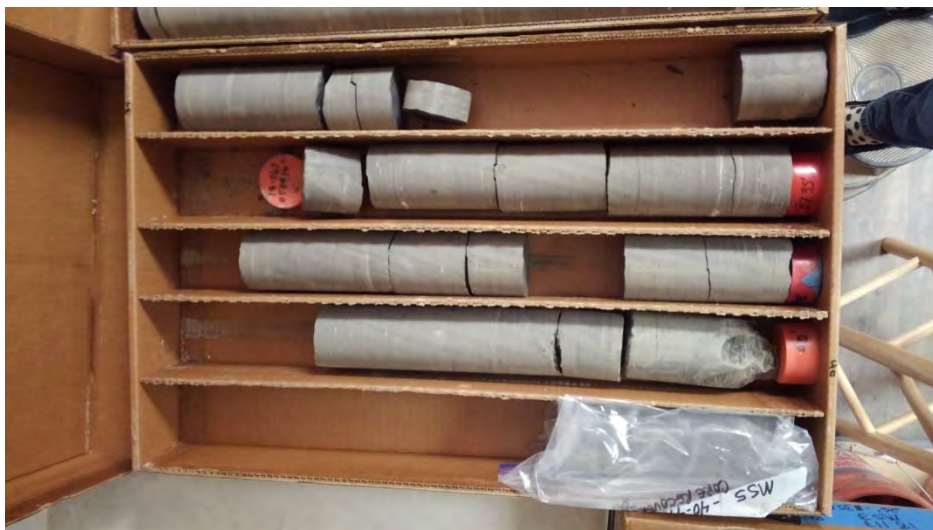
**Photo 23. MS-5 from 35 to 40 feet.**

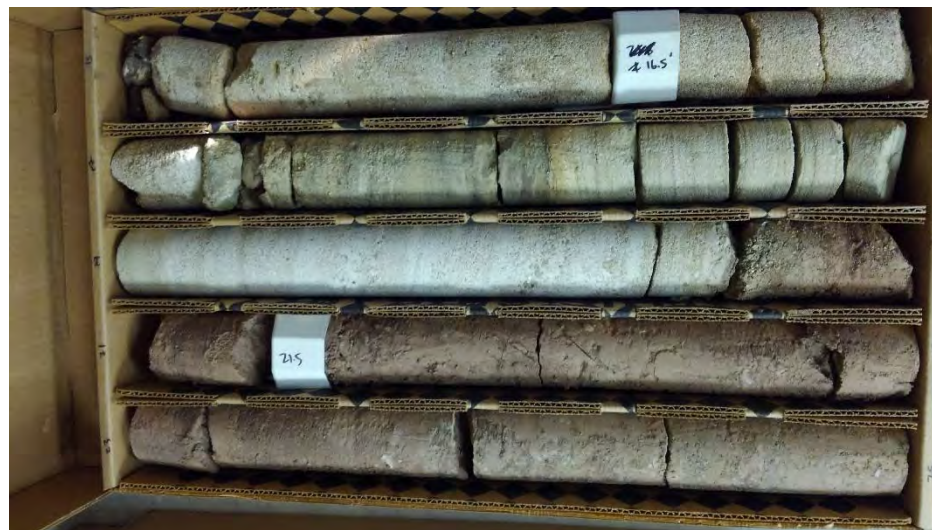
**Photo 24. LVL-1 from 15 to 25 feet.**

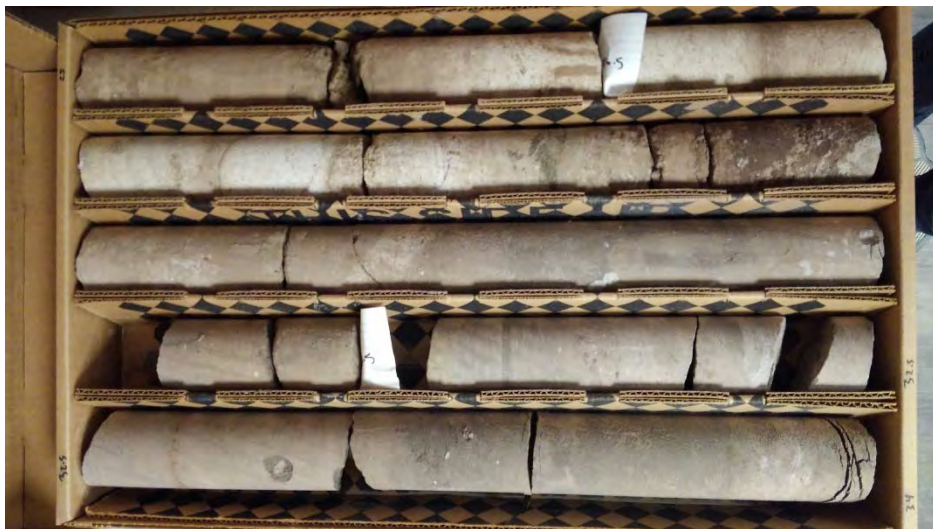
**Photo 25. LVL-1 from 25 to 34 feet.**

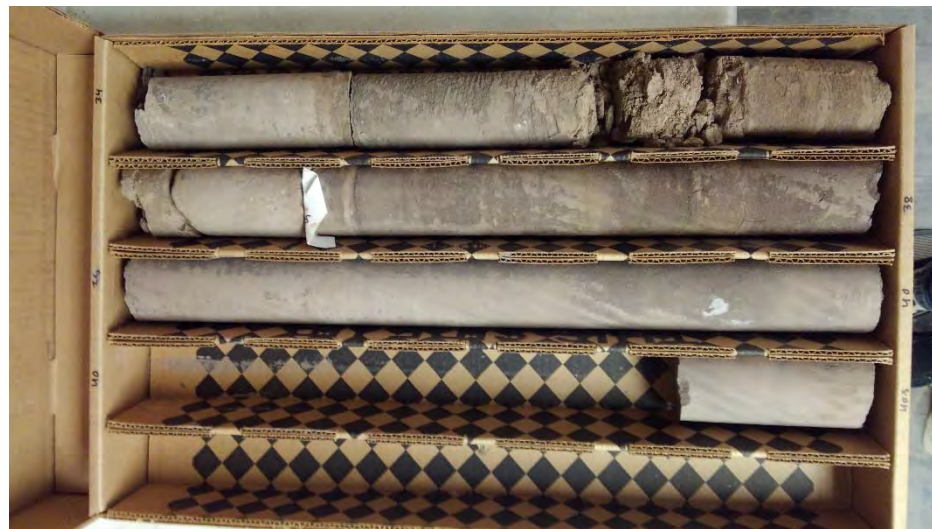
**Photo 26. LVL-1 from 34 to 40.5 feet.**

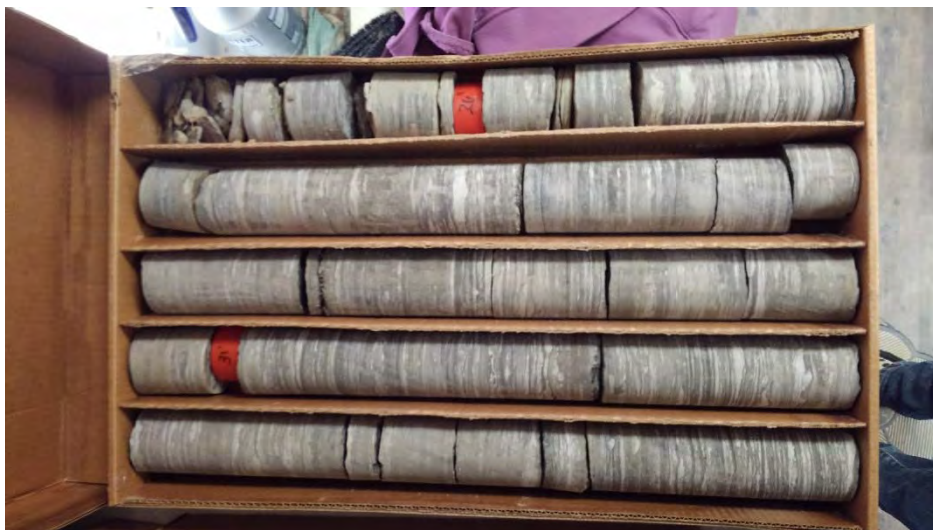
**Photo 27. MS-1 from 25 to 34.6 feet.**

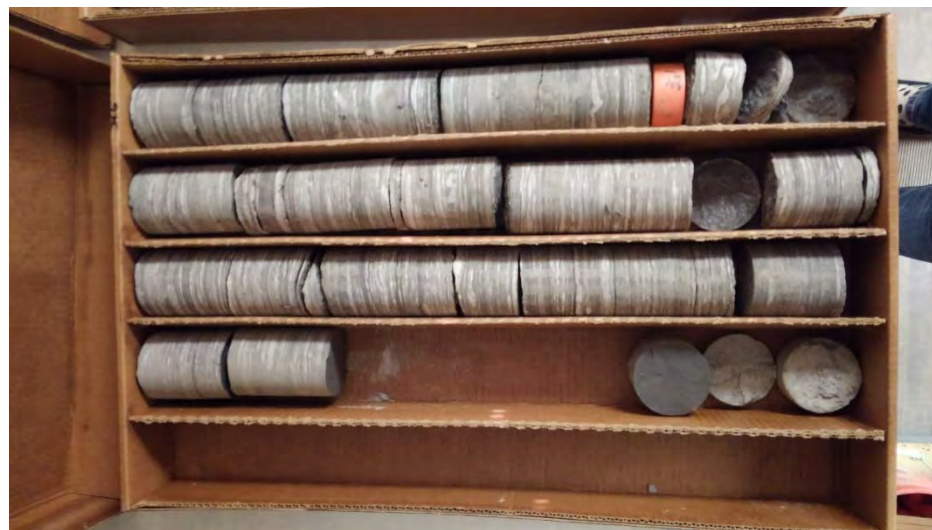
**Photo 28. MS-1 from 34.6 to 41 feet.**

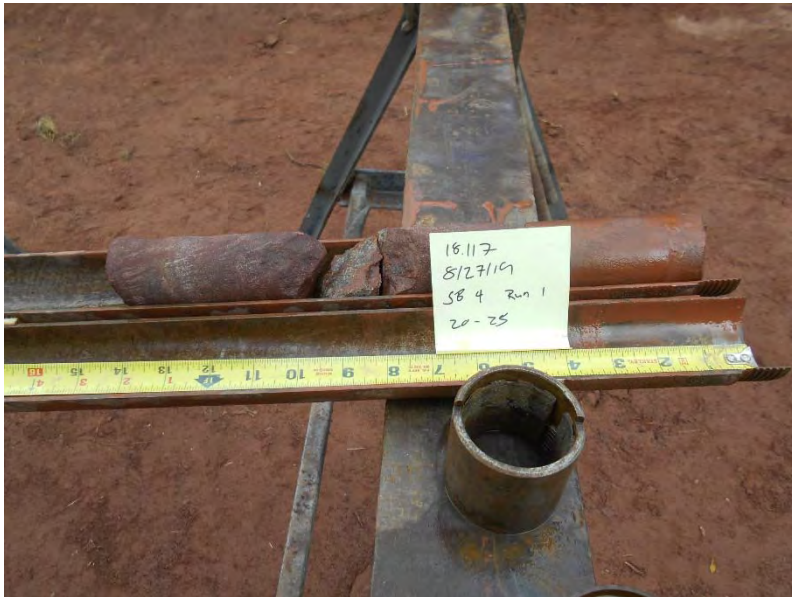
Photo 29. SB-4 from 20 to 25 feet.

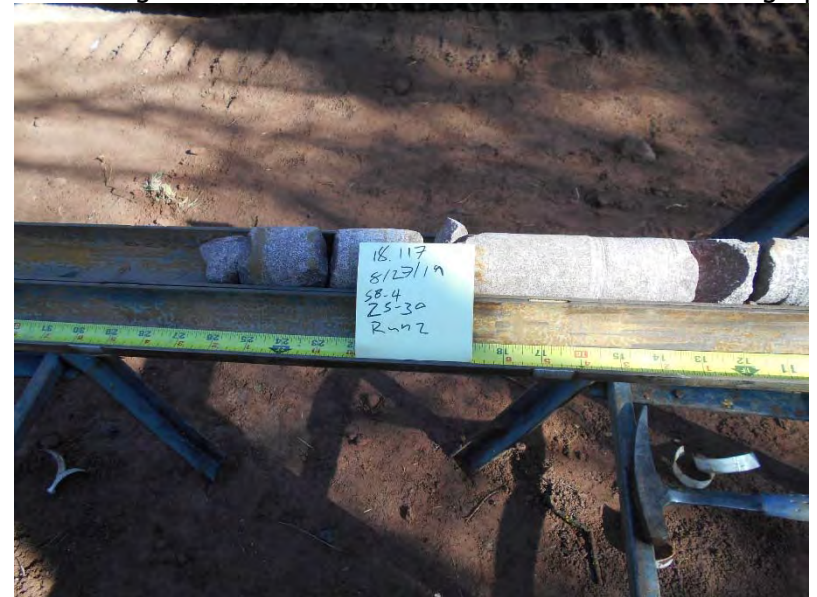
Photo 30. SB-4 from 25 to 27.5 feet.

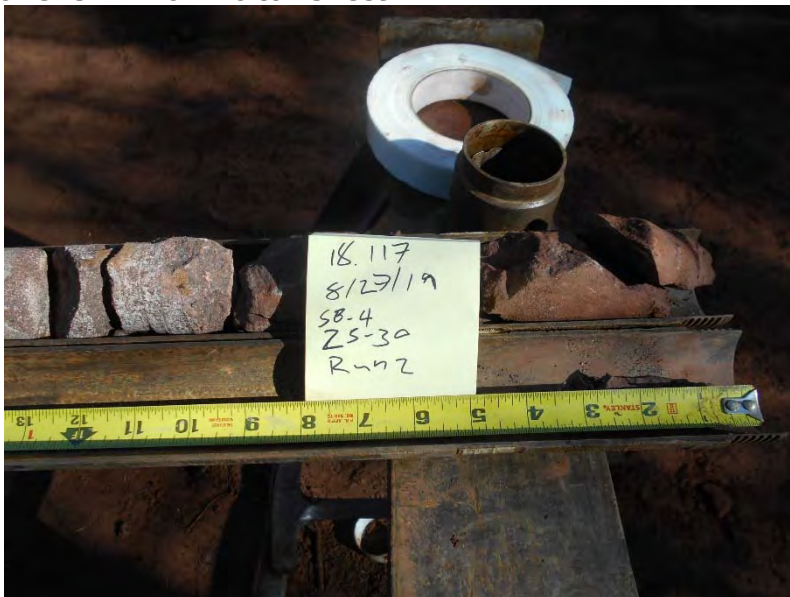
Photo 31. SB-4 from 27.5 to 30 feet.

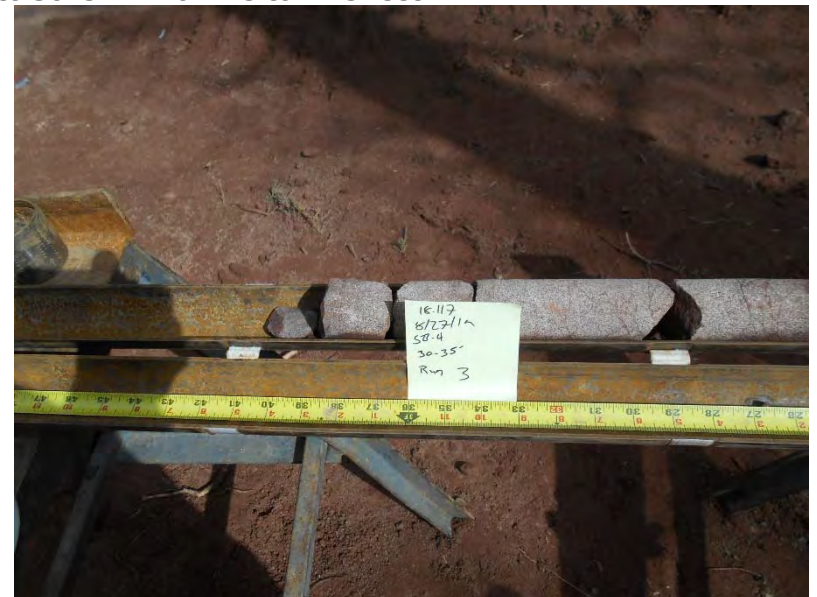
Photo 32. SB-4 from 30 to 31.5 feet.

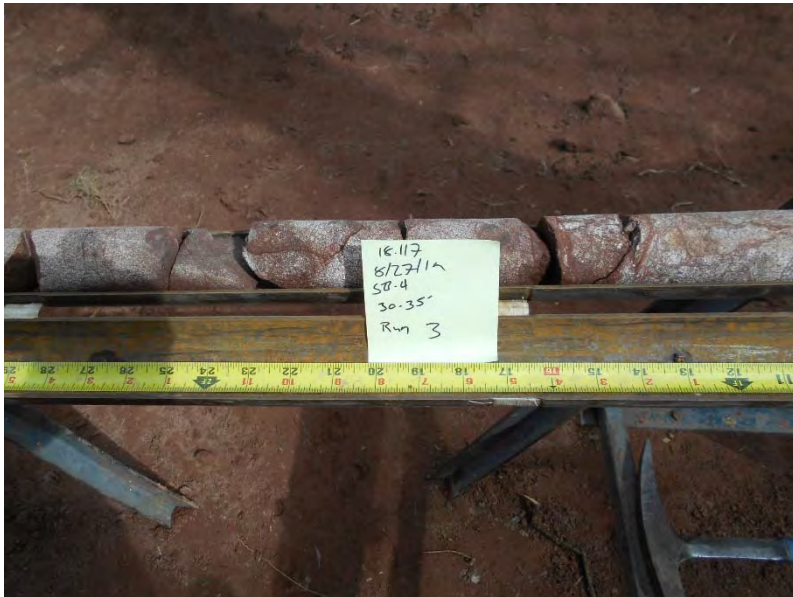
**Photo 33. SB-4 from 31.5 to 33 feet.**

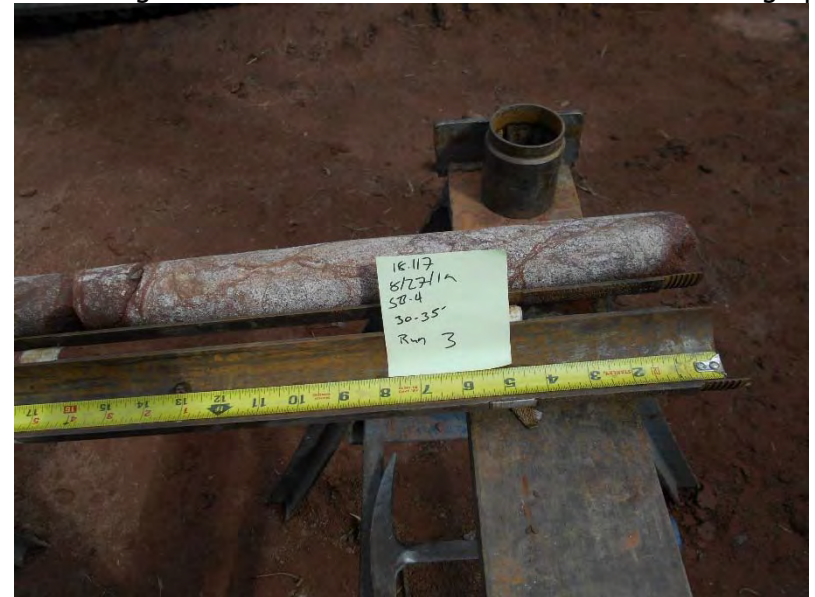
**Photo 34. SB-4 from 33 to 35 feet.**

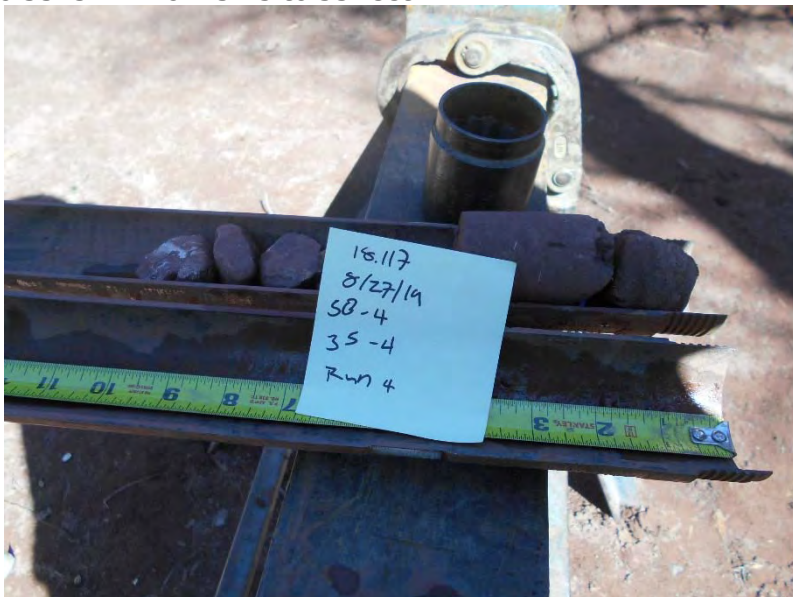
**Photo 35. SB-4 from 35 to 40 feet.**

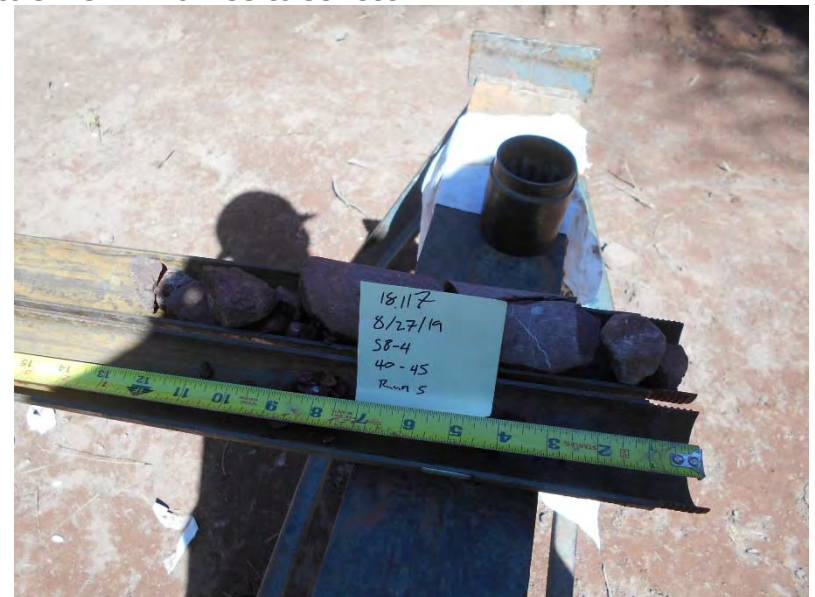
**Photo 36. SB-4 from 40 to 45 feet.**

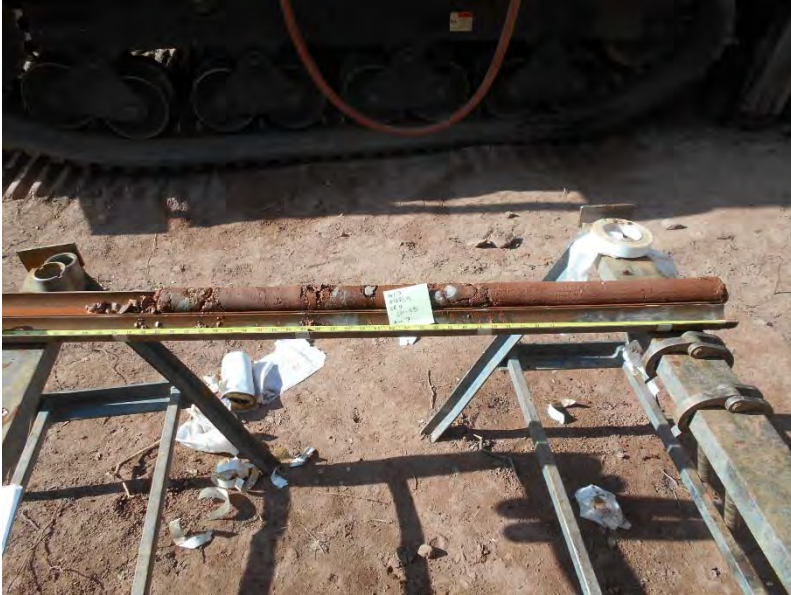
**Photo 37. SB-4 from 50 to 55 feet.**

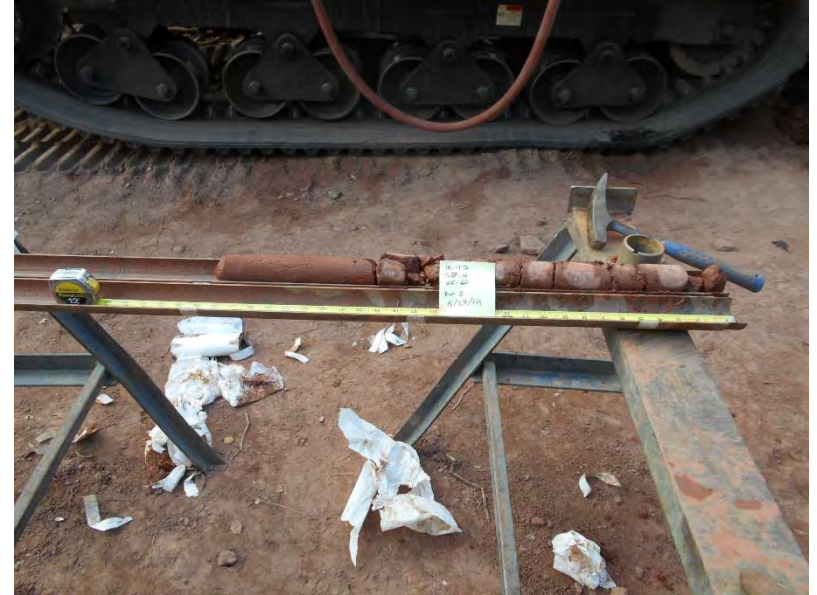
**Photo 38. SB-4 from 55 to 60 feet.**
