# *South Baker Creek Dam*

## 30% Design Report

### Huerfano County Water Conservancy District

AG JOB No. 18-117

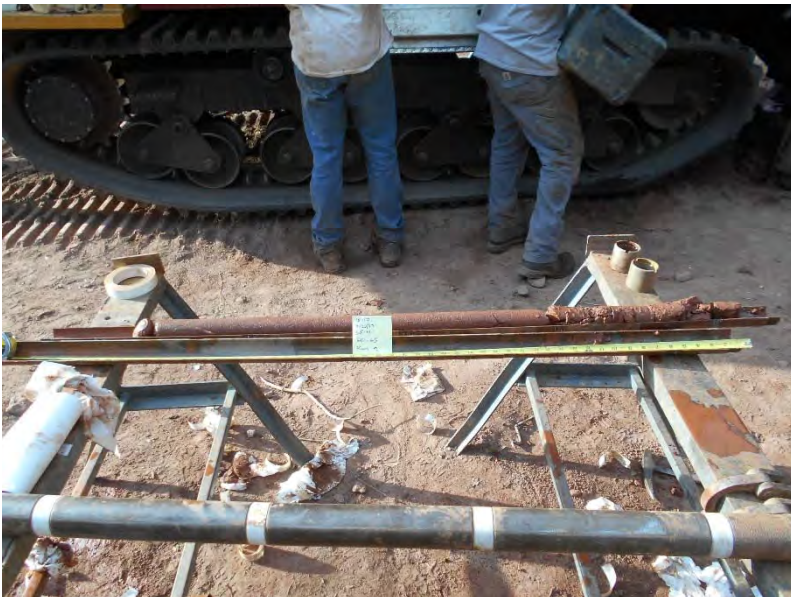
**Photo 39. SB-4 from 60 to 65 feet.**

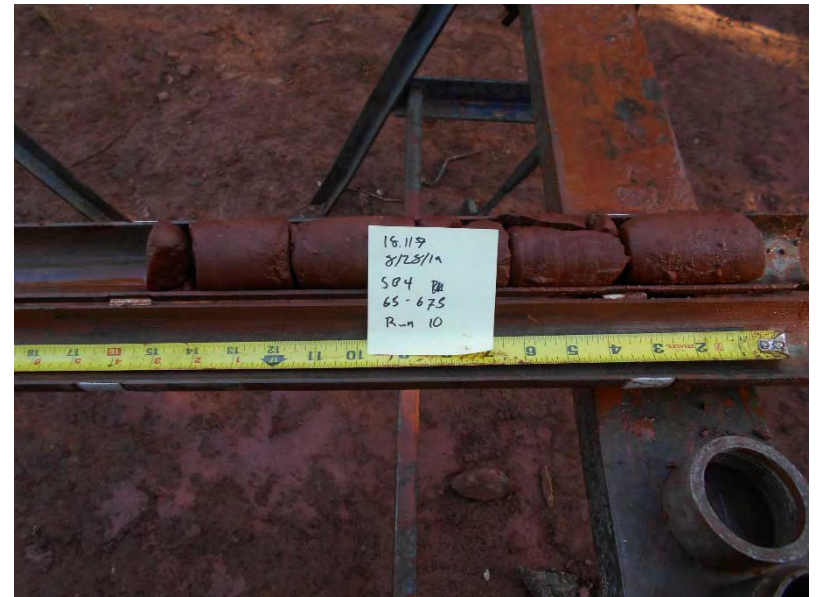
**Photo 40. SB-4 from 65 to 67.5 feet.**

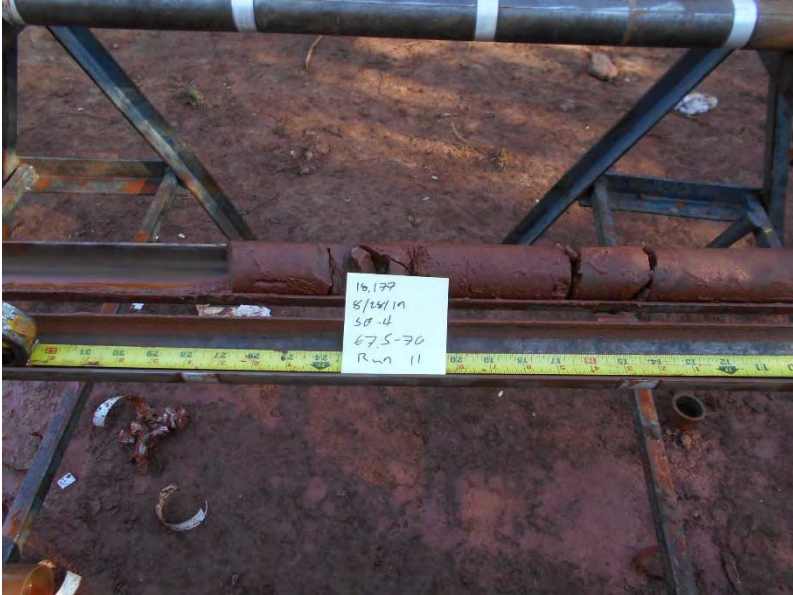
**Photo 41. SB-4 from 67.5 to 69 feet.**

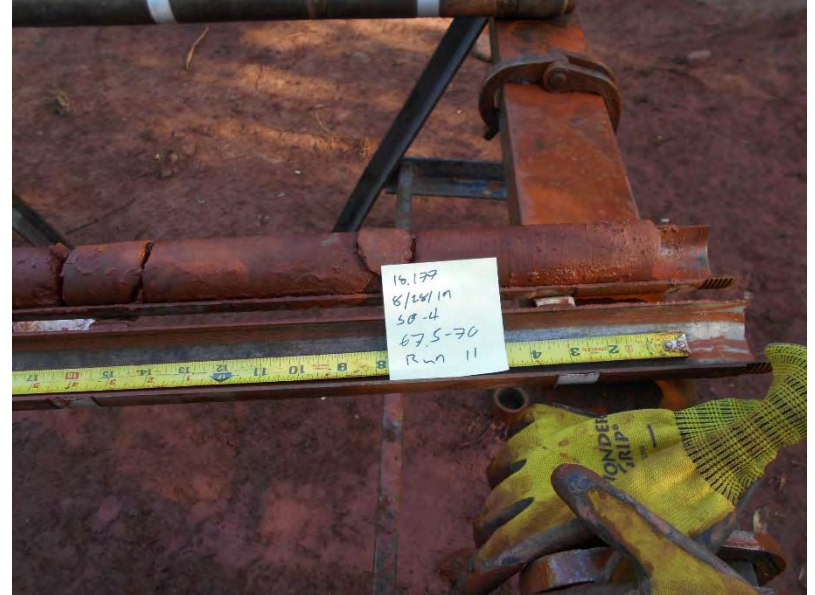
**Photo 42. SB-4 from 69 to 70 feet.**

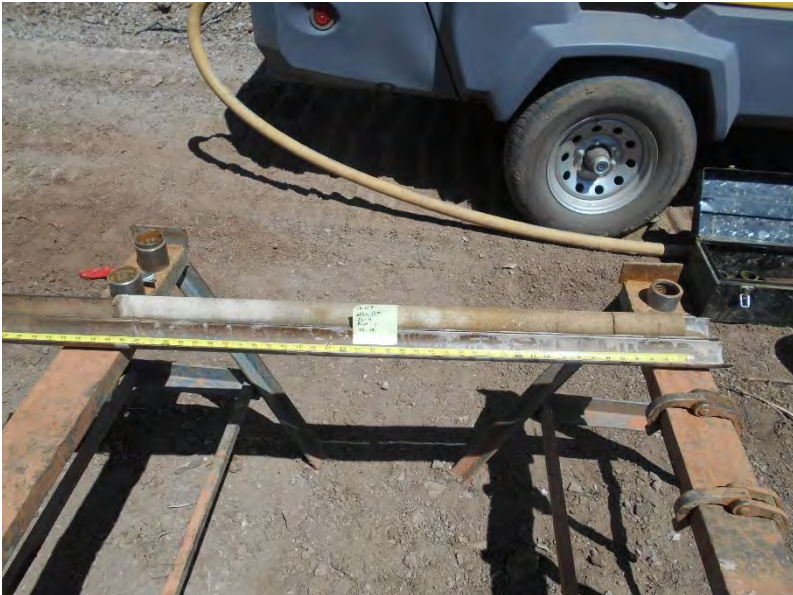
**Photo 43. BC-4 from 10 to 15 feet.**

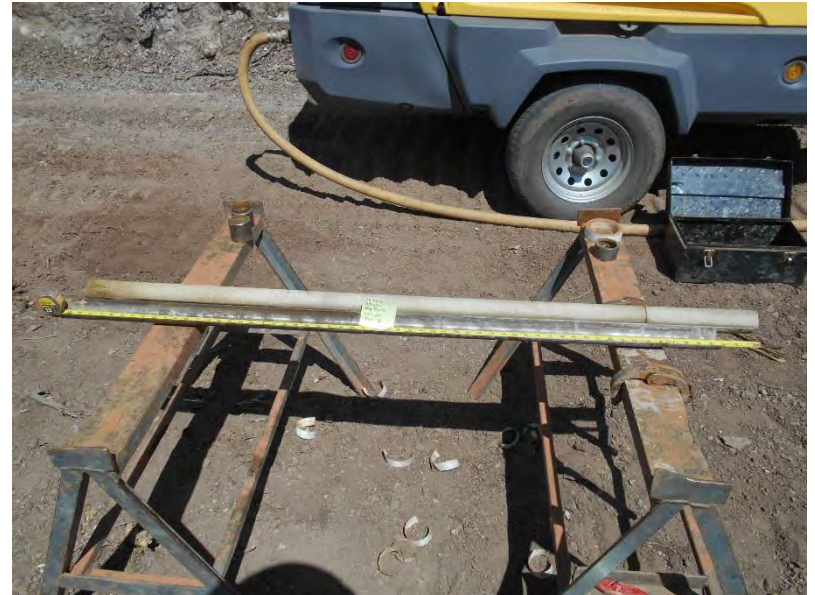
**Photo 44. BC-4 from 15 to 20 feet.**

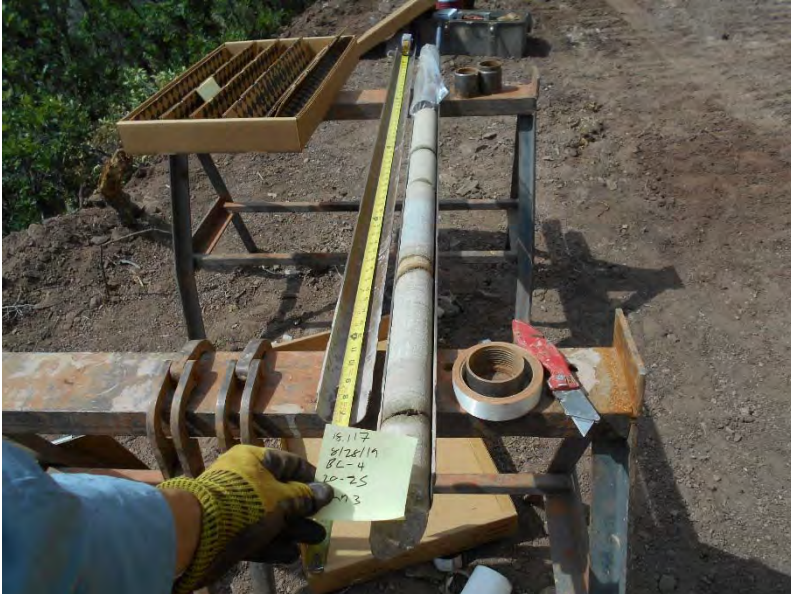
**Photo 45. BC-4 from 20 to 25 feet.**

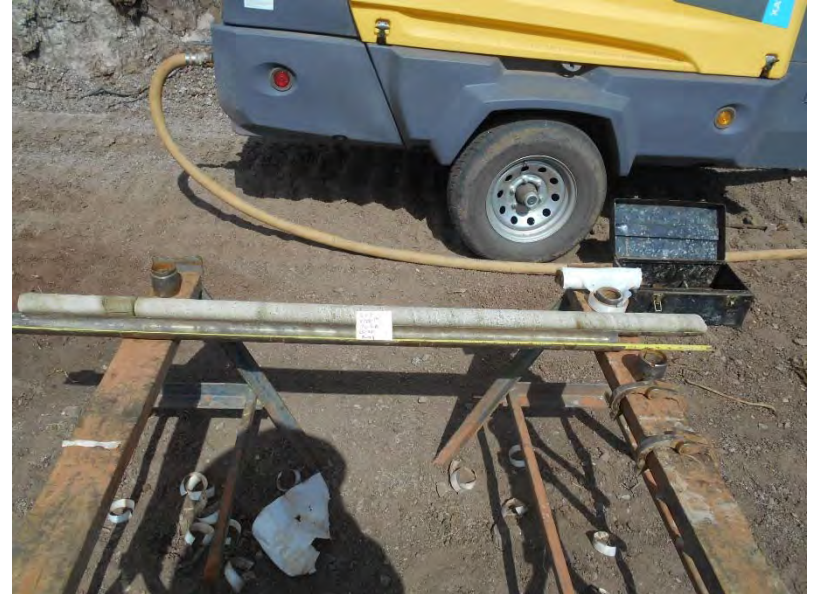
**Photo 46. BC-4 from 25 to 30 feet.**

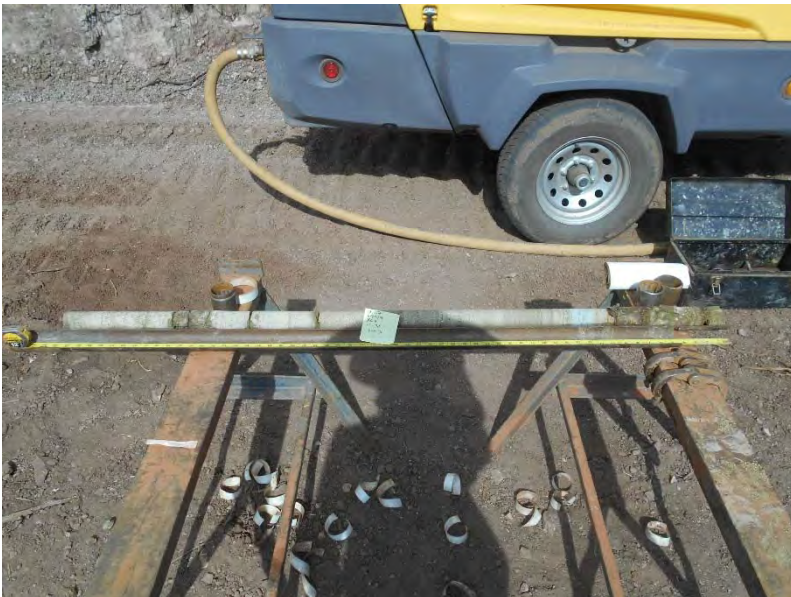
**Photo 47. BC-4 from 30 to 35 feet.**

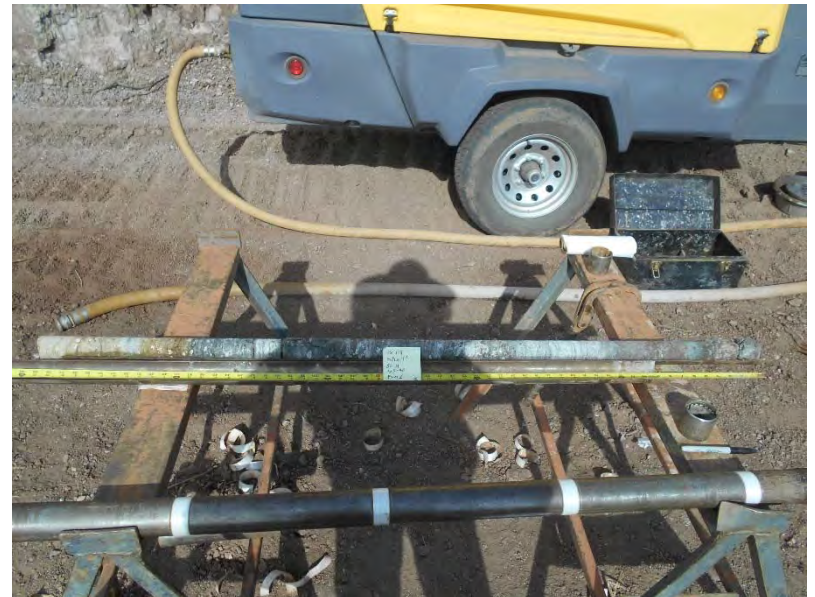
**Photo 48. BC-4 from 35 to 40 feet.**

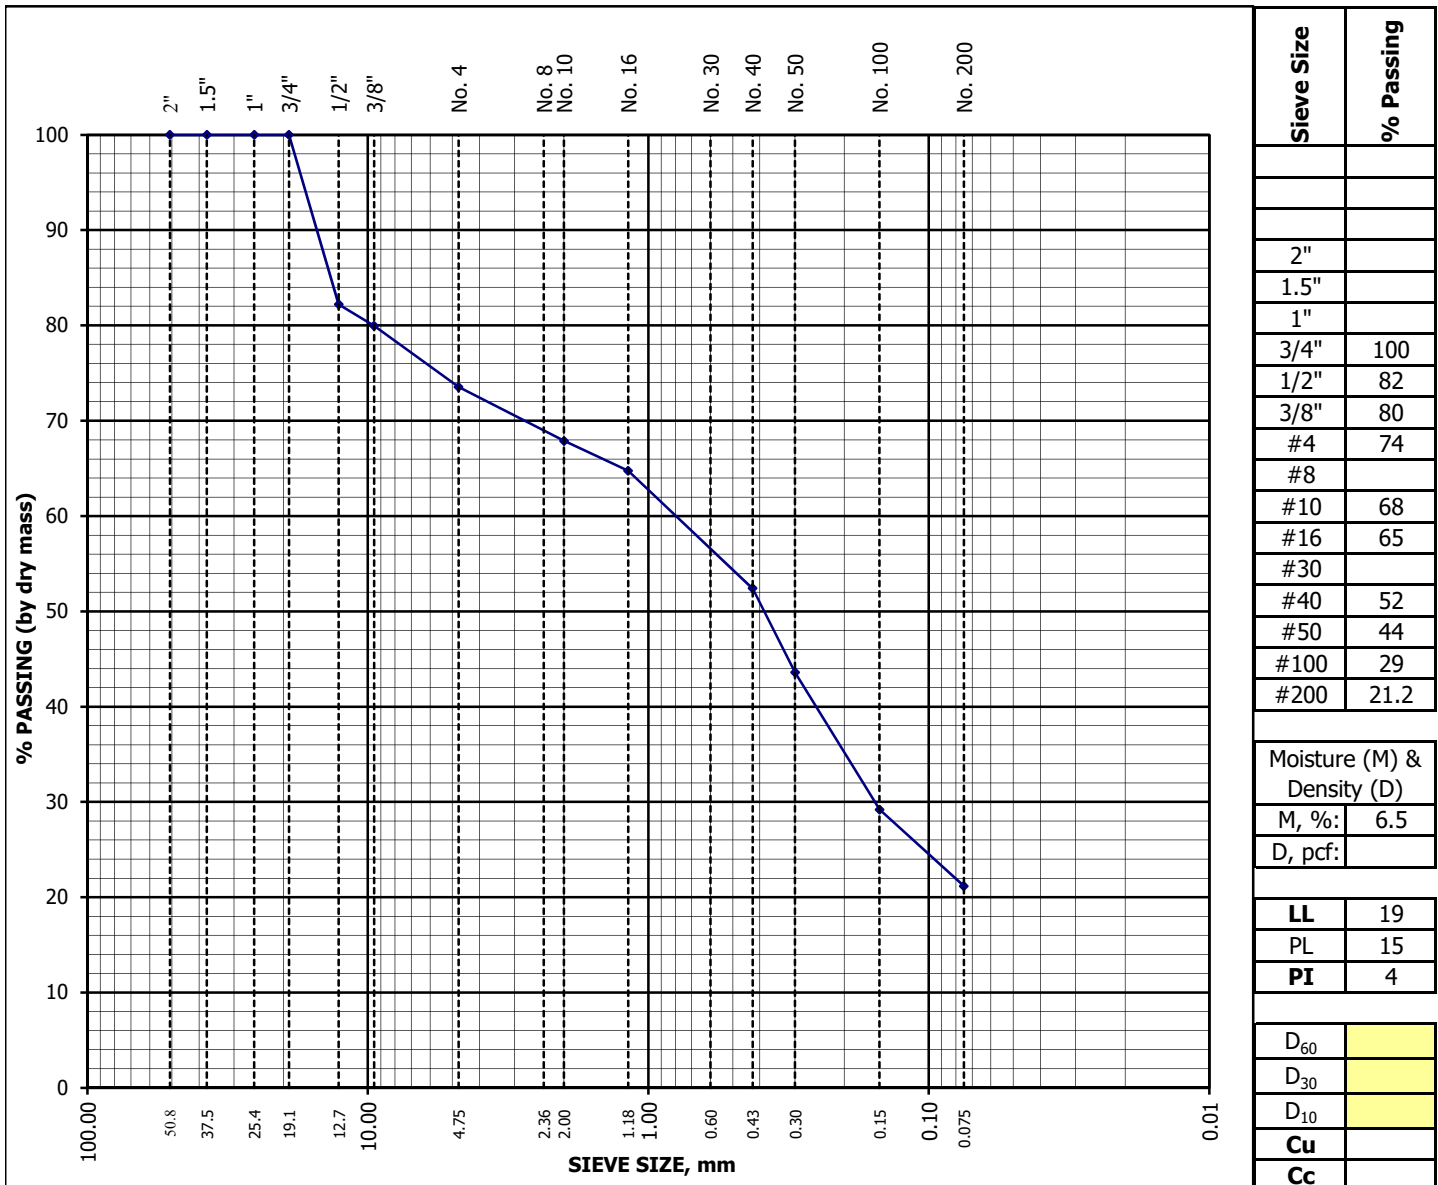
Project Number: 18.117, Applegate Group Date: 8-Sep-18  
Project Name: Cucharas Basin Collaborative Storage Technician: J. Holiman  
Lab ID Number: 1822891 Reviewer: J. Crystal  
Sample Location: B-1 at 7'  
Visual Description: SAND, silty, clayey, reddish brown

**AASHTO M 145 Classification:** A-2-4 **Group Index:** (0)  
**Unified Soil Classification System**  
**(ASTM D 2487):** (SC-SM) Silty, clayey sand

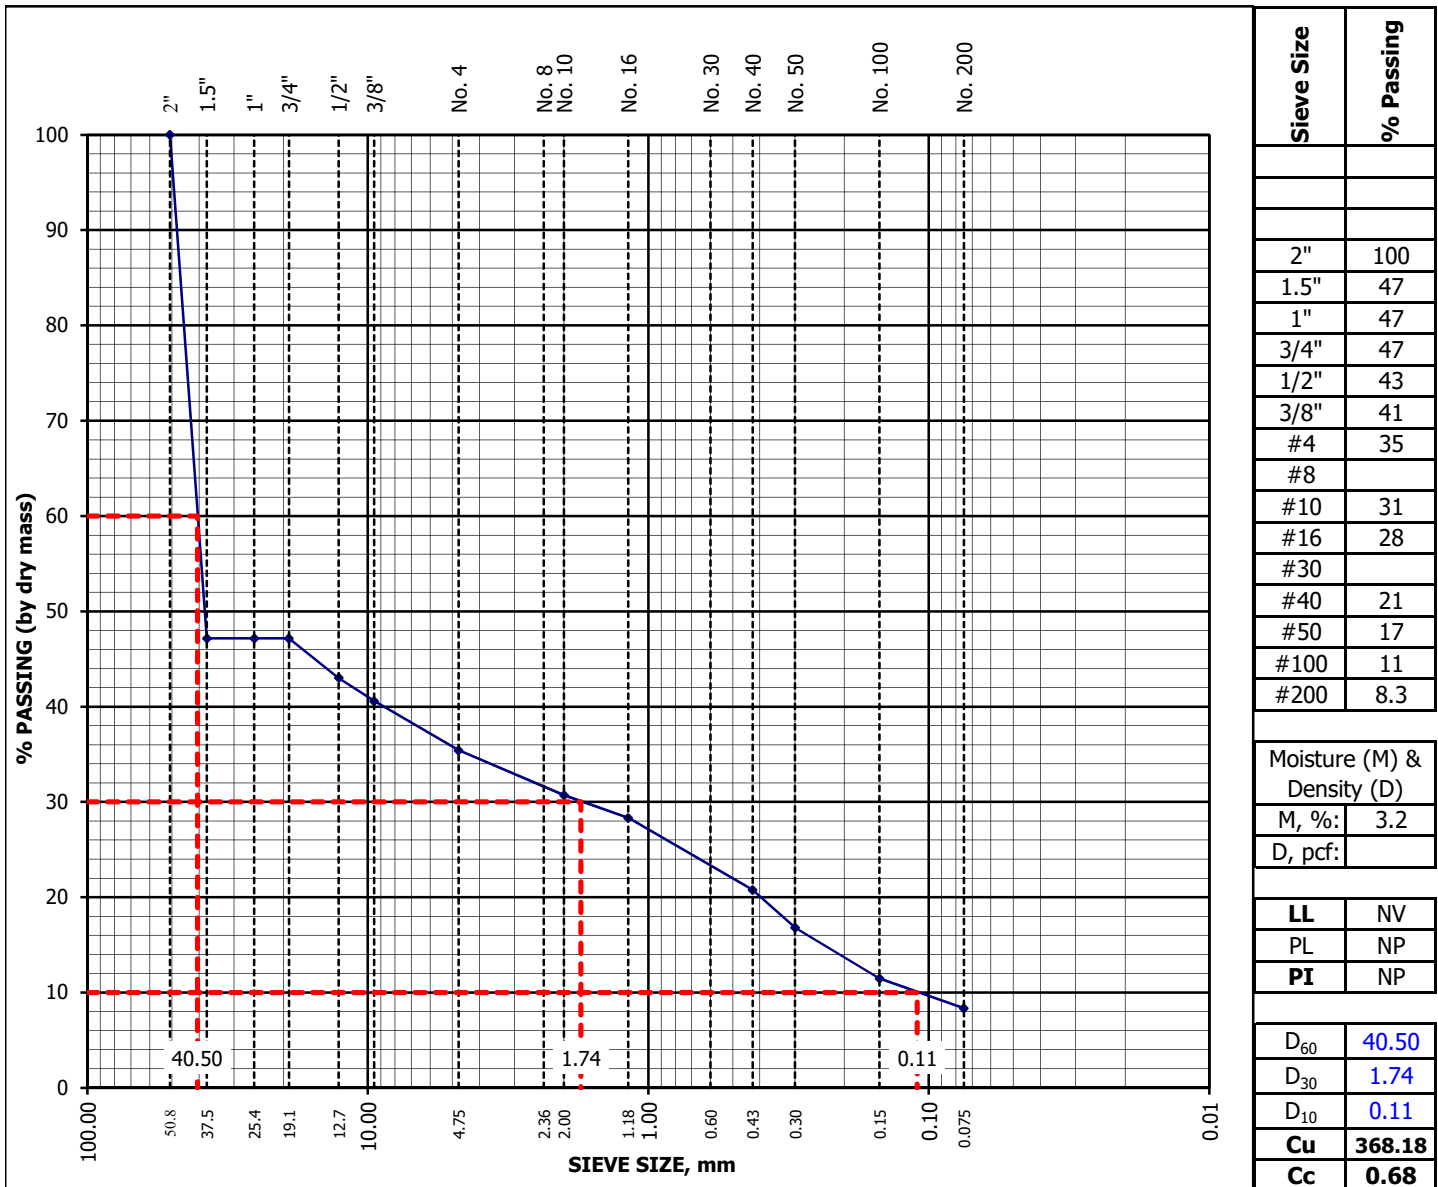
Project Number: 18.117, Applegate Group Date: 8-Sep-18  
Project Name: Cucharas Basin Collaborative Storage Technician: J. Holiman  
Lab ID Number: 1822892 Reviewer: J. Crystal  
Sample Location: B-1 at 17'  
Visual Description: GRAVEL, with silt and sand, reddish brown

**AASHTO M 145 Classification:** A-1-a **Group Index:** 0  
**Unified Soil Classification System**  
**(ASTM D 2487):** (GP-GM) Poorly graded gravel with silt and sand

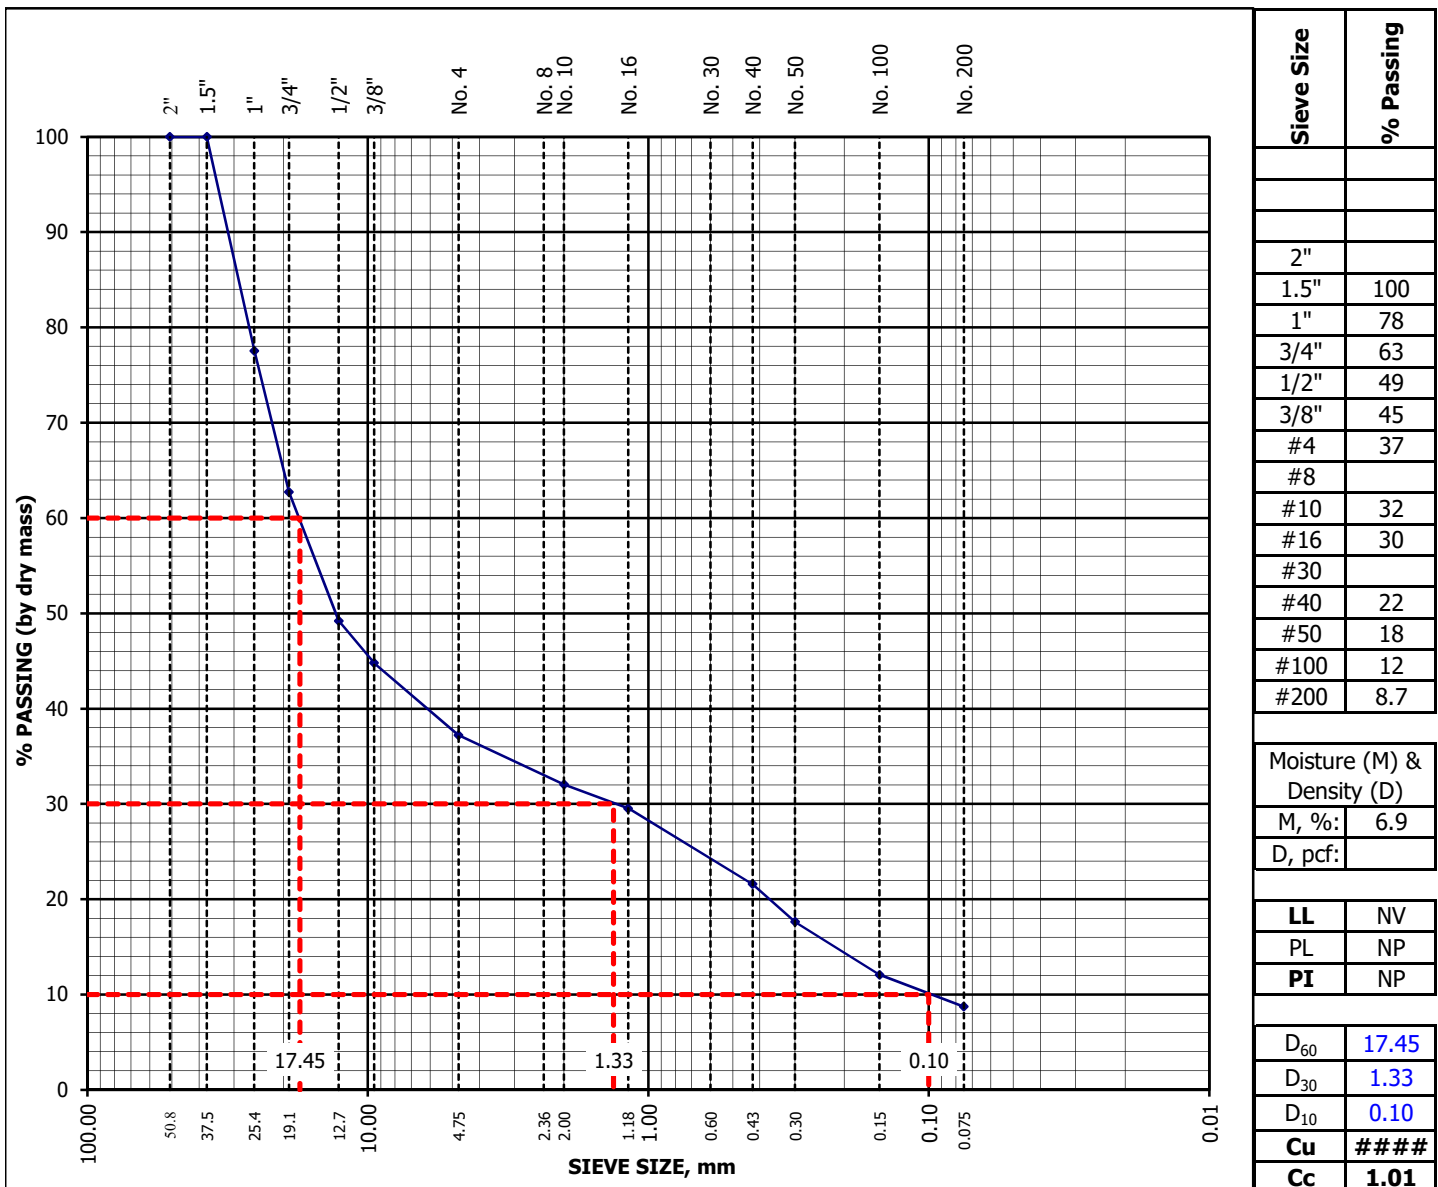
Project Number: 18.117, Applegate Group Date: 5-Sep-18  
Project Name: Cucharas Basin Collaborative Storage Technician: J. Weinerth  
Lab ID Number: 1822893 Reviewer: J. Crystal  
Sample Location: B-2 at 7'  
Visual Description: GRAVEL, with silt and sand, red brown

**AASHTO M 145 Classification:** A-1-a **Group Index:** 0  
**Unified Soil Classification System**  
**(ASTM D 2487):** (GW-GM) Well graded gravel with silt and sand

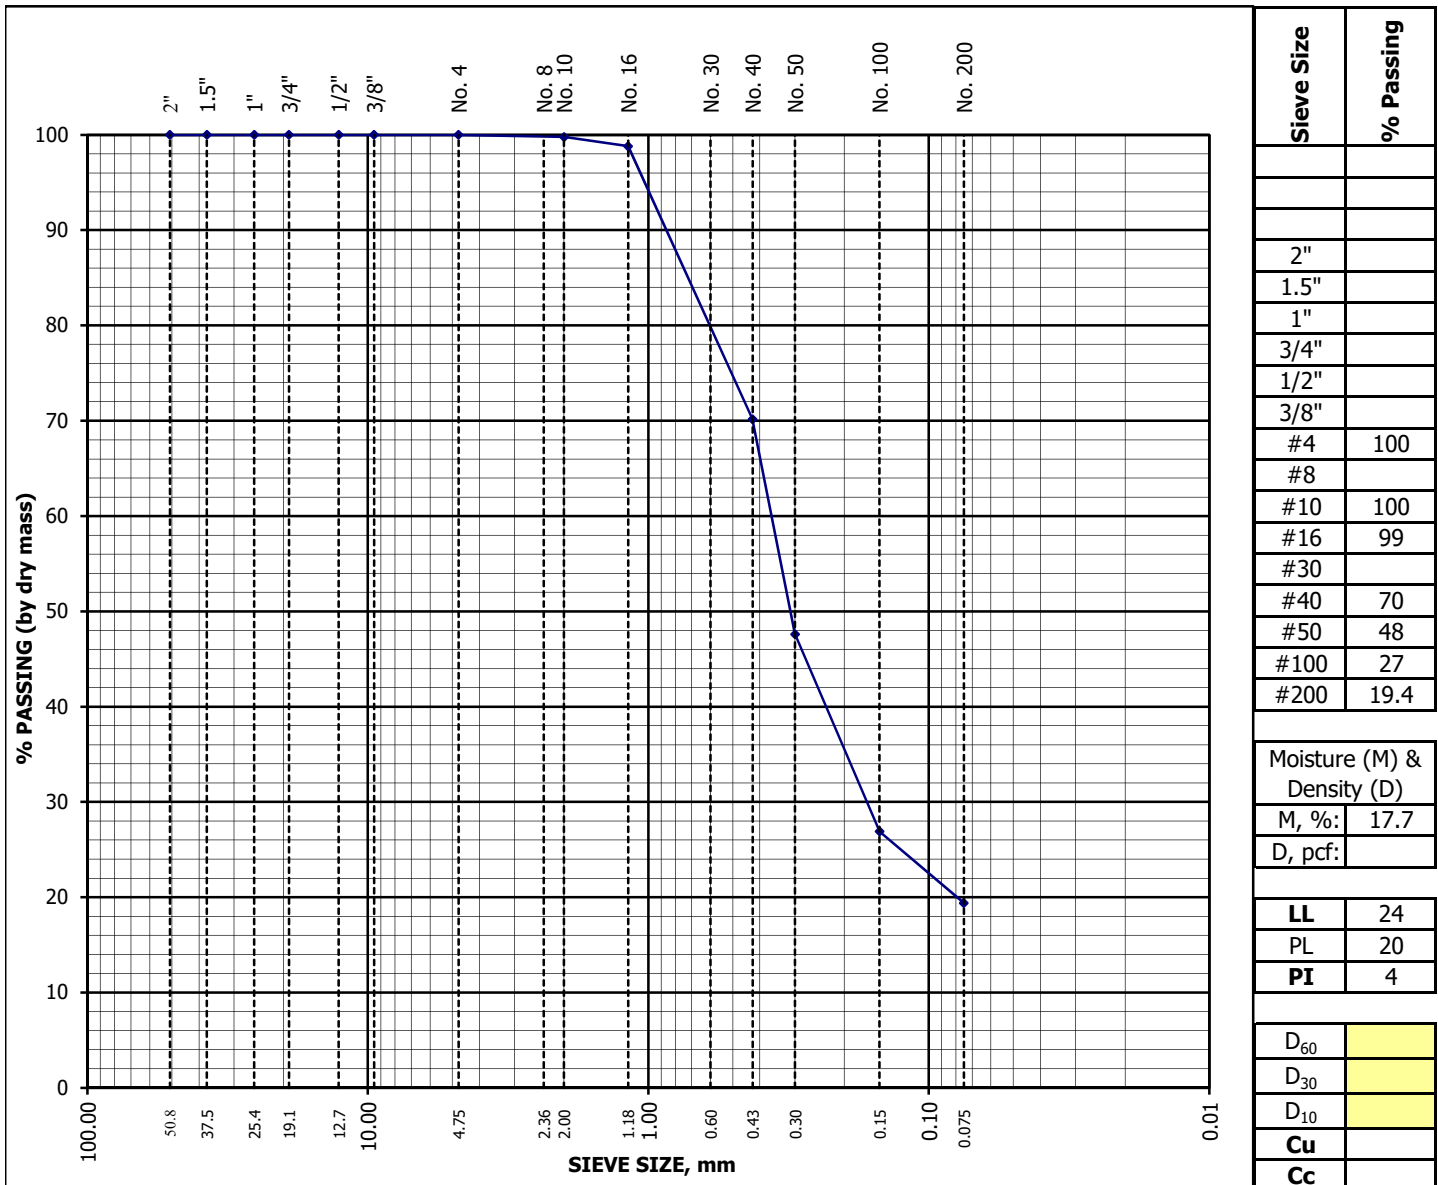
Project Number: 18.117, Applegate Group Date: 8-Sep-18  
Project Name: Cucharas Basin Collaborative Storage Technician: J. Holiman  
Lab ID Number: 1822894 Reviewer: J. Crystal  
Sample Location: B-2 at 12'  
Visual Description: SAND, clay, silty, reddish brown

**AASHTO M 145 Classification:** A-2-4 **Group Index:** (0)  
**Unified Soil Classification System**  
**(ASTM D 2487):** (SC-SM) Silty, clayey sand

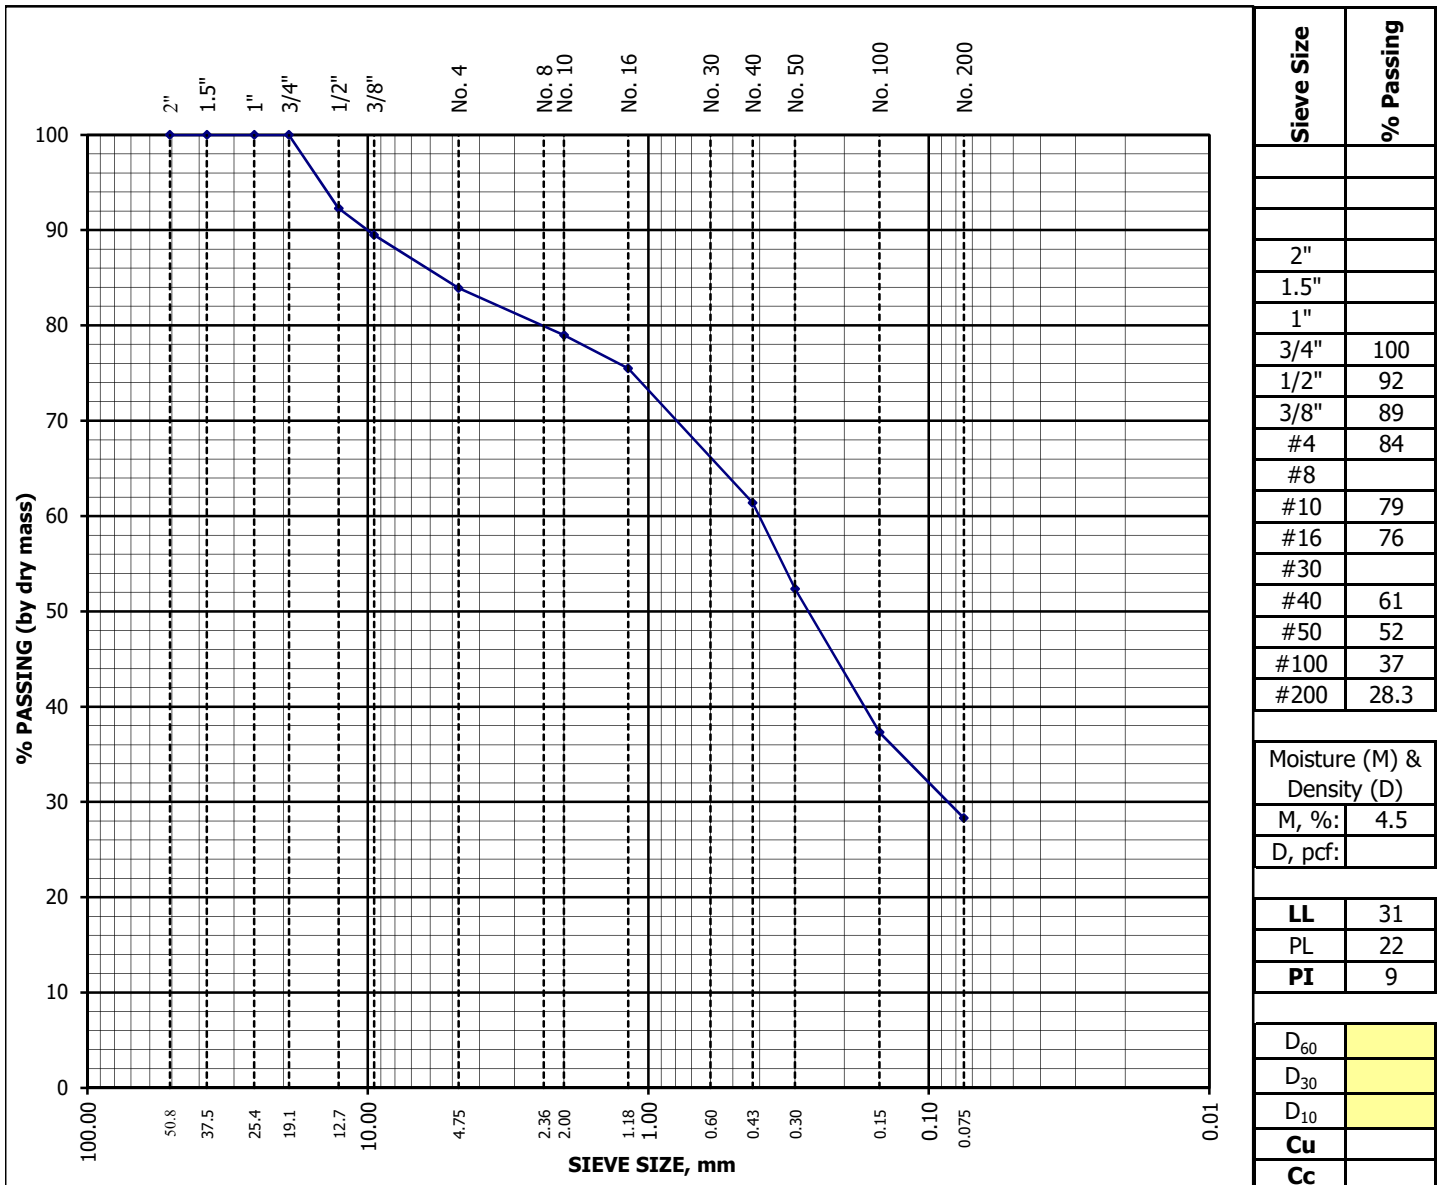
Project Number: 18.117, Applegate Group	Date: 25-Sep-18
Project Name: Cucharas Basin Collaborative Storage	Technician: J. Crystal
Lab ID Number: 1822649	Reviewer: J. Holiman
Sample Location: BP-1 at 1' to 3'	
Visual Description: SAND, clay with gravel, brown

**AASHTO M 145 Classification:** A-2-4 **Group Index:** (0)  
**Unified Soil Classification System**  
**(ASTM D 2487):** (SC) **Clayey sand with gravel**

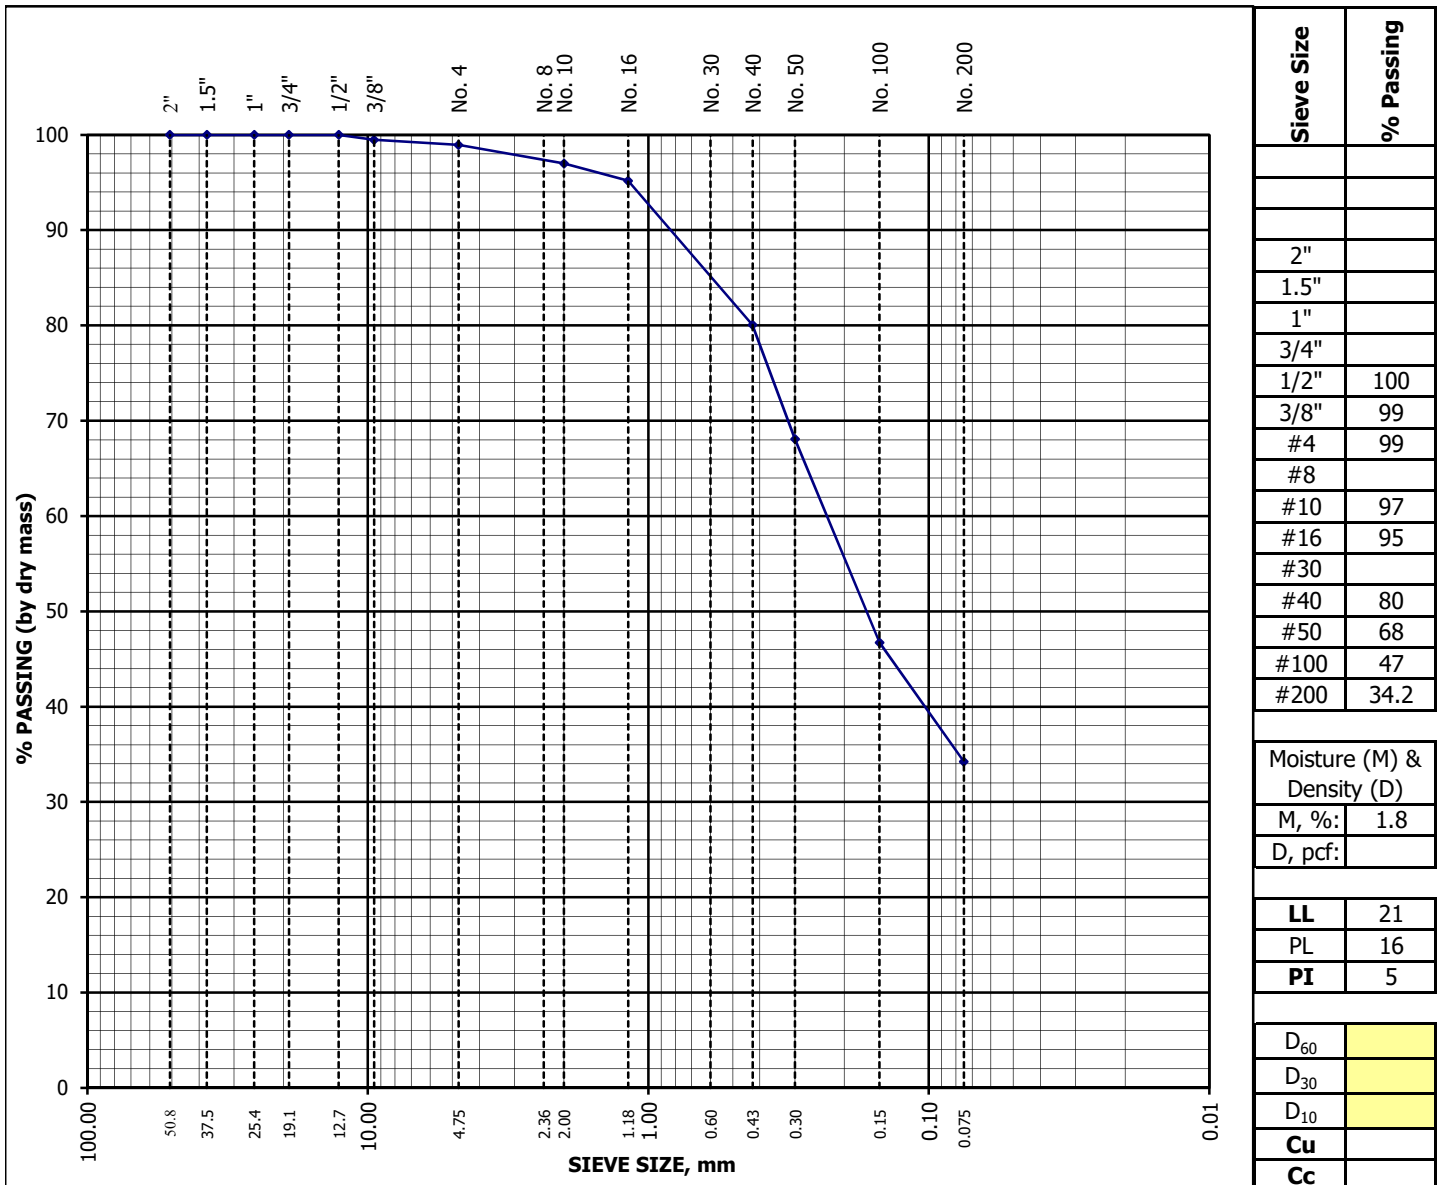
## GRADATION PLOT - SOIL & AGGREGATE

Project Number:	18.117, Applegate Group	Date:	25-Sep-18
Project Name:	Cucharas Basin Collaborative Storage	Technician:	J. Holiman
Lab ID Number:	1822650	Reviewer:	J. Crystal
Sample Location:	BP-3 at 2' to 5'		
Visual Description:	SAND, silty, clayey, brown

**AASHTO M 145 Classification:** A-2-4 **Group Index:** (0)  
**Unified Soil Classification System**  
**(ASTM D 2487):** (SC-SM) Silty, clayey sand

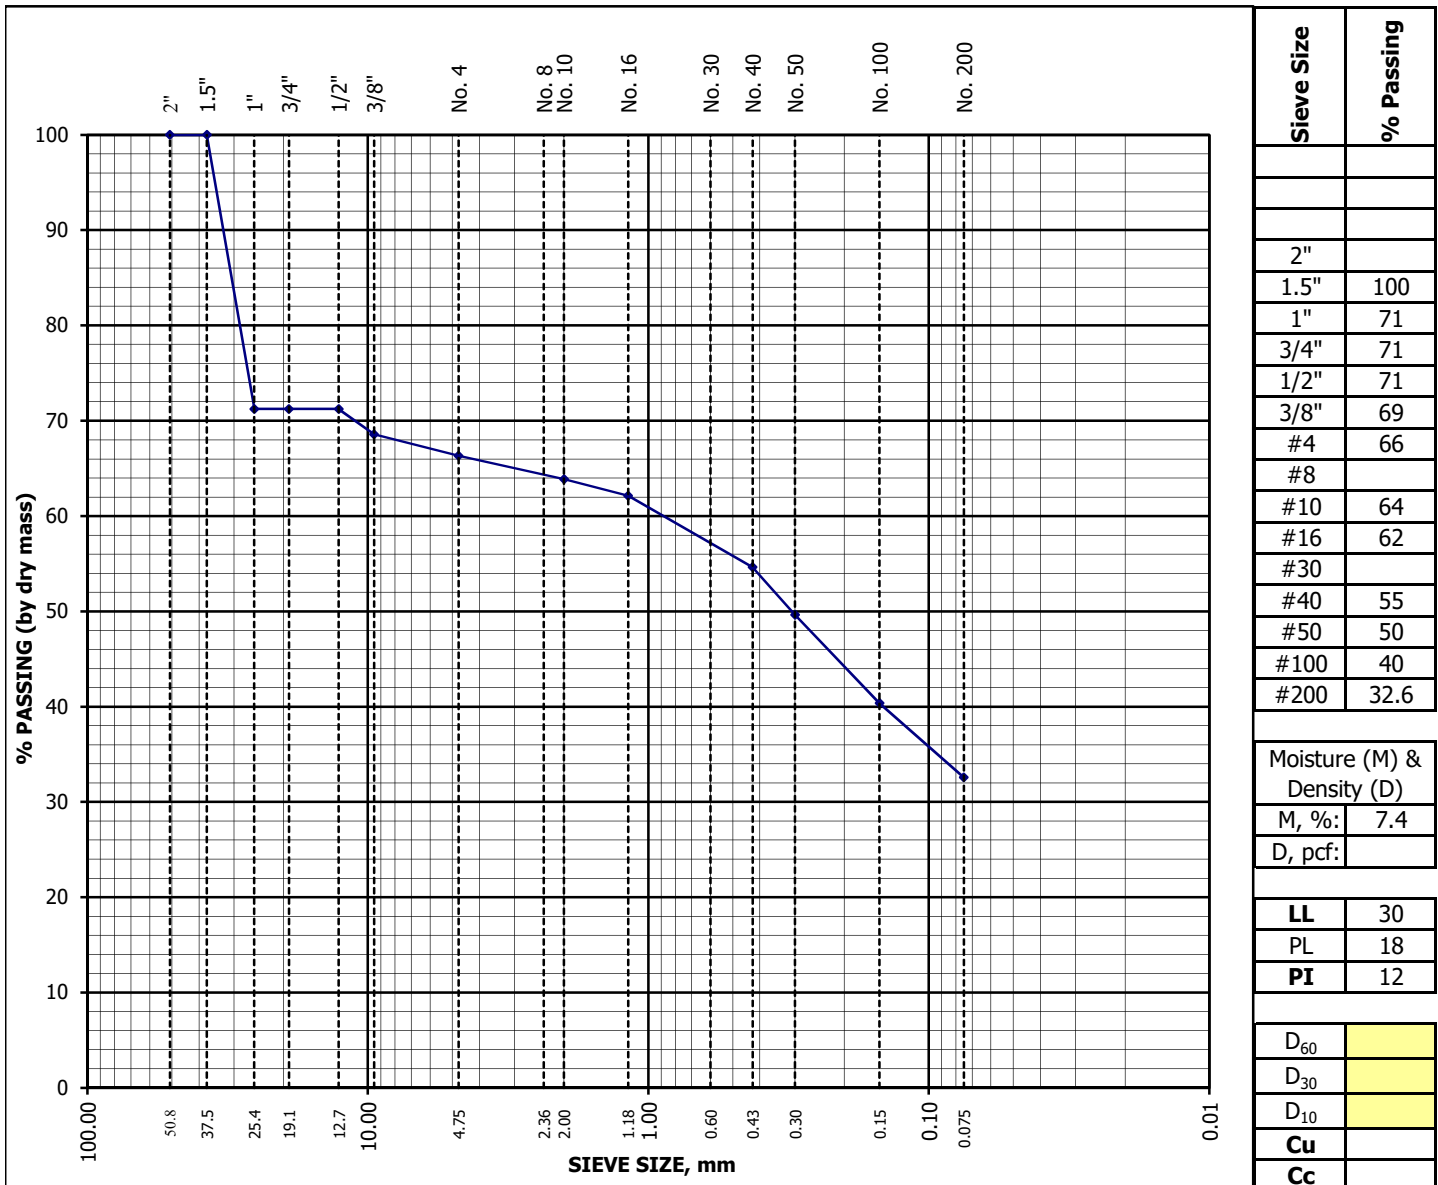
## GRADATION PLOT - SOIL & AGGREGATE

Project Number:	18.117, Applegate Group	Date:	6-Oct-18
Project Name:	Cucharas Basin Collaborative Storage	Technician:	J. Holiman
Lab ID Number:	1822651	Reviewer:	J. Crystal
Sample Location:	BP-5 at 3.5' to 5'		
Visual Description:	SAND, clayey, with gravel, red brown

**AASHTO M 145 Classification:** A-2-6 **Group Index:** (0)  
**Unified Soil Classification System**  
**(ASTM D 2487):** (SC) **Clayey sand with gravel**

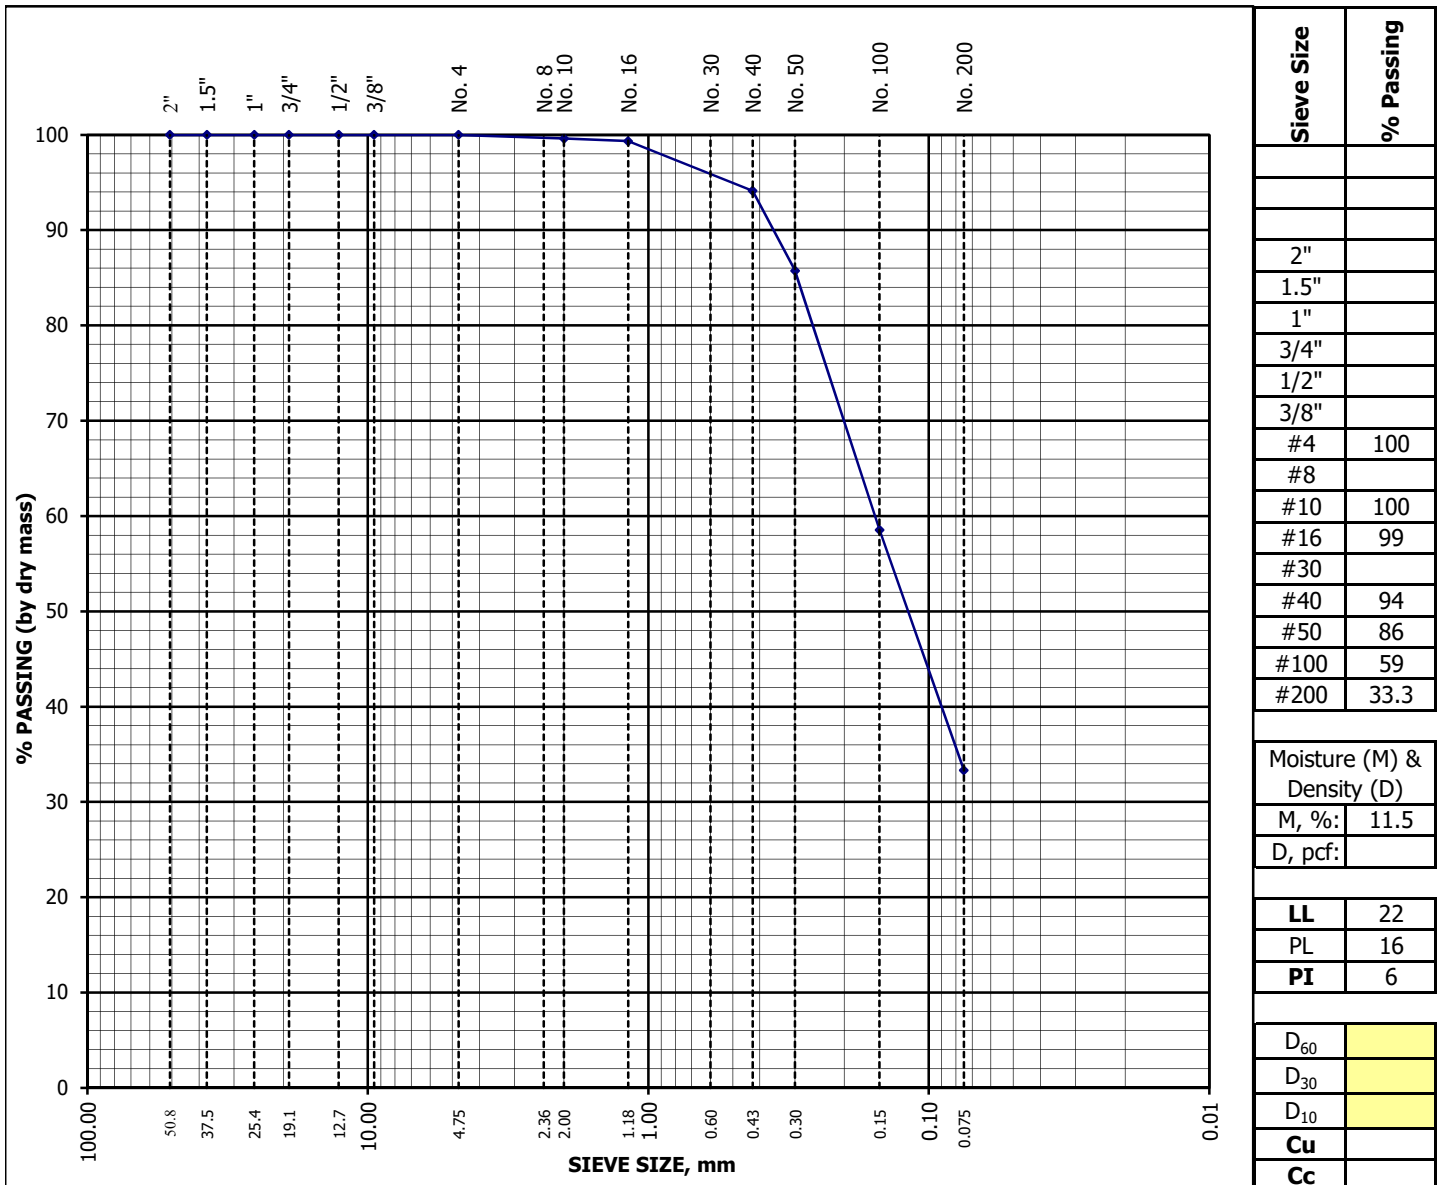
## GRADATION PLOT - SOIL & AGGREGATE

Project Number: 18.117, Applegate Group Date: 5-Sep-18  
Project Name: Cucharas Basin Collaborative Storage Technician: J. Weinerth  
Lab ID Number: 1822871 Reviewer: J. Crystal  
Sample Location: BC-1 at 5'  
Visual Description: SAND, clayey, brown

**AASHTO M 145 Classification:** A-2-4 **Group Index:** (0)  
**Unified Soil Classification System**  
**(ASTM D 2487):** (SC) **Clayey sand**

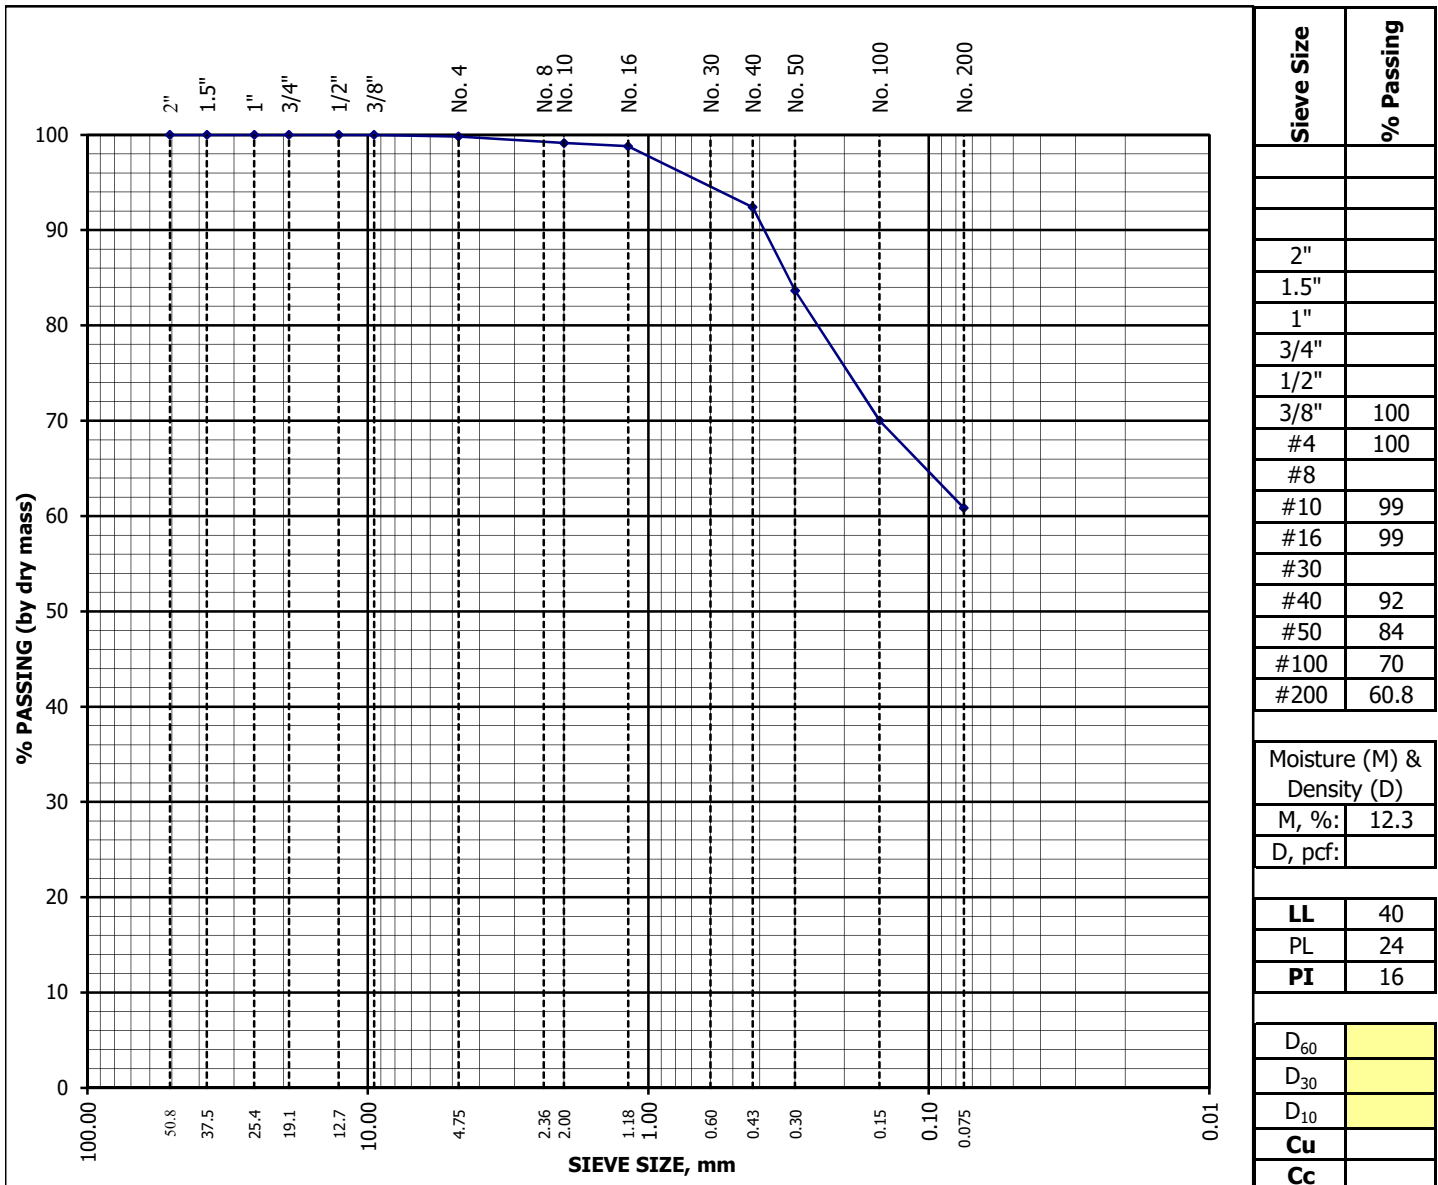
## GRADATION PLOT - SOIL & AGGREGATE

Project Number: 18.117, Applegate Group Date: 5-Sep-18  
Project Name: Cucharas Basin Collaborative Storage Technician: J. Weinerth  
Lab ID Number: 1822872 Reviewer: J. Crystal  
Sample Location: BC-1 at 25'  
Visual Description: CLAYSTONE: CLAY, sandy, red

**AASHTO M 145 Classification:** A-6 **Group Index:** 8  
**Unified Soil Classification System**  
**(ASTM D 2487):** (CL) **Sandy lean clay**

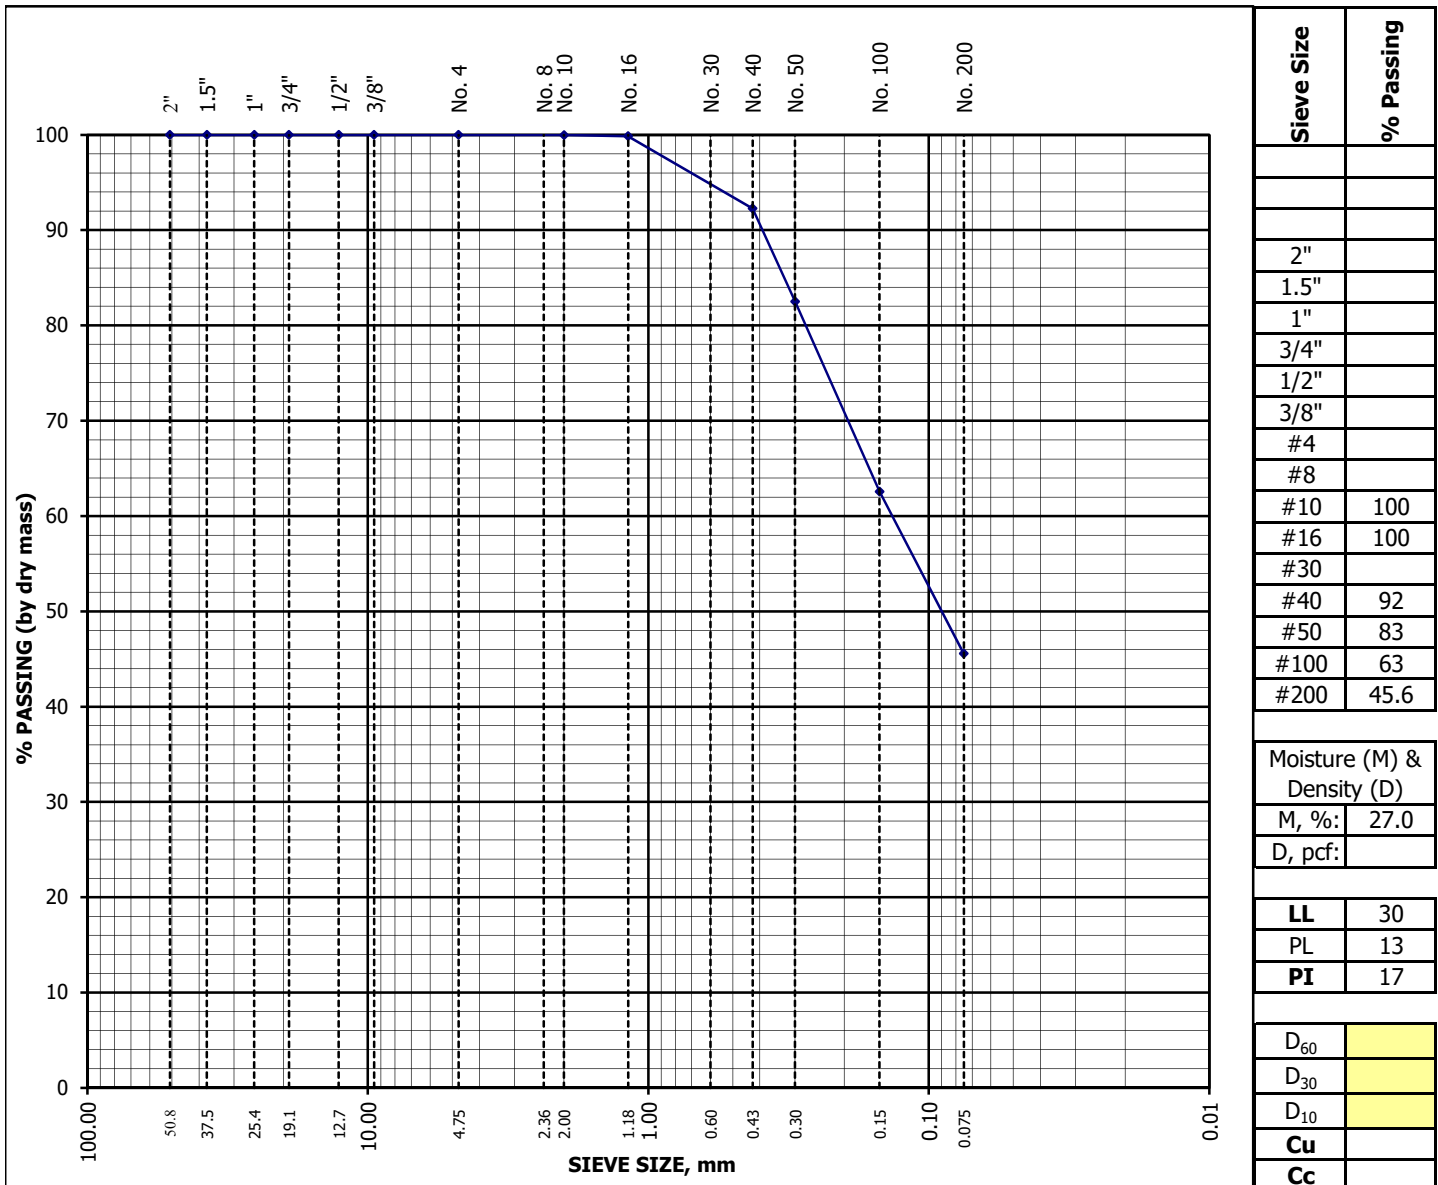
## GRADATION PLOT - SOIL & AGGREGATE

Project Number: 18.117, Applegate Group	Date: 5-Sep-18
Project Name: Cucharas Basin Collaborative Storage	Technician: J. Weinerth
Lab ID Number: 1822873	Reviewer: J. Crystal
Sample Location: BC-2 at 5'	
Visual Description: SAND, clayey, brown

**AASHTO M 145 Classification:** A-6 **Group Index:** 4  
**Unified Soil Classification System**  
**(ASTM D 2487):** (SC) Clayey sand
