# *South Baker Creek Dam*

## 30% Design Report

### Huerfano County Water Conservancy District

AG JOB No. 18-117

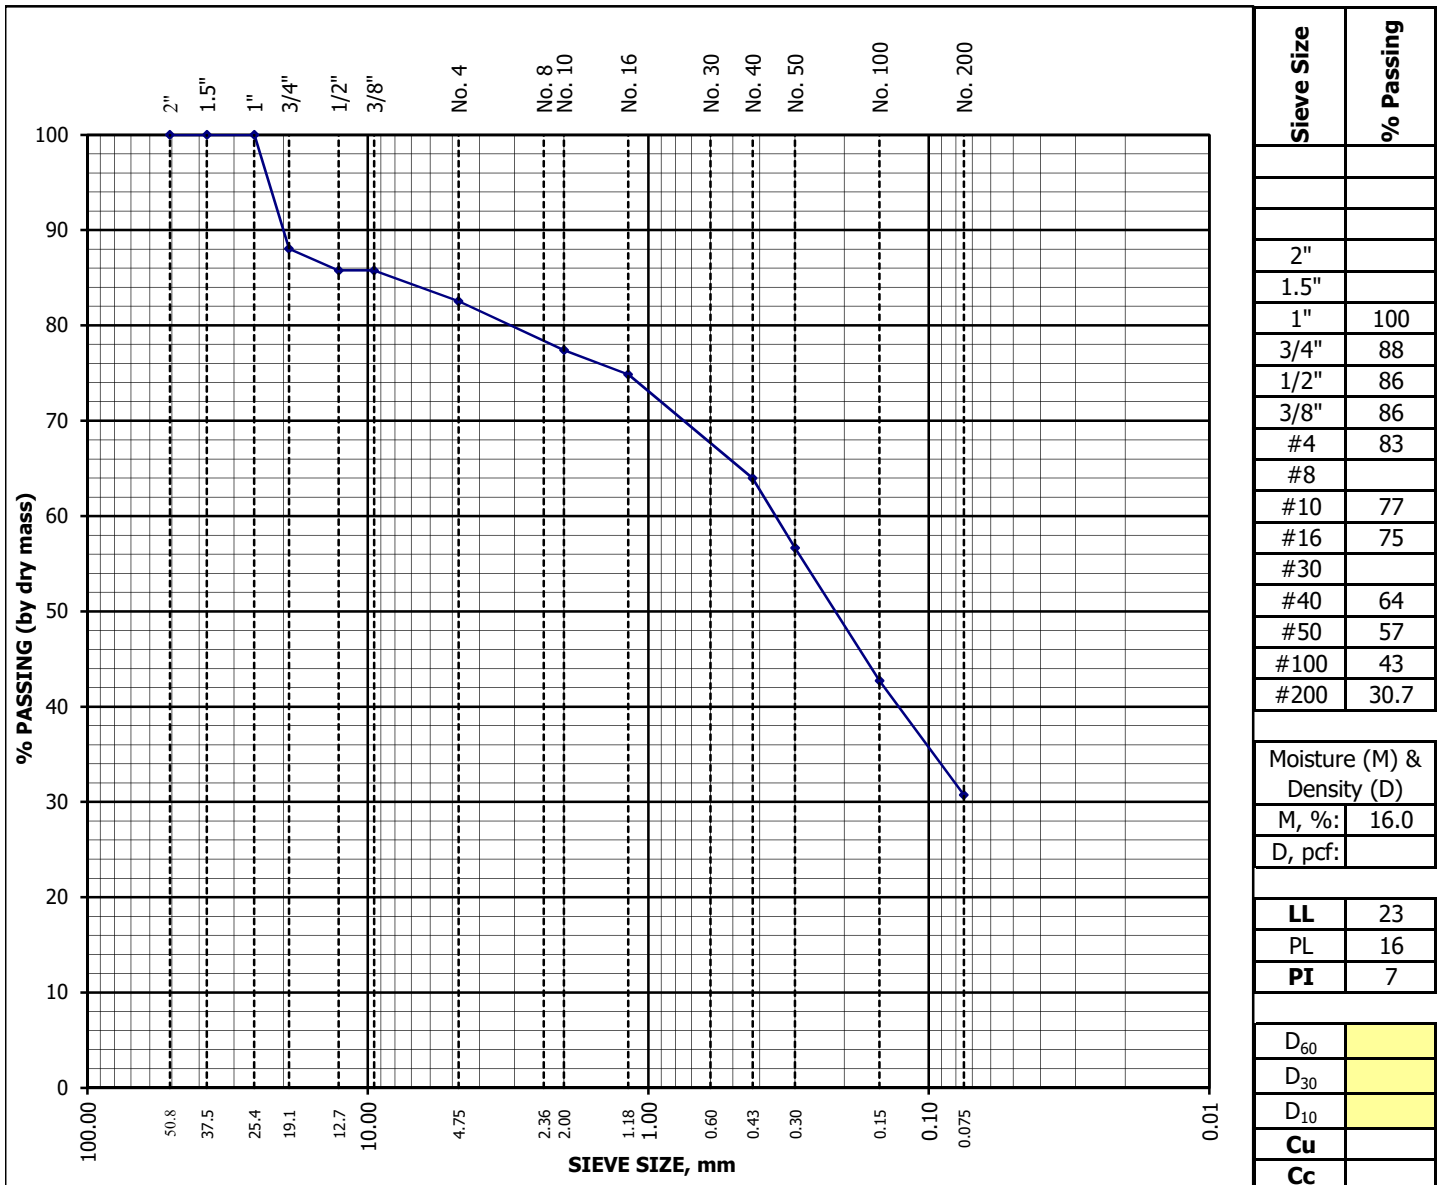
## GRADATION PLOT - SOIL & AGGREGATE

Project Number: 18.117, Applegate Group	Date: 5-Sep-18
Project Name: Cucharas Basin Collaborative Storage	Technician: J. Weinerth
Lab ID Number: 1822874	Reviewer: J. Crystal
Sample Location: BC-2 at 10'	
Visual Description: SAND, clayey, with gravel, brown

**AASHTO M 145 Classification:** A-2-4 **Group Index:** (0)  
**Unified Soil Classification System**  
**(ASTM D 2487):** (SC) **Clayey sand with gravel**

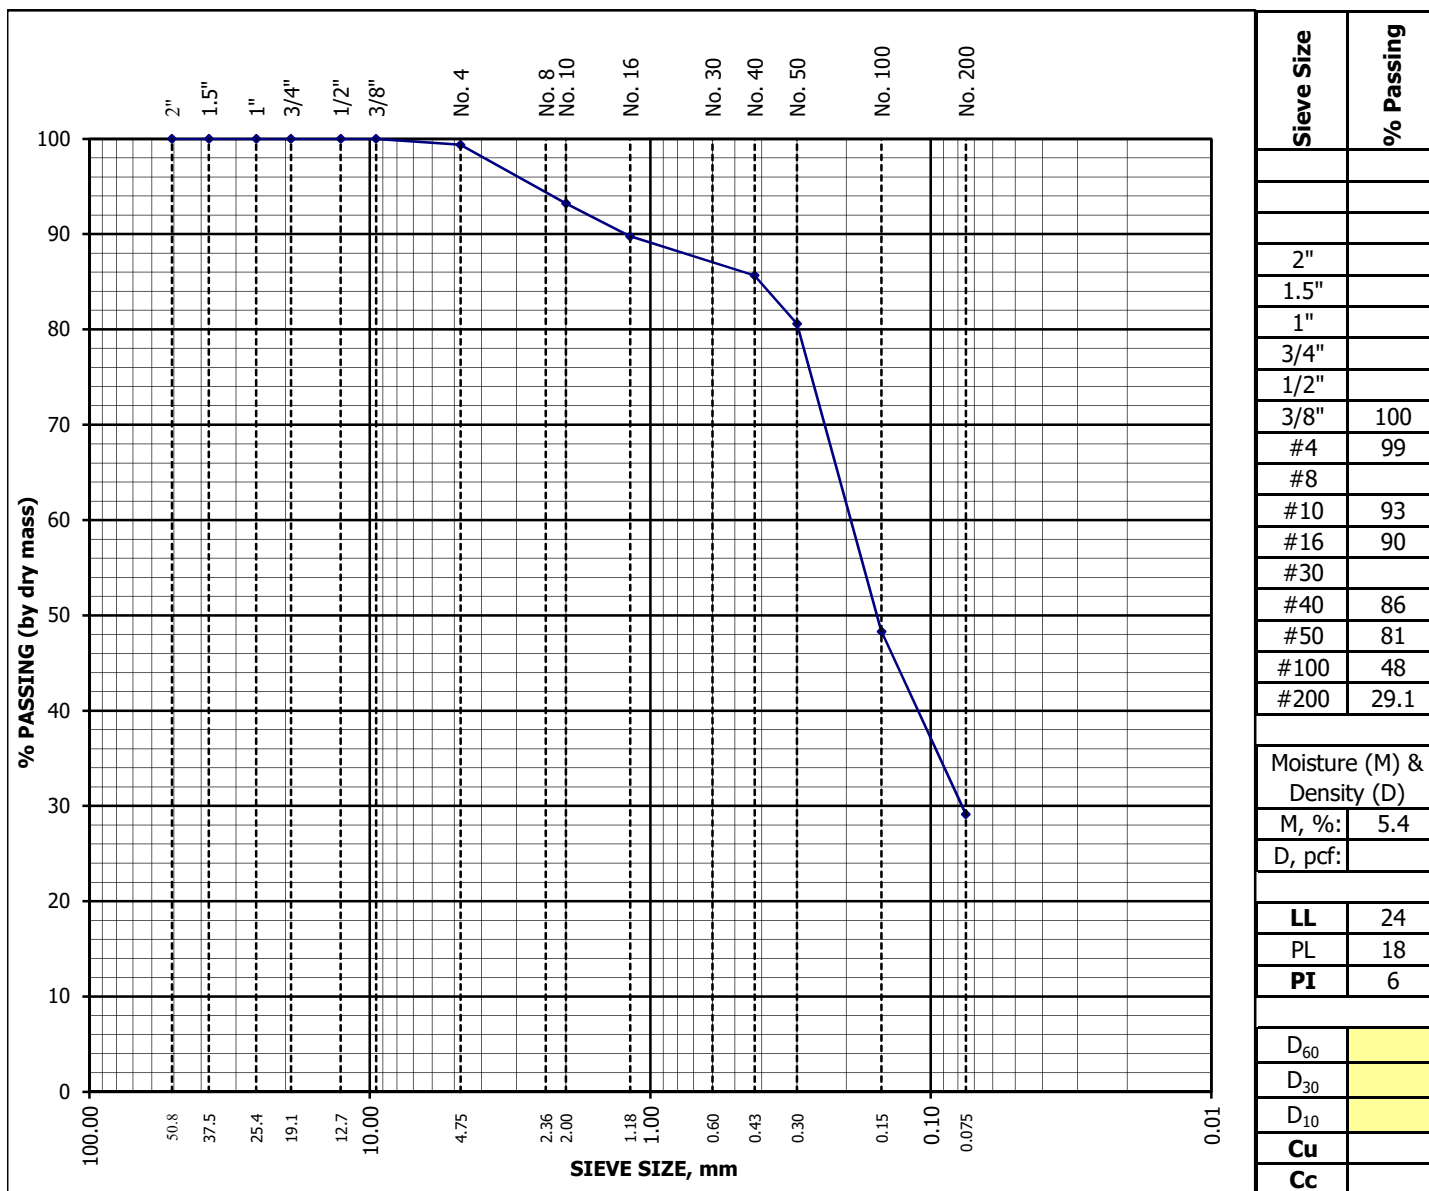
## GRADATION PLOT - SOIL & AGGREGATE

Project Number: 18.117, Applegate Group Date: 5-Sep-18  
Project Name: Cucharas Basin Collaborative Storage Technician: J. Weinerth  
Lab ID Number: 1822875 Reviewer: J. Crystal  
Sample Location: BC-3 at 5'  
Visual Description: SAND, silty, clayey, brown

**AASHTO M 145 Classification:** A-2-4 **Group Index:** (0)  
**Unified Soil Classification System**  
**(ASTM D 2487):** (SC-SM) Silty, clayey sand

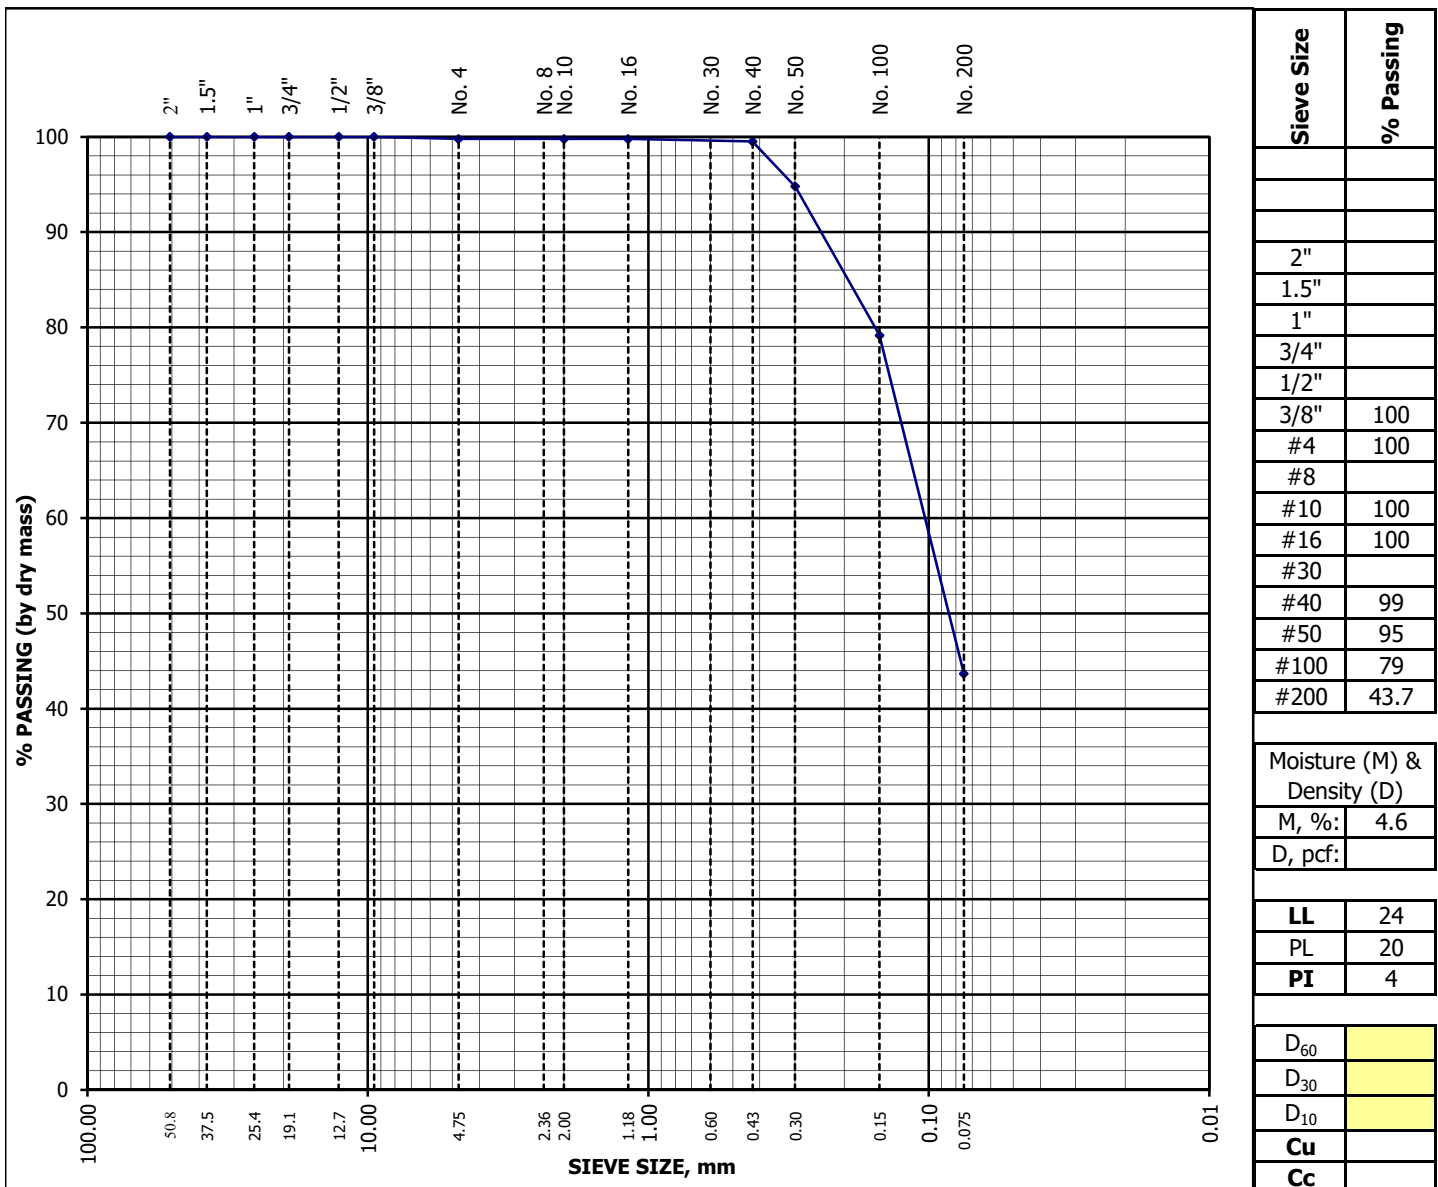
## GRADATION PLOT - SOIL & AGGREGATE

Project Number: 18.117, Applegate Group	Date: 5-Sep-18
Project Name: Cucharas Basin Collaborative Storage	Technician: J. Weinerth
Lab ID Number: 1822876	Reviewer: J. Crystal
Sample Location: BC-3 at 15'	
Visual Description: SANDSTONE, silty, clayey, brown

**AASHTO M 145 Classification:** A-4 **Group Index:** (0)  
**Unified Soil Classification System**  
**(ASTM D 2487):** (SC-SM) Silty, clayey sand

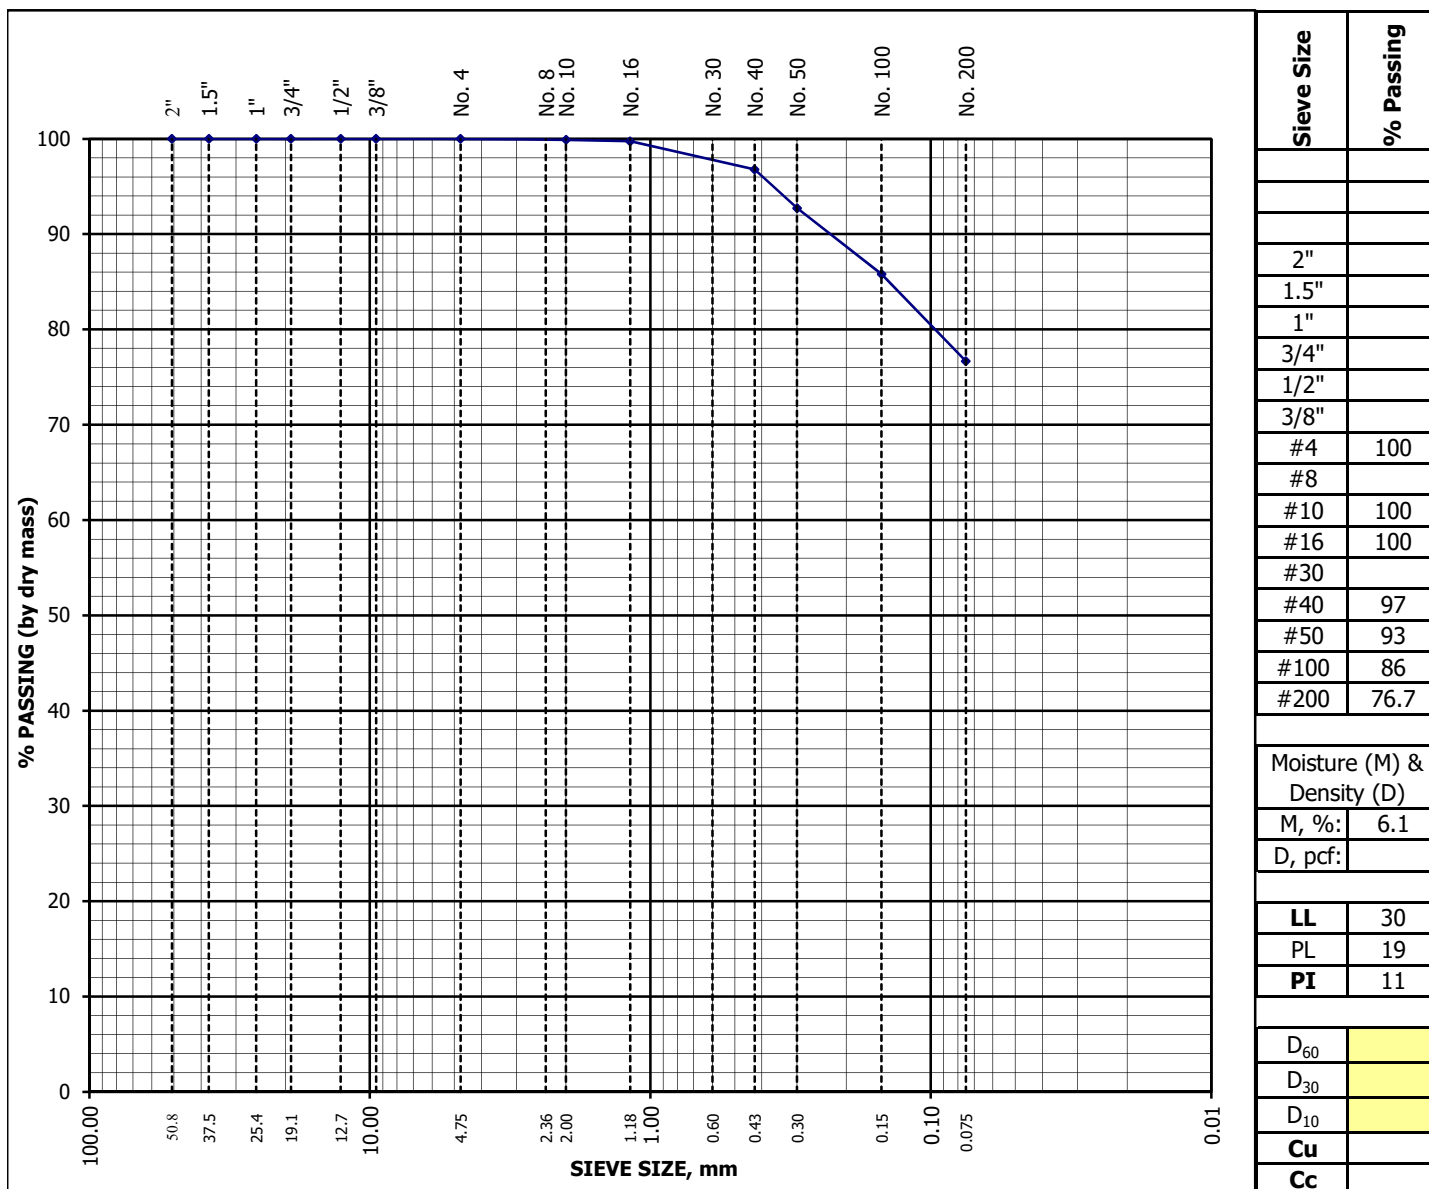
## GRADATION PLOT - SOIL & AGGREGATE

Project Number: 18.117, Applegate Group Date: 9-Sep-19  
Project Name: Cucharas Basin Collaborative Storage Technician: C. Zoetewey  
Lab ID Number: 1921469 Reviewer: J. Crystal  
Sample Location: BC-4 at 10'  
Visual Description: CLAY, with sand, brown

**AASHTO M 145 Classification:** A-6 **Group Index:** 7  
**Unified Soil Classification System**  
**(ASTM D 2487):** (CL) **Lean clay with sand**

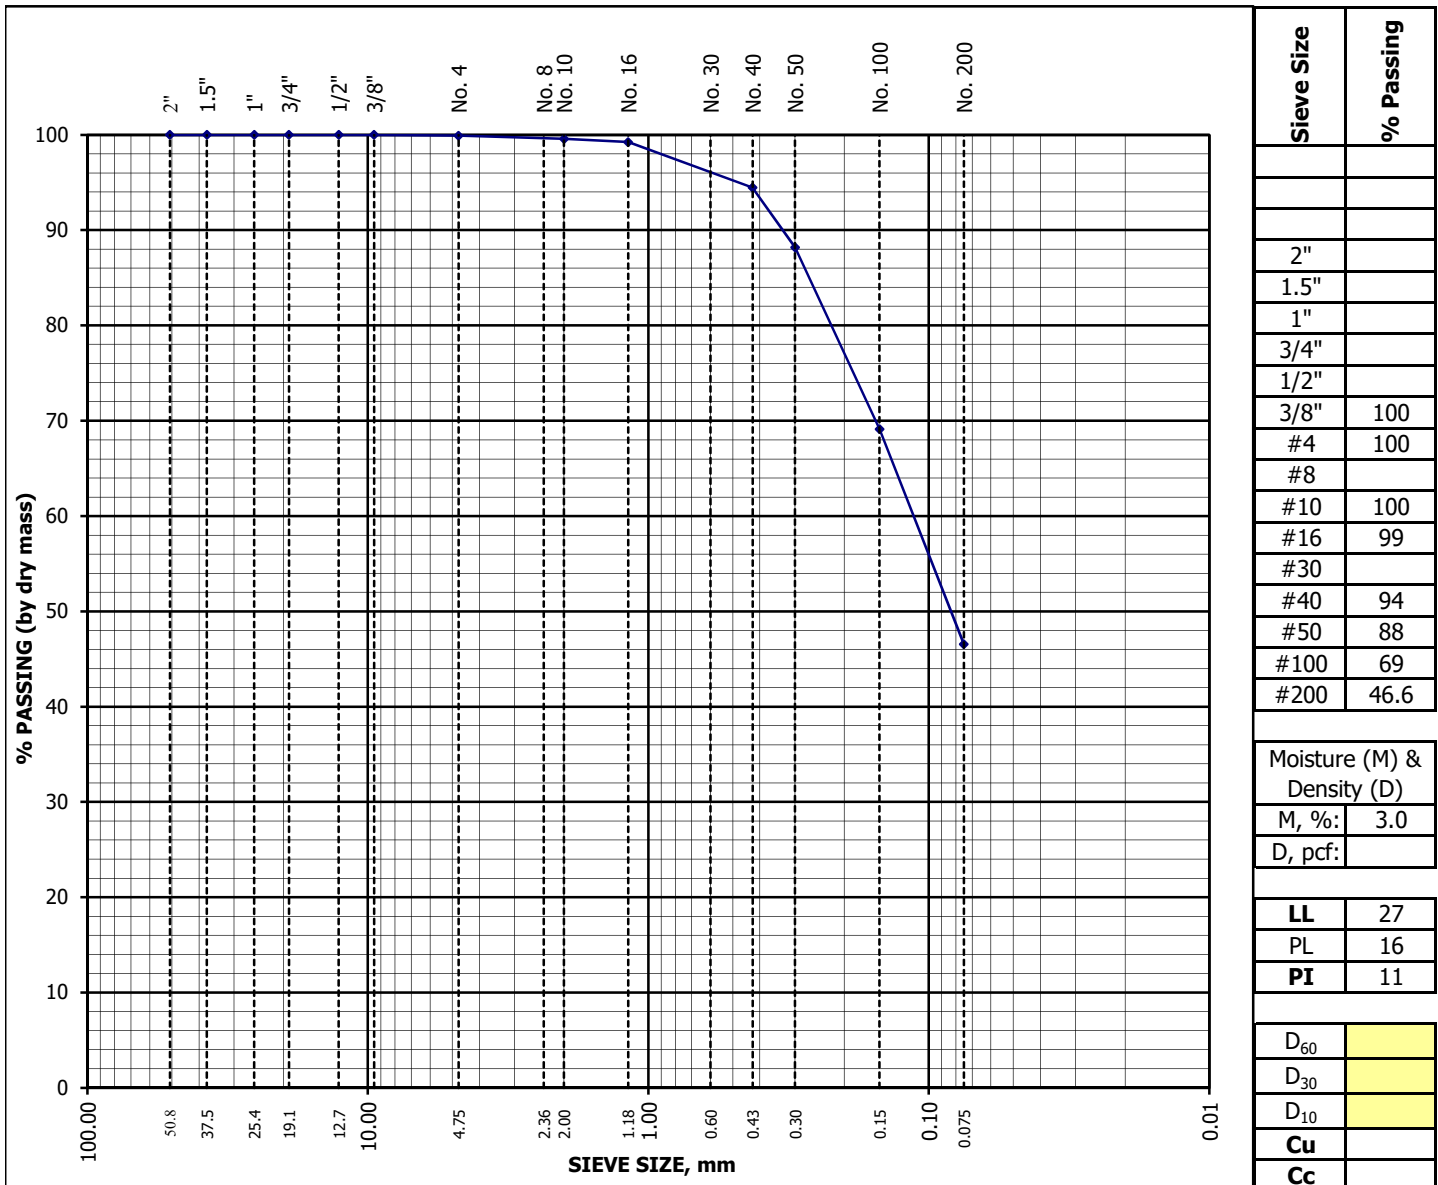
## GRADATION PLOT - SOIL & AGGREGATE

Project Number: 18.117, Applegate Group Date: 25-Sep-18  
Project Name: Cucharas Basin Collaborative Storage Technician: J. Holiman  
Lab ID Number: 1822652 Reviewer: J. Crystal  
Sample Location: BCP-1 at 1' to 8'  
Visual Description: SAND, clayey, brown

**AASHTO M 145 Classification:** A-6 **Group Index:** 2  
**Unified Soil Classification System**  
**(ASTM D 2487):** (SC) Clayey sand

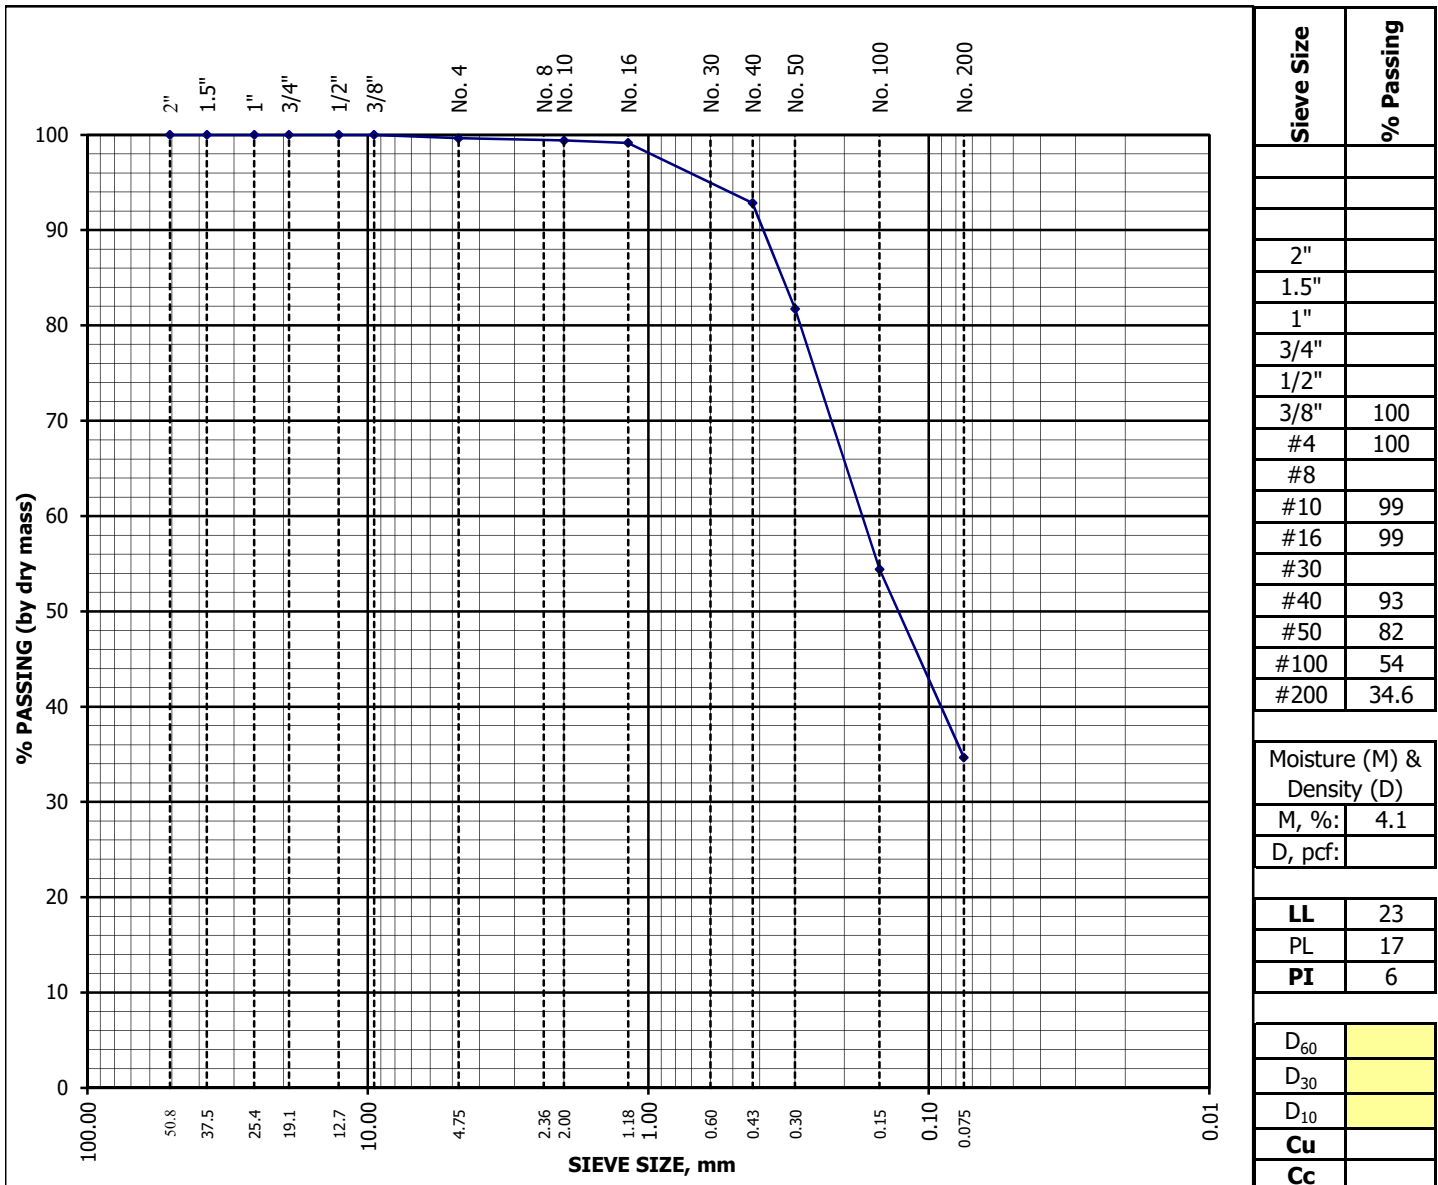
## GRADATION PLOT - SOIL & AGGREGATE

Project Number: 18.117, Applegate Group Date: 25-Sep-18  
Project Name: Cucharas Basin Collaborative Storage Technician: J. Holiman  
Lab ID Number: 1822653 Reviewer: J. Crystal  
Sample Location: BCP-2 at 2' to 10'  
Visual Description: SAND, silty, clayey, brown

**AASHTO M 145 Classification:** A-2-4 **Group Index:** (0)  
**Unified Soil Classification System**  
**(ASTM D 2487):** (SC-SM) Silty, clayey sand

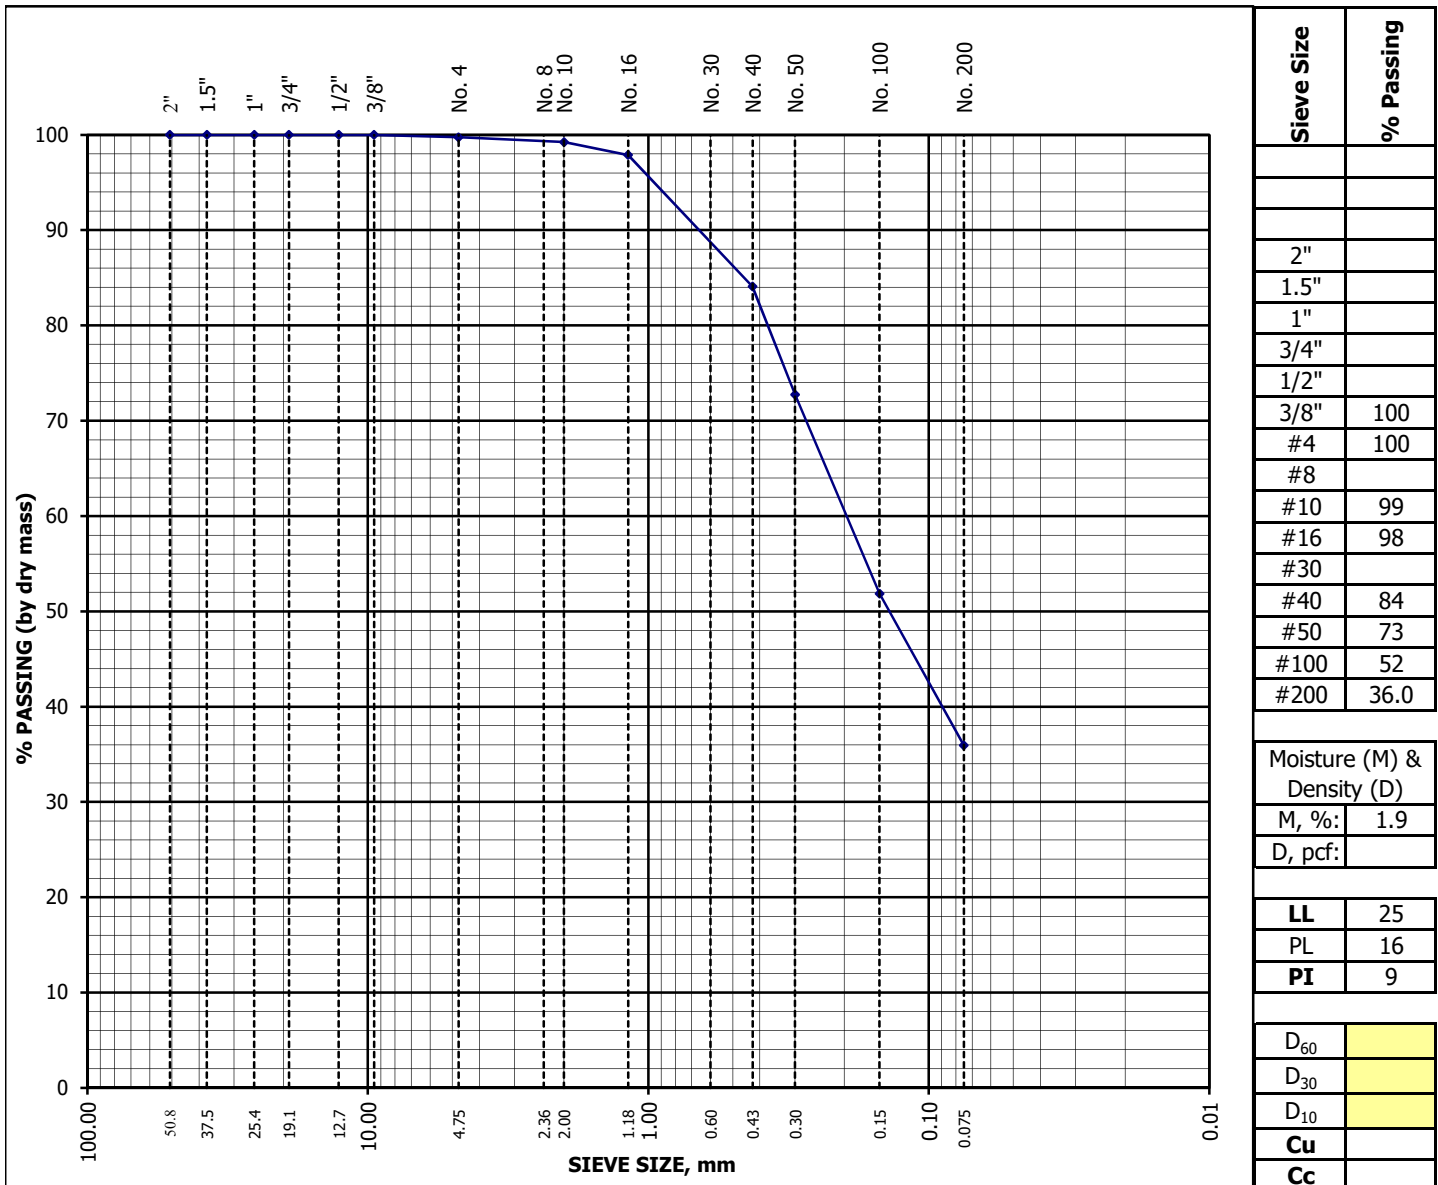
## GRADATION PLOT - SOIL & AGGREGATE

Project Number: 18.117, Applegate Group Date: 25-Sep-18  
Project Name: Cucharas Basin Collaborative Storage Technician: J. Holiman  
Lab ID Number: 1822654 Reviewer: J. Crystal  
Sample Location: BCP-4 at 2' to 8'  
Visual Description: SAND, clayey, red brown

**AASHTO M 145 Classification:** A-4 **Group Index:** (0)  
**Unified Soil Classification System**  
**(ASTM D 2487):** (SC) **Clayey sand**

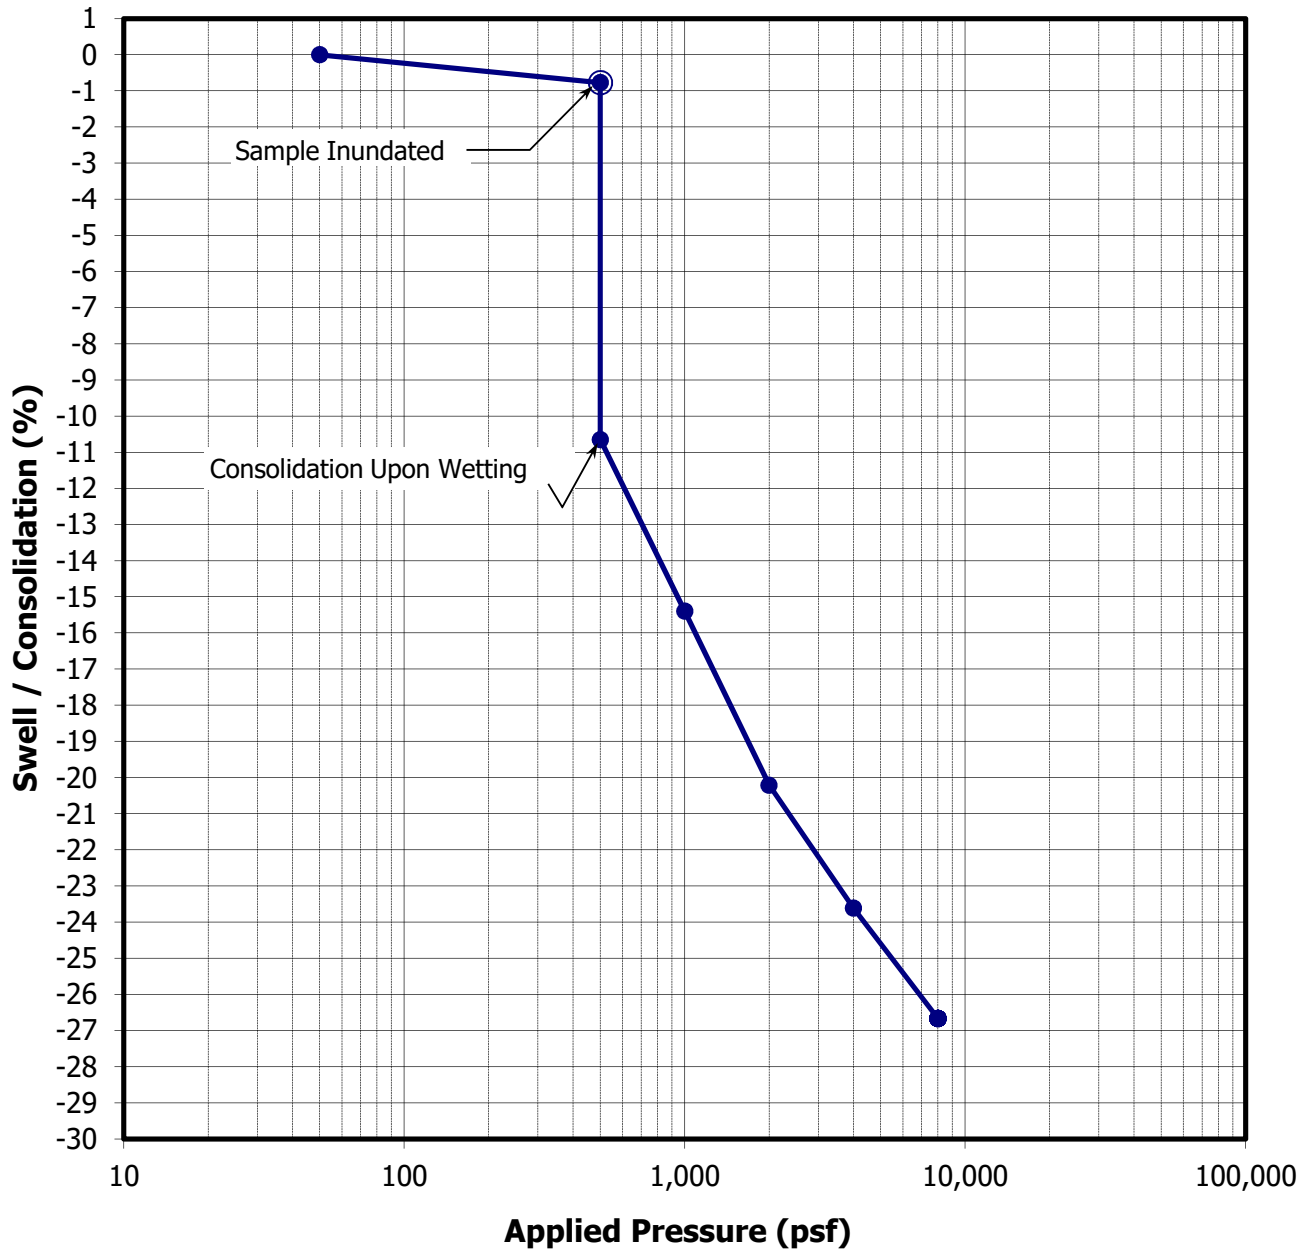
**SWELL/CONSOLIDATION PLOT**

Sample Location	Sample Depth (feet)	Lab ID Number: 1822500	Dry Density (pcf)	Moisture Content (%)	Inundation Pressure (psf)	Volume Change (%)	Swell Pressure (psf)
		Visual Description of Sample					
BCP-5	0 to 8	CLAY, sandy, brown	82.8	5.1	500	-9.9	N/A
Client:		Applegate Group			Project No.:	18.117	
Project:		Cucharas Basin Collaborative Storage			Figure:	1822500

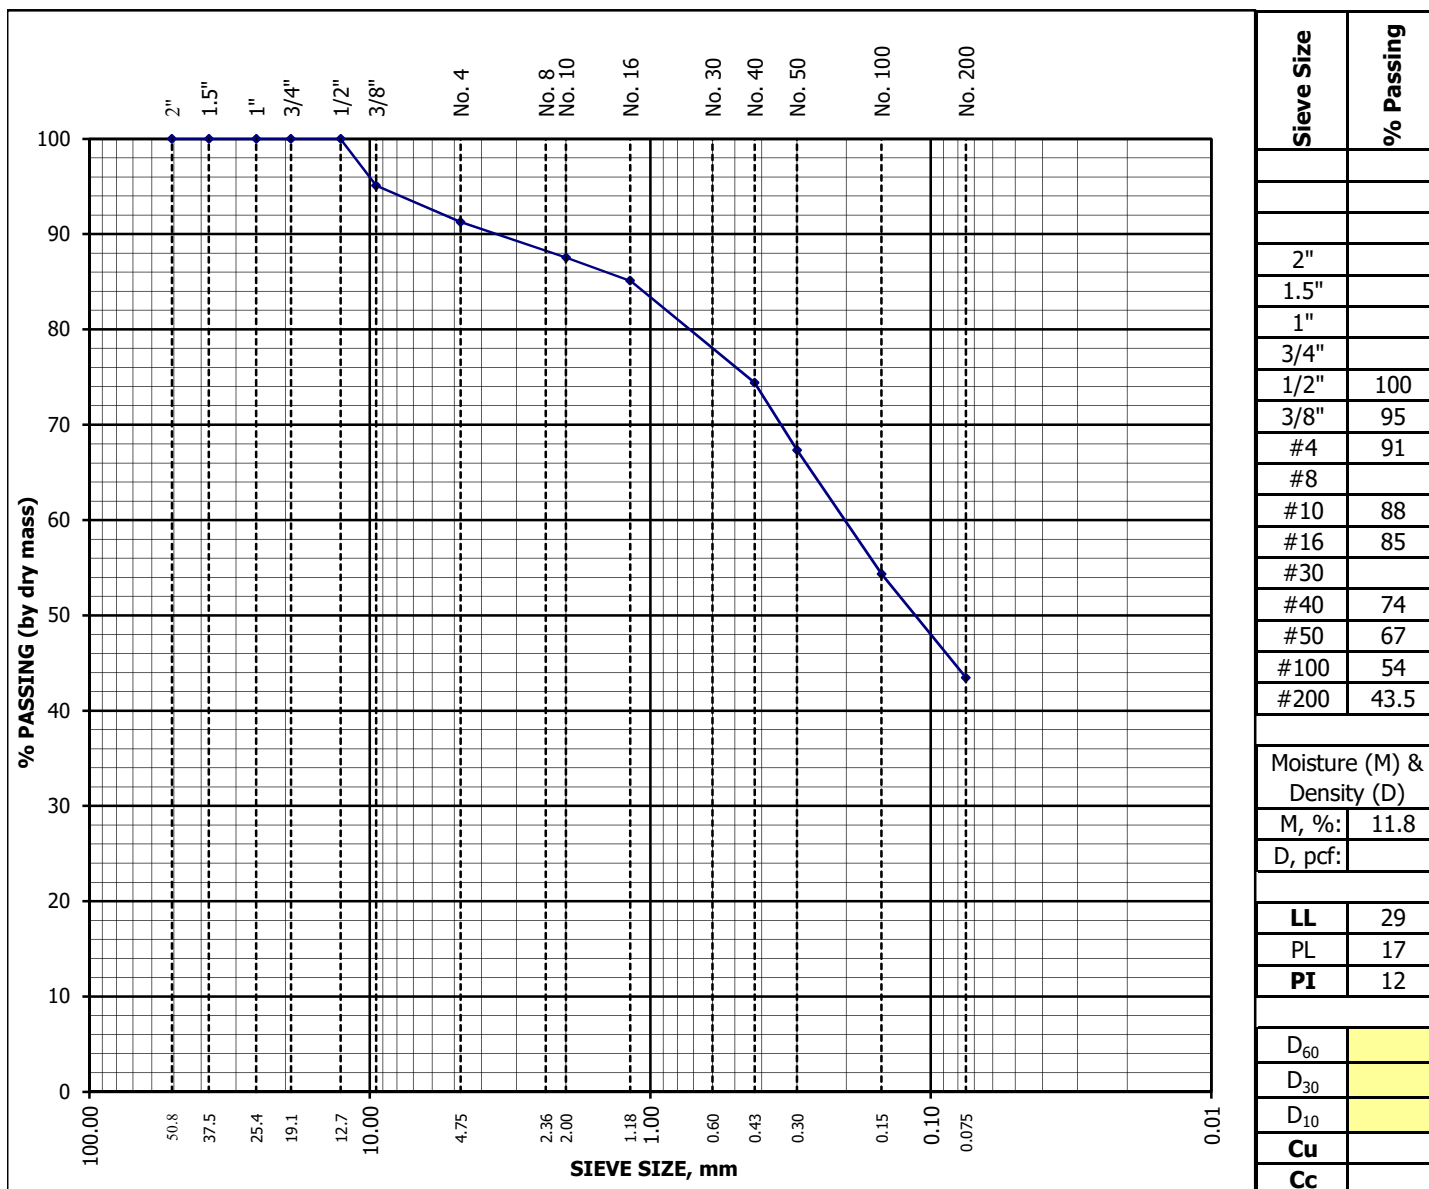
## GRADATION PLOT - SOIL & AGGREGATE

Project Number: 18.117, Applegate Group Date: 7-Oct-18  
Project Name: Cucharas Basin Collaborative Storage Technician: G. Hoyos  
Lab ID Number: 1822655 Reviewer: J. Crystal  
Sample Location: BCP-5 at 2' to 8'  
Visual Description: SAND, clayey, reddish brown

**AASHTO M 145 Classification:** A-6 **Group Index:** 2  
**Unified Soil Classification System**  
**(ASTM D 2487):** (SC) Clayey Sand

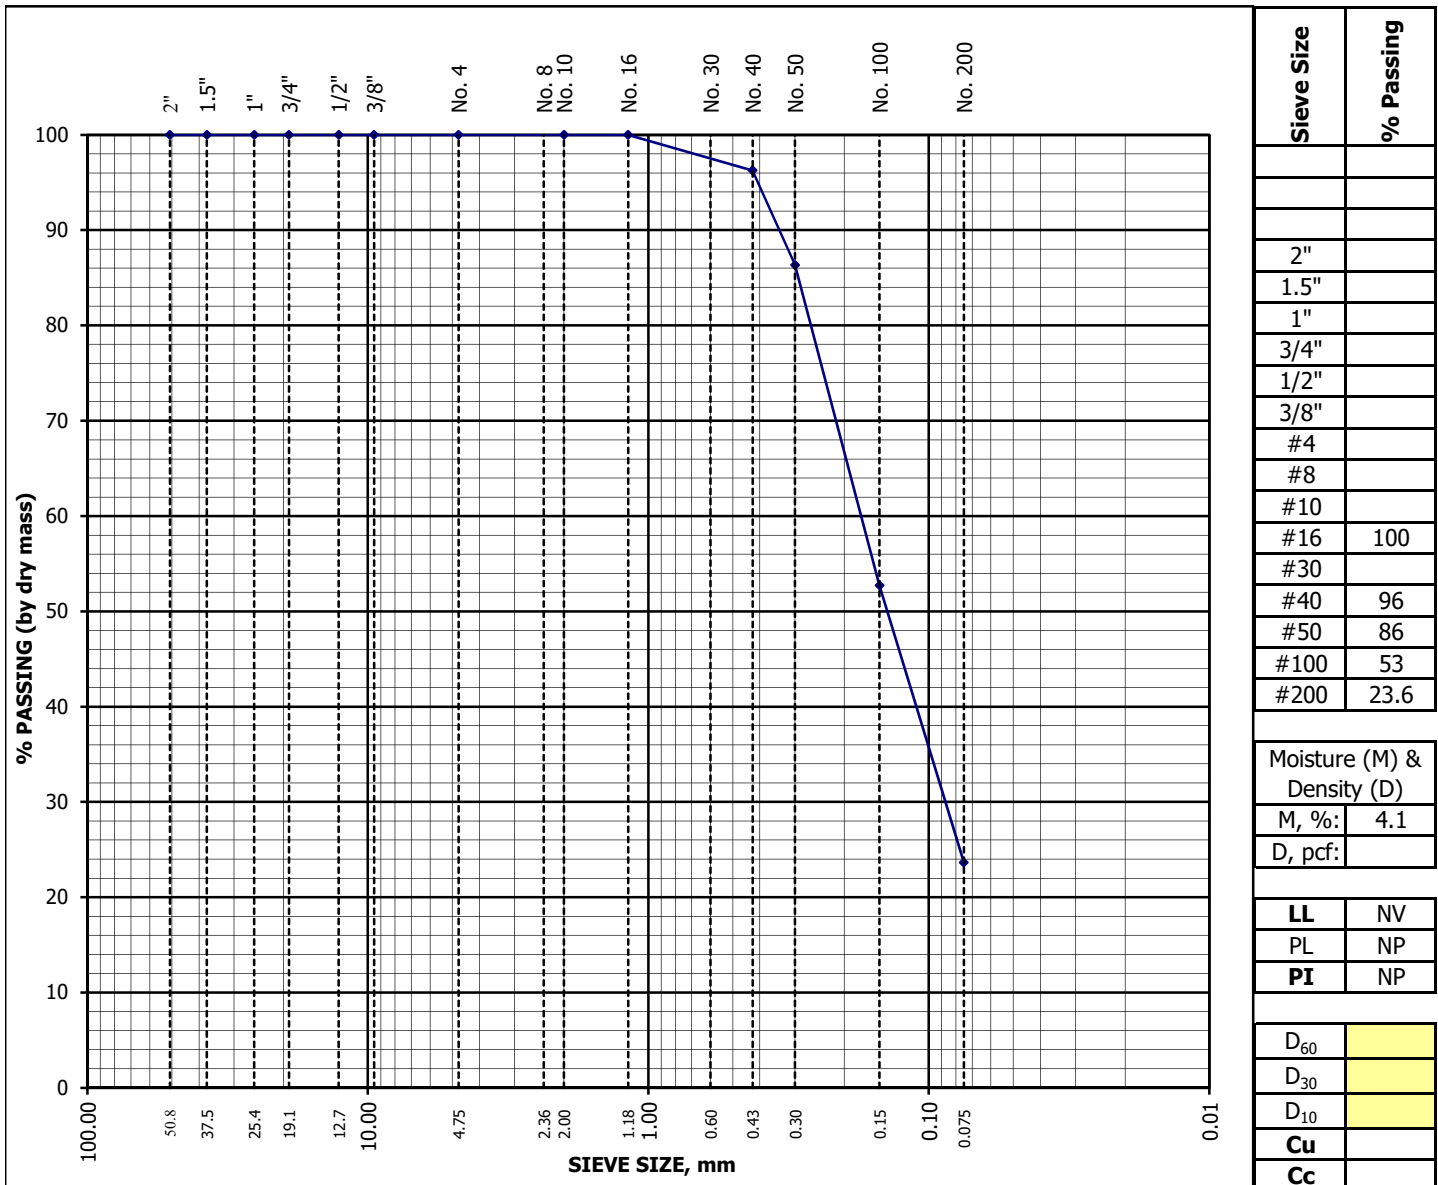
## GRADATION PLOT - SOIL & AGGREGATE

Project Number: 18.117, Applegate Group	Date: 6-Oct-18
Project Name: Cucharas Basin Collaborative Storage	Technician: J. Holiman
Lab ID Number: 1822656	Reviewer: J. Crystal
Sample Location: BCP-6 at 7' to 9'	
Visual Description: SAND, silty, brown

**AASHTO M 145 Classification:** A-2-4 **Group Index:** 0  
**Unified Soil Classification System**  
**(ASTM D 2487):** (SM) Silty sand

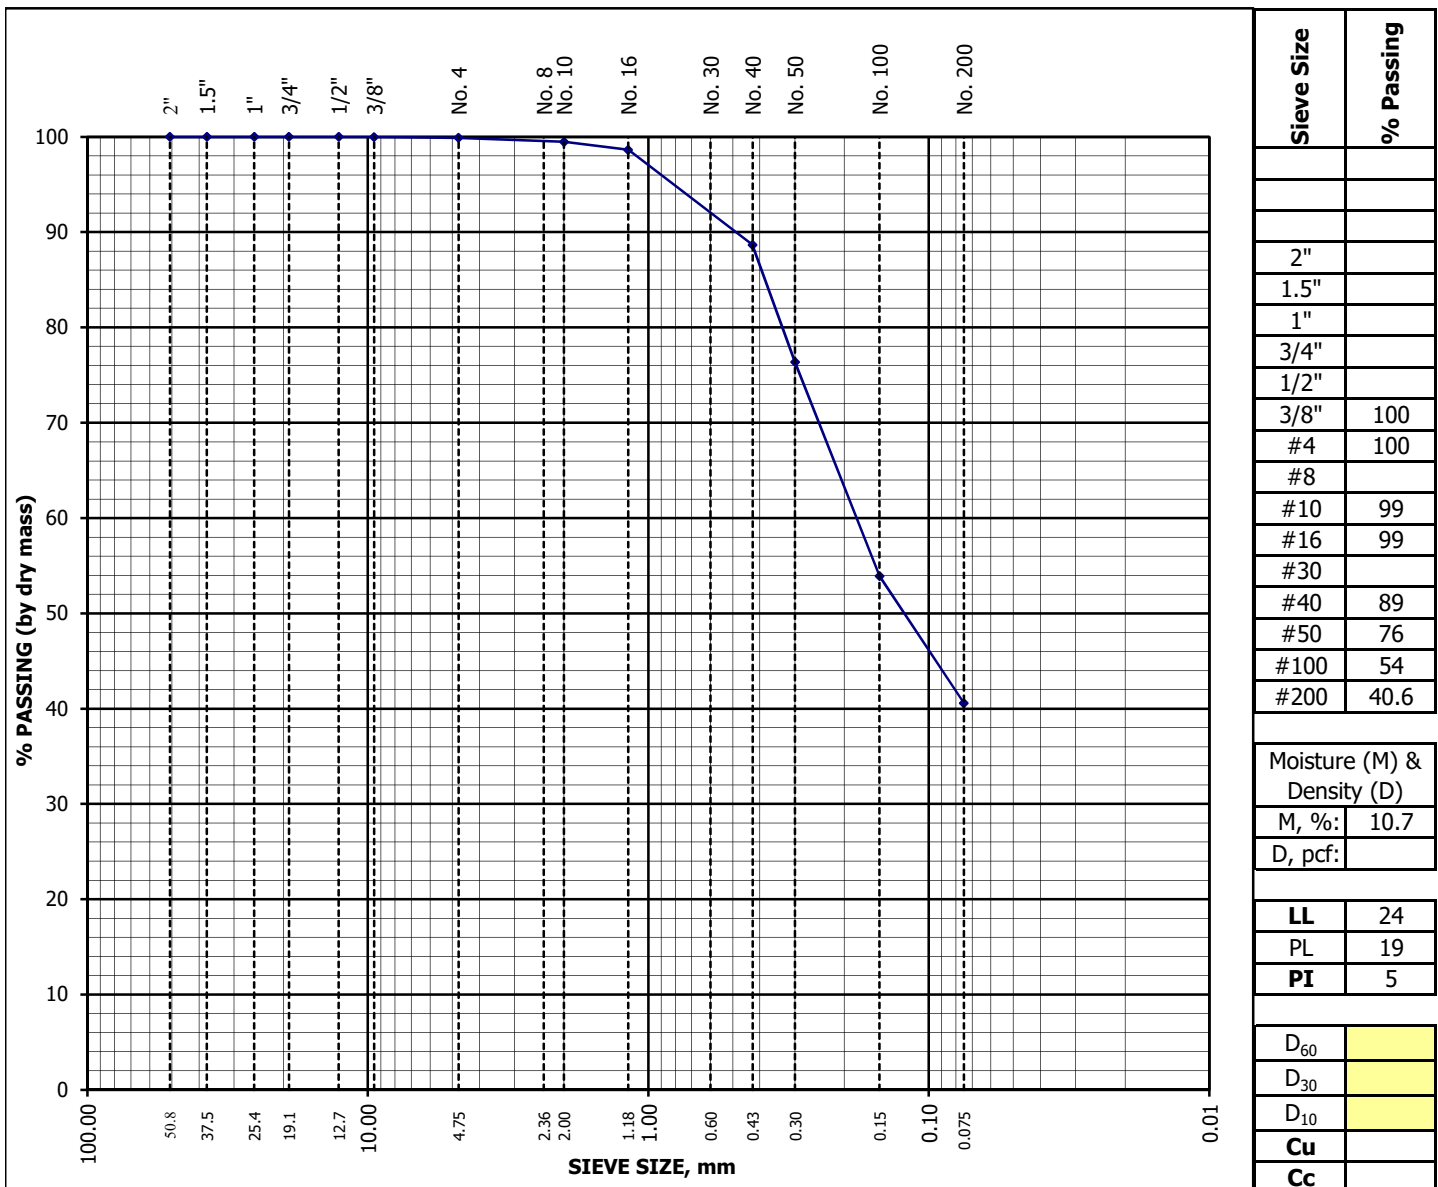
## GRADATION PLOT - SOIL & AGGREGATE

Project Number: 18.117, Applegate Group Date: 8-Sep-18  
 Project Name: Cucharas Basin Collaborative Storage Technician: J. Holiman  
 Lab ID Number: 1822895 Reviewer: J. Crystal  
 Sample Location: LVL-1 at 15'  
 Visual Description: SAND, silty, clayey, brown

**AASHTO M 145 Classification:** A-4 **Group Index:** (0)  
**Unified Soil Classification System**  
**(ASTM D 2487):** (SC-SM) Silty, clayey sand

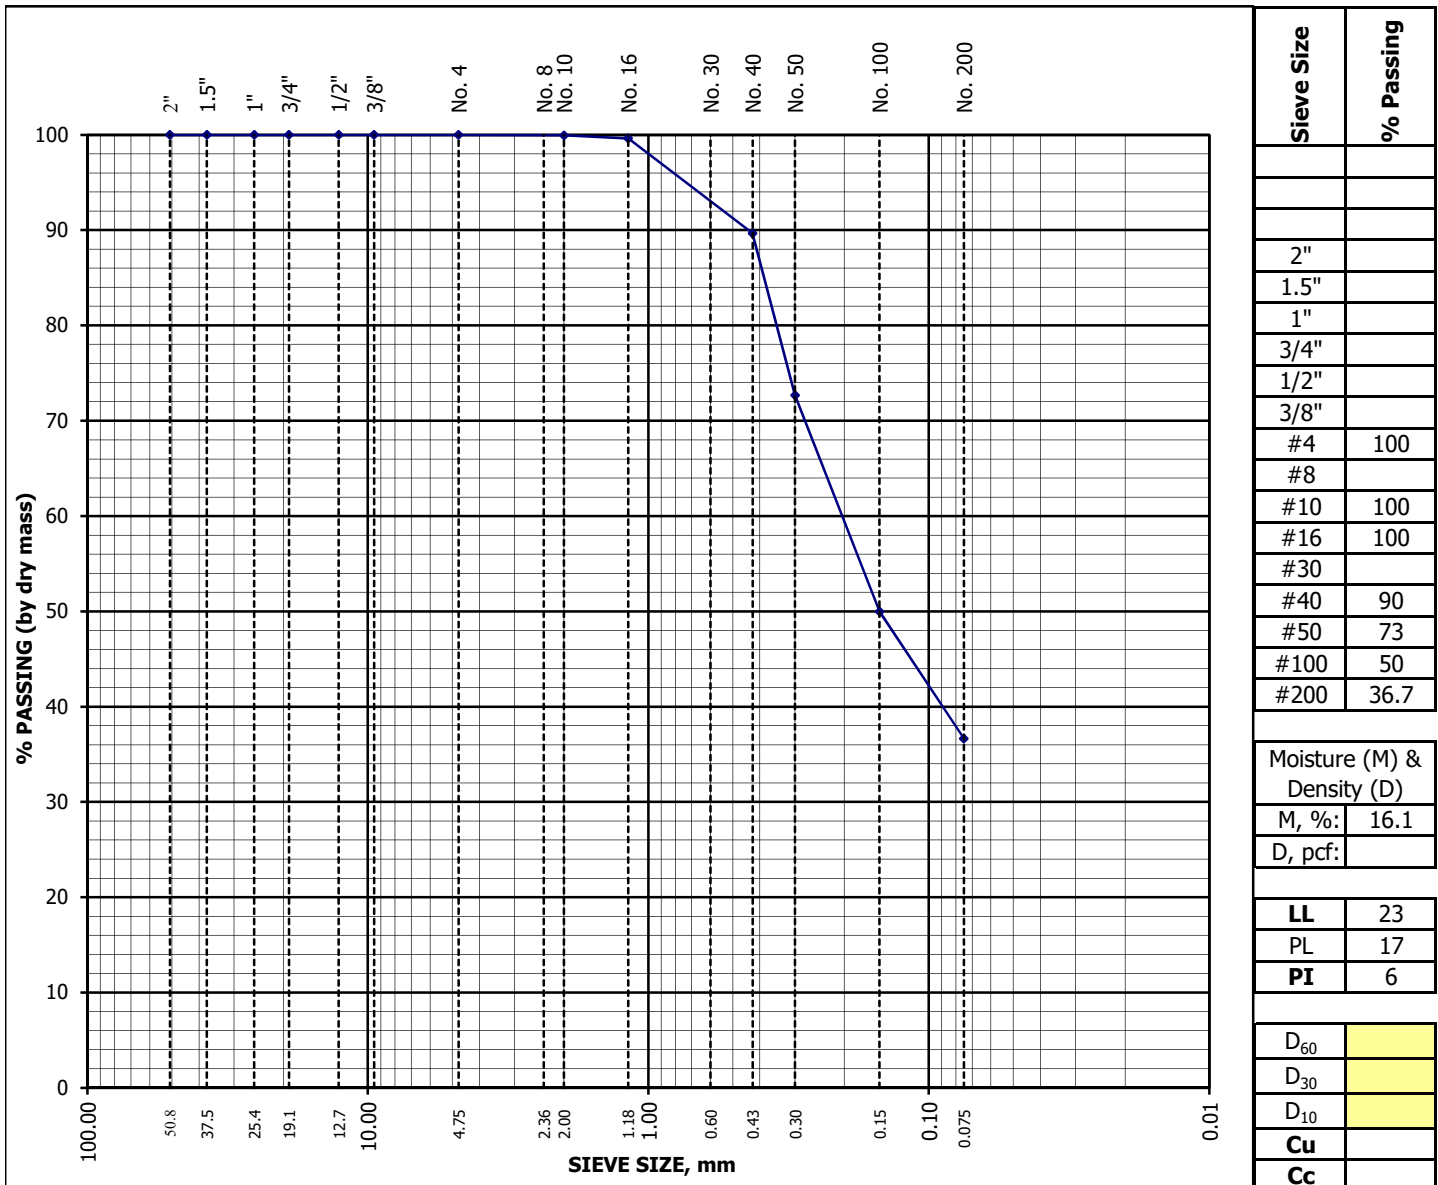
## GRADATION PLOT - SOIL & AGGREGATE

Project Number: 18.117, Applegate Group Date: 8-Sep-18  
Project Name: Cucharas Basin Collaborative Storage Technician: J. Holiman  
Lab ID Number: 1822896 Reviewer: J. Crystal  
Sample Location: LVL-4 at 9'  
Visual Description: SAND, clay, silty, reddish brown

**AASHTO M 145 Classification:** A-4 **Group Index:** (0)  
**Unified Soil Classification System**  
**(ASTM D 2487):** (SC-SM) Silty, clayey sand
