# *South Baker Creek Dam*

## 30% Design Report

### Huerfano County Water Conservancy District

AG JOB No. 18-117

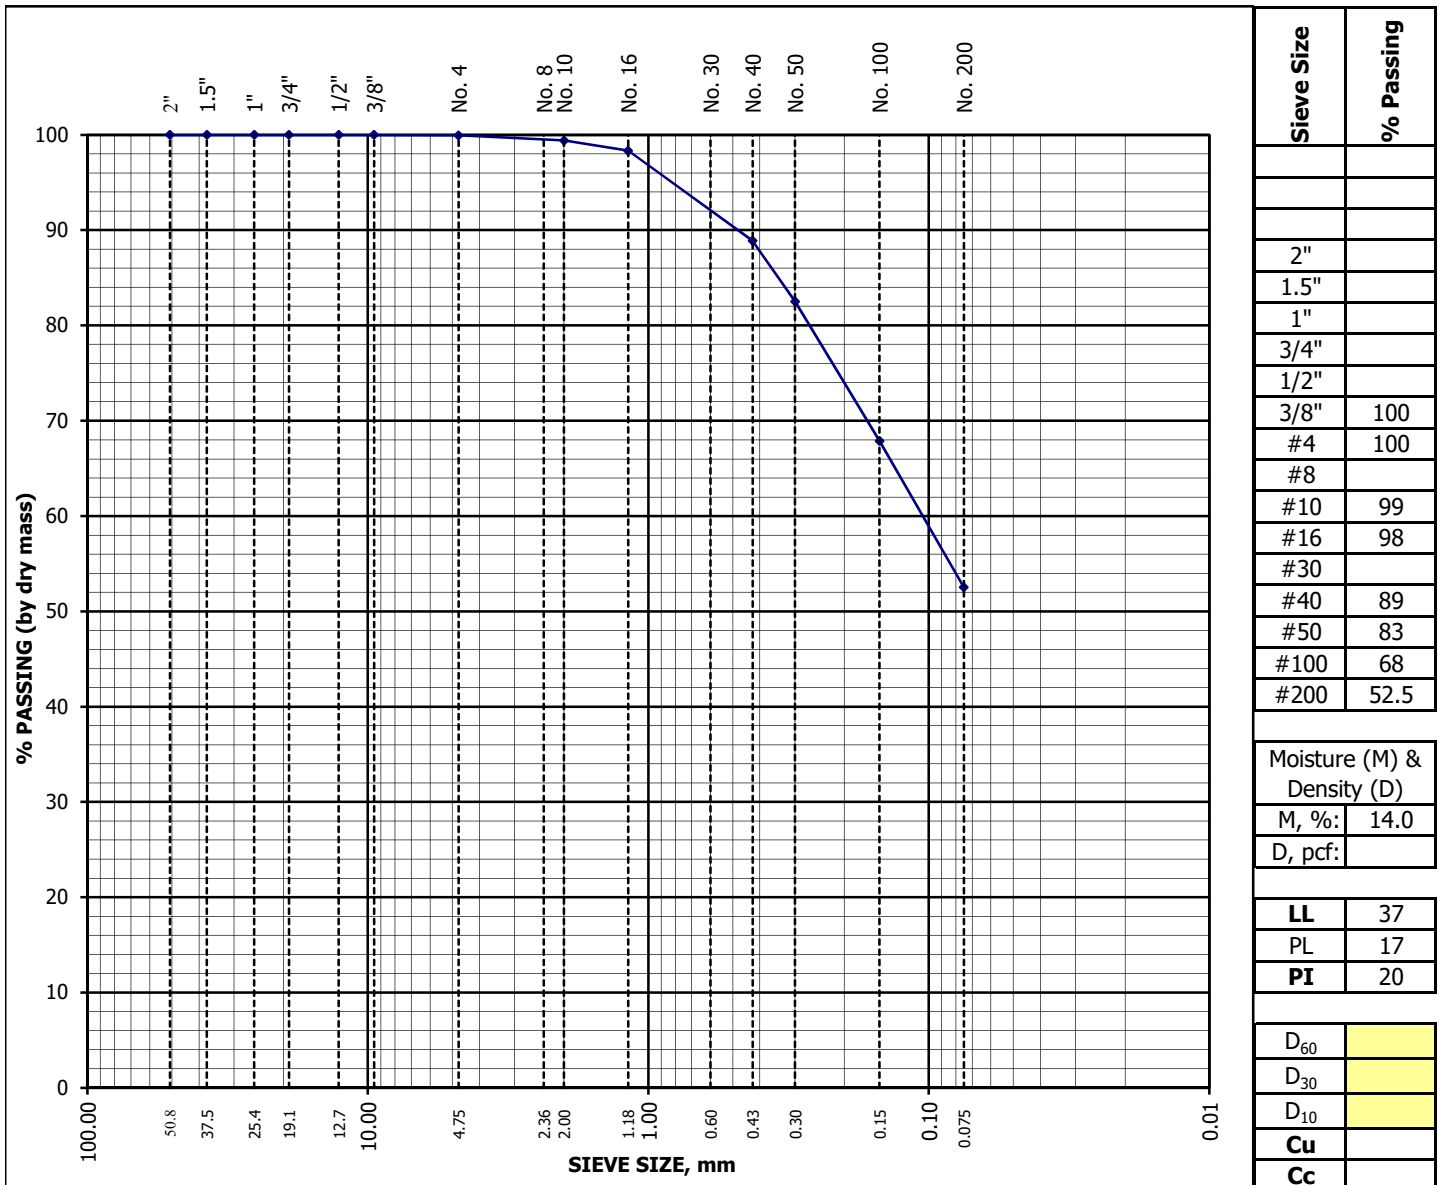
## GRADATION PLOT - SOIL & AGGREGATE

Project Number:	18.117, Applegate Group	Date:	8-Sep-18
Project Name:	Cucharas Basin Collaborative Storage	Technician:	J. Holiman
Lab ID Number:	1822897	Reviewer:	J. Crystal
Sample Location:	LVL-5 at 5'		
Visual Description:	CLAY, sandy, brown

**AASHTO M 145 Classification:** A-6 **Group Index:** 7  
**Unified Soil Classification System**  
**(ASTM D 2487):** (CL) Sandy lean clay

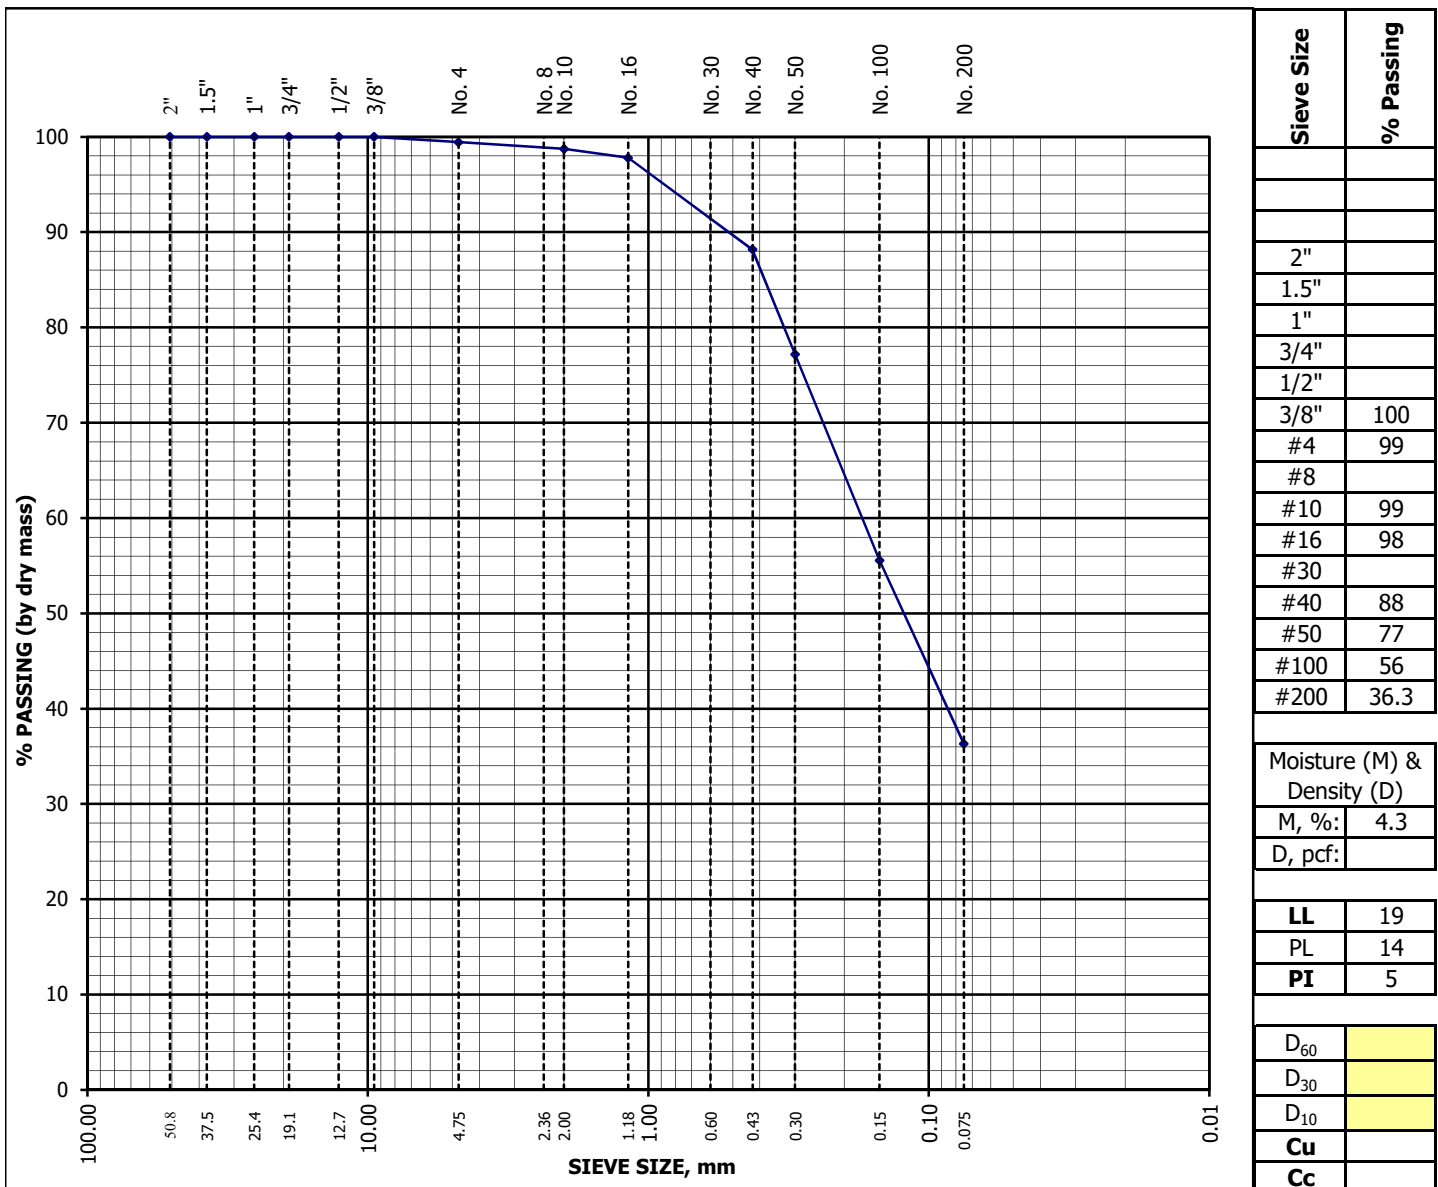
## GRADATION PLOT - SOIL & AGGREGATE

Project Number: 18.117, Applegate Group Date: 8-Sep-18  
 Project Name: Cucharas Basin Collaborative Storage Technician: J. Holiman  
 Lab ID Number: 1822898 Reviewer: J. Crystal  
 Sample Location: LVL-7 at 4'  
 Visual Description: SAND, silty, clayey, brown

**AASHTO M 145 Classification:** A-4 **Group Index:** (0)  
**Unified Soil Classification System**  
**(ASTM D 2487):** (SC-SM) Silty, clayey sand

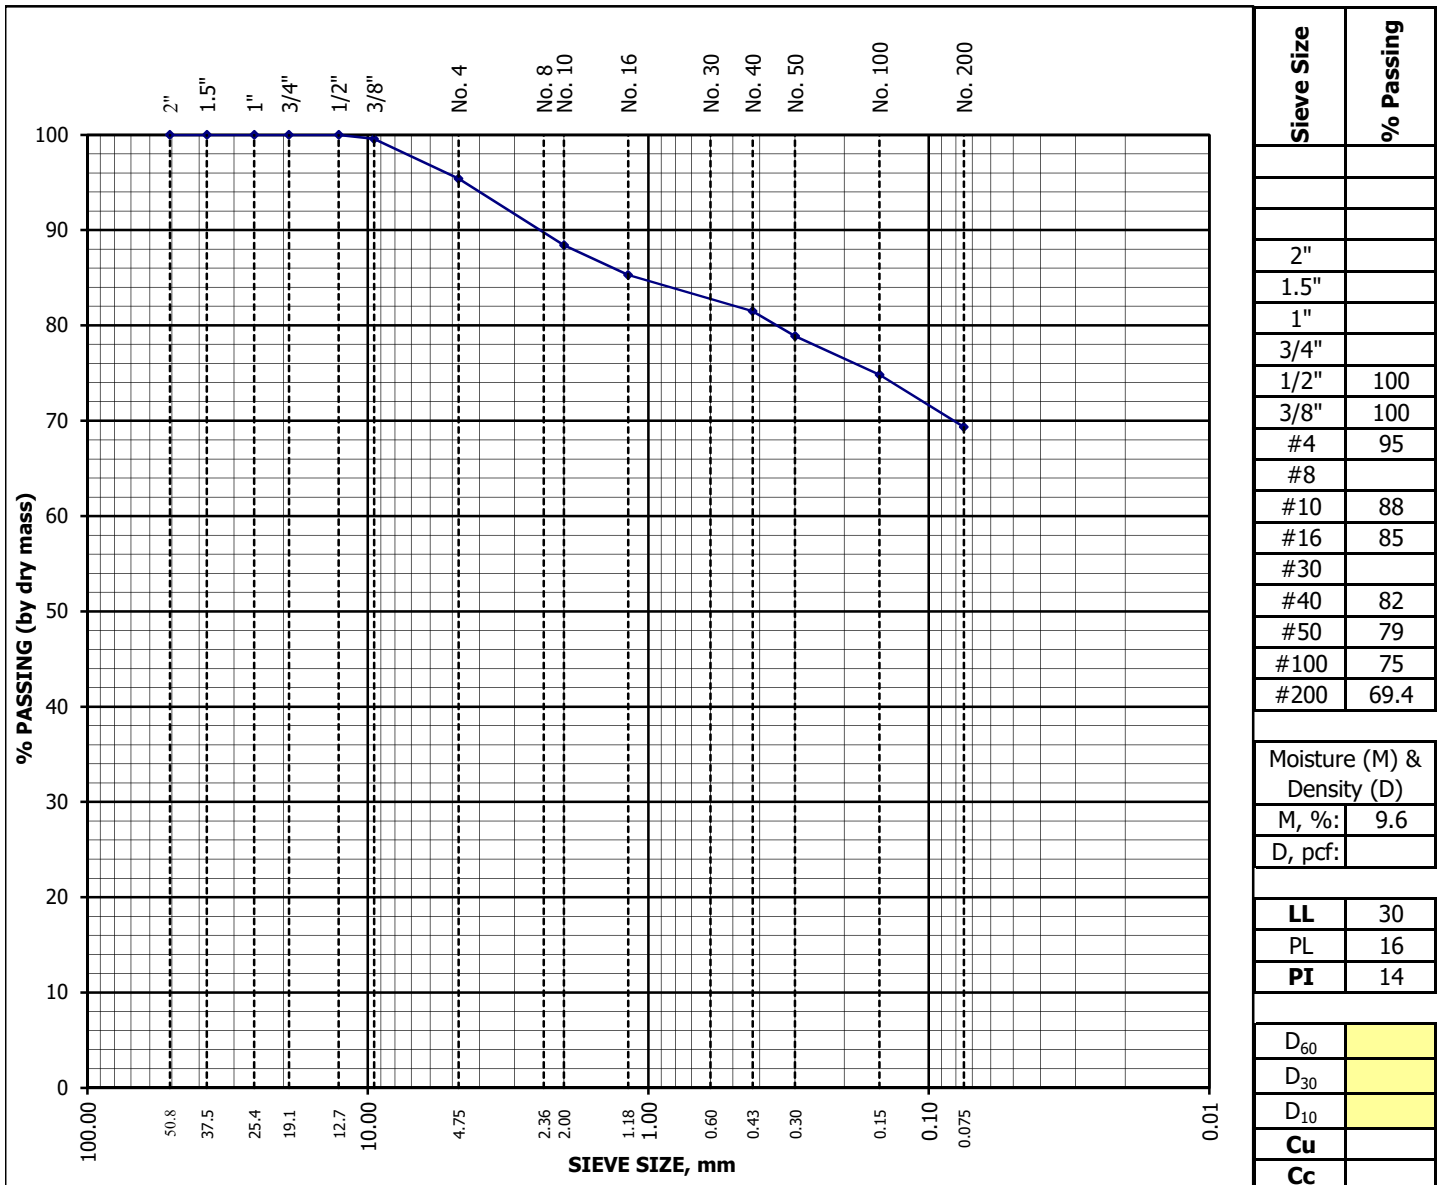
## GRADATION PLOT - SOIL & AGGREGATE

Project Number: 18.117, Applegate Group	Date: 8-Sep-18
Project Name: Cucharas Basin Collaborative Storage	Technician: J. Holiman
Lab ID Number: 1822877	Reviewer: J. Crystal
Sample Location: MS-1 at 10'	
Visual Description: CLAY, sandy, brown

**AASHTO M 145 Classification:** A-6 **Group Index:** 7  
**Unified Soil Classification System**  
**(ASTM D 2487):** (CL) Sandy lean clay

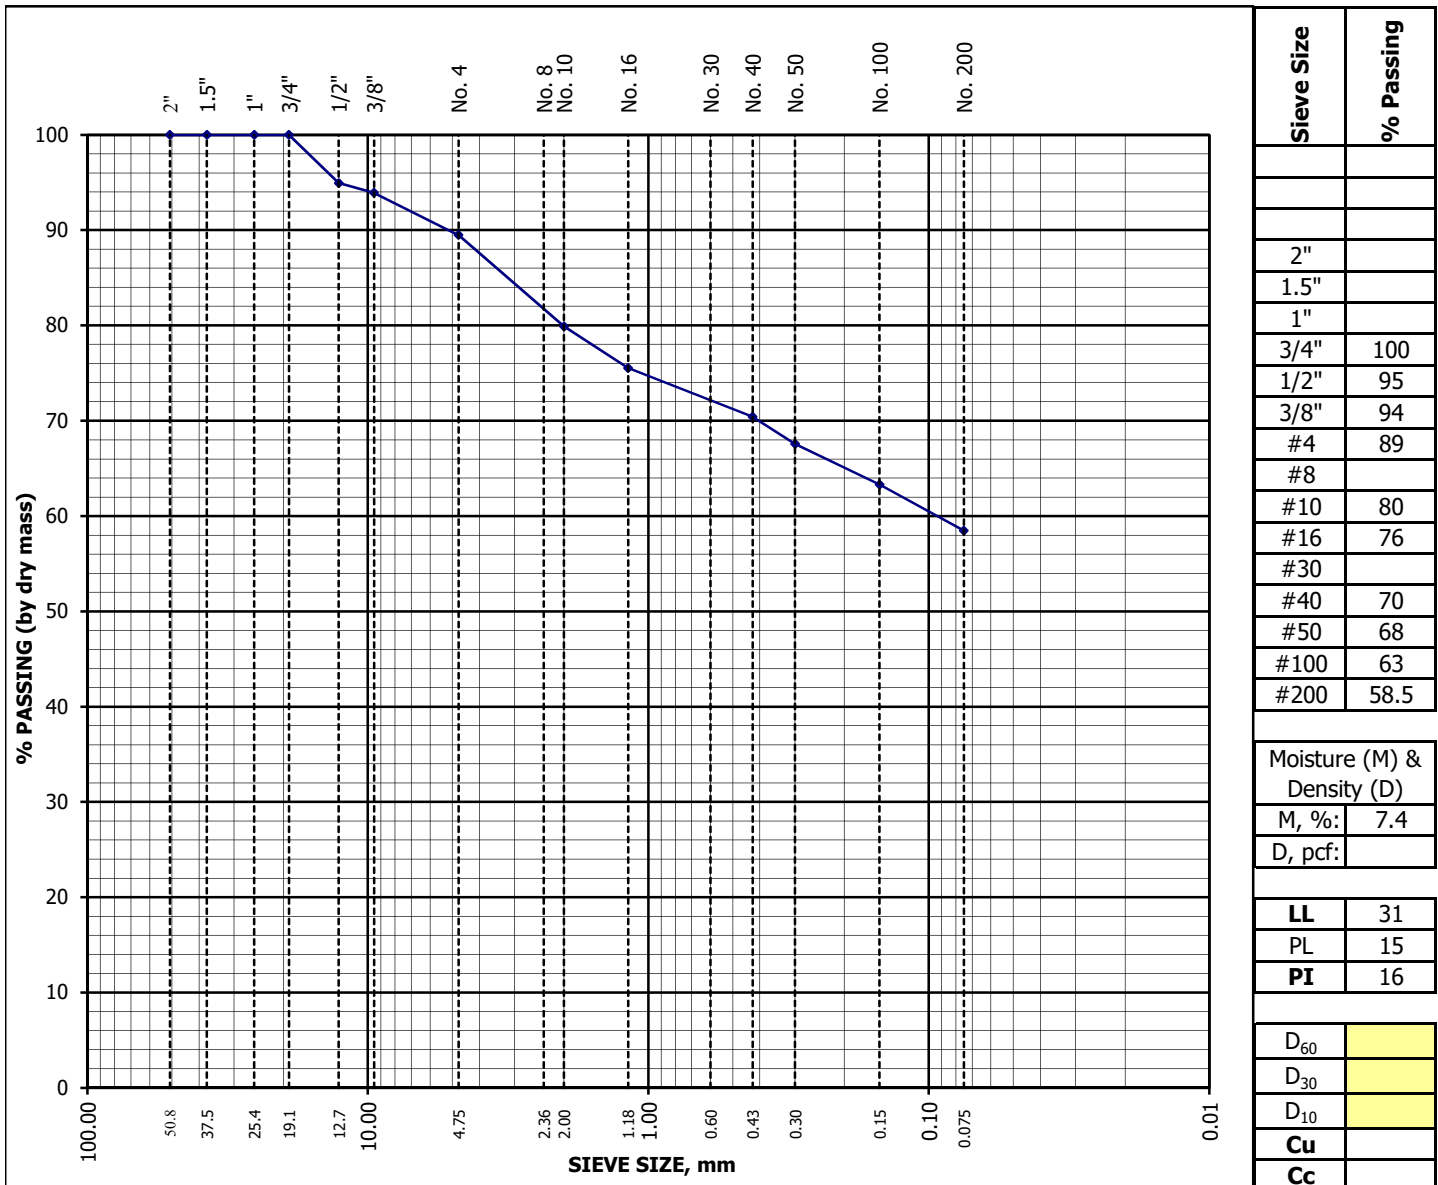
## GRADATION PLOT - SOIL & AGGREGATE

Project Number: 18.117, Applegate Group Date: 8-Sep-18  
Project Name: Cucharas Basin Collaborative Storage Technician: J. Holiman  
Lab ID Number: 1822878 Reviewer: J. Crystal  
Sample Location: MS-1 at 20'  
Visual Description: CLAY, sandy, brown

**AASHTO M 145 Classification:** A-6 **Group Index:** 6  
**Unified Soil Classification System**  
**(ASTM D 2487):** (CL) Sandy lean clay

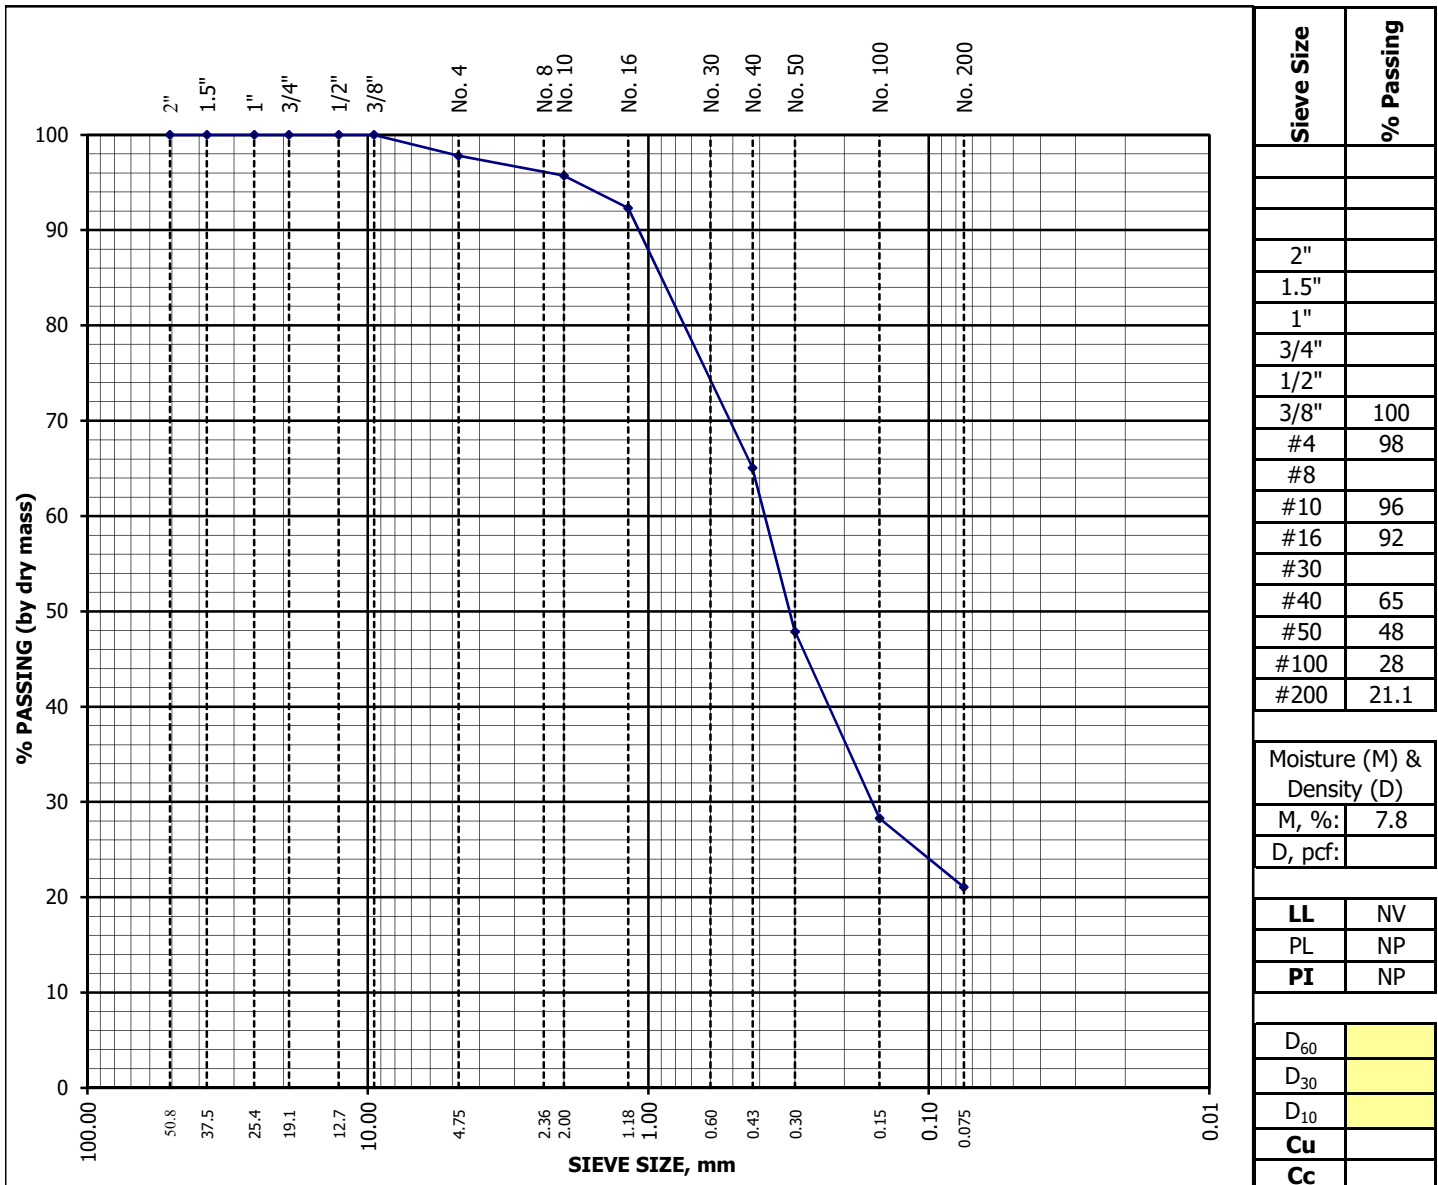
## GRADATION PLOT - SOIL & AGGREGATE

Project Number: 18.117, Applegate Group Date: 8-Sep-18  
Project Name: Cucharas Basin Collaborative Storage Technician: J. Holiman  
Lab ID Number: 1822879 Reviewer: J. Crystal  
Sample Location: MS-2 at 10'  
Visual Description: SAND, silty, brown

**AASHTO M 145 Classification:** A-2-4 **Group Index:** 0  
**Unified Soil Classification System**  
**(ASTM D 2487):** (SM) Silty sand

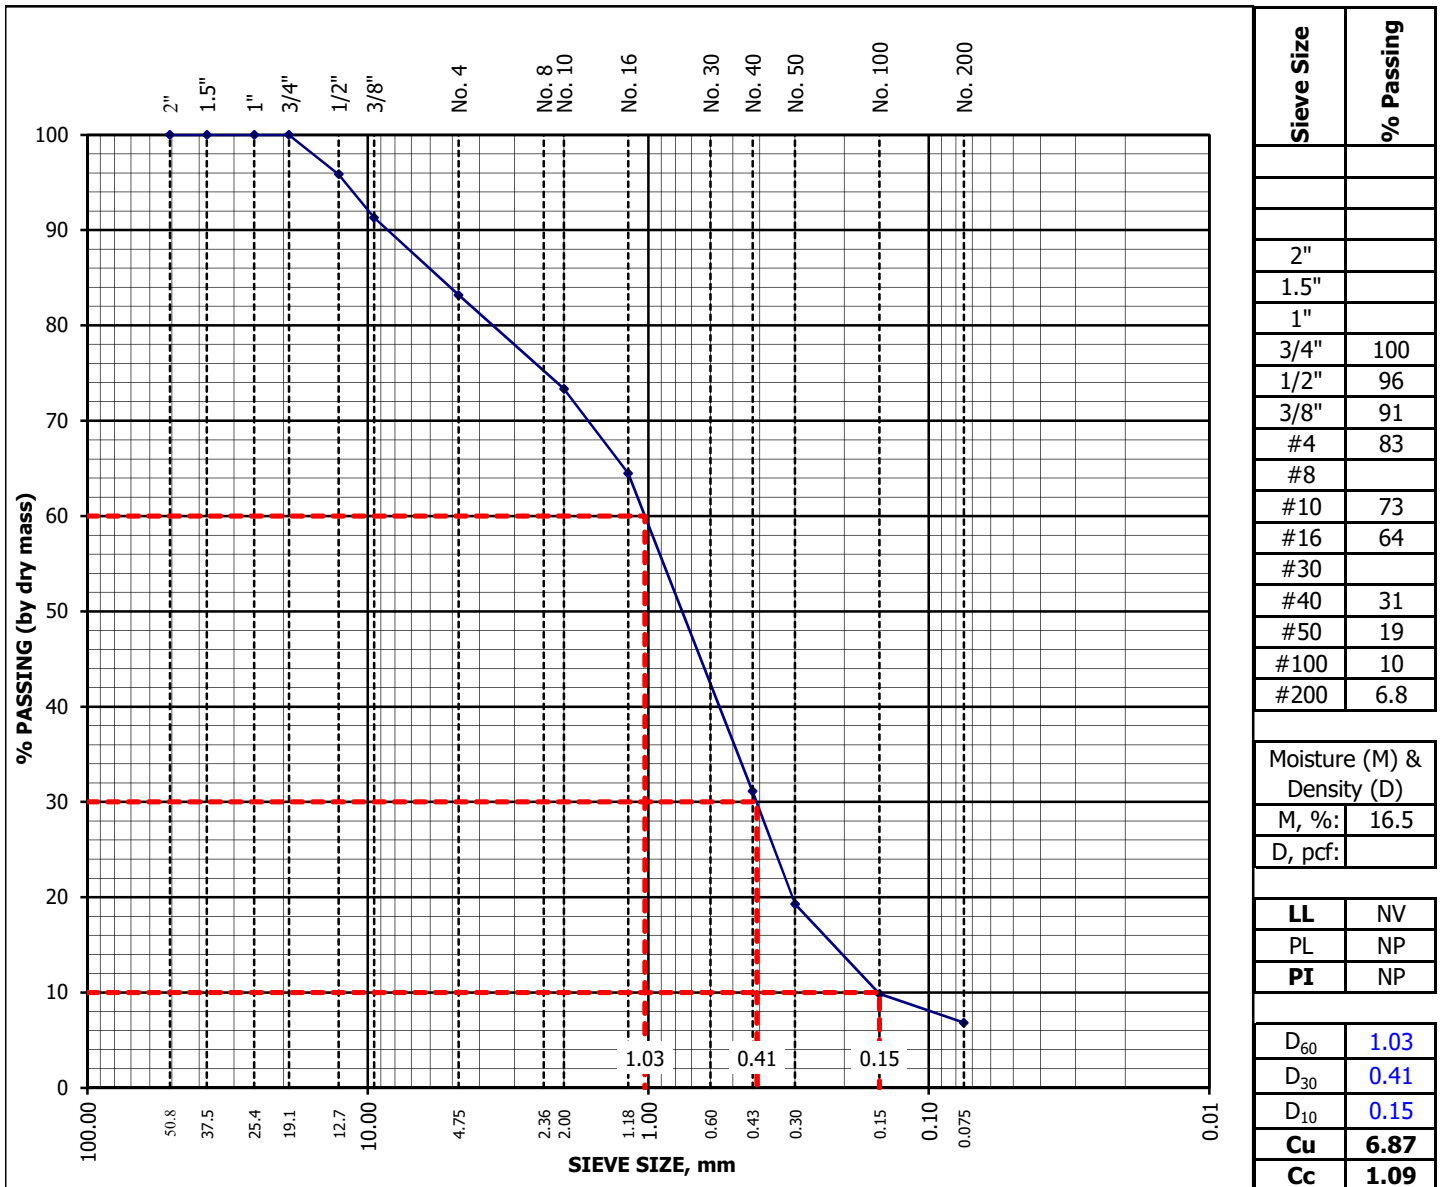
## GRADATION PLOT - SOIL & AGGREGATE

Project Number: 18.117, Applegate Group Date: 5-Sep-18  
Project Name: Cucharas Basin Collaborative Storage Technician: J. Weinerth  
Lab ID Number: 1822880 Reviewer: J. Crystal  
Sample Location: MS-2 at 20'  
Visual Description: SAND, with silt and gravel, brown

**AASHTO M 145 Classification:** A-1-b **Group Index:** 0  
**Unified Soil Classification System**  
**(ASTM D 2487):** (SW-SM) Well-graded sand with silt and gravel

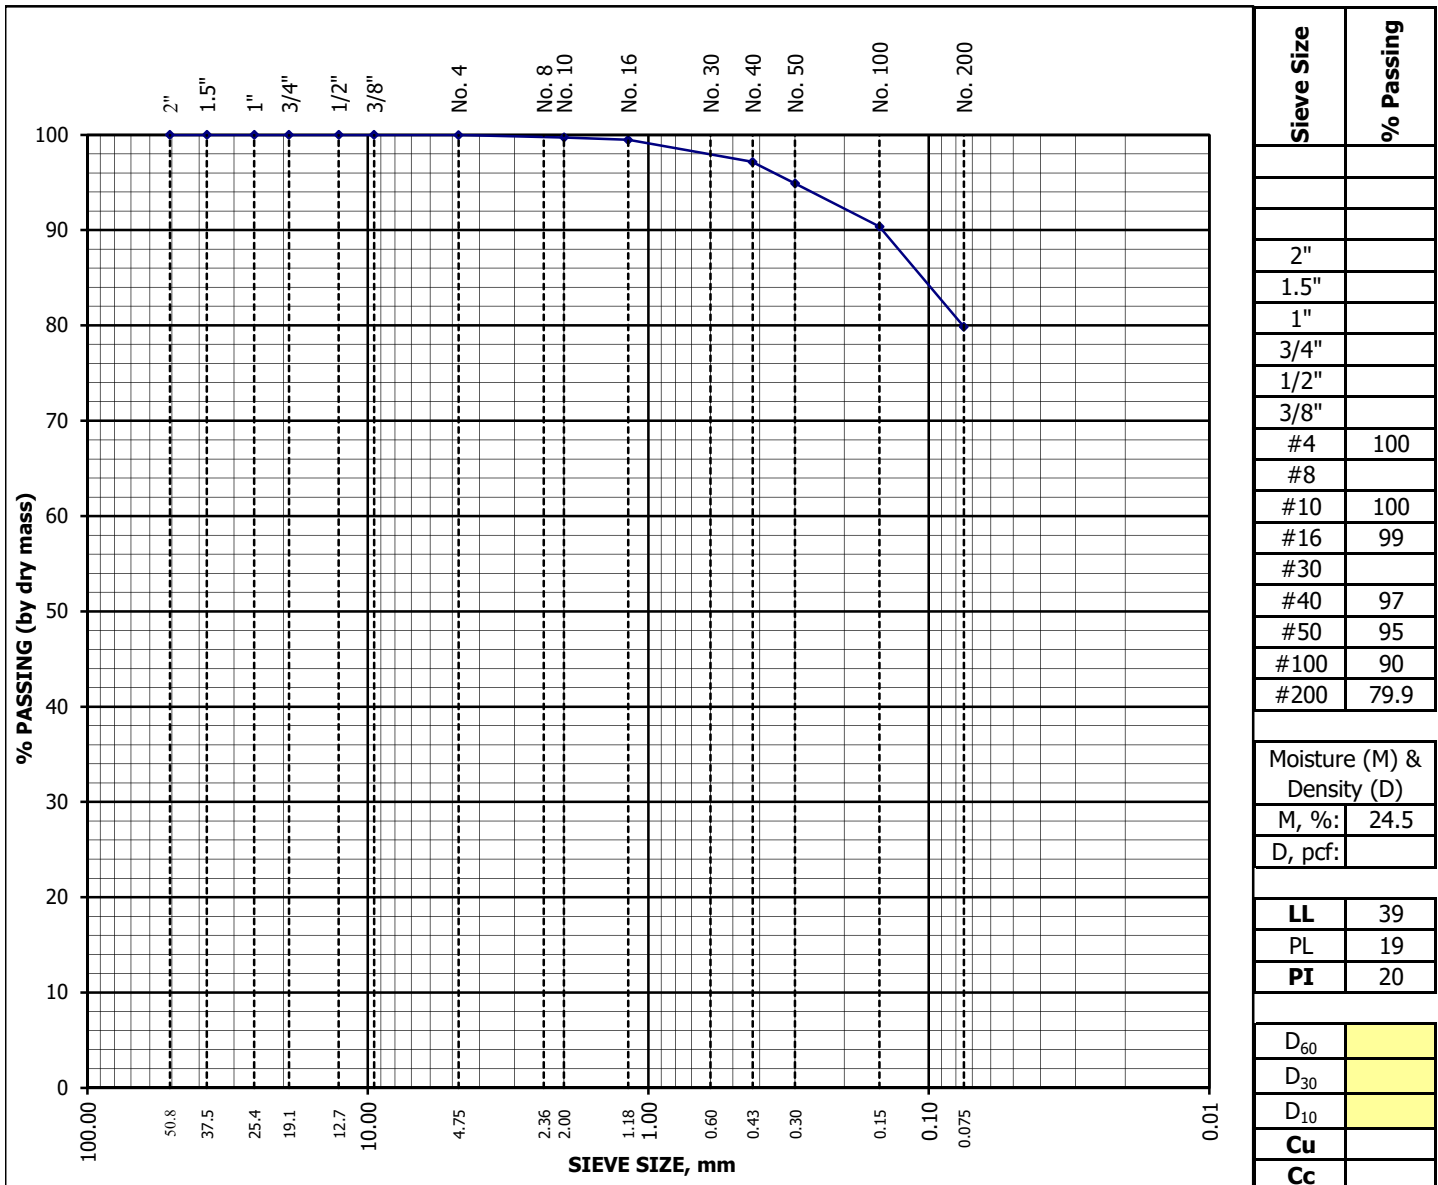
## GRADATION PLOT - SOIL & AGGREGATE

Project Number: 18.117, Applegate Group Date: 8-Sep-18  
Project Name: Cucharas Basin Collaborative Storage Technician: J. Holiman  
Lab ID Number: 1822881 Reviewer: J. Crystal  
Sample Location: MS-3 at 5'  
Visual Description: CLAY, with sand, brown

**AASHTO M 145 Classification:** A-6 **Group Index:** 15  
**Unified Soil Classification System**  
**(ASTM D 2487):** (CL) **Lean clay with sand**

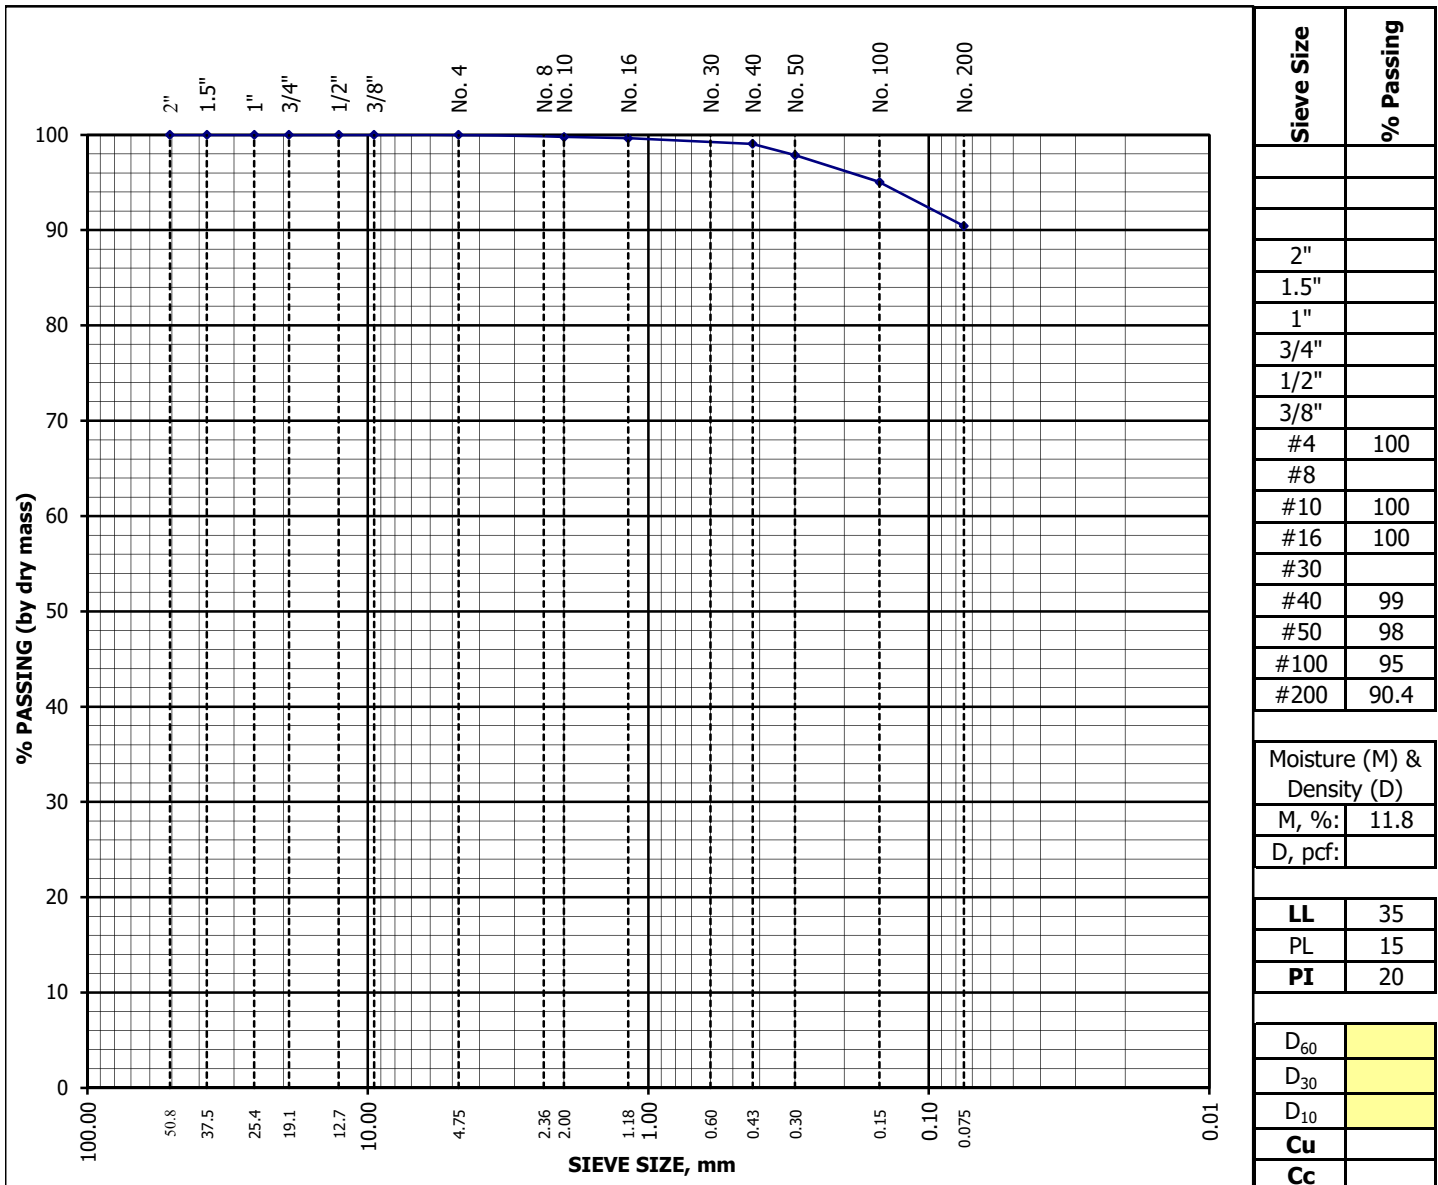
## GRADATION PLOT - SOIL & AGGREGATE

Project Number: 18.117, Applegate Group Date: 8-Sep-18  
Project Name: Cucharas Basin Collaborative Storage Technician: J. Holiman  
Lab ID Number: 1822882 Reviewer: J. Crystal  
Sample Location: MS-4 at 10'  
Visual Description: CLAY, brown

**AASHTO M 145 Classification:** A-6 **Group Index:** 17  
**Unified Soil Classification System**  
**(ASTM D 2487):** (CL) **Lean clay**

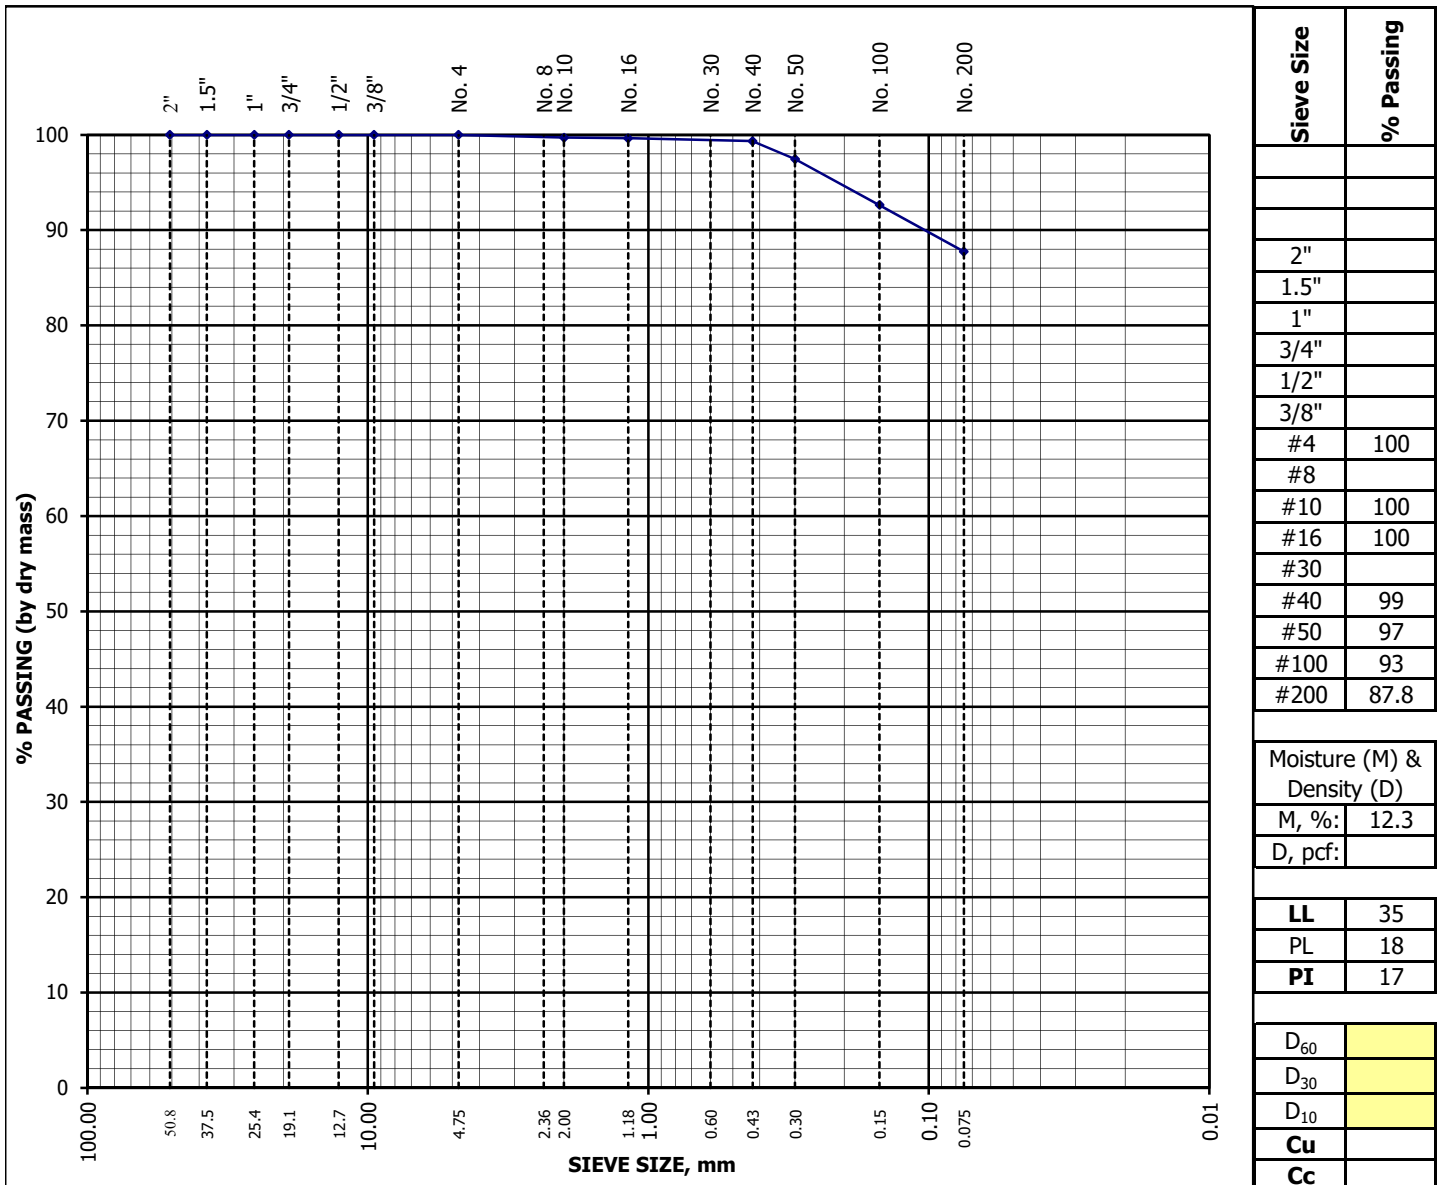
## GRADATION PLOT - SOIL & AGGREGATE

Project Number: 18.117, Applegate Group	Date: 8-Sep-18
Project Name: Cucharas Basin Collaborative Storage	Technician: J. Holiman
Lab ID Number: 1822883	Reviewer: J. Crystal
Sample Location: MS-5 at 10'	
Visual Description: CLAY, brown

**AASHTO M 145 Classification:** A-6 **Group Index:** 14  
**Unified Soil Classification System**  
**(ASTM D 2487):** (CL) **Lean clay**

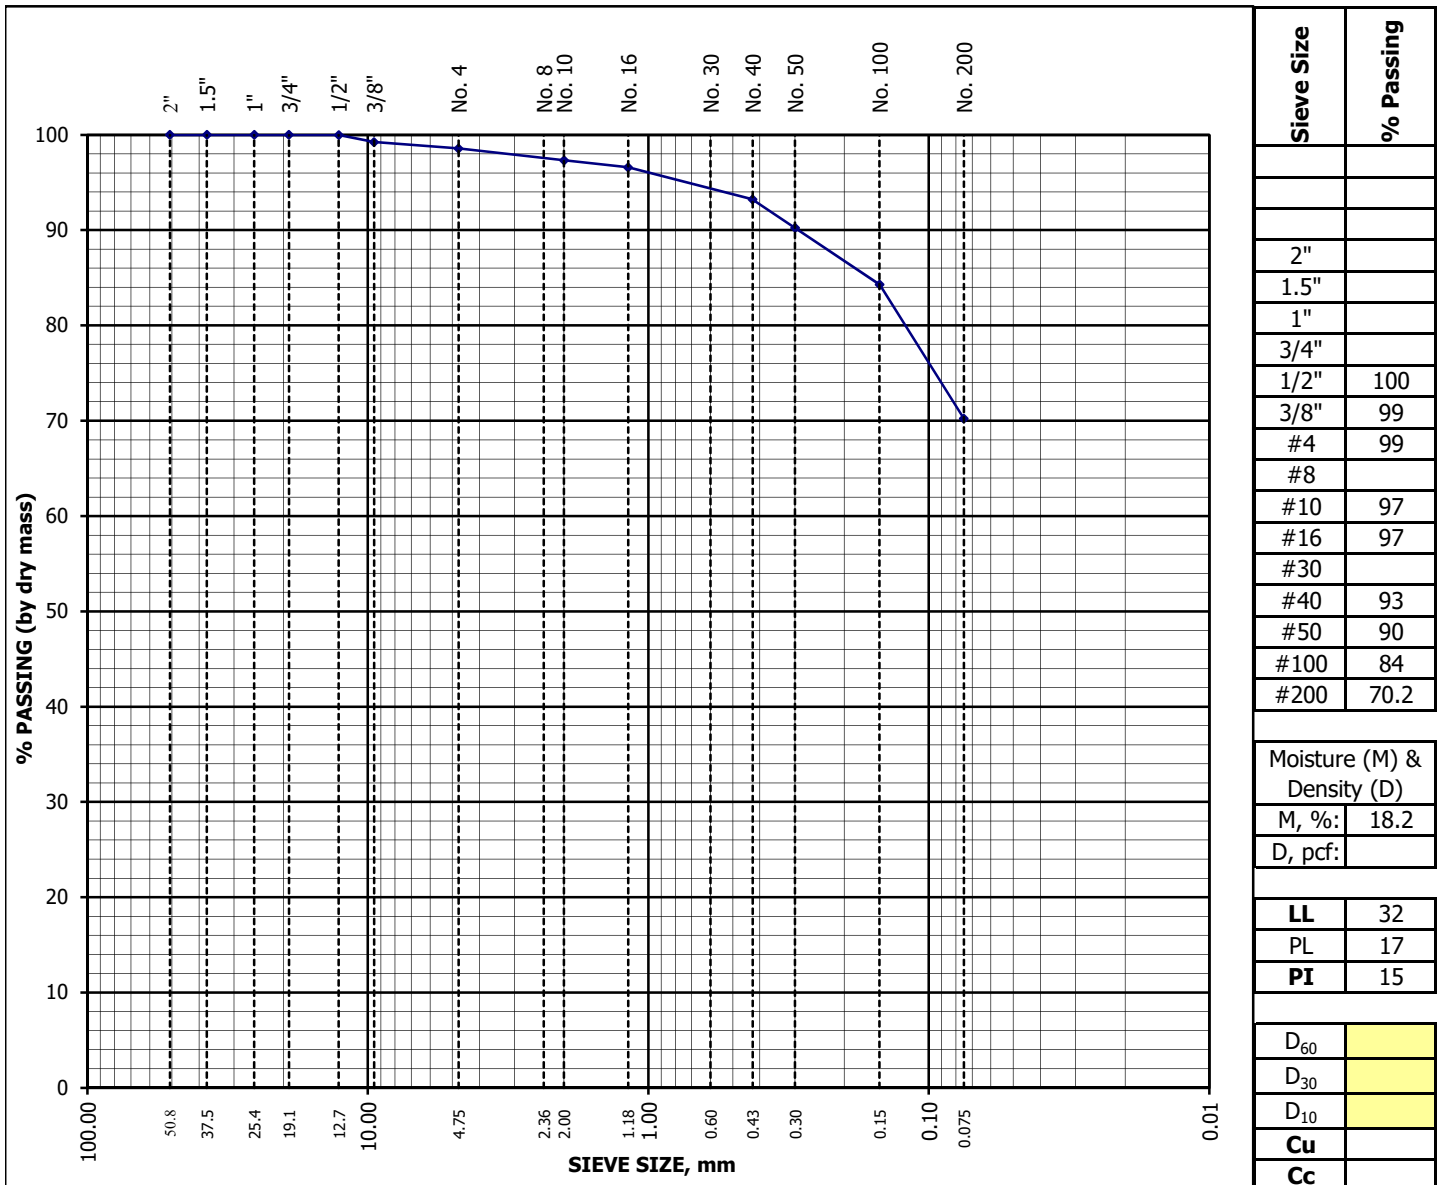
## GRADATION PLOT - SOIL & AGGREGATE

Project Number: 18.117, Applegate Group	Date: 8-Sep-18
Project Name: Cucharas Basin Collaborative Storage	Technician: J. Holiman
Lab ID Number: 1822884	Reviewer: J. Crystal
Sample Location: MS-6 at 10'	
Visual Description: CLAY, sandy, brown

**AASHTO M 145 Classification:** A-6 **Group Index:** 8  
**Unified Soil Classification System**  
**(ASTM D 2487):** (CL) Sandy lean clay

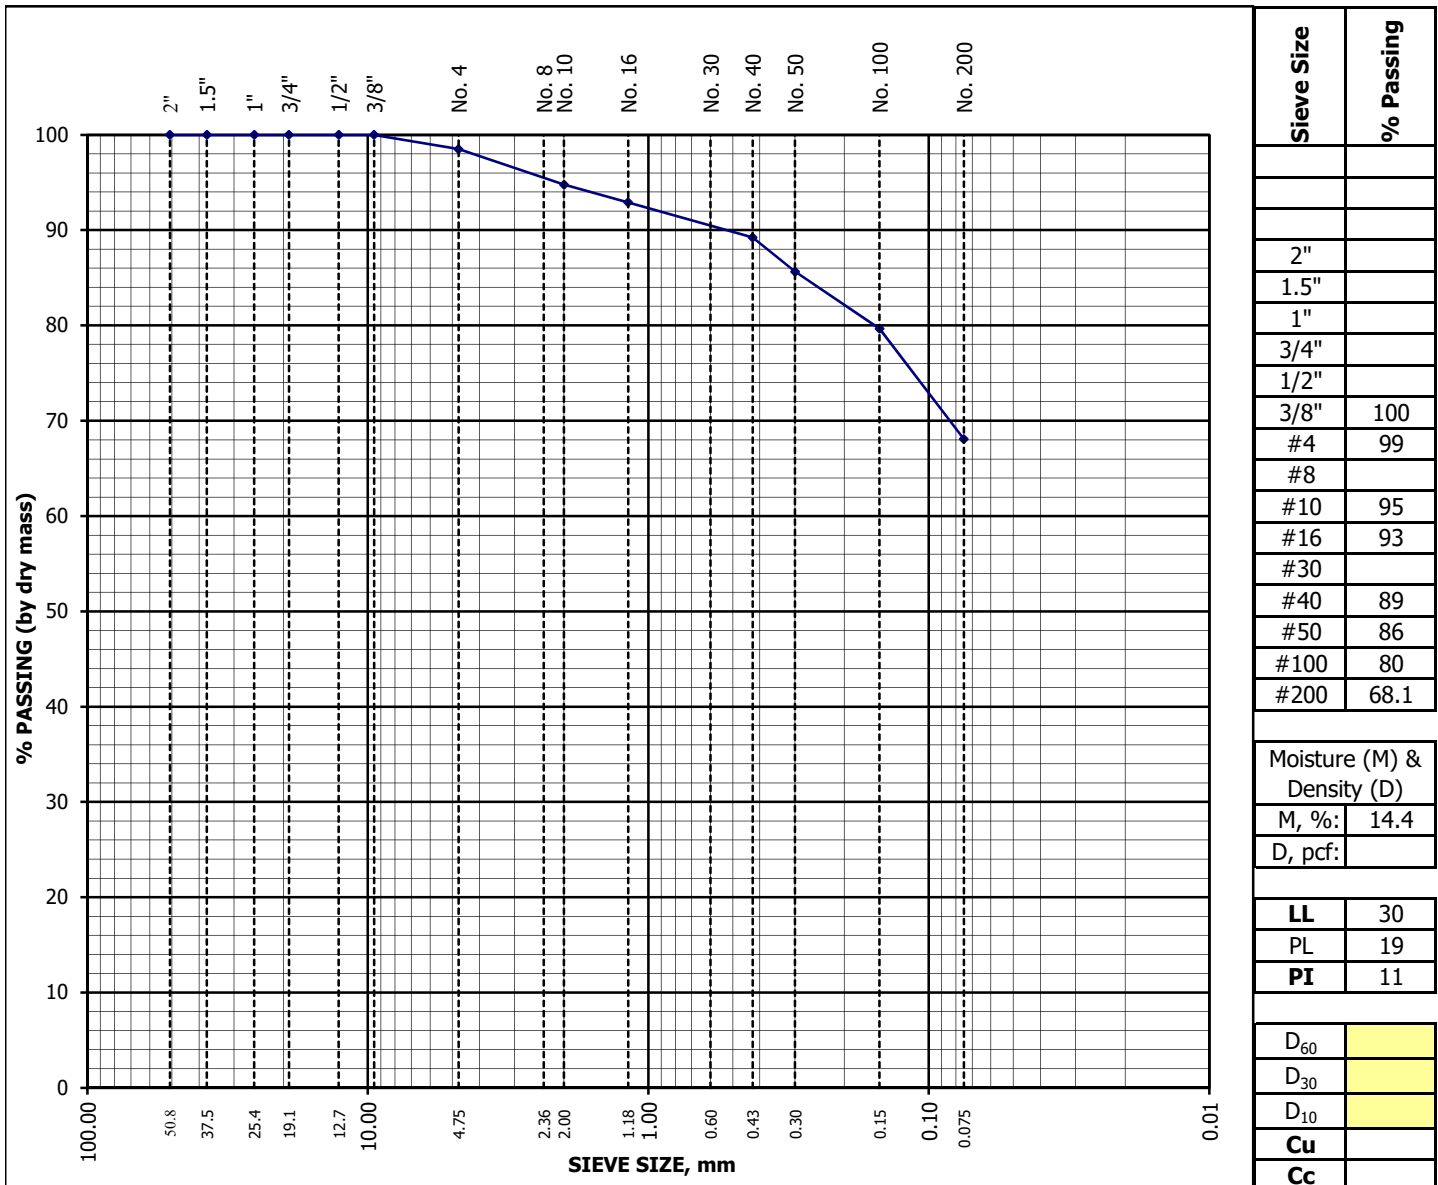
## GRADATION PLOT - SOIL & AGGREGATE

Project Number: 18.117, Applegate Group Date: 5-Sep-18  
Project Name: Cucharas Basin Collaborative Storage Technician: J. Weinerth  
Lab ID Number: 1822885 Reviewer: J. Crystal  
Sample Location: MS-6 at 25'  
Visual Description: CLAY, sandy, brown

**AASHTO M 145 Classification:** A-6 **Group Index:** 5  
**Unified Soil Classification System**  
**(ASTM D 2487):** (CL) Sandy lean clay

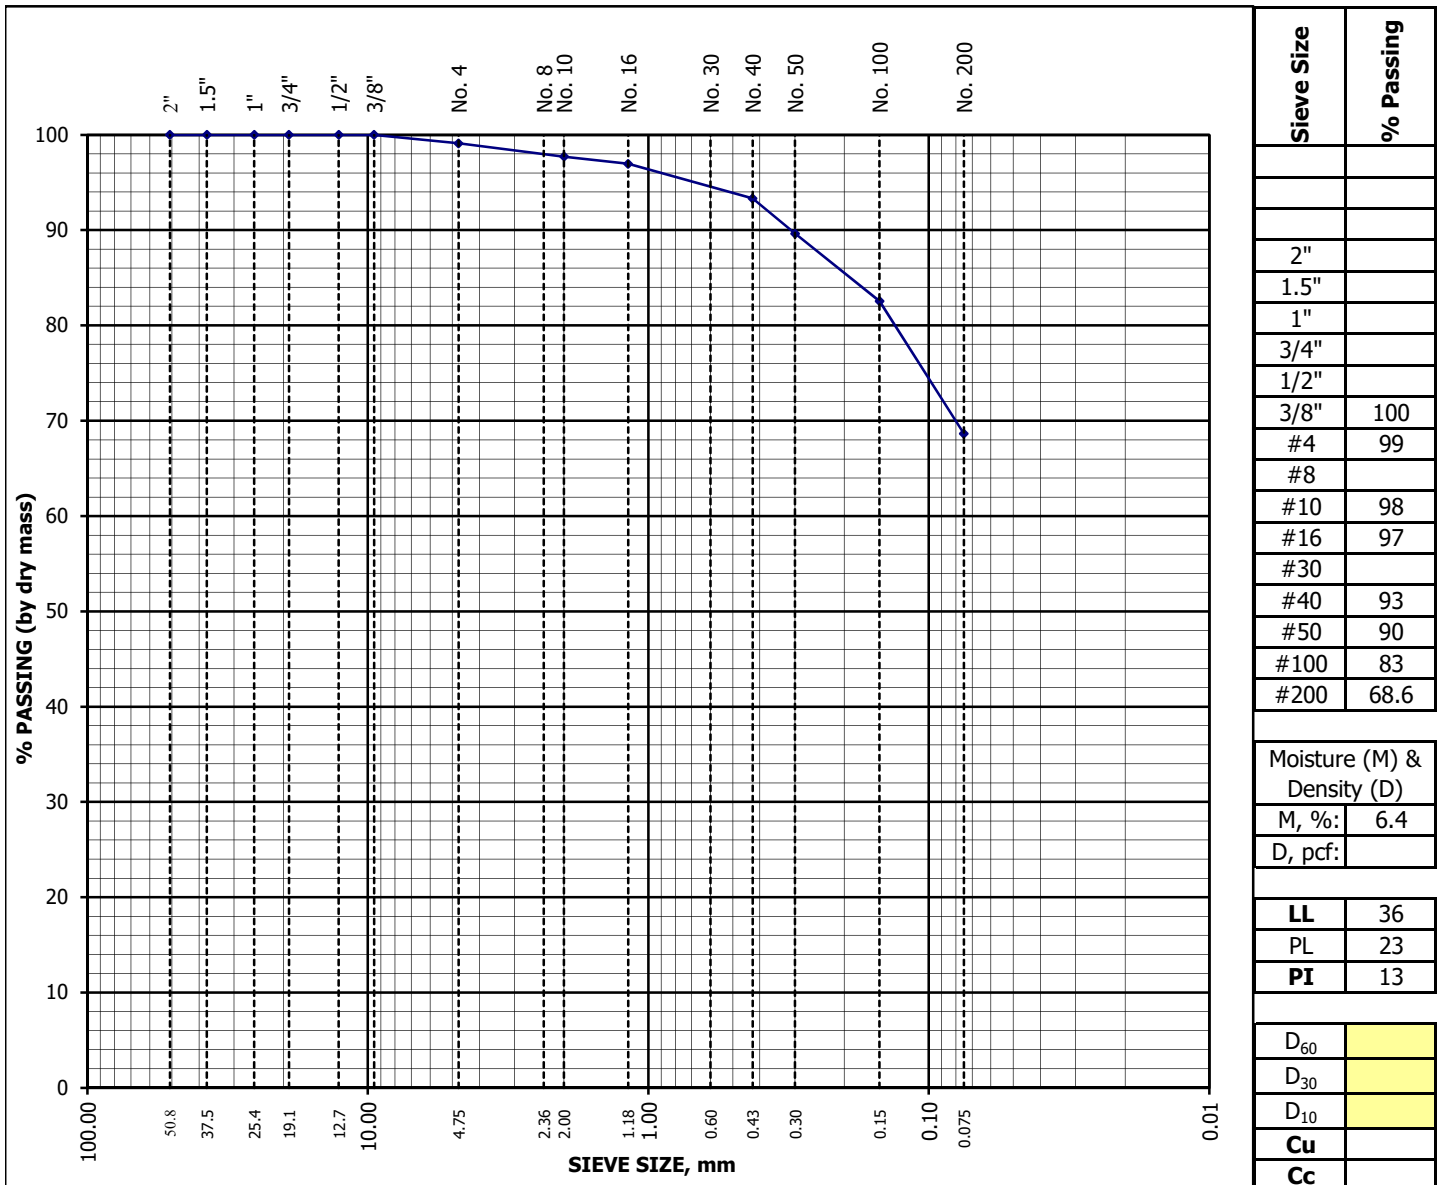
## GRADATION PLOT - SOIL & AGGREGATE

Project Number: 18.117, Applegate Group Date: 21-Sep-18  
 Project Name: Cucharas Basin Collaborative Storage Technician: J. Holiman  
 Lab ID Number: 1822641 Reviewer: J. Crystal  
 Sample Location: MSP-2 at 1' to 3'  
 Visual Description: CLAY, sandy, light brown

**AASHTO M 145 Classification:** A-6 **Group Index:** 8  
**Unified Soil Classification System**  
**(ASTM D 2487):** (CL) **Sandy lean clay**
