# *South Baker Creek Dam*

## 30% Design Report

### Huerfano County Water Conservancy District

AG JOB No. 18-117

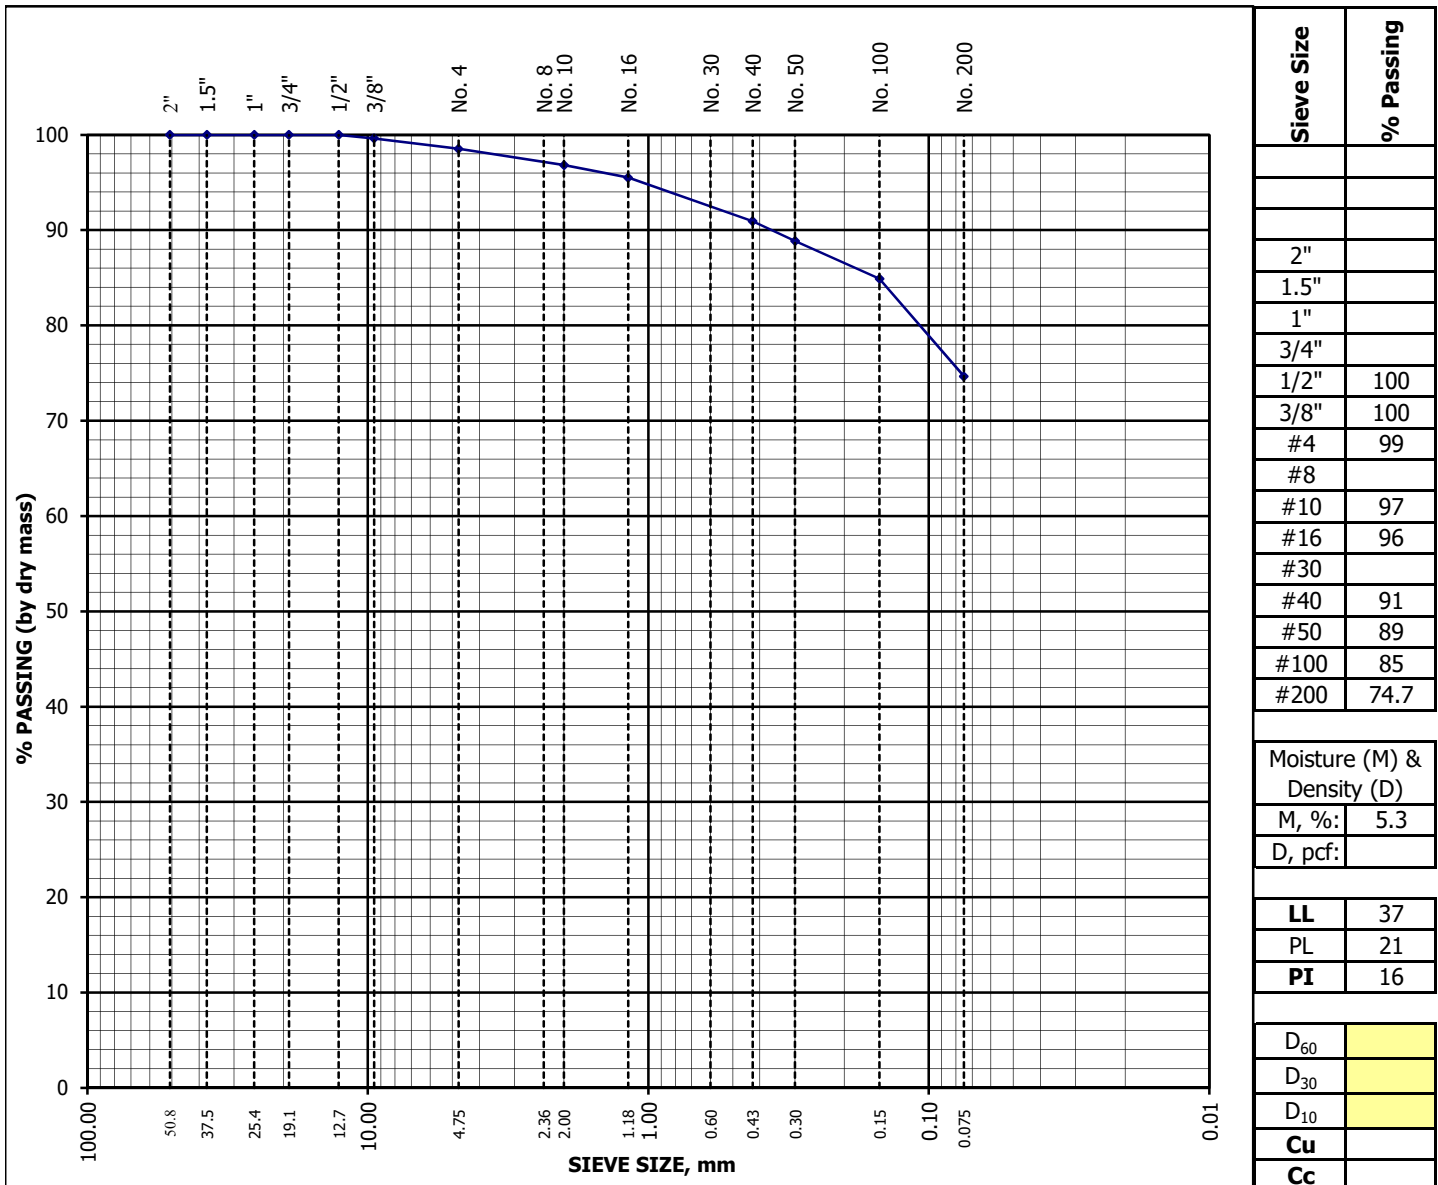
Project Number:	18.117, Applegate Group	Date:	7-Oct-18
Project Name:	Cucharas Basin Collaborative Storage	Technician:	G. Hoyos
Lab ID Number:	1822642	Reviewer:	J. Crystal
Sample Location:	MSP-4 at 1' to 4'		
Visual Description:	CLAY, with sand, brown

**AASHTO M 145 Classification:** A-6 **Group Index:** 11  
**Unified Soil Classification System**  
**(ASTM D 2487):** (CL) **Lean clay with sand**

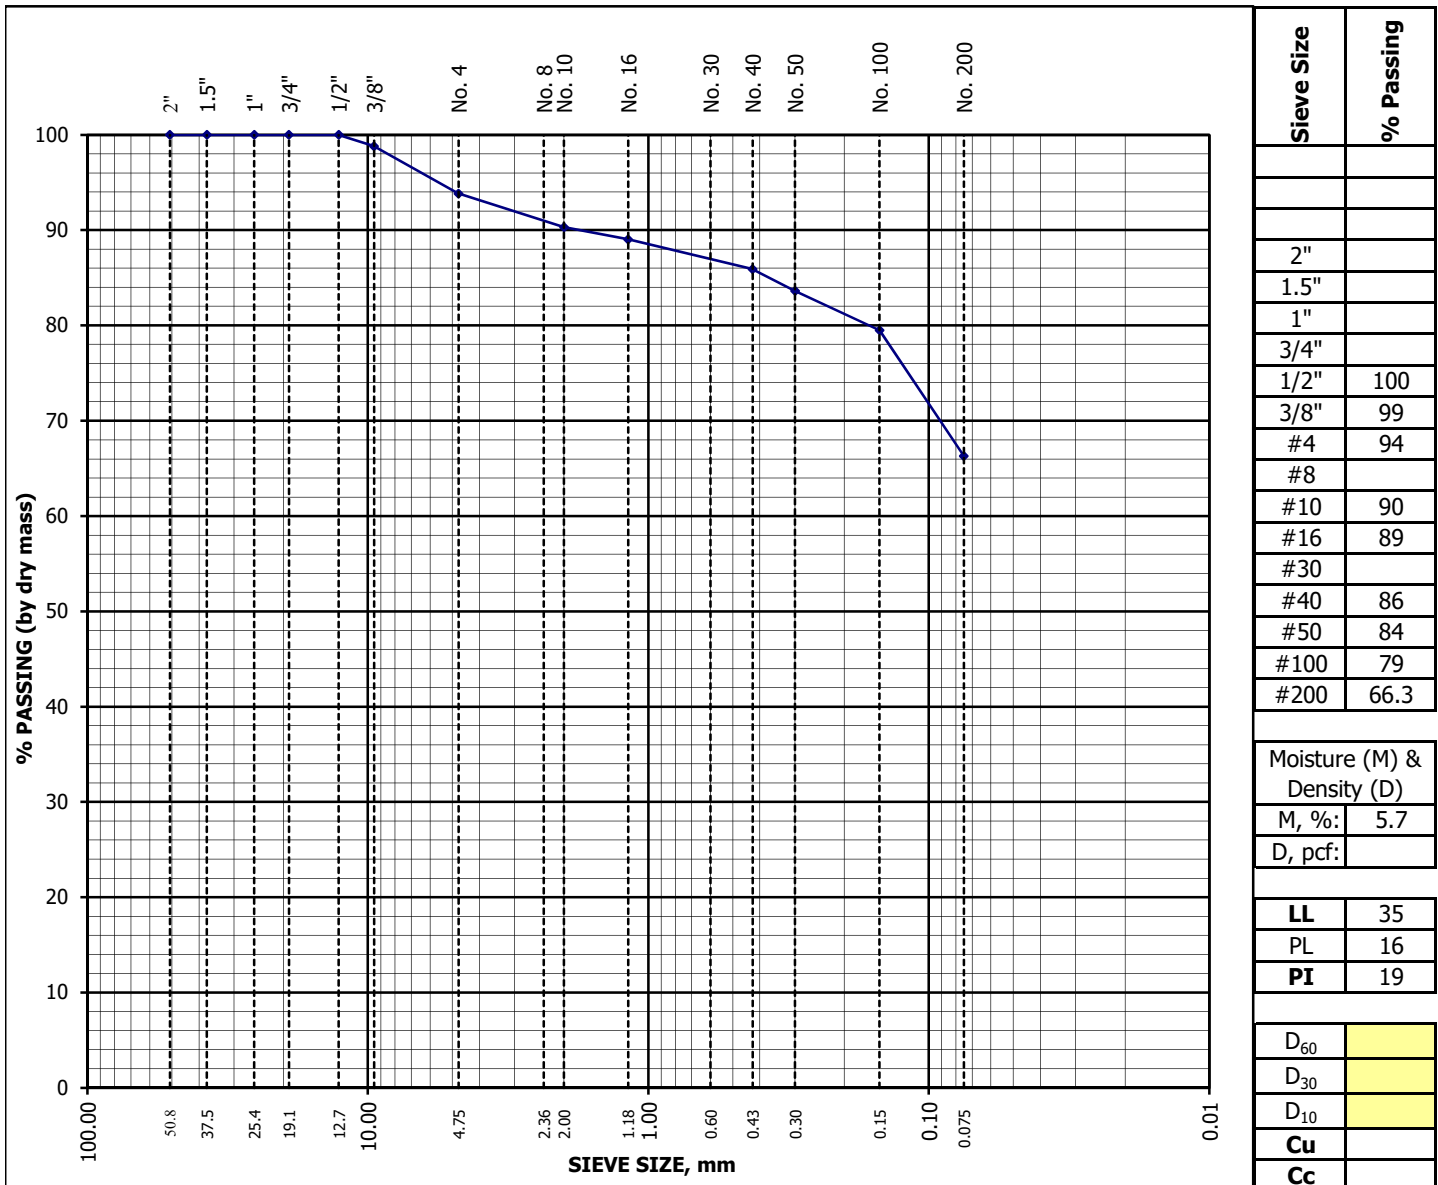
Project Number:	18.117, Applegate Group	Date:	21-Sep-18
Project Name:	Cucharas Basin Collaborative Storage	Technician:	J. Holiman
Lab ID Number:	1822643	Reviewer:	J. Crystal
Sample Location:	MSP-5 at 1' to 4'		
Visual Description:	CLAY, sandy, brown

**AASHTO M 145 Classification:** A-6 **Group Index:** 10  
**Unified Soil Classification System**  
**(ASTM D 2487):** (CL) **Sandy lean clay**

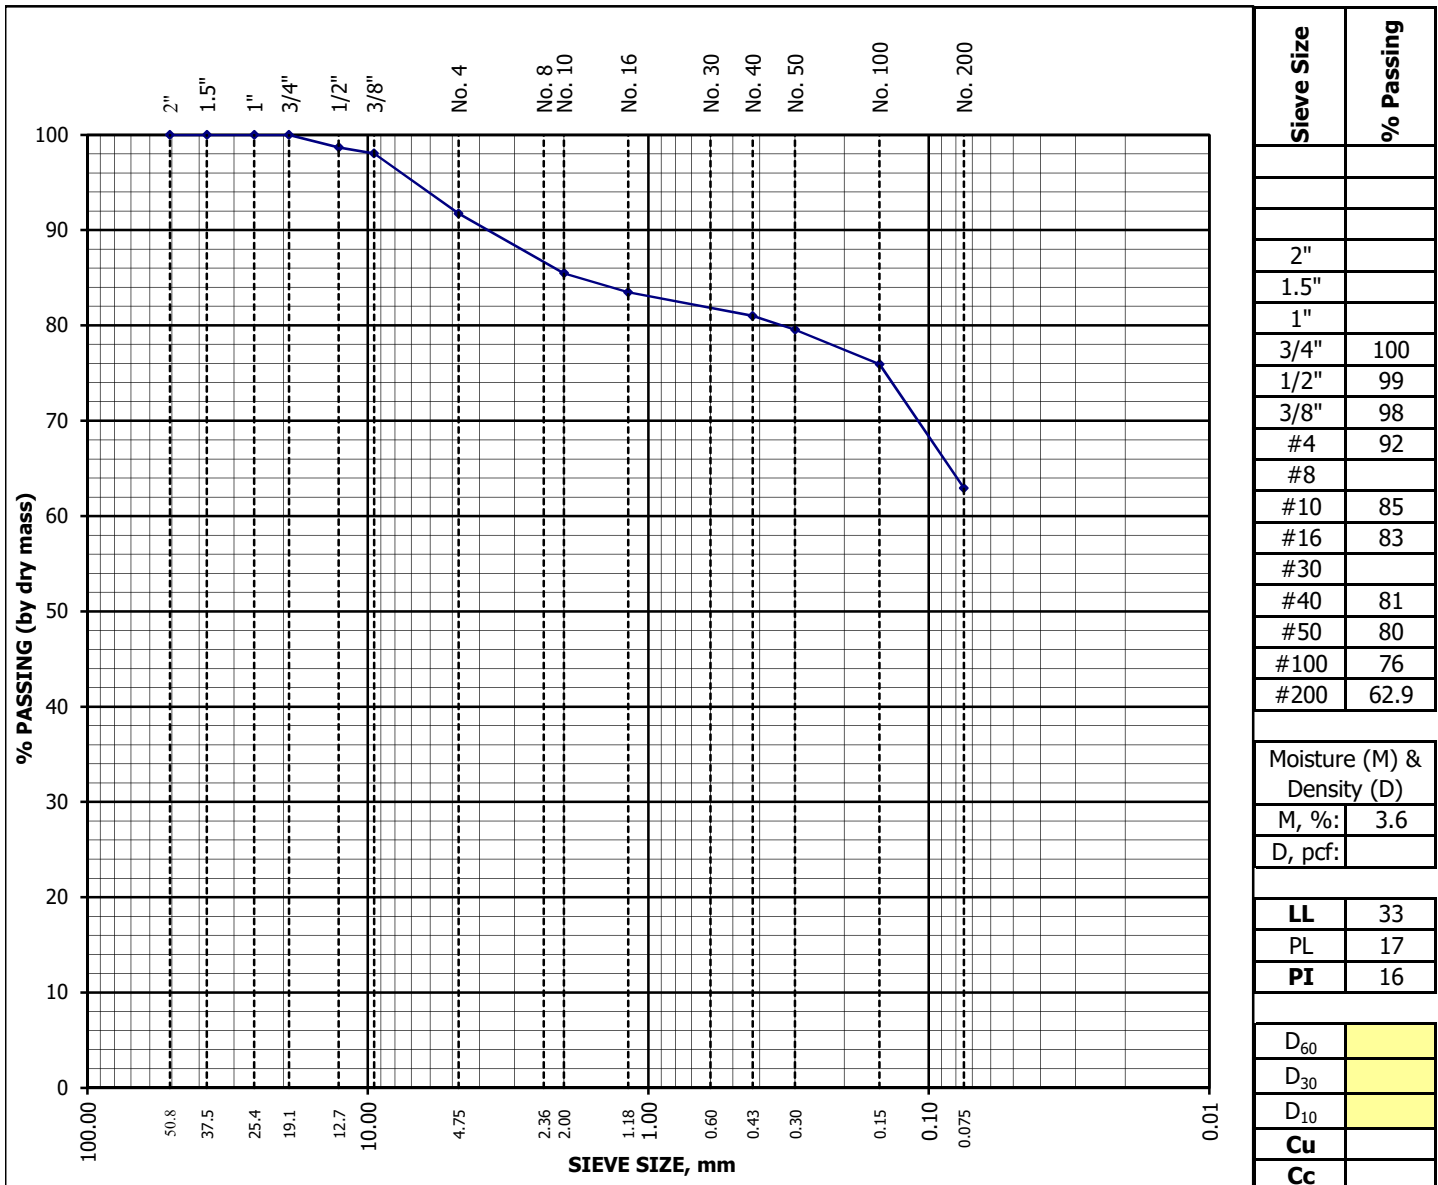
Project Number: 18.117, Applegate Group Date: 21-Sep-18  
Project Name: Cucharas Basin Collaborative Storage Technician: J. Holiman  
Lab ID Number: 1822644 Reviewer: J. Crystal  
Sample Location: MSP-5 at 4' to 7'  
Visual Description: CLAYSTONE, sandy, brown

**AASHTO M 145 Classification:** A-6 **Group Index:** 7  
**Unified Soil Classification System**  
**(ASTM D 2487):** (CL) **Sandy lean clay**

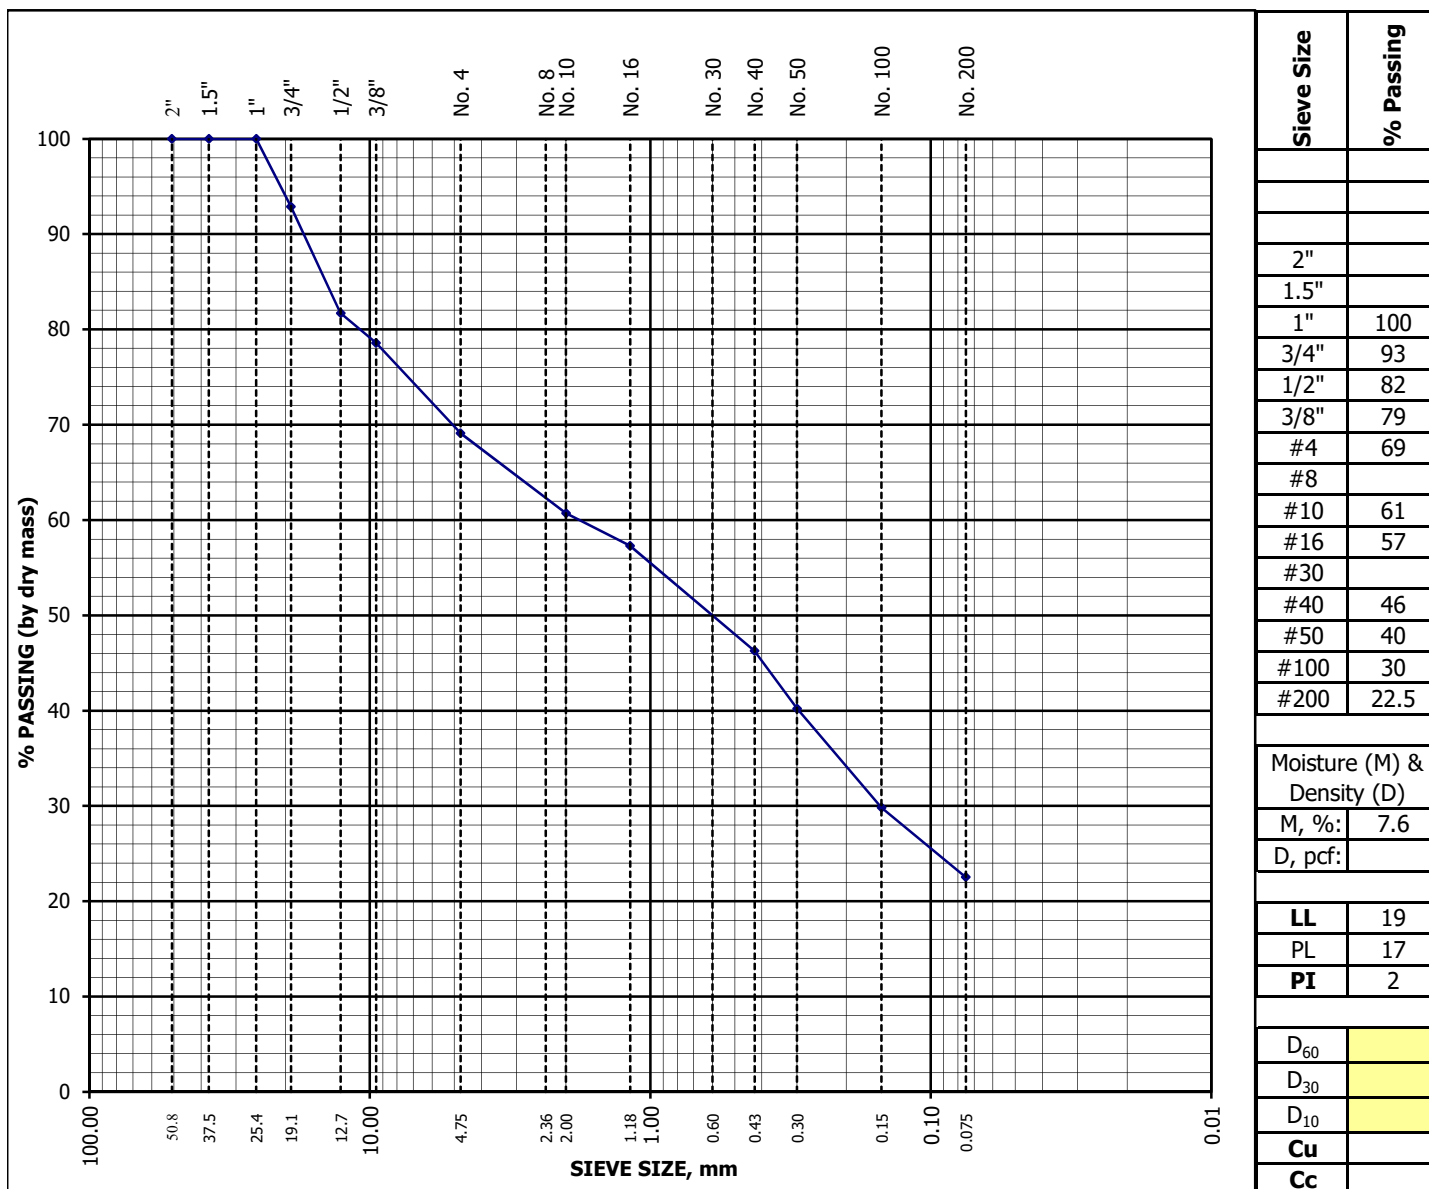
Project Number: 18.117, Applegate Group Date: 12-Sep-18  
Project Name: Cucharas Basin Collaborative Storage Technician: G. Hoyos  
Lab ID Number: 1822886 Reviewer: J. Crystal  
Sample Location: SB-1 at 5'  
Visual Description: SAND, silty, with gravel, red

**AASHTO M 145 Classification:** A-1-b **Group Index:** (0)  
**Unified Soil Classification System**  
**(ASTM D 2487):** (SM) **Silty sand with gravel**

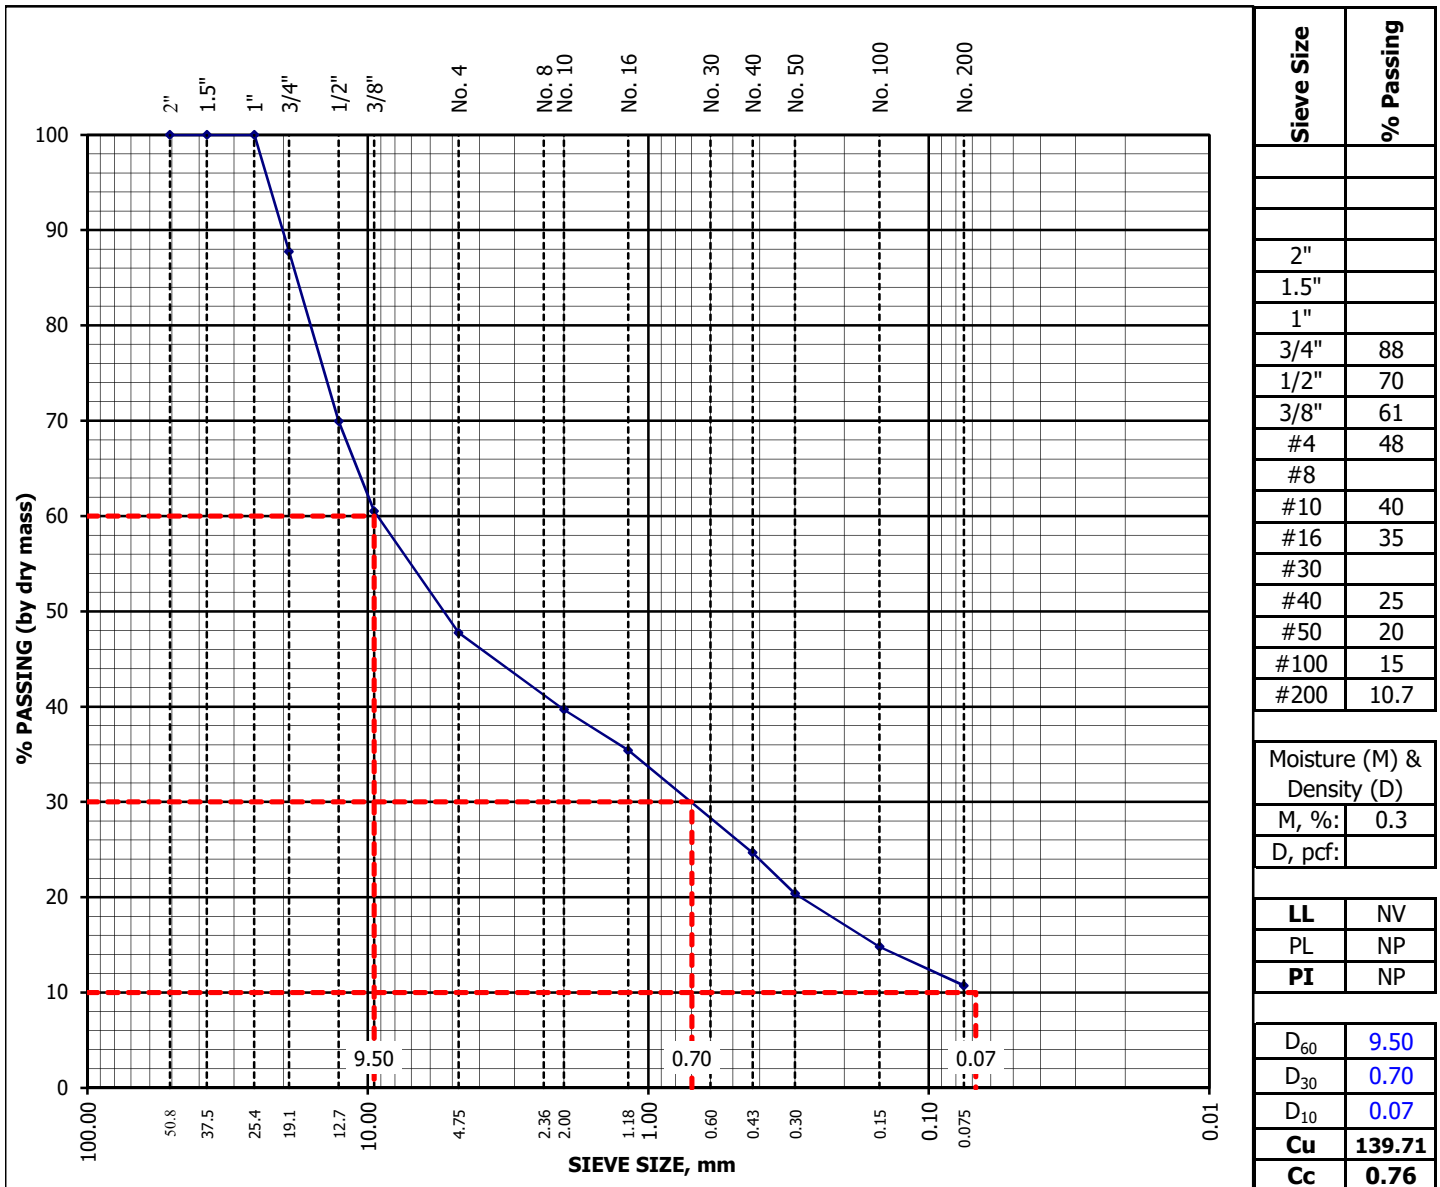
Project Number: 18.117, Applegate Group Date: 5-Sep-18  
 Project Name: Cucharas Basin Collaborative Storage Technician: J. Weinerth  
 Lab ID Number: 1822887 Reviewer: J. Crystal  
 Sample Location: SB-1 at 12.5'  
 Visual Description: Gravel, with silt, with sand, pink

**AASHTO M 145 Classification:** A-1-b **Group Index:** 0  
**Unified Soil Classification System**  
**(ASTM D 2487):** (GP-GM) Poorly graded gravel with silt and sand

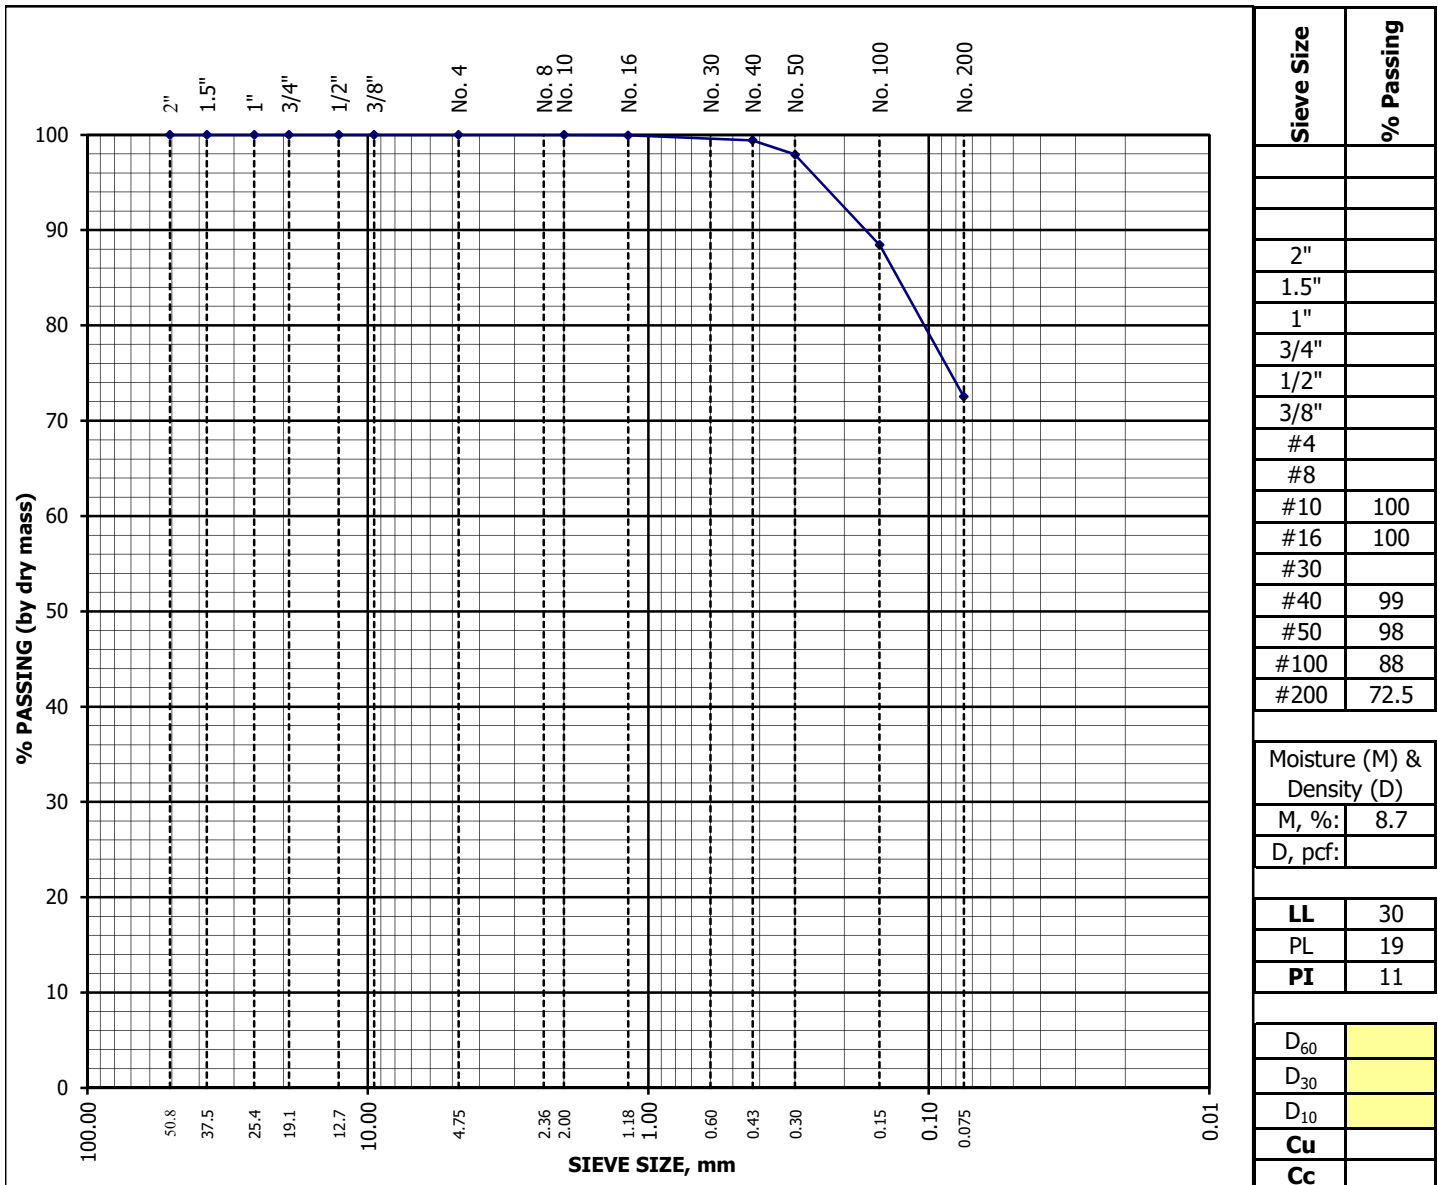
Project Number: 18.117, Applegate Group Date: 8-Sep-18  
Project Name: Cucharas Basin Collaborative Storage Technician: J. Holiman  
Lab ID Number: 1822888 Reviewer: J. Crystal  
Sample Location: SB-1 at 20'  
Visual Description: CLAY, with sand, red

**AASHTO M 145 Classification:** A-6 **Group Index:** 6  
**Unified Soil Classification System**  
**(ASTM D 2487):** (CL) **Lean clay with sand**

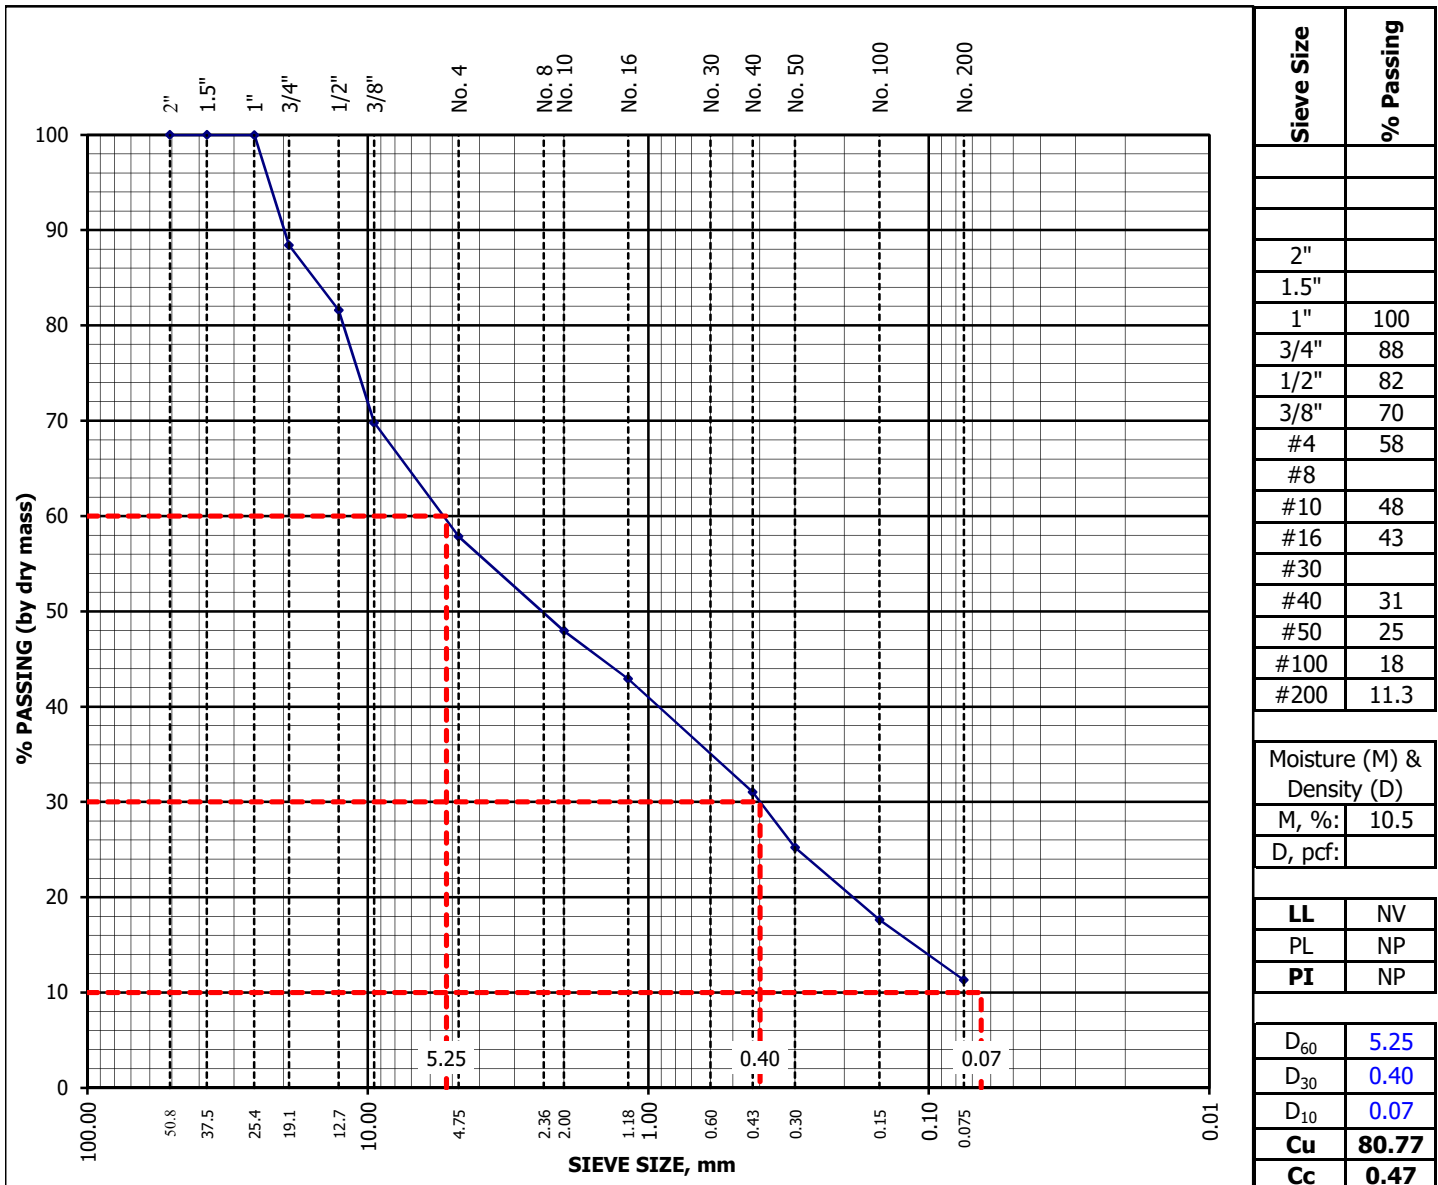
Project Number: 18.117, Applegate Group Date: 5-Sep-18  
Project Name: Cucharas Basin Collaborative Storage Technician: J. Weinerth  
Lab ID Number: 1822889 Reviewer: J. Crystal  
Sample Location: SB-2 at 10'  
Visual Description: SAND, with silt and gravel, red brown

**AASHTO M 145 Classification:** A-1-b **Group Index:** 0  
**Unified Soil Classification System**  
**(ASTM D 2487):** (SP-SM) Poorly graded sand with silt and gravel

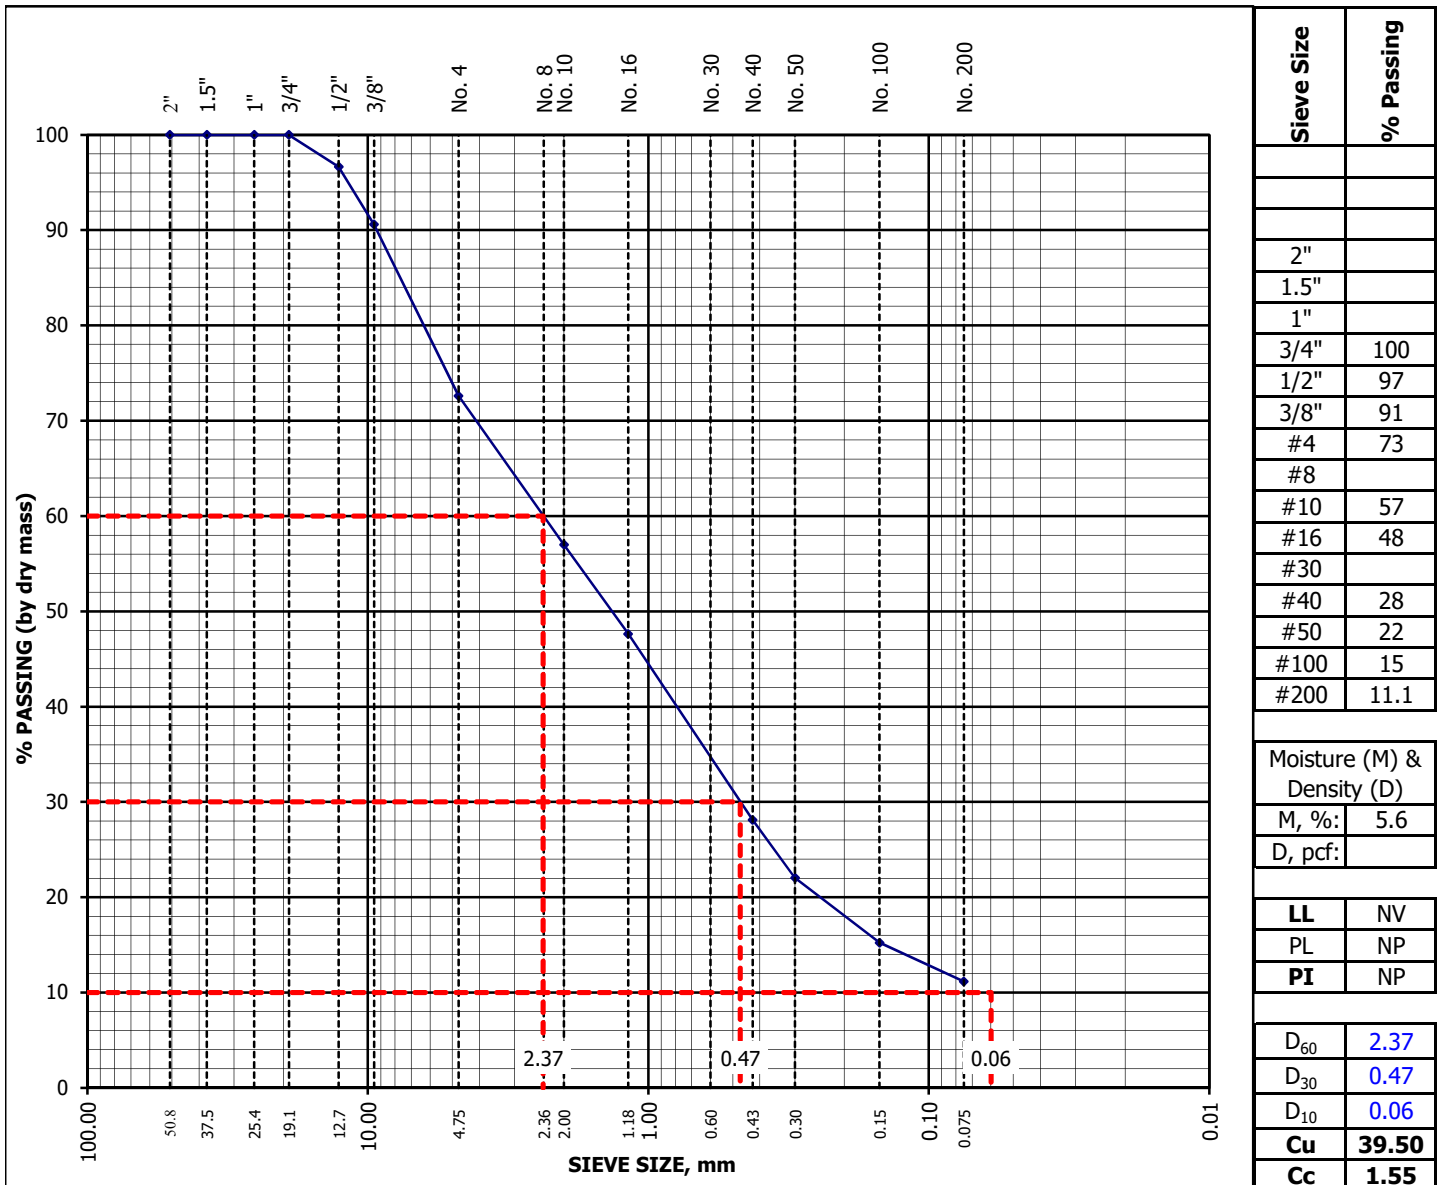
Project Number: 18.117, Applegate Group Date: 12-Sep-18  
Project Name: Cucharas Basin Collaborative Storage Technician: G. Hoyos  
Lab ID Number: 1822890 Reviewer: J. Crystal  
Sample Location: SB-3 at 5'  
Visual Description: SAND, with silt and gravel, red

**AASHTO M 145 Classification:** A-1-b **Group Index:** 0  
**Unified Soil Classification System**  
**(ASTM D 2487):** (SW-SM) Well graded sand with silt and gravel

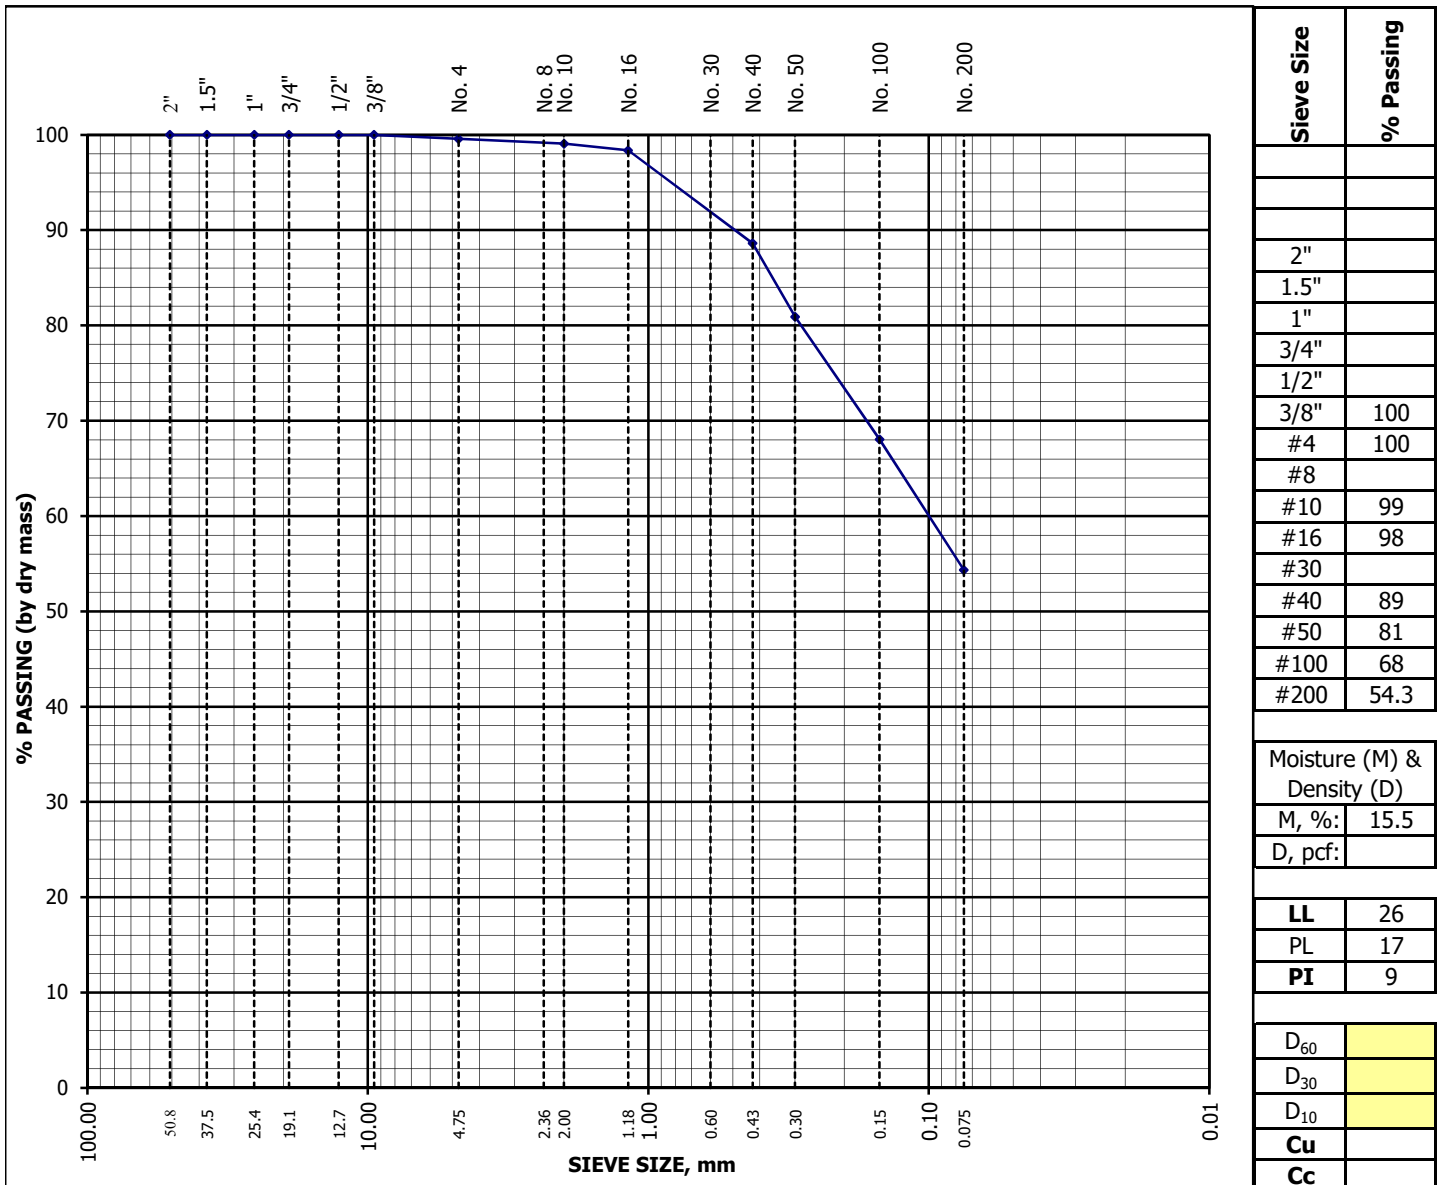
Project Number: 18.117, Applegate Group Date: 9-Sep-19  
Project Name: Cucharas Basin Collaborative Storage Technician: C. Zoetewey  
Lab ID Number: 1921465 Reviewer: J. Crystal  
Sample Location: SB-4 at 5'  
Visual Description: CLAY, sandy, brown

**AASHTO M 145 Classification:** A-4 **Group Index:** 2  
**Unified Soil Classification System**  
**(ASTM D 2487):** (CL) Sandy lean clay

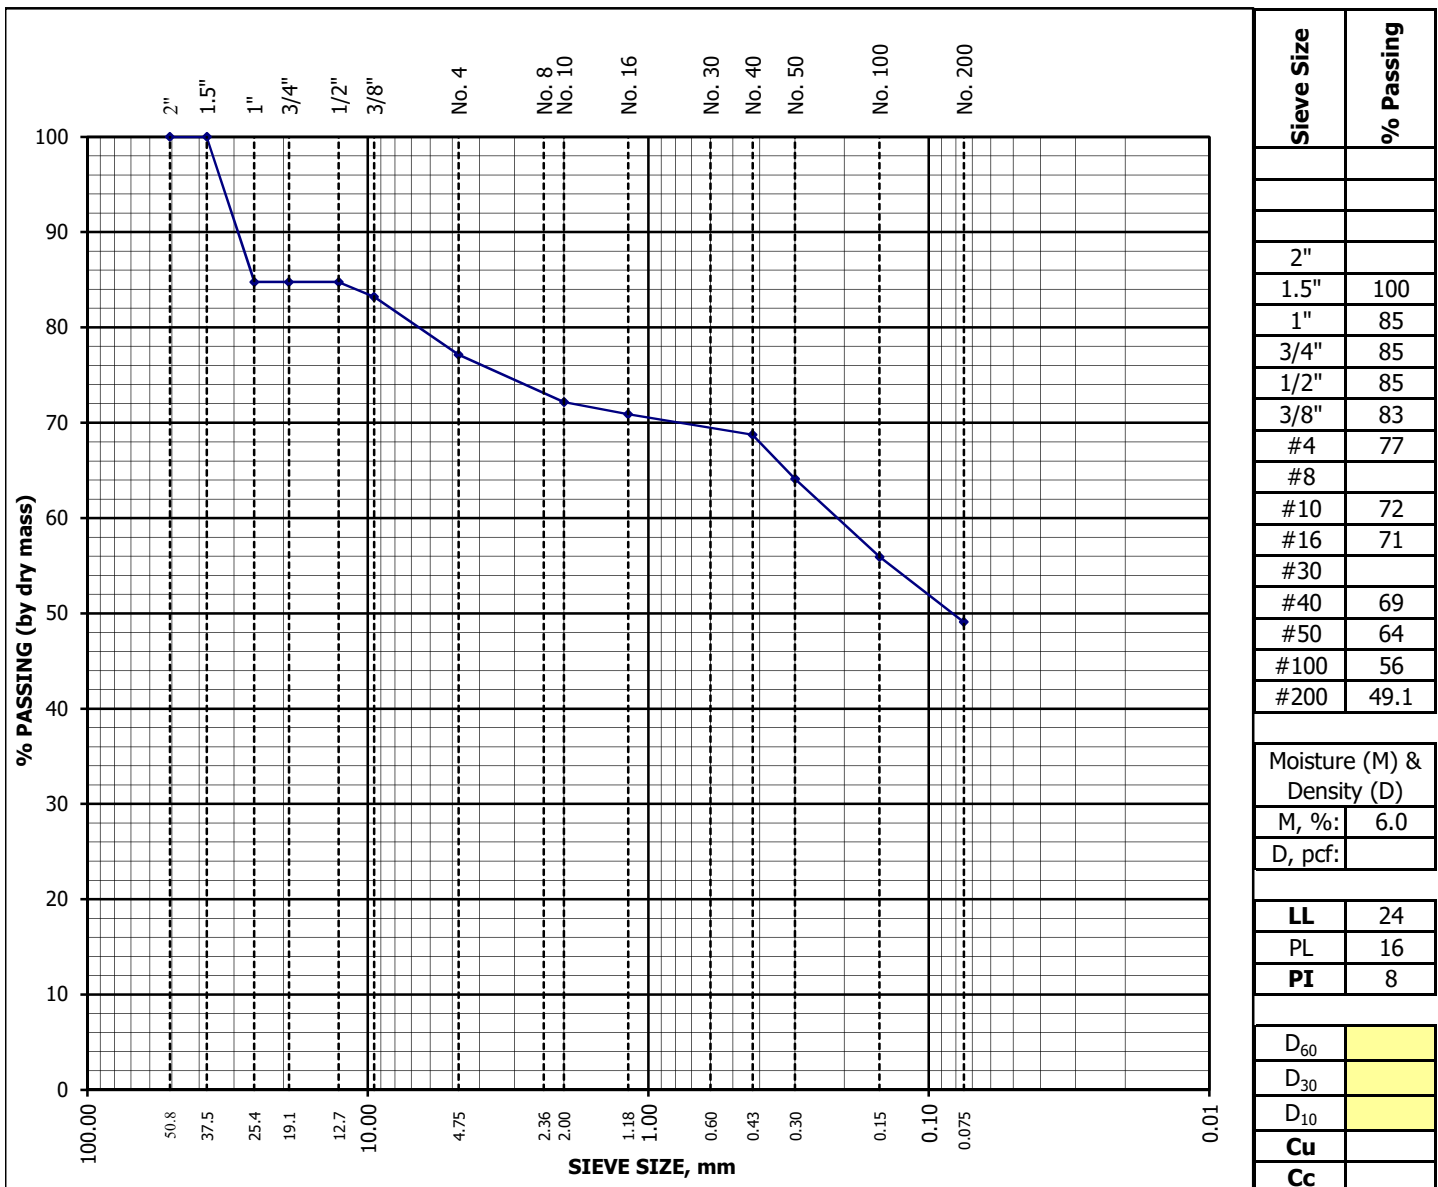
Project Number: 18.117, Applegate Group Date: 9-Sep-19  
Project Name: Cucharas Basin Collaborative Storage Technician: C. Zoetewey  
Lab ID Number: 1921466 Reviewer: J. Crystal  
Sample Location: SB-4 at 15'  
Visual Description: CLAY, sandy, with gravel, reddish brown

**AASHTO M 145 Classification:** A-4 **Group Index:** 1  
**Unified Soil Classification System**  
**(ASTM D 2487):** (CL) Sandy lean clay with gravel

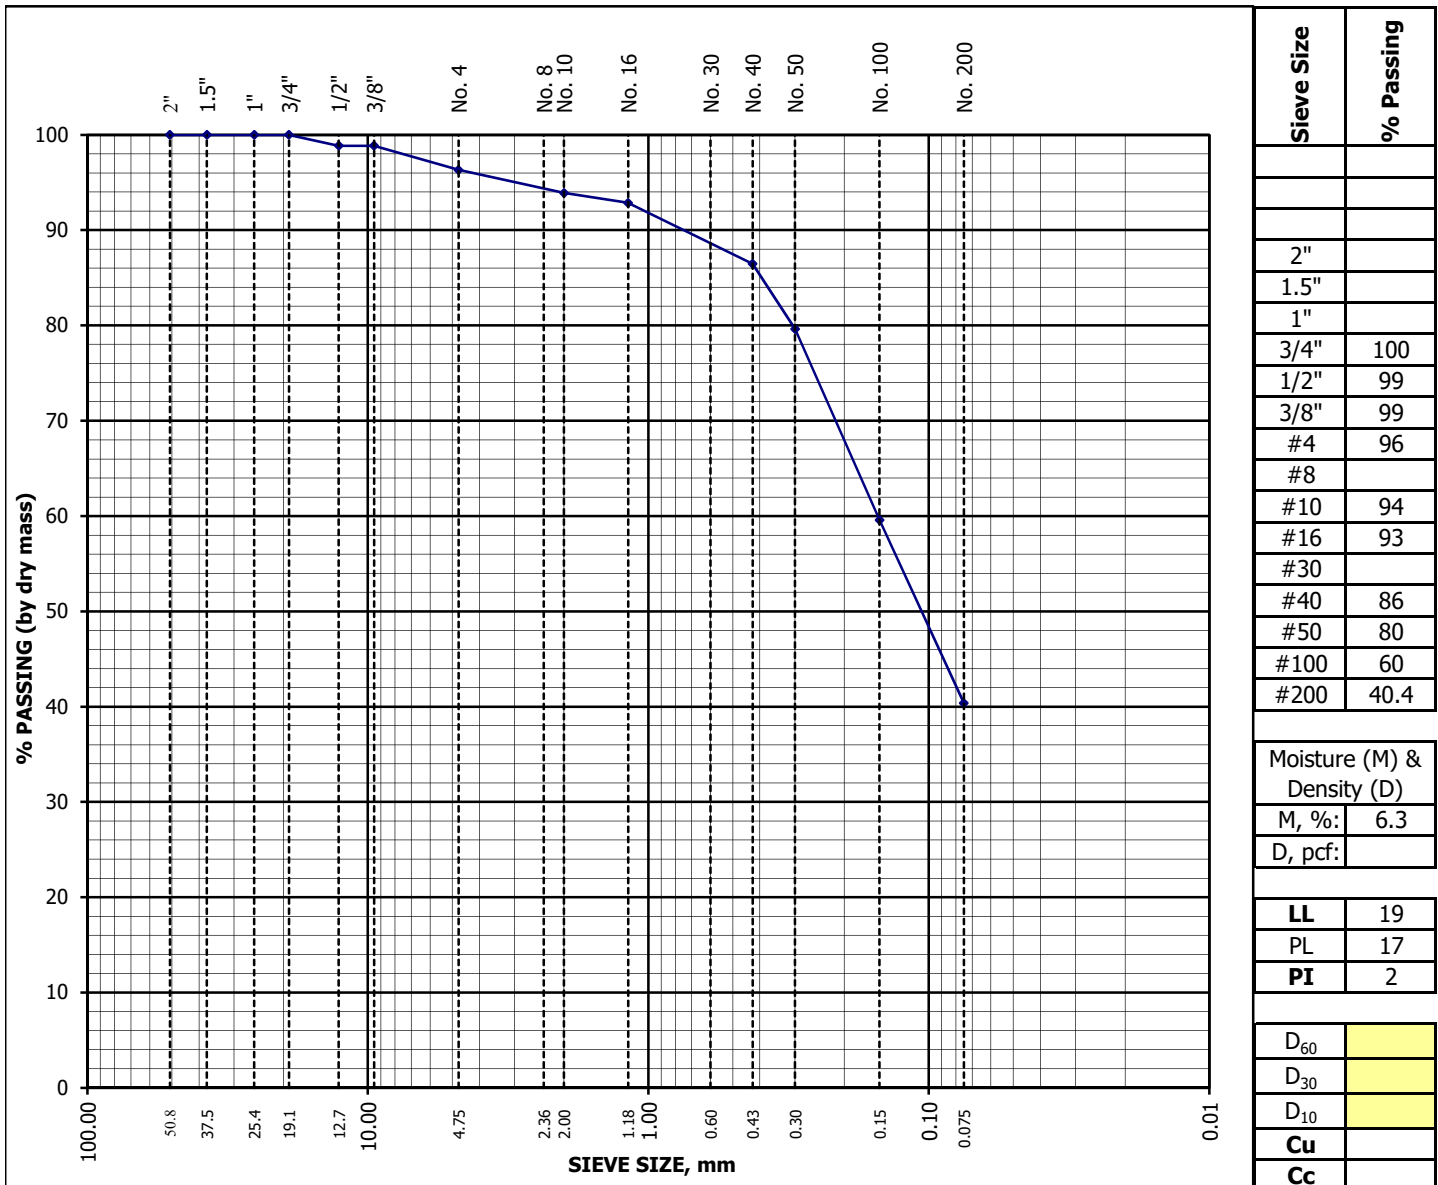
Project Number: 18.117, Applegate Group	Date: 9-Sep-19
Project Name: Cucharas Basin Collaborative Storage	Technician: C. Zoetewey
Lab ID Number: 1921468	Reviewer: J. Crystal
Sample Location: SB-5 at 1'	
Visual Description: SAND, silty, reddish brown

**AASHTO M 145 Classification:** A-4 **Group Index:** (0)  
**Unified Soil Classification System**  
**(ASTM D 2487):** (SM) **Silty sand**

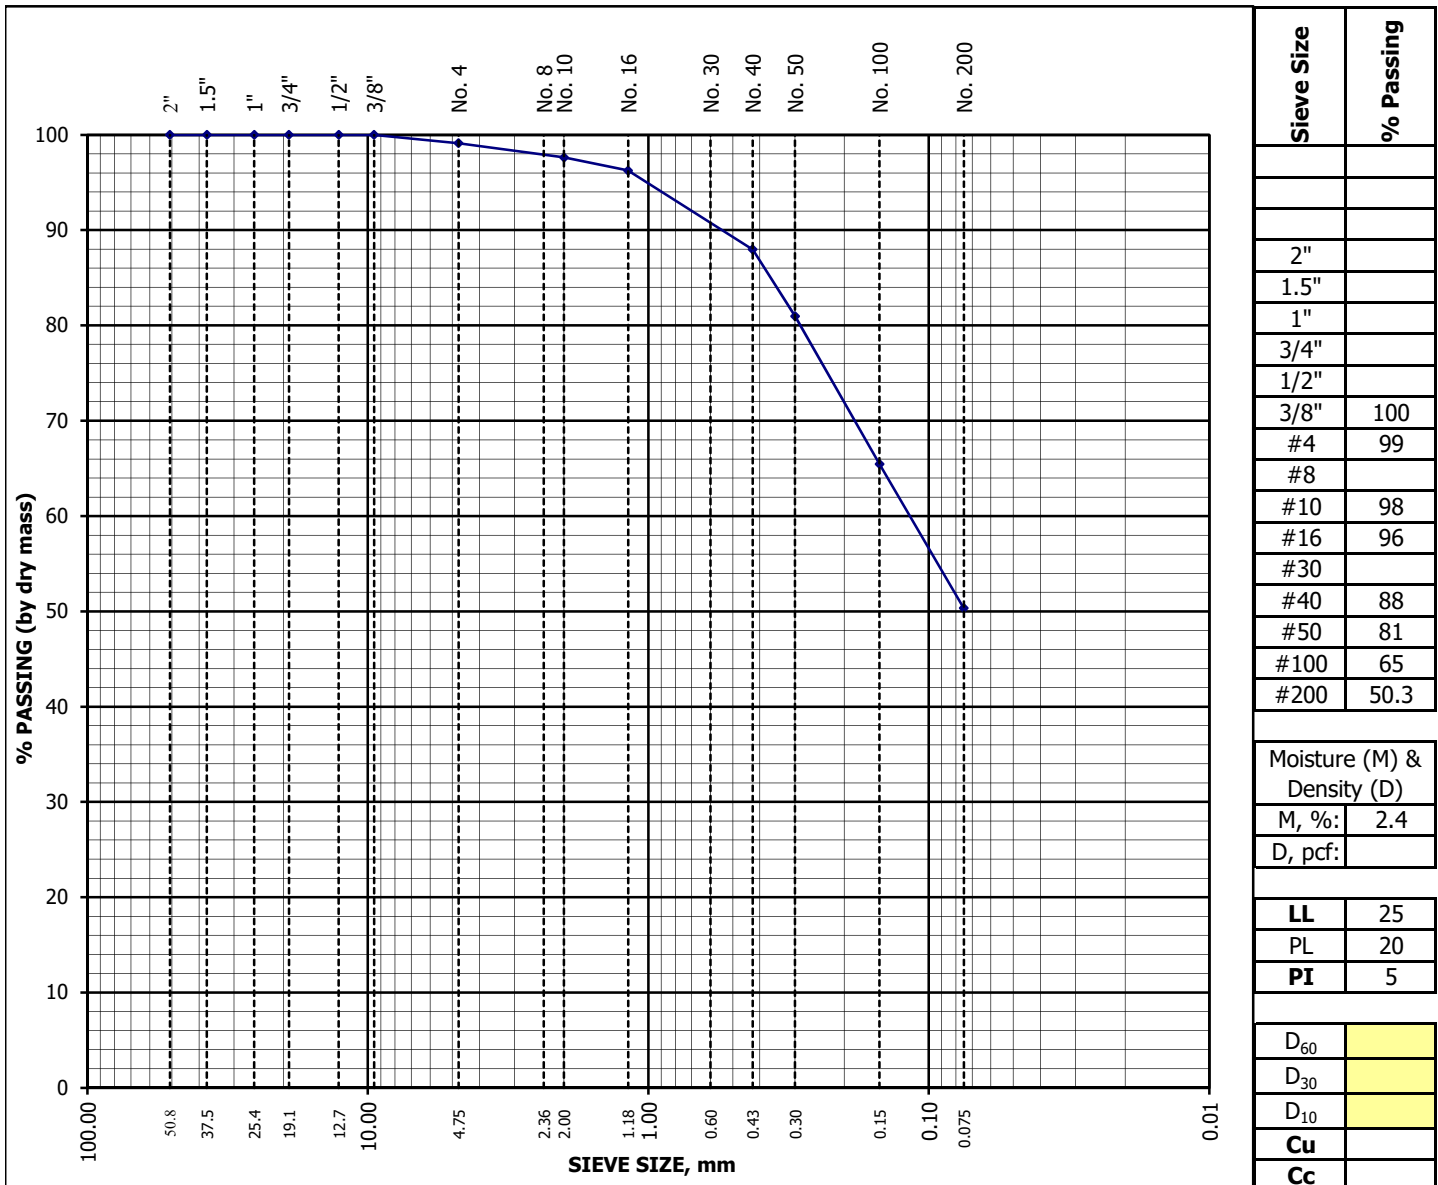
Project Number:	18.117, Applegate Group	Date:	21-Sep-18
Project Name:	Cucharas Basin Collaborative Storage	Technician:	J. Holiman
Lab ID Number:	1822645	Reviewer:	J. Crystal
Sample Location:	SBP-1 at 1' to 3'		
Visual Description:	CLAY, sandy, red

**AASHTO M 145 Classification:** A-4 **Group Index:** 0  
**Unified Soil Classification System**  
**(ASTM D 2487):** (CL-ML) Silty clay with sand
