# *South Baker Creek Dam*

## 30% Design Report

### Huerfano County Water Conservancy District

AG JOB No. 18-117

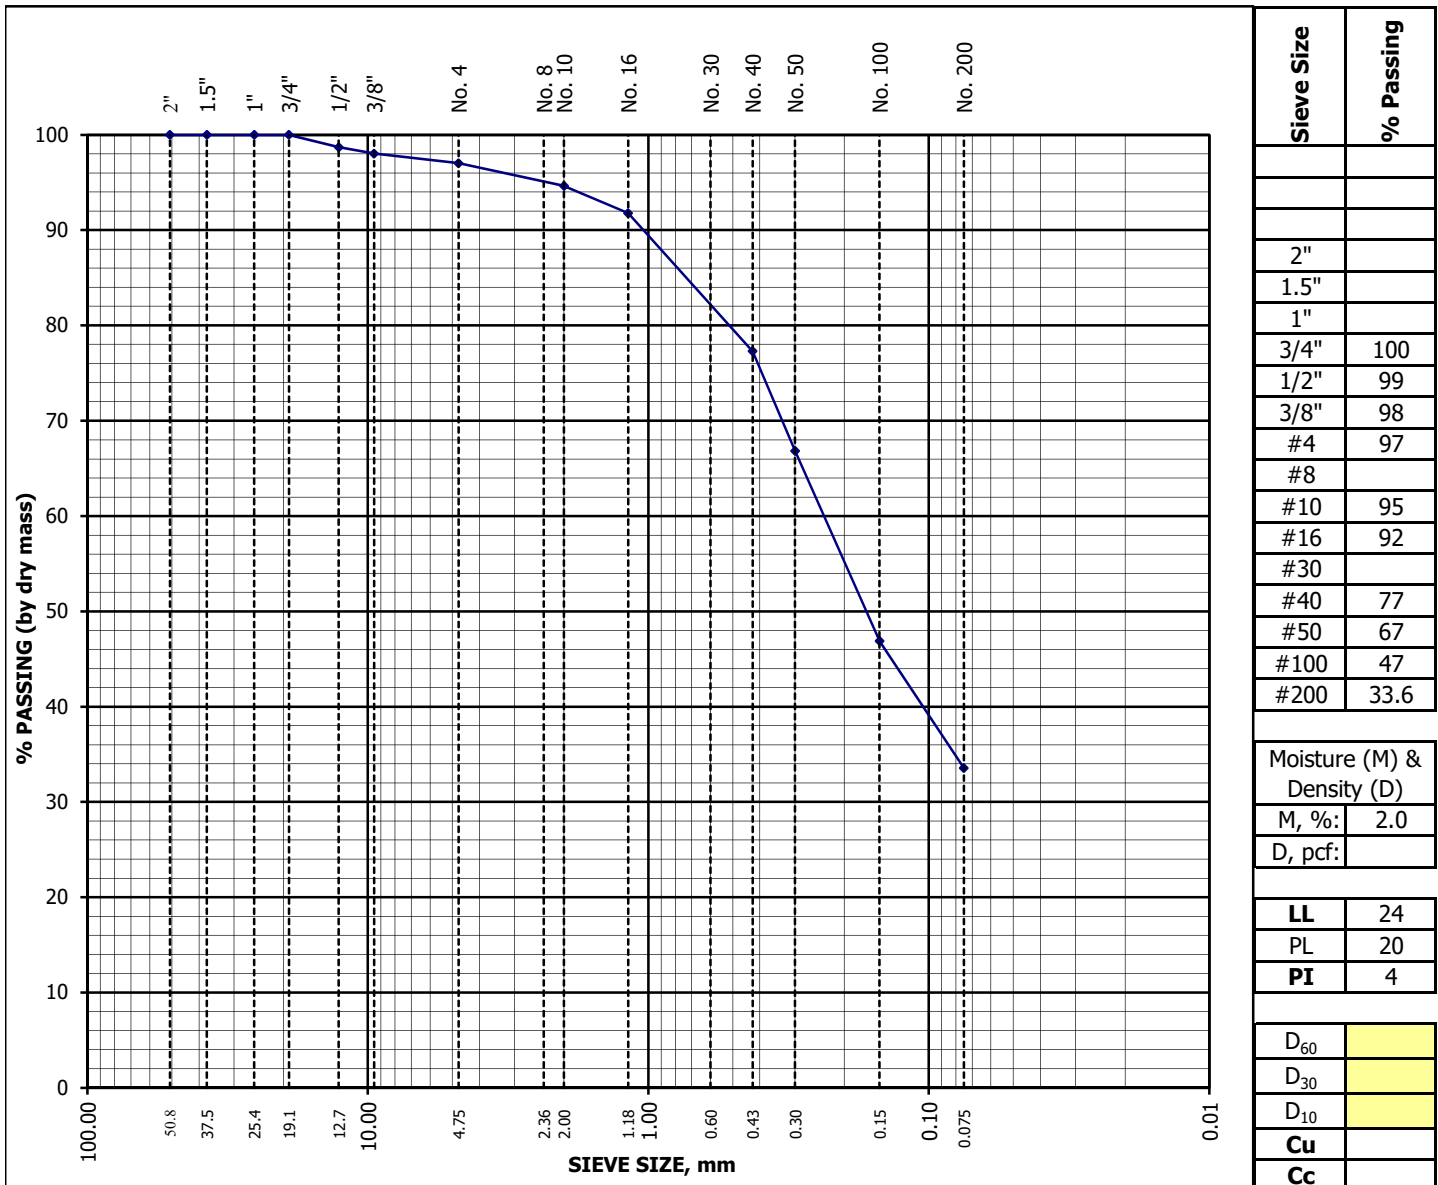
Project Number: 18.117, Applegate Group Date: 25-Sep-18  
Project Name: Cucharas Basin Collaborative Storage Technician: J. Holiman  
Lab ID Number: 1822646 Reviewer: J. Crystal  
Sample Location: SBP-3 at 1' to 3'  
Visual Description: SAND, clayey, with silt, brown

**AASHTO M 145 Classification:** A-2-4 **Group Index:** (0)  
**Unified Soil Classification System**  
**(ASTM D 2487):** (SC-SM) Silty, clayey sand

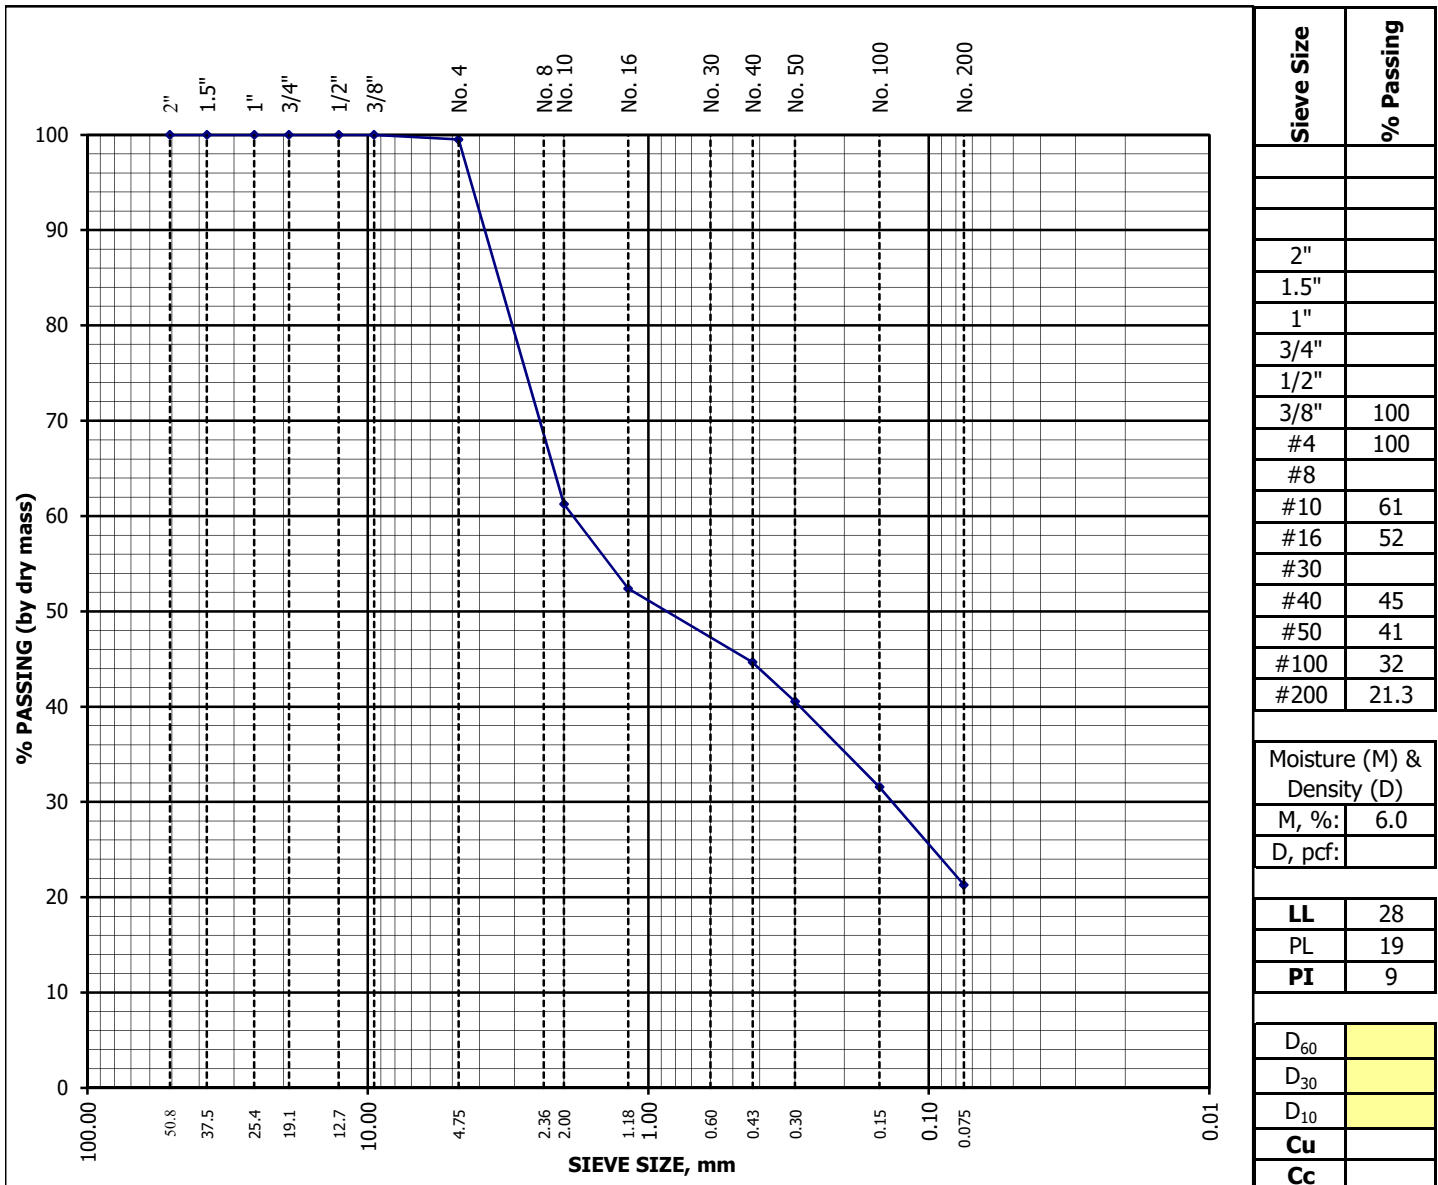
Project Number: 18.117, Applegate Group	Date: 6-Oct-18
Project Name: Cucharas Basin Collaborative Storage	Technician: J. Holiman
Lab ID Number: 1822647	Reviewer: J. Crystal
Sample Location: SBP-3 at 6' to 8'	
Visual Description: SAND, clayey, red brown

**AASHTO M 145 Classification:** A-2-4 **Group Index:** (0)  
**Unified Soil Classification System**  
**(ASTM D 2487):** (SC) **Clayey sand**

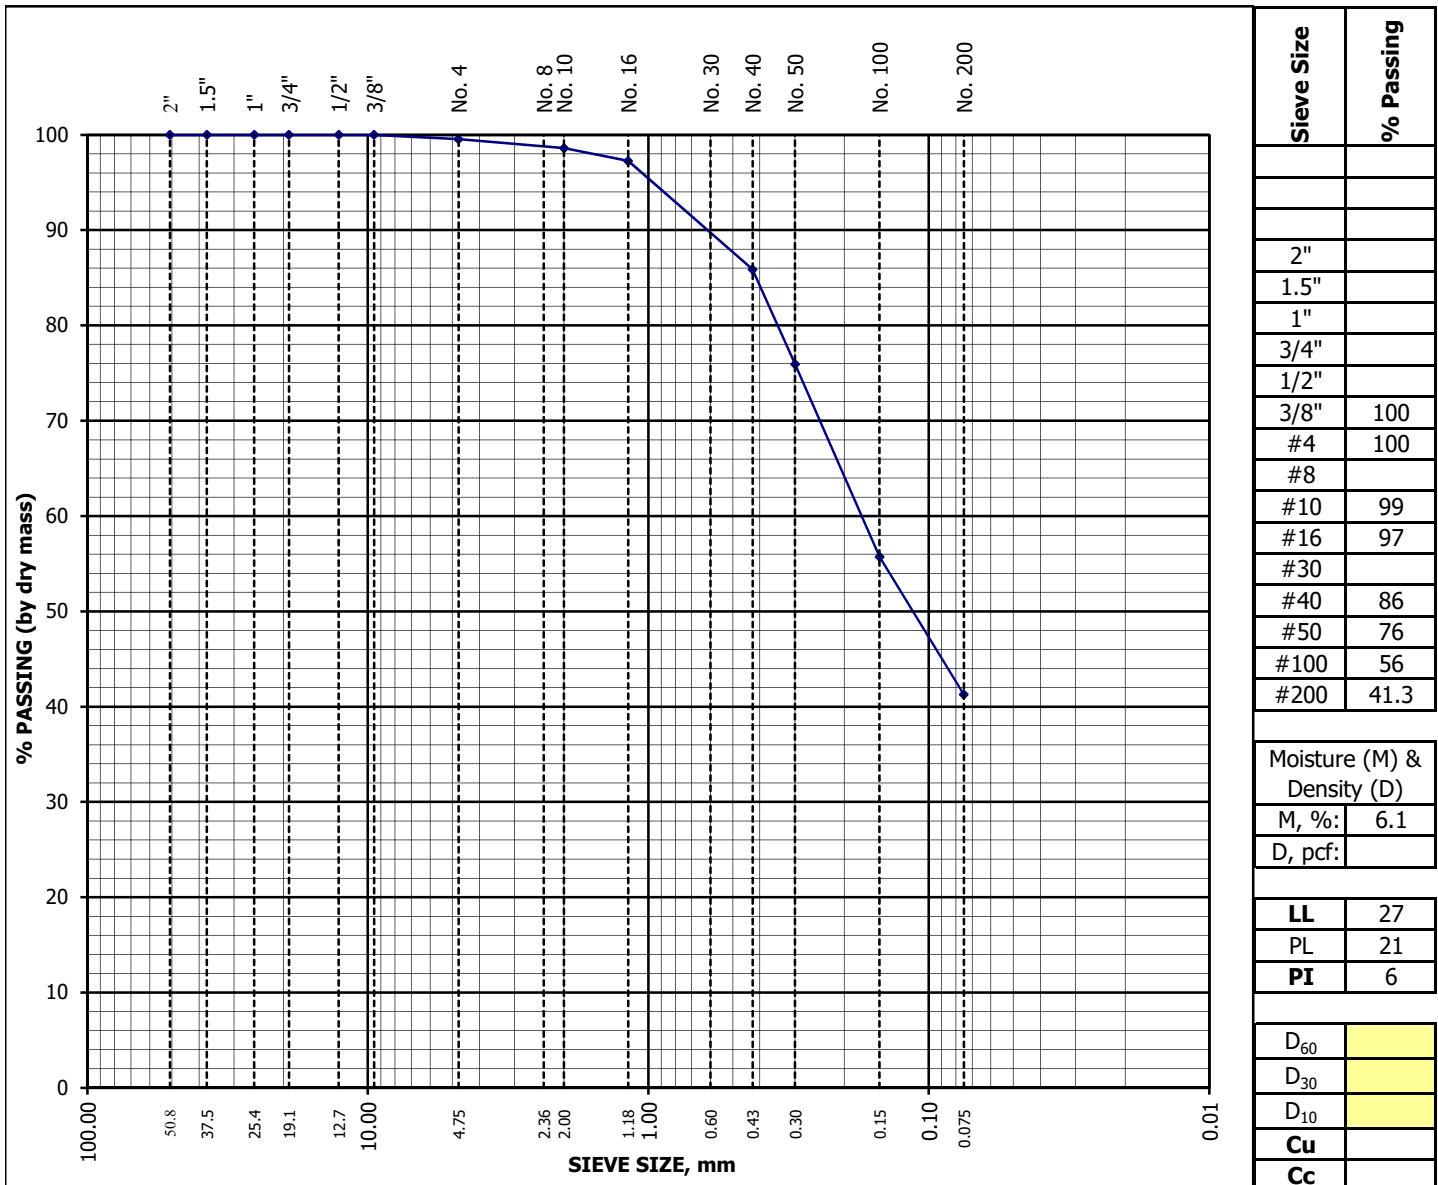
Project Number:	18.117, Applegate Group	Date:	25-Sep-18
Project Name:	Cucharas Basin Collaborative Storage	Technician:	J. Holiman
Lab ID Number:	1822648	Reviewer:	J. Crystal
Sample Location:	SBP-5 at 1' to 3'		
Visual Description:	SAND, silty, clayey, brown

**AASHTO M 145 Classification:** A-4 **Group Index:** (0)  
**Unified Soil Classification System**  
**(ASTM D 2487):** (SC-SM) Silty, clayey sand

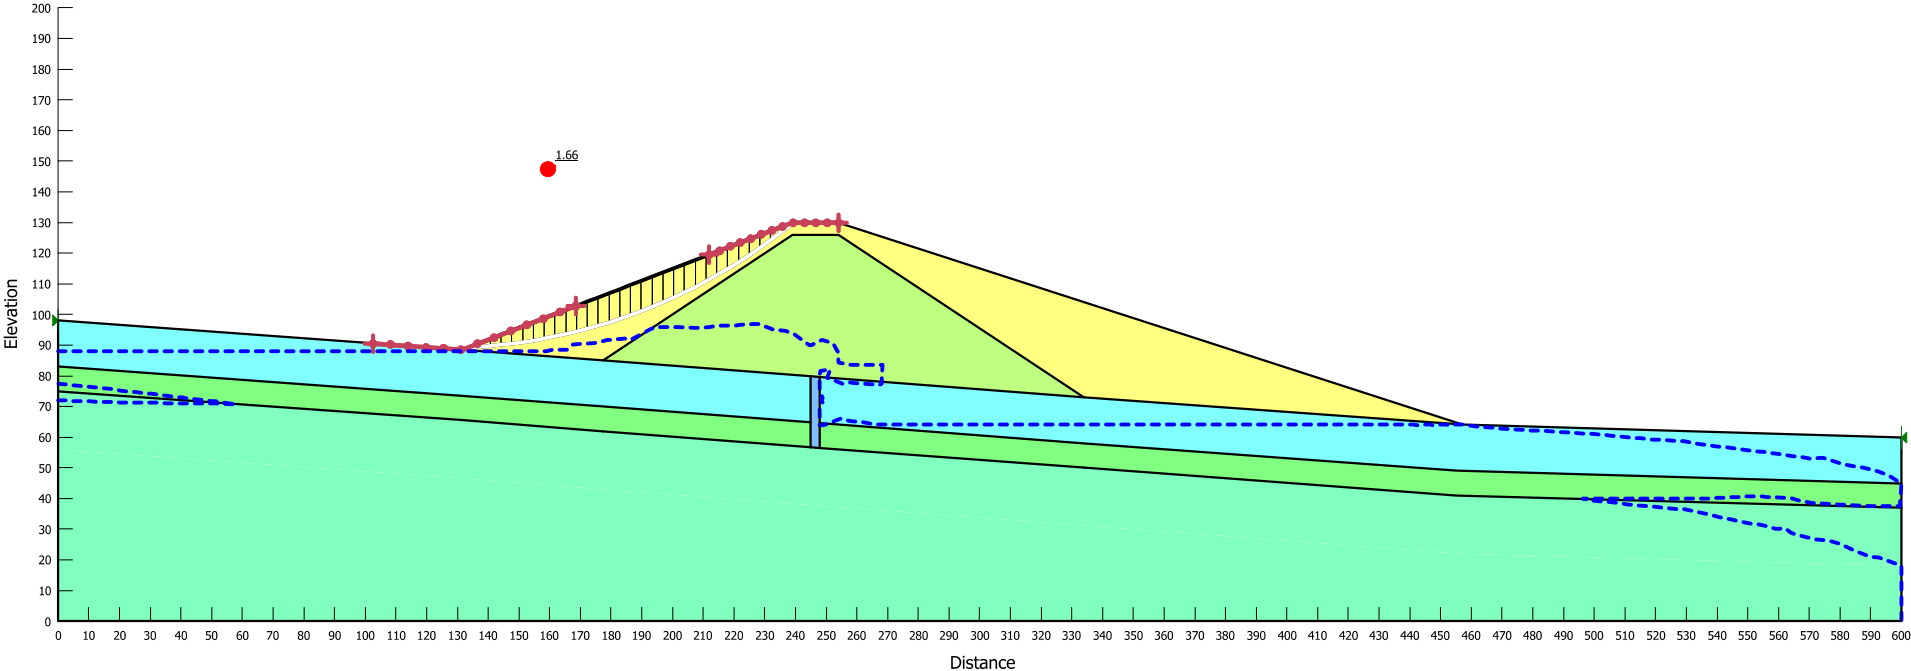
Color	Name	Model	Unit Weight (pcf)	Cohesion' (psf)	Phi' (°)	Phi-B (°)
<span style="color: green;">■</span>	Claystone	Mohr-Coulomb	135	3,000	0	0
<span style="color: yellow;">■</span>	Core	Mohr-Coulomb	125	25	30	0
<span style="color: blue;">■</span>	Cutoff	Mohr-Coulomb	125	10	11	0
<span style="color: cyan;">■</span>	Overburden	Mohr-Coulomb	130	10	30	0
<span style="color: green;">■</span>	Sandstone	Mohr-Coulomb	140	3,000	0	0
<span style="color: yellow;">■</span>	Shell	Mohr-Coulomb	132	25	30	0

**Transient Seepage Stability, Circular Failure, Twentieth Day**

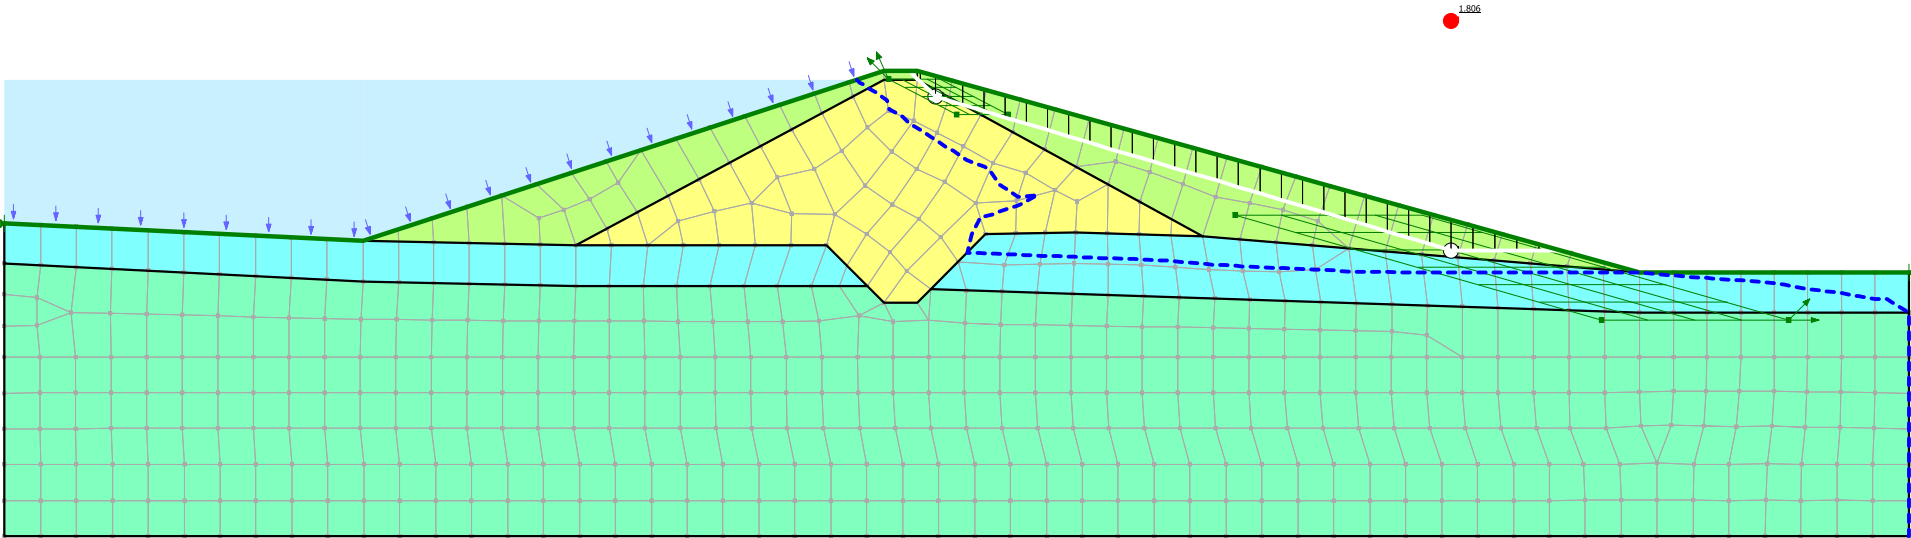
Color	Name	Model	Unit Weight (pcf)	Cohesion' (psf)	Phi' (°)	Phi-B (°)
<div></div>	Core	Mohr-Coulomb	125	25	25	0
<div></div>	Gravel	Mohr-Coulomb	132	10	35	0
<div></div>	Sandstone	Mohr-Coulomb	140	3,000	0	0
<div></div>	Shell	Mohr-Coulomb	125	25	25	0

**Steady State Seepage Stability, Block Failure**

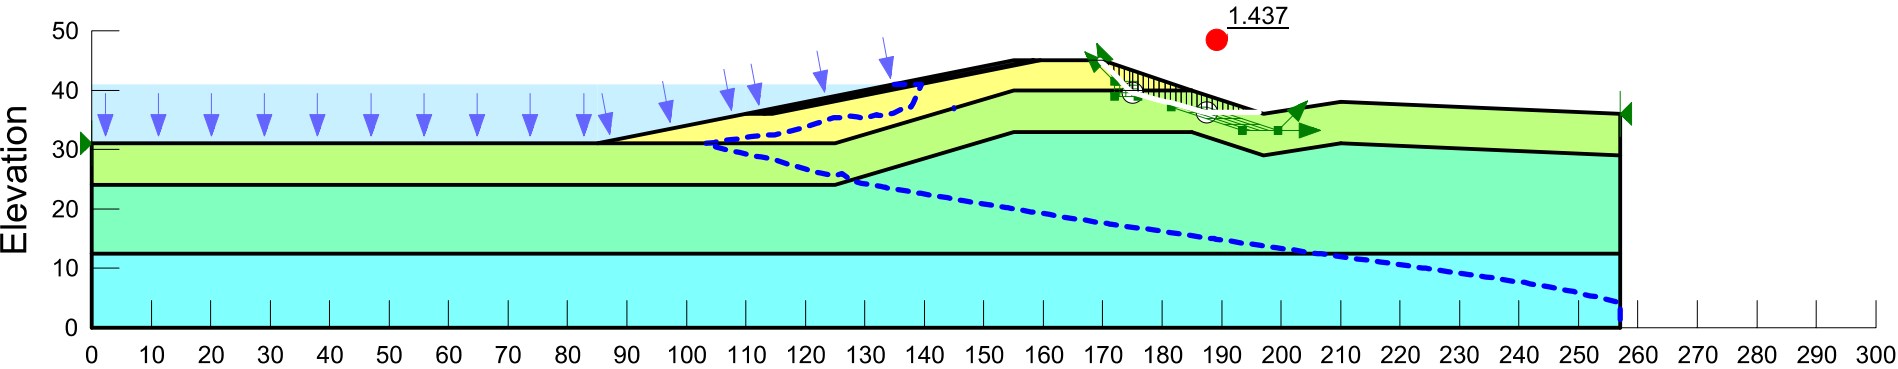
Color	Name	Model	Unit Weight (pcf)	Cohesion' (psf)	Phi' (°)	Phi-B (°)
<span style="display:inline-block; width:15px; height:15px; background-color:yellow;"></span>	Clay Embankment	Mohr-Coulomb	125	25	25	0
<span style="display:inline-block; width:15px; height:15px; background-color:cyan;"></span>	Claystone	Mohr-Coulomb	135	3,000	0	0
<span style="display:inline-block; width:15px; height:15px; background-color:lightgreen;"></span>	Existing Fill	Mohr-Coulomb	115	10	20	0
<span style="display:inline-block; width:15px; height:15px; background-color:mediumgreen;"></span>	Native Clay	Mohr-Coulomb	115	10	15	0
<span style="display:inline-block; width:15px; height:15px; background-color:blue;"></span>	Rip Rap	Mohr-Coulomb	135	10	40	0
<span style="display:inline-block; width:15px; height:15px; background-color:darkgreen;"></span>	Sand Bedding	Mohr-Coulomb	125	10	30	0

Steady State Seepage Stability, Block Failure

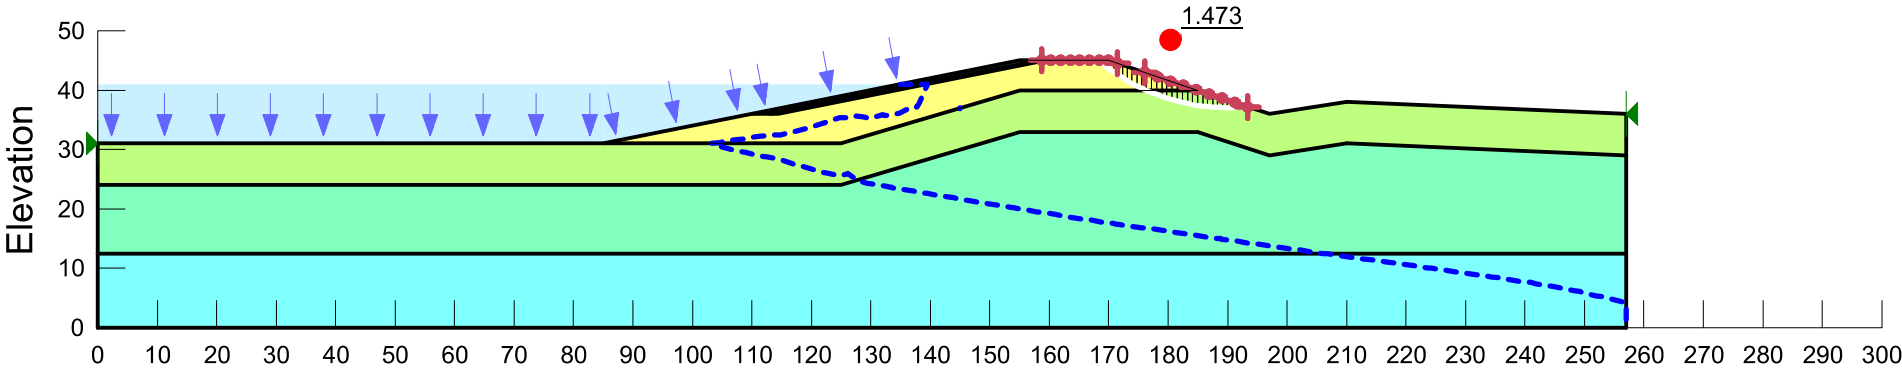
Color	Name	Model	Unit Weight (pcf)	Cohesion' (psf)	Phi' (°)	Phi-B (°)
<span style="display:inline-block; width:15px; height:15px; background-color:yellow; border:1px solid black;"></span>	Clay Embankment	Mohr-Coulomb	125	25	25	0
<span style="display:inline-block; width:15px; height:15px; background-color:cyan; border:1px solid black;"></span>	Claystone	Mohr-Coulomb	135	3,000	0	0
<span style="display:inline-block; width:15px; height:15px; background-color:lightgreen; border:1px solid black;"></span>	Existing Fill	Mohr-Coulomb	115	10	20	0
<span style="display:inline-block; width:15px; height:15px; background-color:lightblue; border:1px solid black;"></span>	Native Clay	Mohr-Coulomb	115	10	15	0
<span style="display:inline-block; width:15px; height:15px; background-color:blue; border:1px solid black;"></span>	Rip Rap	Mohr-Coulomb	135	10	40	0
<span style="display:inline-block; width:15px; height:15px; background-color:limegreen; border:1px solid black;"></span>	Sand Bedding	Mohr-Coulomb	125	10	30	0

Steady State Seepage Stability, Circular Failure

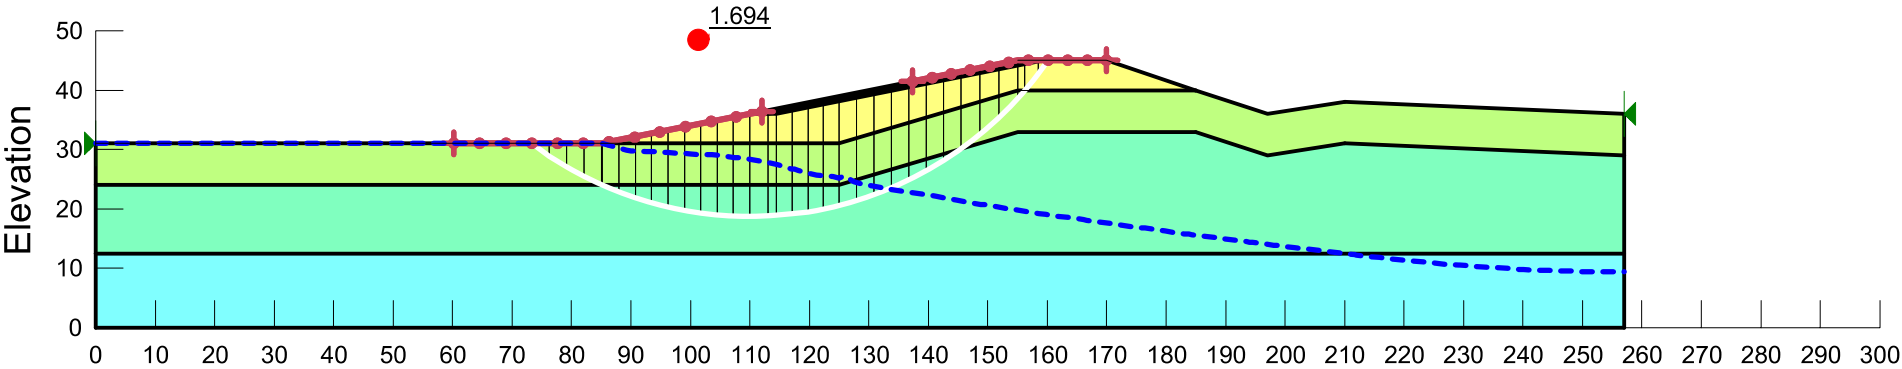
Color	Name	Model	Unit Weight (pcf)	Cohesion' (psf)	Phi' (°)	Phi-B (°)
<span style="display:inline-block; width:15px; height:15px; background-color:yellow; border:1px solid black;"></span>	Clay Embankment	Mohr-Coulomb	125	25	25	0
<span style="display:inline-block; width:15px; height:15px; background-color:cyan; border:1px solid black;"></span>	Claystone	Mohr-Coulomb	135	3,000	0	0
<span style="display:inline-block; width:15px; height:15px; background-color:lightgreen; border:1px solid black;"></span>	Existing Fill	Mohr-Coulomb	115	10	20	0
<span style="display:inline-block; width:15px; height:15px; background-color:green; border:1px solid black;"></span>	Native Clay	Mohr-Coulomb	115	10	15	0
<span style="display:inline-block; width:15px; height:15px; background-color:blue; border:1px solid black;"></span>	Rip Rap	Mohr-Coulomb	135	10	40	0
<span style="display:inline-block; width:15px; height:15px; background-color:darkgreen; border:1px solid black;"></span>	Sand Bedding	Mohr-Coulomb	125	10	30	0

Transient Seepage Stability, Circular Failure, Tenth Day

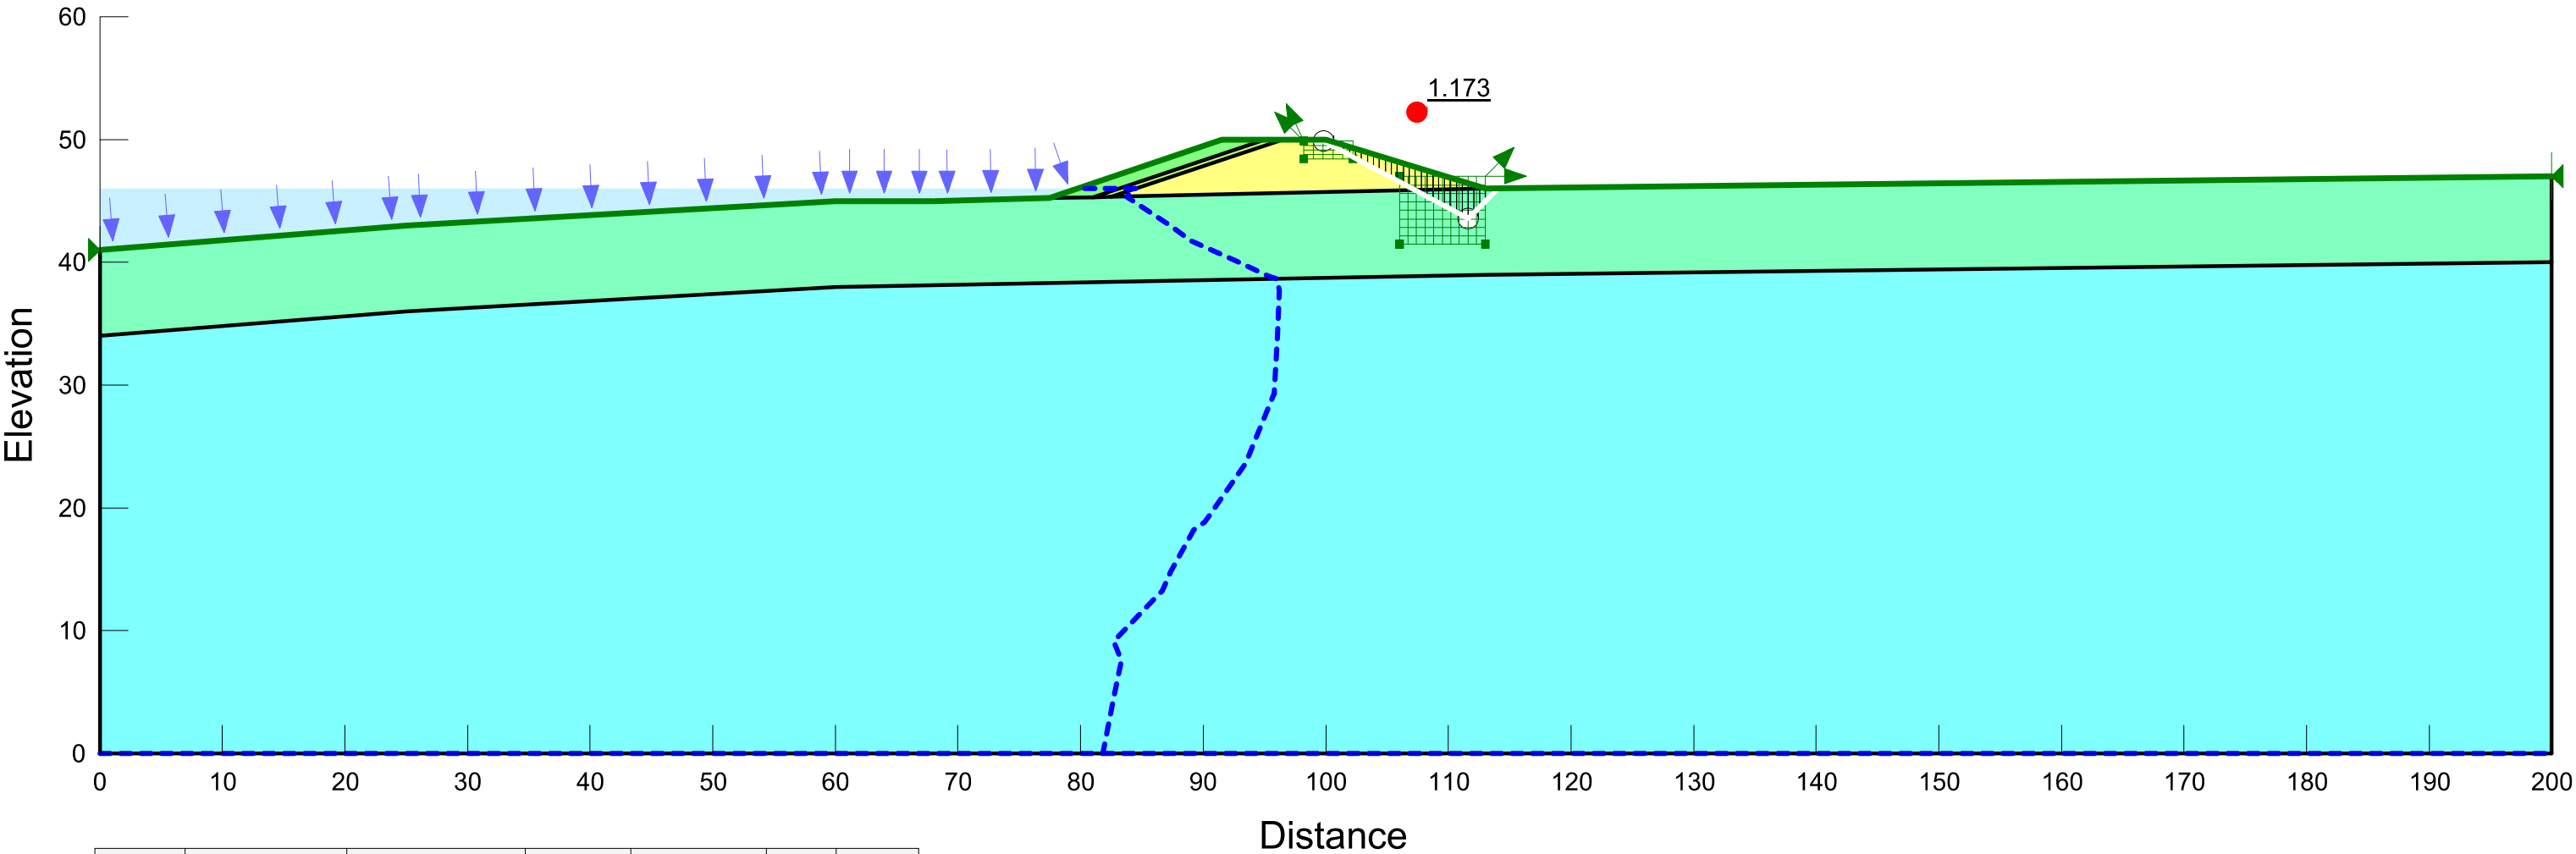
Color	Name	Model	Unit Weight (pcf)	Cohesion' (psf)	Phi' (°)	Phi-B (°)
<span style="color: yellow;">■</span>	Clay Embankment	Mohr-Coulomb	125	25	25	0
<span style="color: cyan;">■</span>	Claystone	Mohr-Coulomb	135	3,000	0	0
<span style="color: lightgreen;">■</span>	Native Clay	Mohr-Coulomb	115	0	15	0
<span style="color: green;">■</span>	Rip Rap	Mohr-Coulomb	135	10	40	0
<span style="color: limegreen;">■</span>	Sand Bedding	Mohr-Coulomb	125	10	30	0

Steady State Seepage, Block Failure Stability Analysis	
Maria Stevens West.gsz	
10/24/2018	1:159

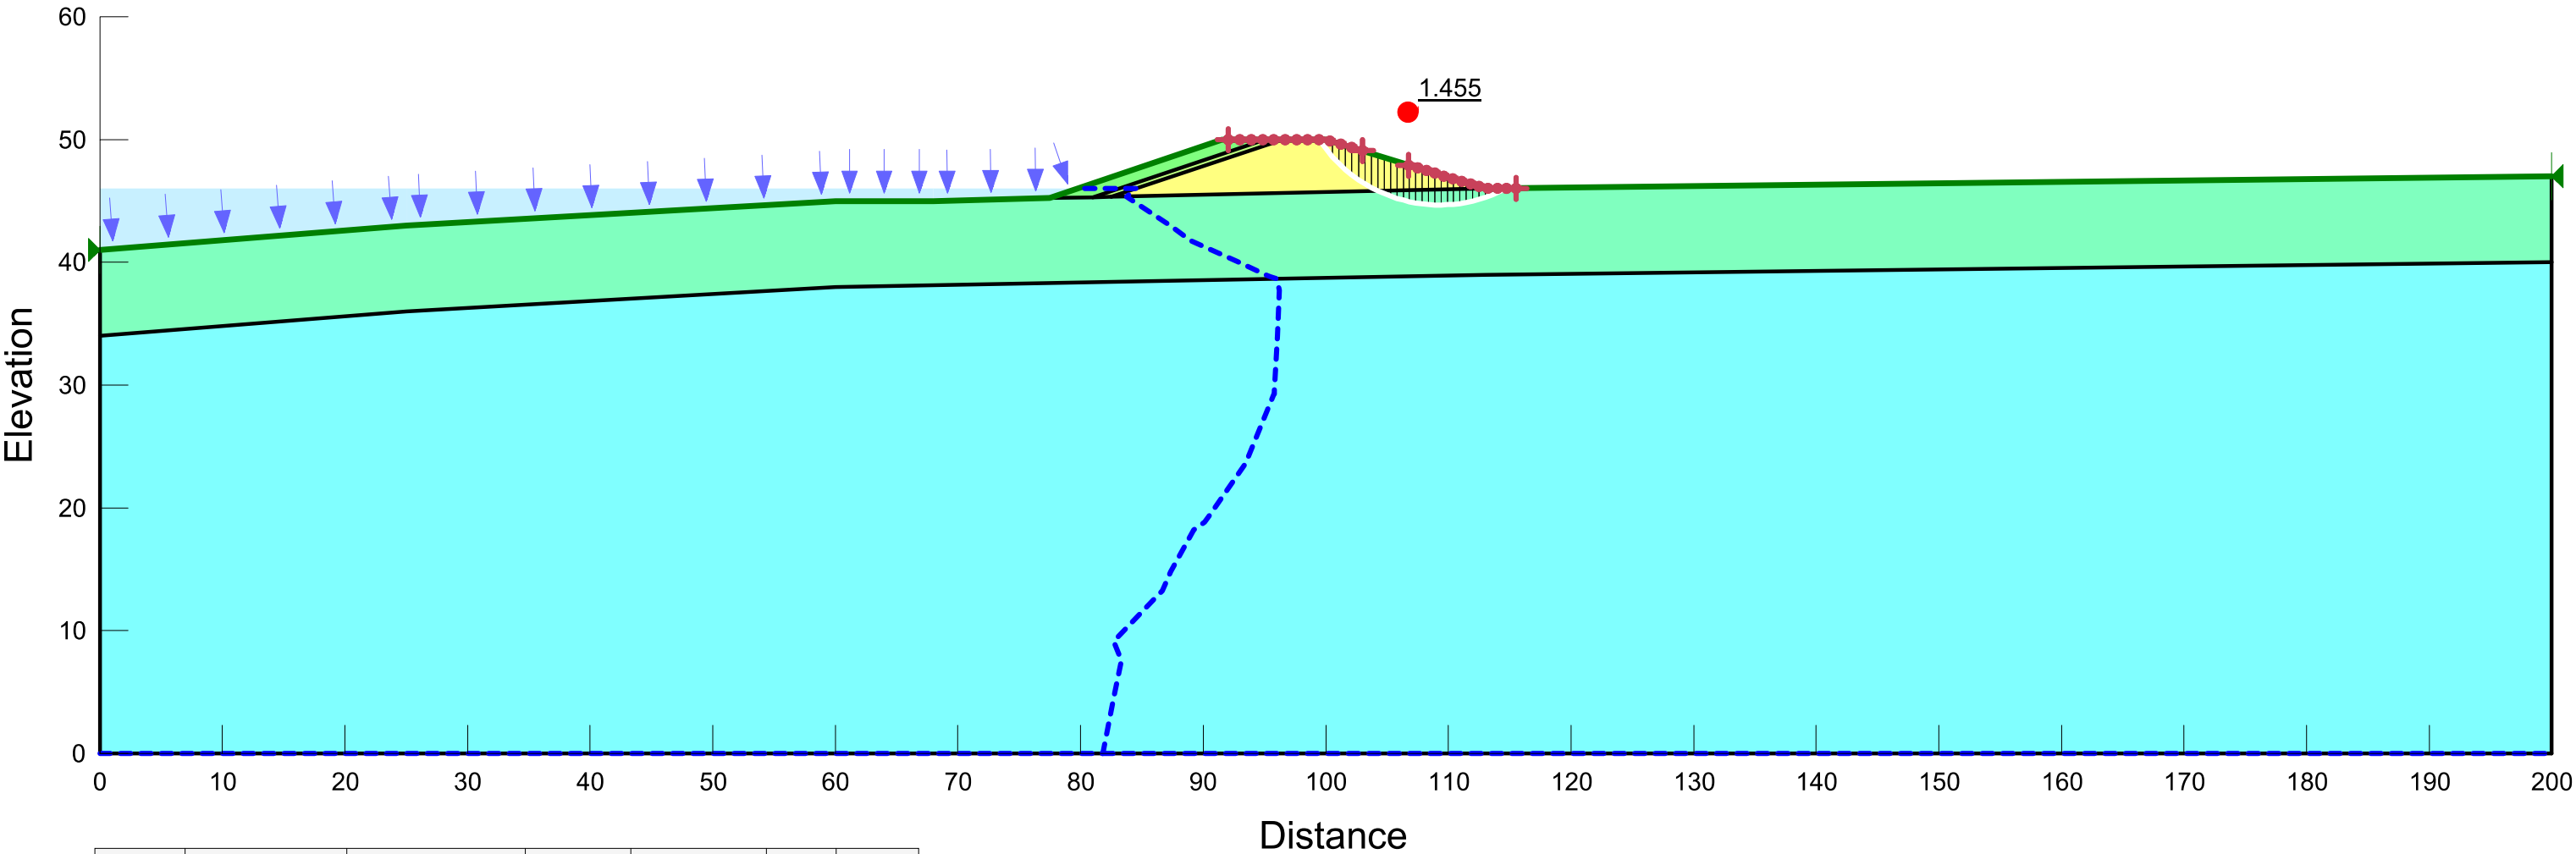
Color	Name	Model	Unit Weight (pcf)	Cohesion' (psf)	Phi' (°)	Phi-B (°)
<span style="color: yellow;">■</span>	Clay Embankment	Mohr-Coulomb	125	25	25	0
<span style="color: cyan;">■</span>	Claystone	Mohr-Coulomb	135	3,000	0	0
<span style="color: lightblue;">■</span>	Native Clay	Mohr-Coulomb	115	0	15	0
<span style="color: green;">■</span>	Rip Rap	Mohr-Coulomb	135	10	40	0
<span style="color: limegreen;">■</span>	Sand Bedding	Mohr-Coulomb	125	10	30	0

Transient Seepage, First Day Circular Failure Stability Analysis

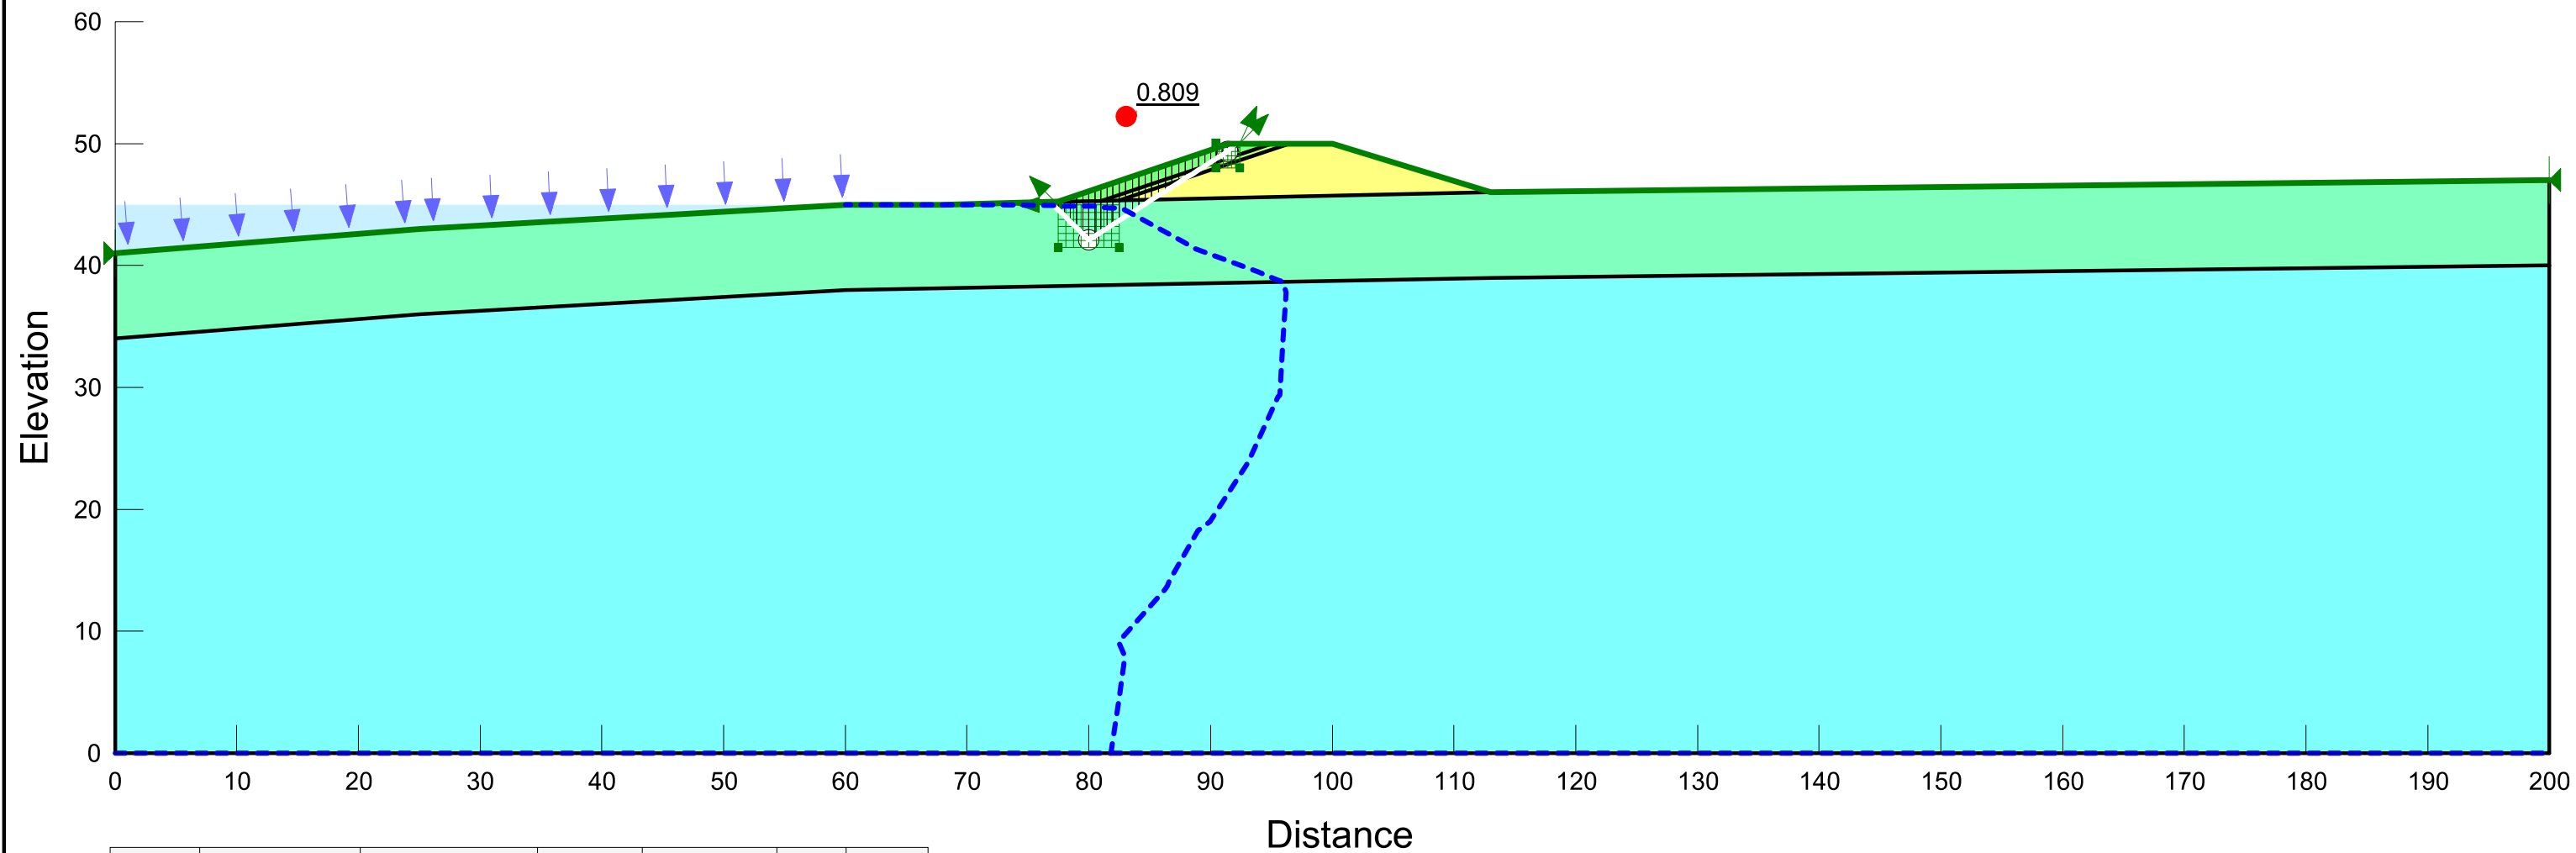
Color	Name	Model	Unit Weight (pcf)	Cohesion' (psf)	Phi' (°)	Phi-B (°)
<div></div>	Clay Embankment	Mohr-Coulomb	125	25	25	0
<div></div>	Claystone	Mohr-Coulomb	135	3,000	0	0
<div></div>	Native Clay	Mohr-Coulomb	115	0	15	0
<div></div>	Rip Rap	Mohr-Coulomb	135	10	40	0
<div></div>	Sand Bedding	Mohr-Coulomb	125	10	30	0

Transient Seepage, First Day Circular Failure Stability Analysis

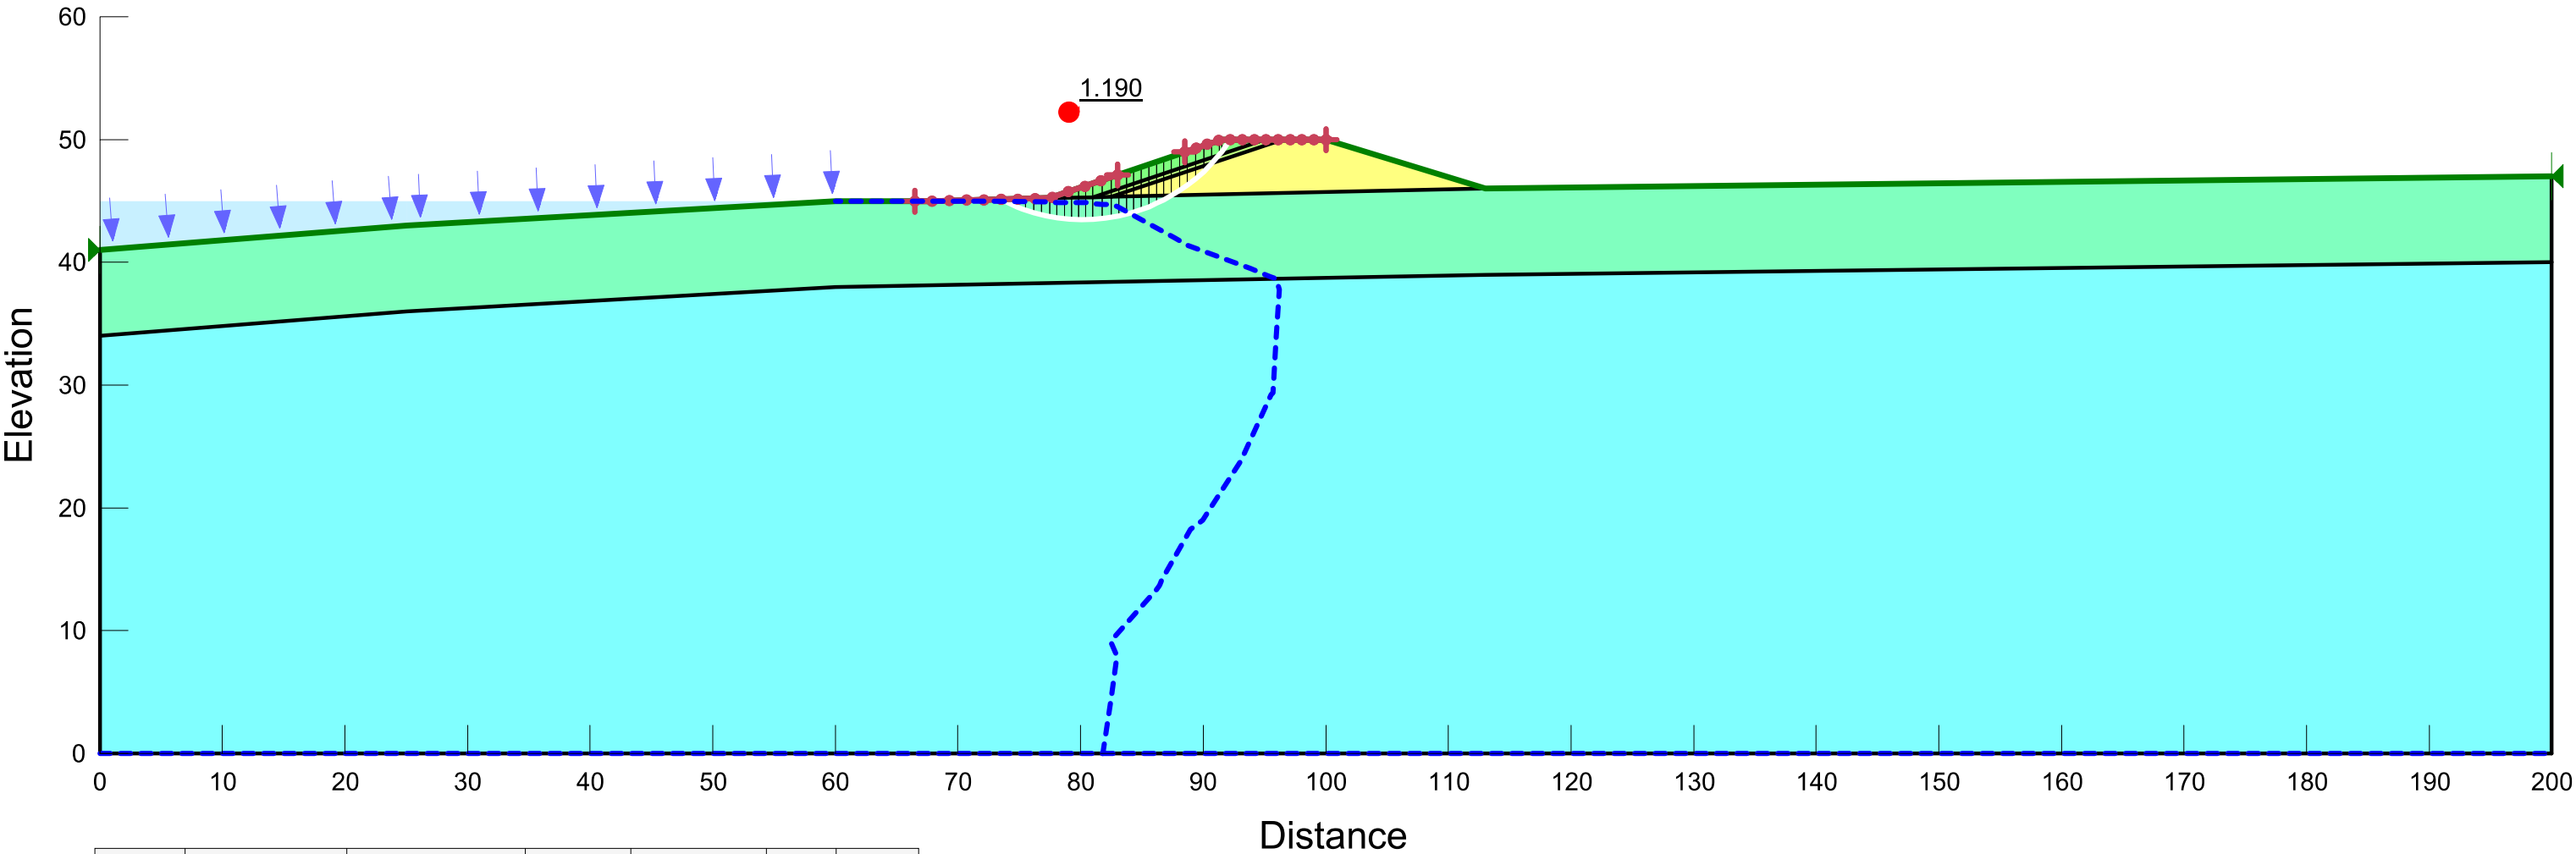
Color	Name	Model	Unit Weight (pcf)	Cohesion' (psf)	Phi' (°)	Phi-B (°)
<div></div>	Clay Embankment	Mohr-Coulomb	125	25	25	0
<div></div>	Claystone	Mohr-Coulomb	135	3,000	0	0
<div></div>	Native Clay	Mohr-Coulomb	115	0	15	0
<div></div>	Rip Rap	Mohr-Coulomb	135	10	40	0
<div></div>	Sand Bedding	Mohr-Coulomb	125	10	30	0

Transient Seepage, First Day Circular Failure Stability Analysis
