DESIGN REPORT
FOR
CHAMBERS DAM & RESERVOIR
WATER DIVISION No. 1
WATER DISTRICT No. 8
DAMID: 080451
CONSTRUCTION FILE No.: C-1967

CHAMBERS DAM & RESERVOIR PROJECT

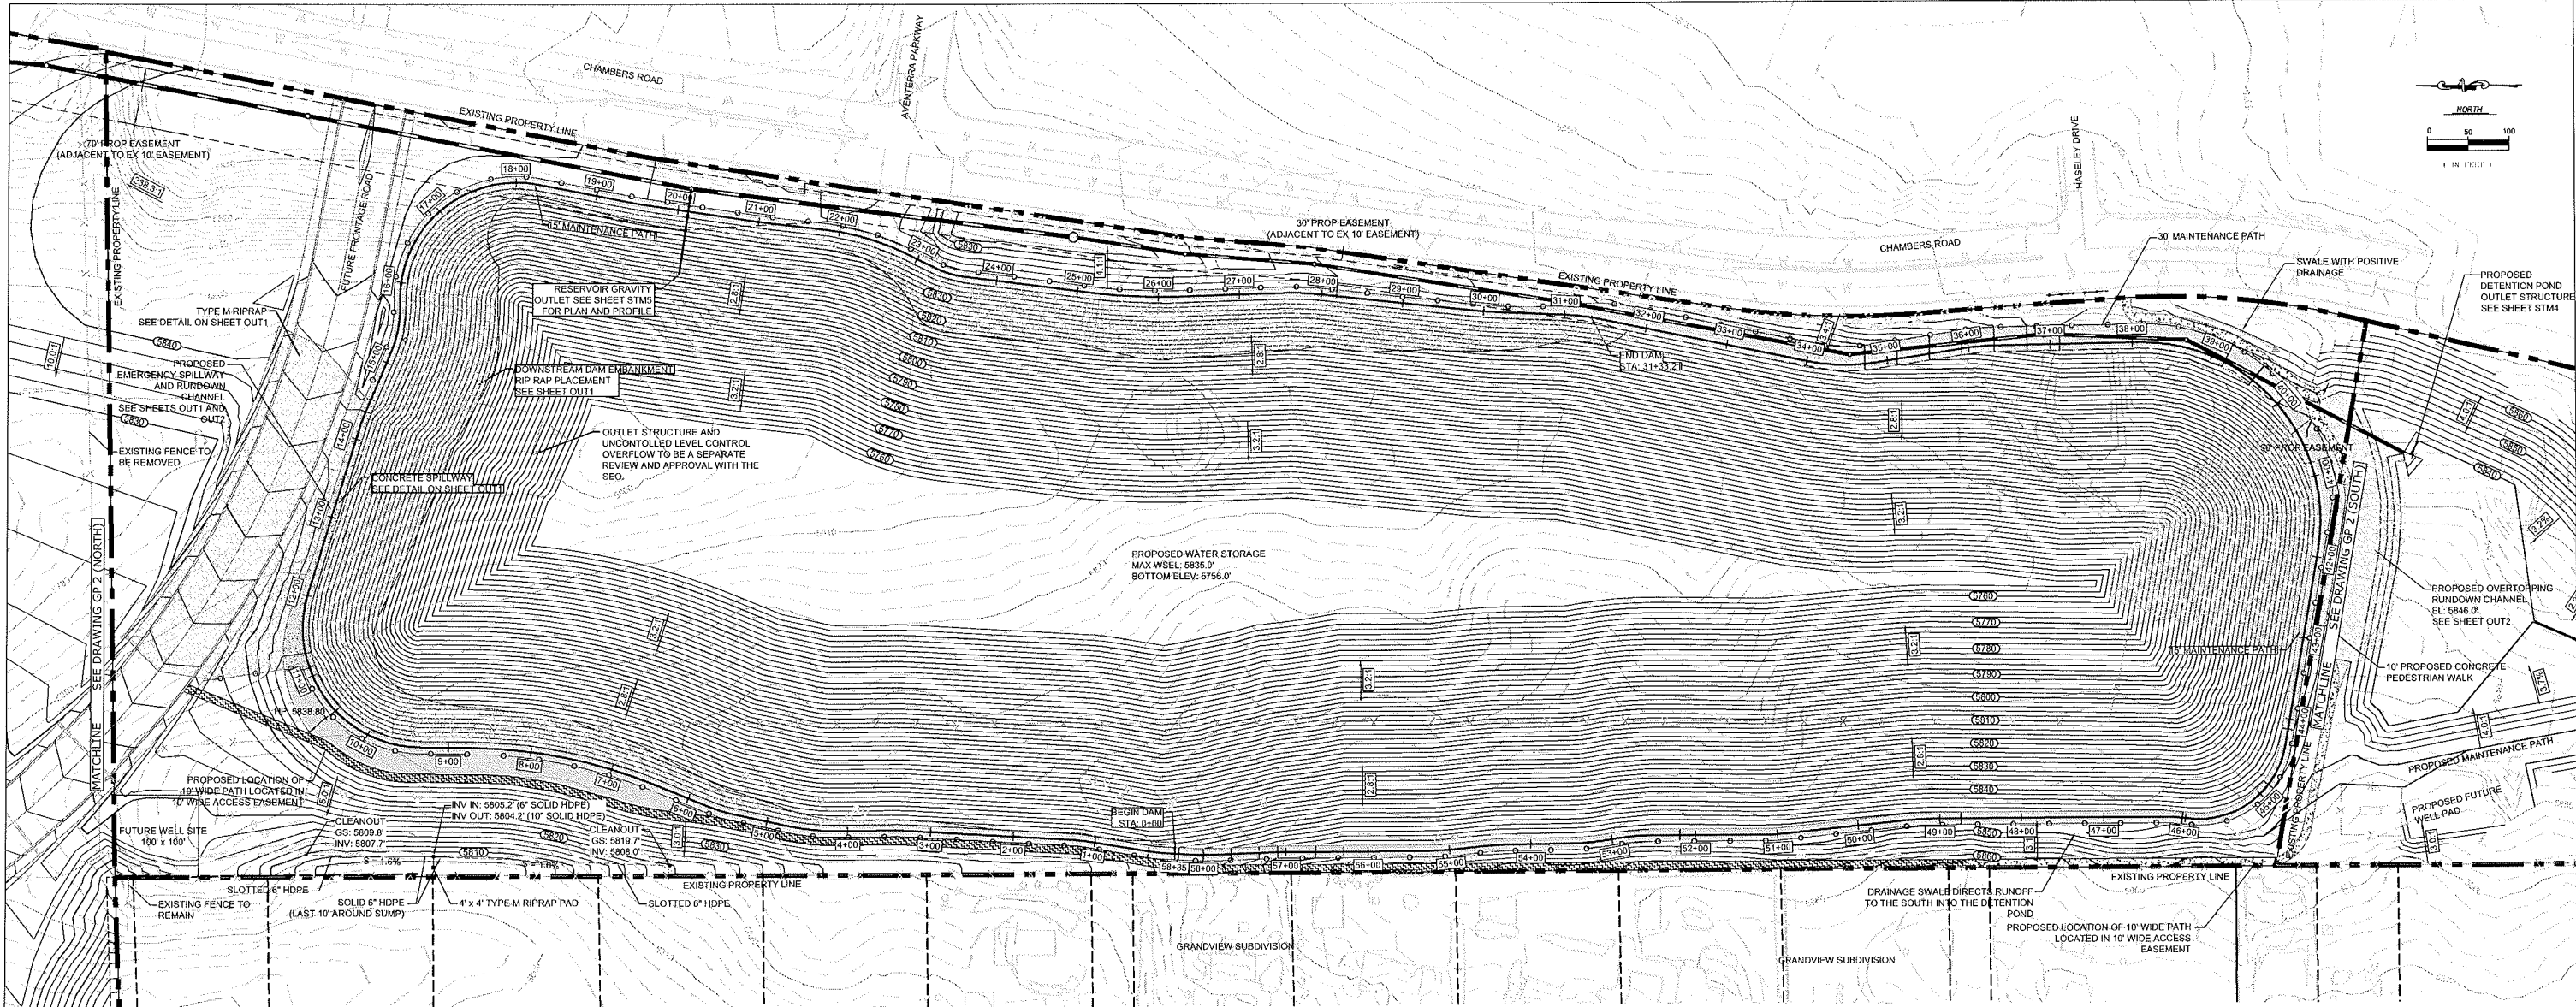
| DATE: 08/2010 | FIGURE: 2C | |

| CIVIL RESOURCES, LLC | | UNITED WATER AND SANITATION CHAMBERS DAM & RESERVOIR |

The Chamber Reservoir elevation-capacity curve used in the HEC-HMS modeling was derived from the proposed grading shown on Figure 2c. Table 6 through 8 summarize the stage-area-storage-discharge relationships for the existing detention pond, proposed detention pond and Chambers Reservoir as it was input into the HEC-HMS model. The initial water surface elevation was set to the elevation of the uncontrolled service spillway inlet invert (5835.0 feet). Figures 10 through 12 graph the stage-discharge relationships.
