# Conejos River Stream Management Plan

Rio Grande Basin Roundtable and the  
Stream Management Plan Technical Advisory Team

Rio Grande Headwaters Restoration Project  
623 E Fourth St  
Alamosa, CO 81101

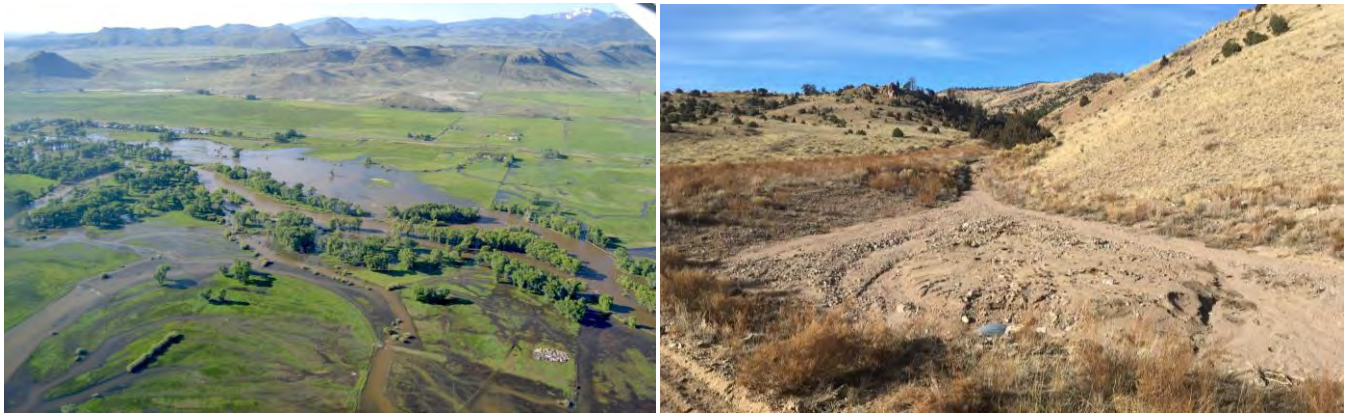
**Figure 1.7: Left: Snowmelt runoff doing geomorphic work on the Rio Grande floodplain, June 2019. Right: Sediment washed down from a small watershed that feeds a tributary to Saguache Creek (Photo: Round River Design, LLC).**

Monsoon season typically results in sufficient precipitation to increase flows again in mid- to late-summer. Flooding from both snowmelt runoff and small-scale convective rainfall events during the monsoon are common mechanisms for high water events in the SMP study streams (Figure 1.7). Though rare in the period of record, extreme events have been observed to occur on streams draining into the SLV from the San Juan Mountains. Localized flash floods are likely to occur on tributary streams, which may cause the mainstems to swell, but more likely influence the streams by bringing fresh sediment down to the valley bottom and supplying the channels with material (Figure 1.7).

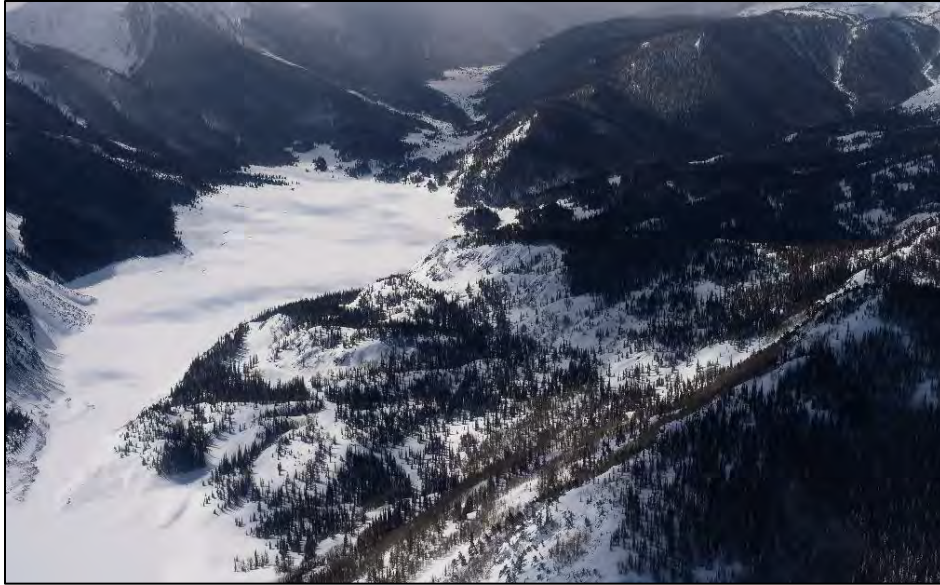
**Upper portion of Platoro Reservoir during winter (Photo: Christi Bode).**

Platoro Reservoir and Trujillo Meadows Reservoir, both of which are post-Compact reservoirs, provide the only significant storage in the Conejos River watershed. The Platoro dam was completed in 1951 by the Bureau of Reclamation (BOR), making it a post-Compact reservoir. The dam is an earthfill structure consisting of a main embankment and a dike section, separated by a rock knoll in which the spillway is excavated. The reservoir formed by the dam has a capacity of 59,570 AF, 6,060 AF of which are for flood control and 53,510 AF for joint use. While BOR retains ownership of the dam, operations are managed by the Conejos Water Conservancy District (CWCD). The dam is situated at 10,000 ft, relatively high in the watershed.

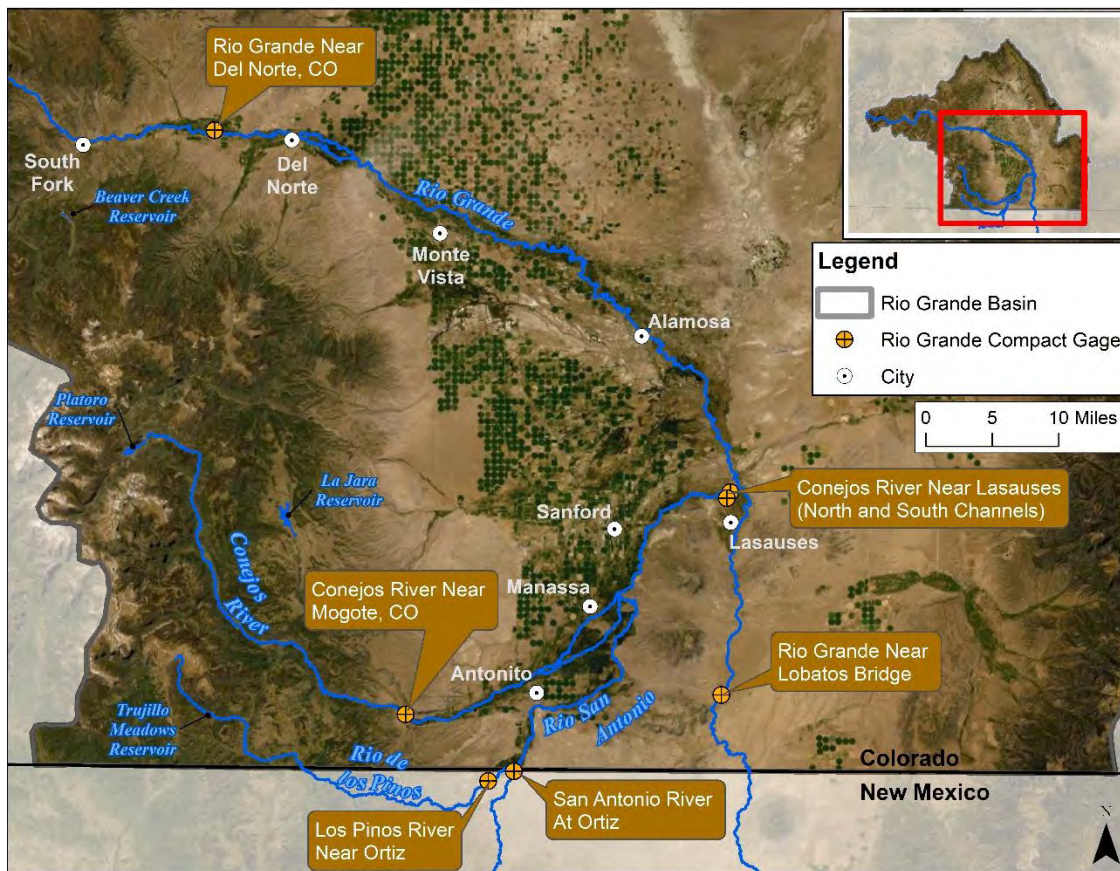
**Figure 1.16: Stream gage locations used to measure Rio Grande Compact index and delivery flows.**

The combined flows of the Rio Grande and Conejos River are measured at the Rio Grande Near Lobatos, CO (RIOLOBCO) stream gage to determine total deliveries to New Mexico (Compact, 1938). Figure 1.16 shows locations of stream gages used to measure Rio Grande Compact index and delivery flows in Colorado, while figure 1.15 shows the larger spatial extent of the international Compact.

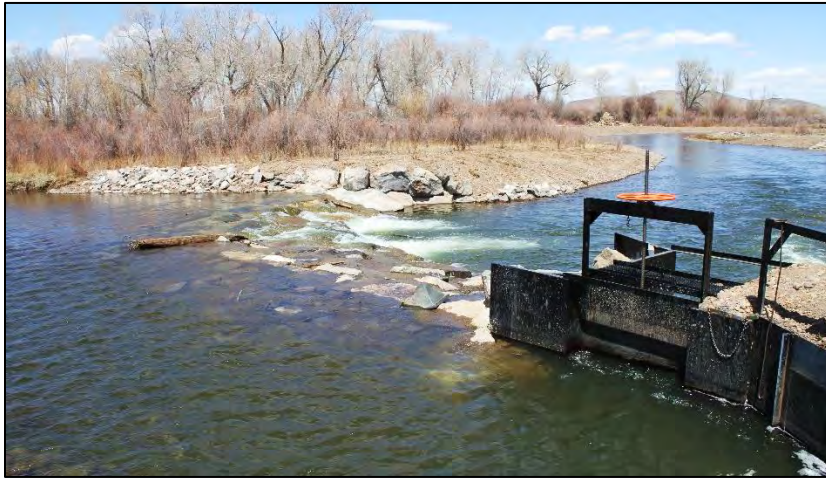
**Figure 2.1: Del Puerticito Ditch diversion on the Conejos River.**

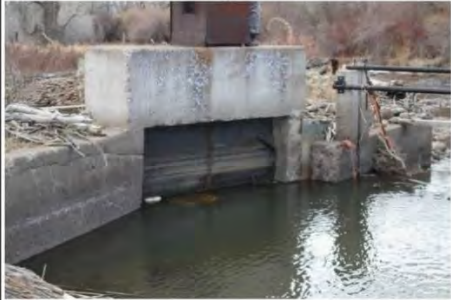
<p>Headgate looking downstream</p>

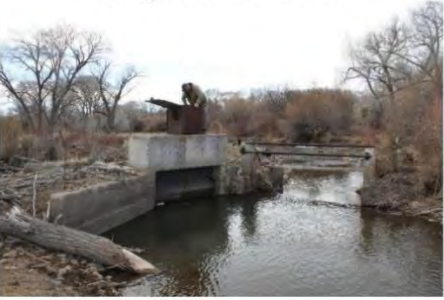
<p>Headgate and diversion dam</p>

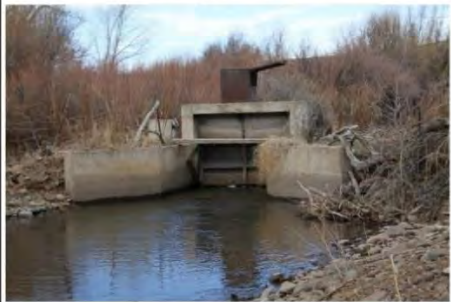
<p>Headgate outlet</p>

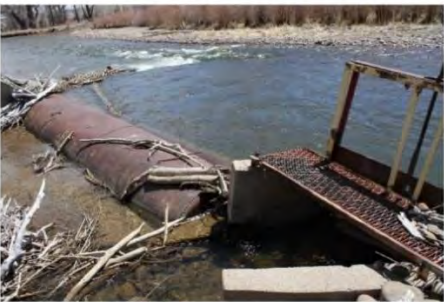
<p>Point of diversion and river headgate</p>

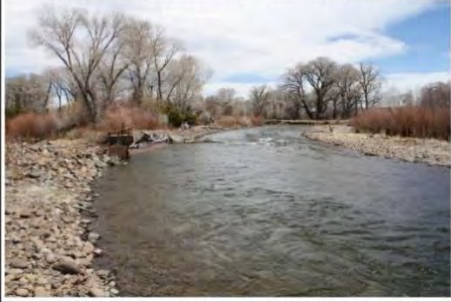
<p>Point of diversion on Conejos looking downstream</p>

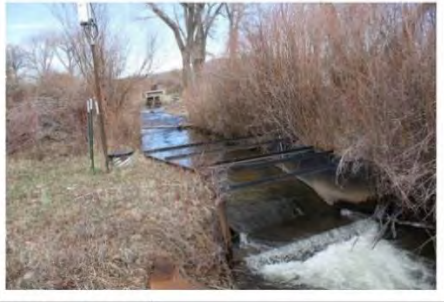
<p>Flume looking upstream</p>

Figure 2.3: Example report card developed for diversion infrastructure inventory (pages 1-2).

Using the information described above, a “report card” containing descriptive statistics, photographs, location, and channel migration maps, and recommended improvements was created for each structure. An example report card for the North Eastern Ditch is shown in Figures 2.3 and 2.4.

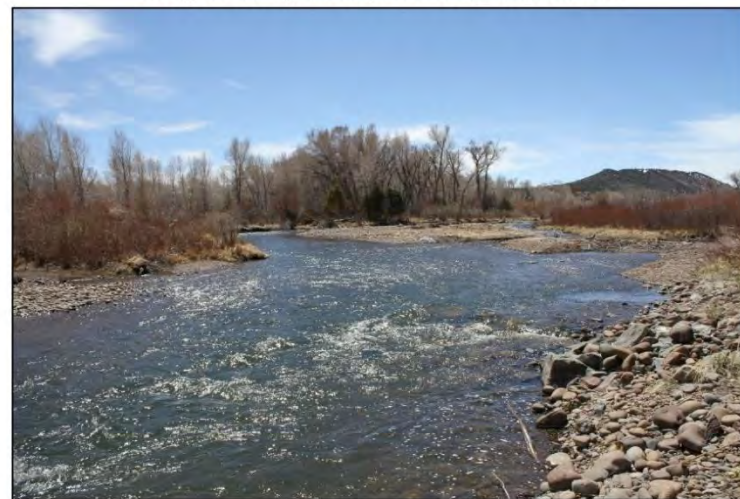
River channel upstream of diversion (looking upstream).

Figure 2.4: Example report card developed for diversion infrastructure inventory (pages 3-4).

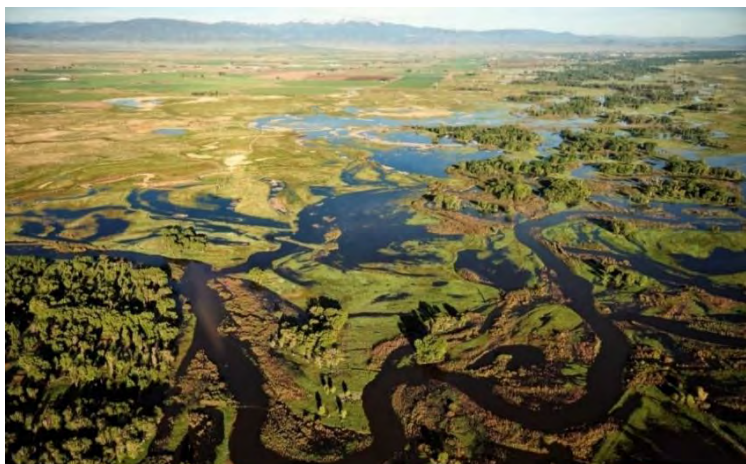
**Figure 2.7: Floodplain activation and resulting alluvial aquifer recharge, June 2019 (Photo: Christi Bode).**

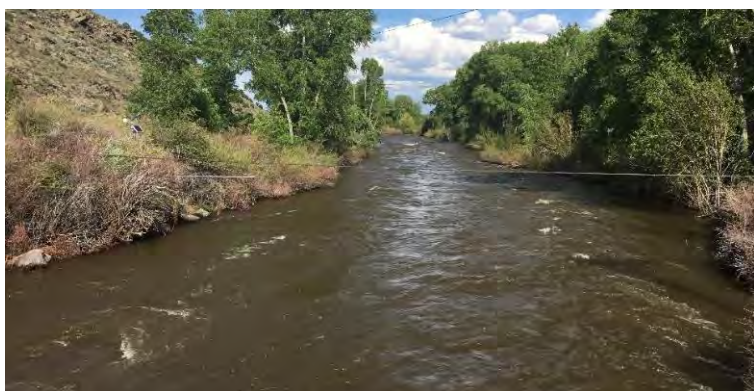
**Figure 2.8: Overbanking event on the Conejos River upstream of Mogote.**

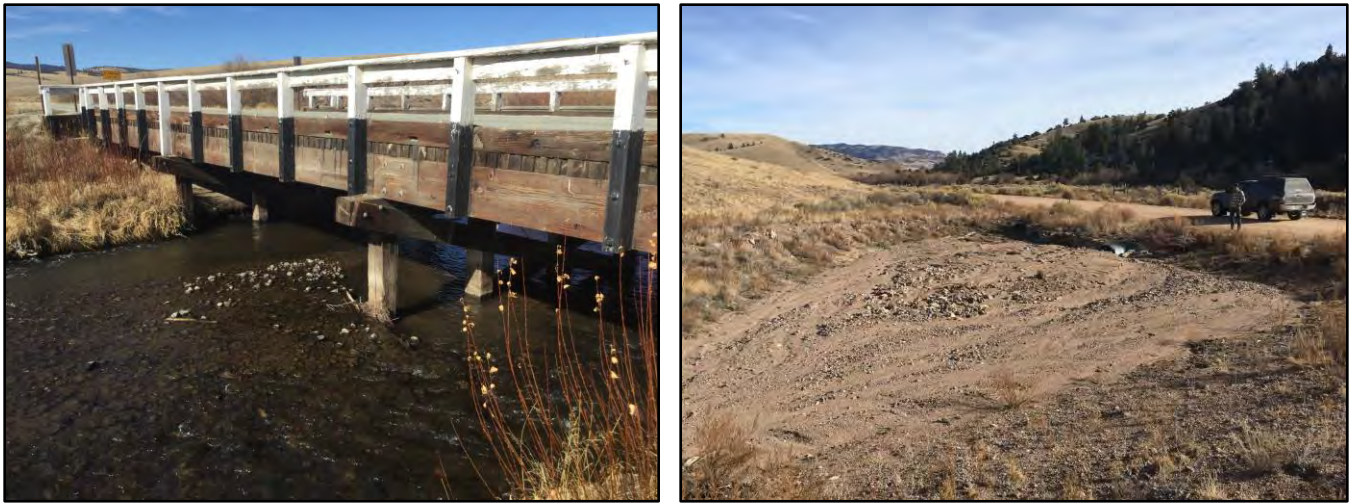
**Figure 2.12: (Left) Bridge over Saguache Creek with a pier in the middle of the bridge that may collect debris during a flood. (Right) Undersized culverts failing to transport sediment in a dry wash in Saguache County.**

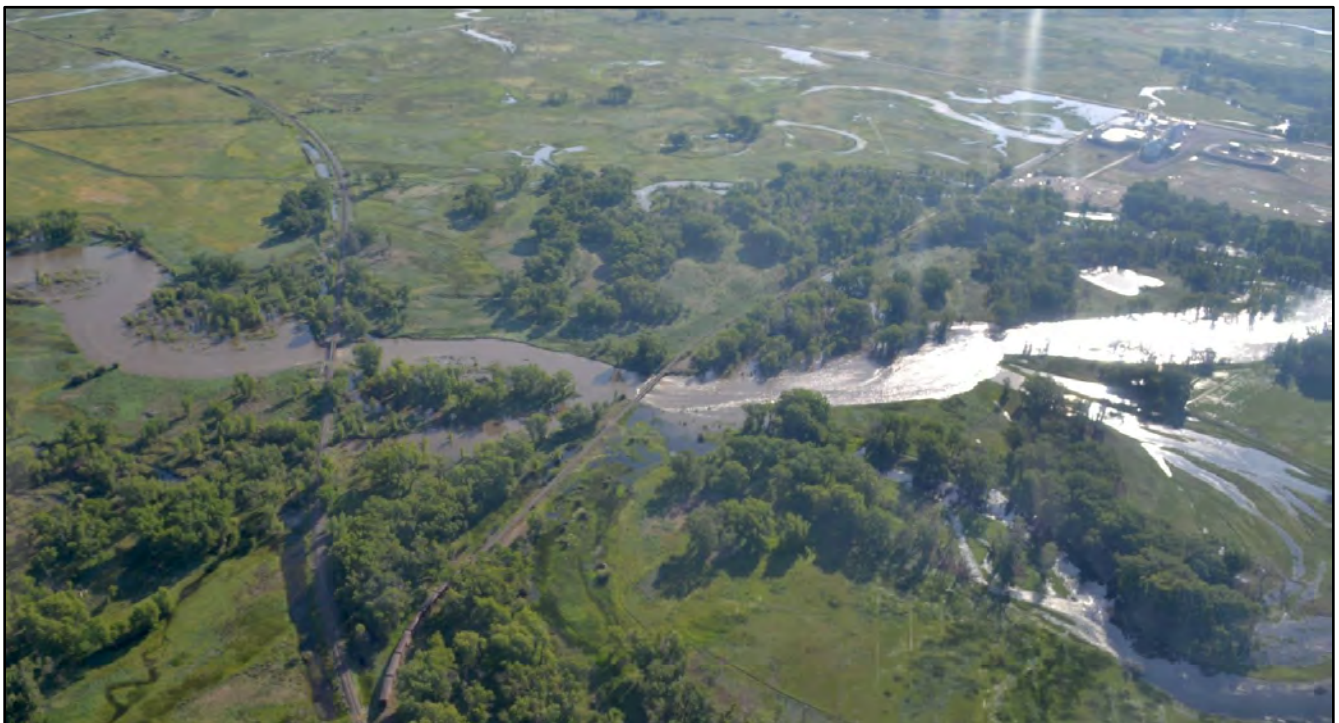
**Figure 2.13: Railroad lines and bridges crossing the Rio Grande near flood stage, June 2019.**

Roads oriented so they constrict the active river corridor can increase flow depths, shear stresses, and sediment transport capacities of streams. These constrictions can affect reaches upstream and downstream. Road and railroad bed encroachment does not appear to be significantly affecting the geomorphic stability of any of the streams in the SMP study area (Figure 2.13).

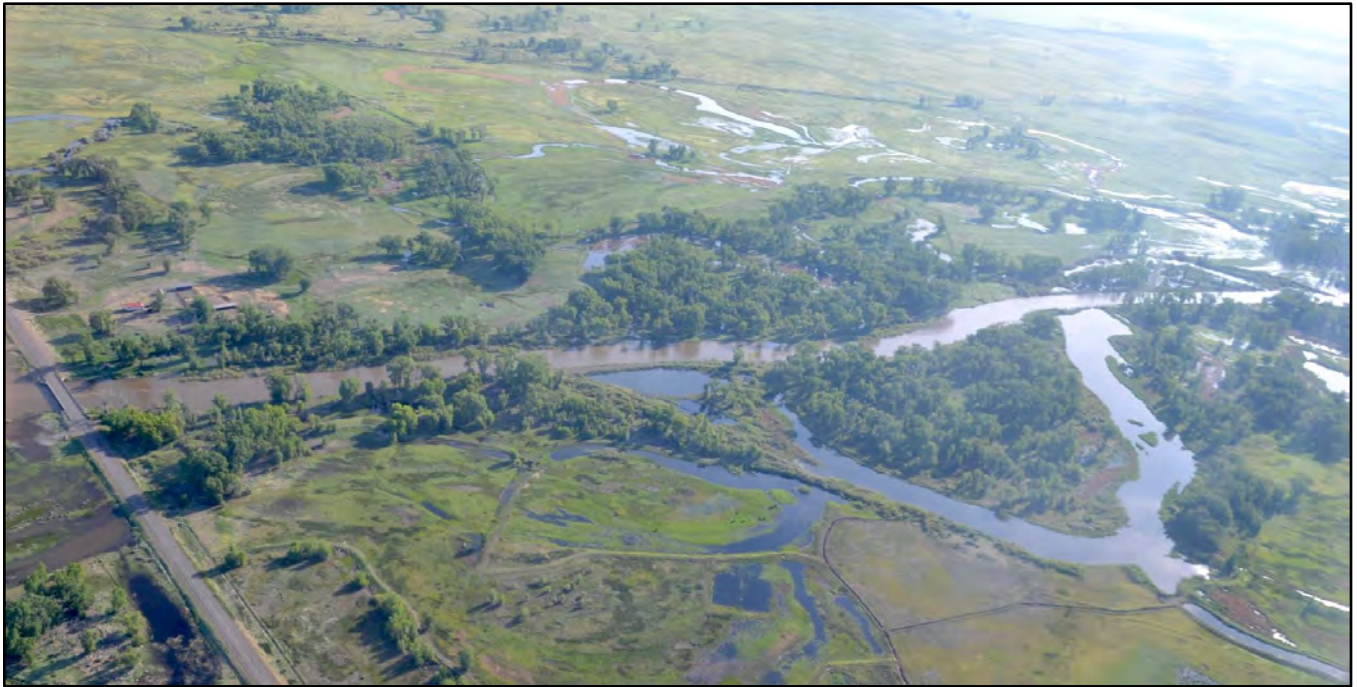
**Figure 2.14: Channelization of the Rio Grande at the Soldiers Home Road (County Road 3E).**

Channelization (i.e., straightening of channel meanders; removal of large wood and/or beavers; filling of side channels to force a stream into a single-thread) and stream bank armoring (i.e., placement of rock riprap, concrete barriers, or other materials to prevent channel migration or widening) has occurred on the SMP study streams and adversely affects natural channel processes and stream health. Figure 2.14 shows a channelized portion of the Rio Grande.

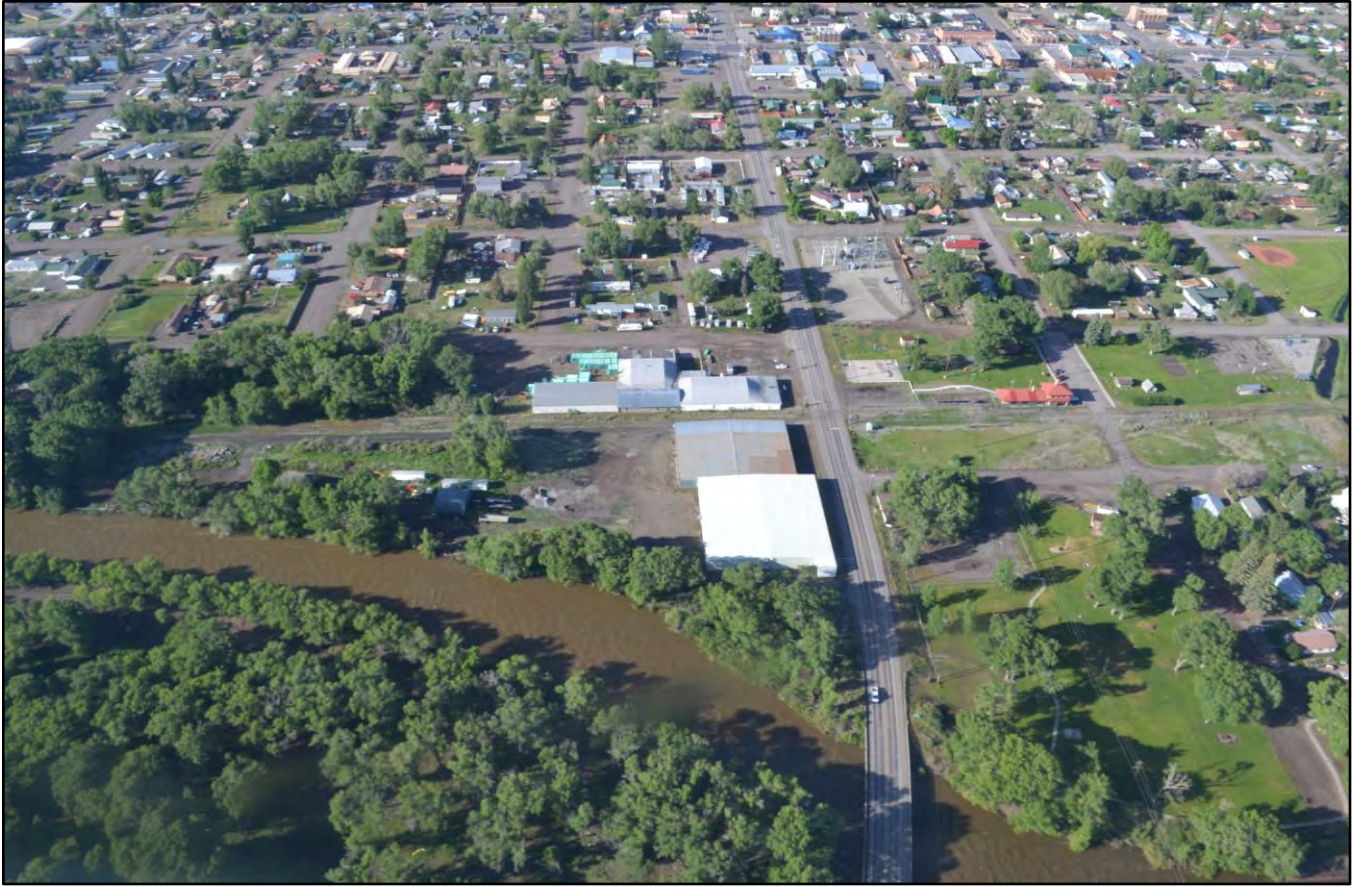
**Figure 2.16: Development in the active river corridor of the Rio Grande in the Town of Del Norte.**

Land conversion can alter or eliminate floodplain complexity, side channels, wetlands, riparian vegetation, overflow relief channels, and other important geomorphic and ecological components of streams. Riparian vegetation and wetlands along some SMP reaches are impacted by fill and/or floodplain/riparian area conversion resulting from development, overgrazing, and nonnative species dominance. Riparian vegetation throughout the floodplain and river corridor, not just along the main channel, is critical to energy dissipation, stream shading, bank stability, wildlife habitat, and many other natural stream processes. Overgrazing and/or development fill brought into the corridor erases the evidence of past channel migration, possibly creating a false sense of protection from fluvial erosion to those that occupy the land. Furthermore, development creates the expectation (e.g., stable banks) that these rivers will remain in their current location indefinitely and therefore current and future generations will be willing and able to invest in the costs (both monetary and ecological) that will be required to resist natural channel processes (e.g., bank erosion and channel migration) (Figure 2.16).

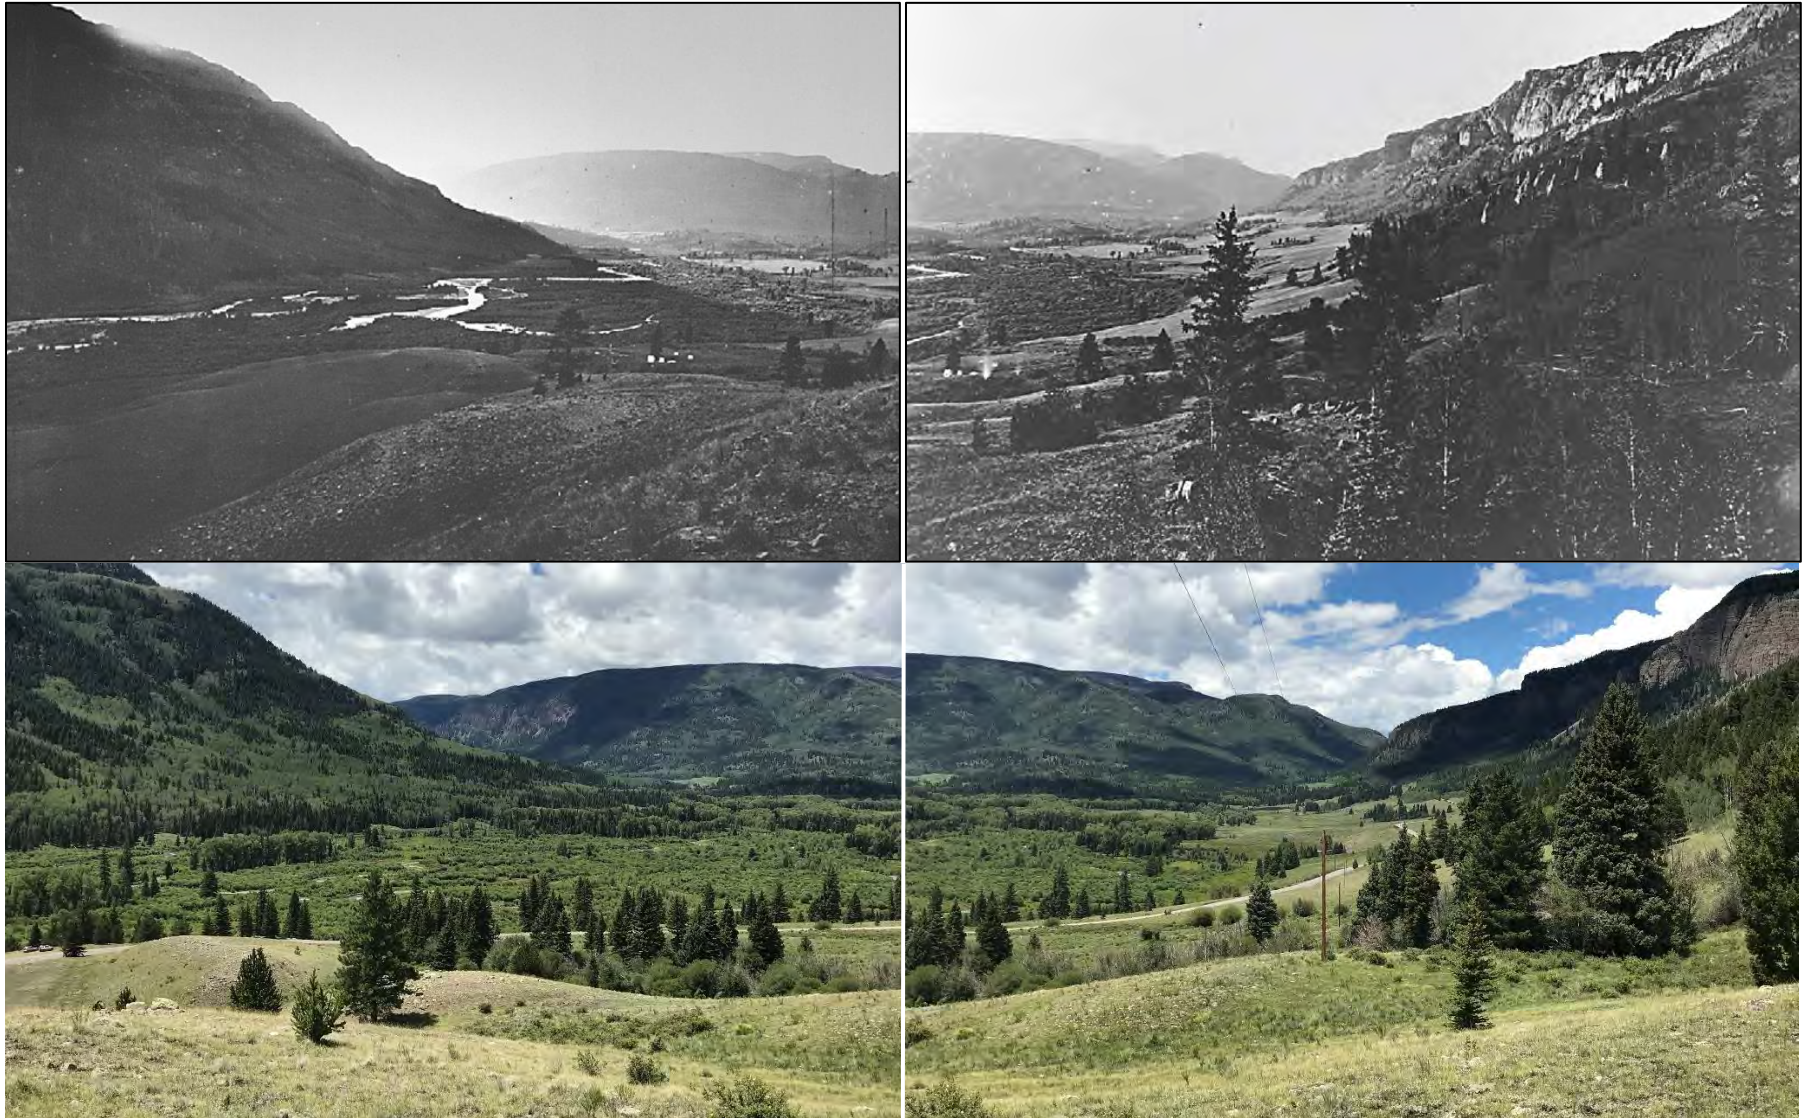
**Figure 3.4: Conejos River immediately downstream of the confluence with the South Fork Conejos River. Photograph from Volume IV of the Wheeler railroad surveys, which were conducted during the 1870s (top) and Conejos River in 2020 (bottom [Wheeler, 1878]).**

Figure 3.4 shows current and historic (1870s) photographs of the Conejos River mainstem immediately downstream of its confluence with the South Fork Conejos River. These images confirm and illustrate the findings from the riparian vegetation assessment, which found large portions of Conejos River’s riparian zones have remained largely unaltered from natural, or “reference” condition (Wheeler, 1878).

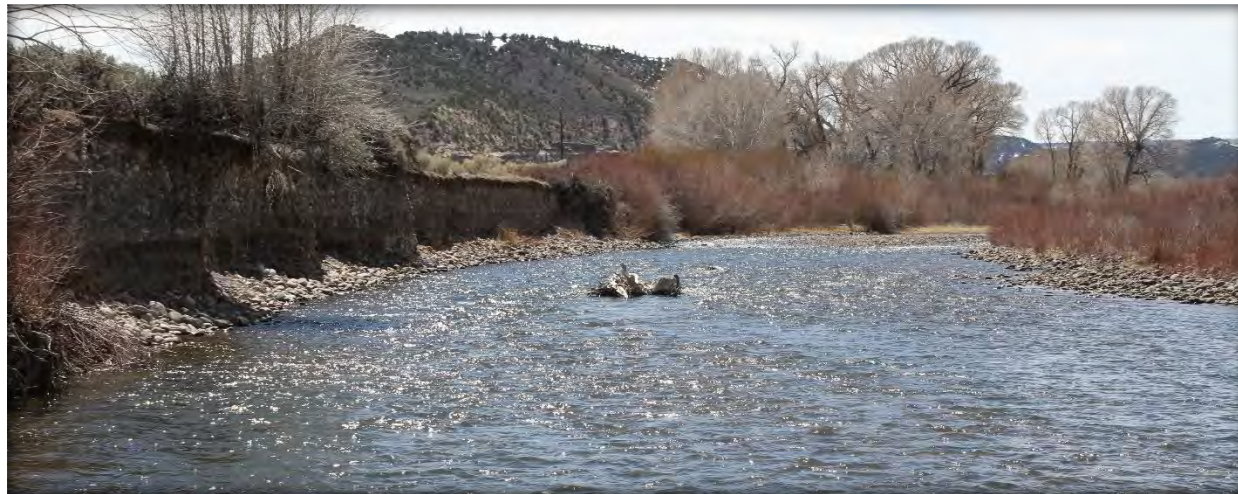
**Figure 4.2: Floodplain disconnection on the mainstem Conejos River near Mogote**

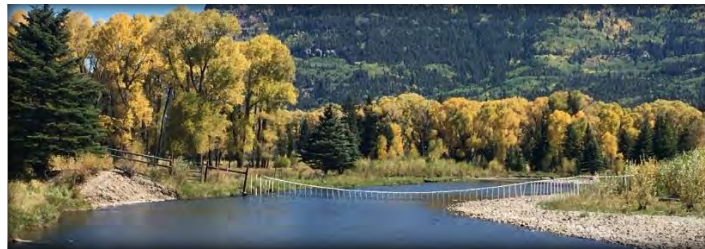
**Figure 4.4: Example of recreation-friendly fencing in reach CR06. In this example, the fence could be raised to provide optimal passage.**

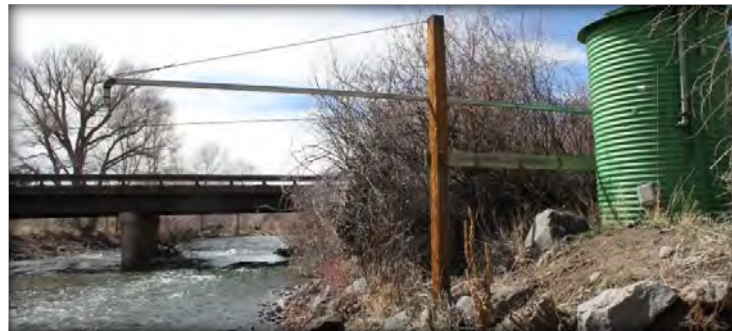
Figure 4.5: Conejos River Near Mogote, CO (CONMOGCO) stream gage.
