Saguache Creek Stream Management Plan

Rio Grande Basin Roundtable and the
Stream Management Plan Technical Advisory Team

Rio Grande Headwaters Restoration Project
623 E Fourth St
Alamosa, CO 81101

2020

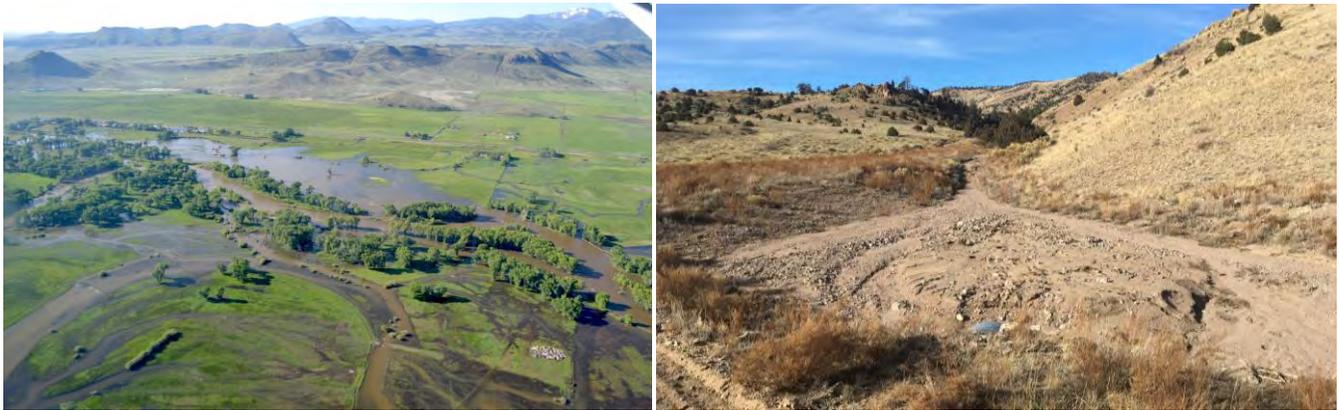
Figure 1.7: Left: Snowmelt runoff doing geomorphic work on the Rio Grande floodplain, June 2019. Right: Sediment washed down from a small watershed that feeds a tributary to Saguache Creek (Photo: Round River Design, LLC).

Monsoon season typically results in sufficient precipitation to increase flows again in mid- to late-summer. Flooding from both snowmelt runoff and small-scale convective rainfall events during the monsoon are common mechanisms for high water events in the SMP study streams (Figure 1.7). Though rare in the period of record, extreme events have been observed to occur on streams draining into the SLV from the San Juan Mountains. Localized flash floods are likely to occur on tributary streams, which may cause the mainstems to swell, but more likely influence the streams by bringing fresh sediment down to the valley bottom and supplying the channels with material (Figure 1.7).

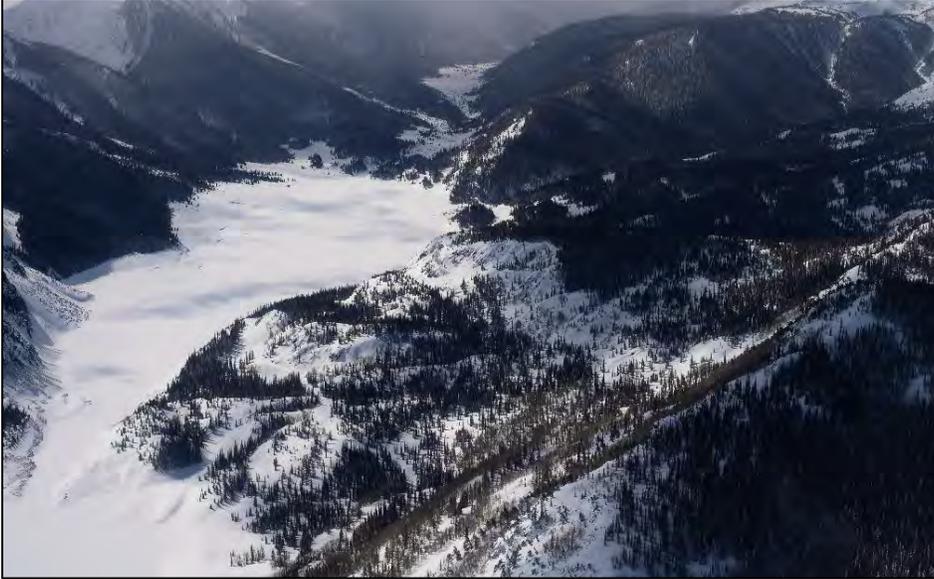
Upper portion of Platoro Reservoir during winter (Photo: Christi Bode).

Platoro Reservoir and Trujillo Meadows Reservoir, both of which are post-Compact reservoirs, provide the only significant storage in the Conejos River watershed. The Platoro dam was completed in 1951 by the Bureau of Reclamation (BOR), making it a post-Compact reservoir. The dam is an earthfill structure consisting of a main embankment and a dike section, separated by a rock knoll in which the spillway is excavated. The reservoir formed by the dam has a capacity of 59,570 AF, 6,060 AF of which are for flood control and 53,510 AF for joint use. While BOR retains ownership of the dam, operations are managed by the Conejos Water Conservancy District (CWCD). The dam is situated at 10,000 ft, relatively high in the watershed.

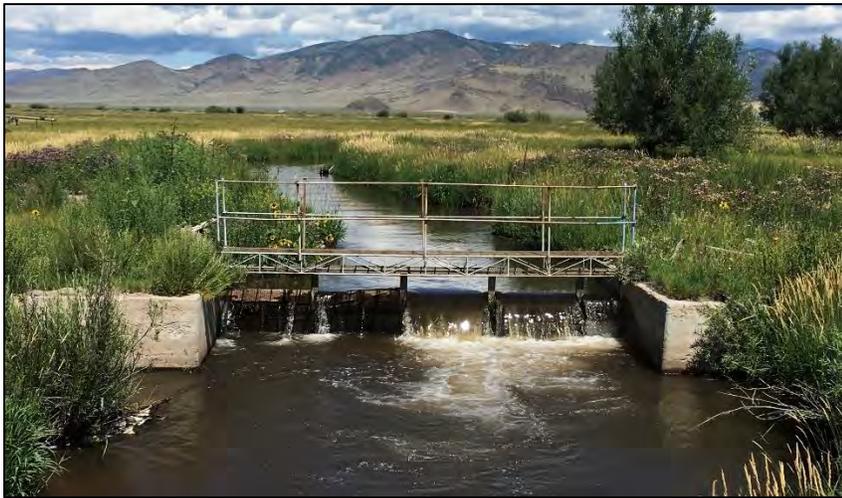
Figure 2.1: Braun Brothers Ditch No. 1 diversion on Saguache Creek.

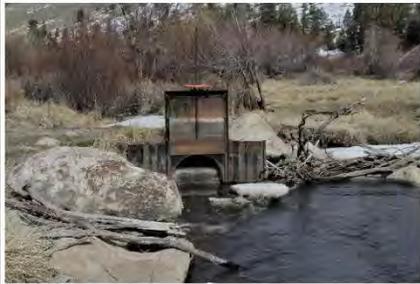
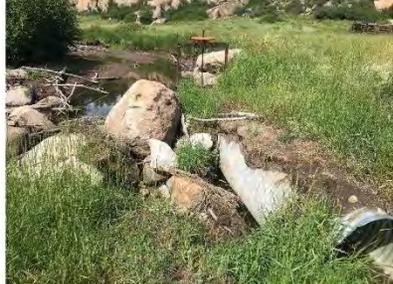
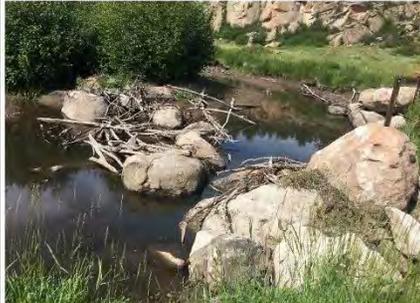
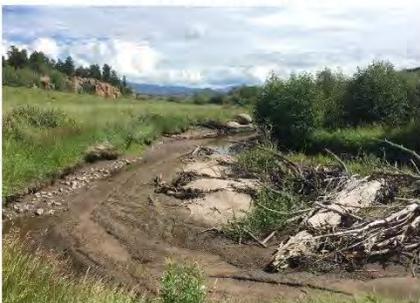
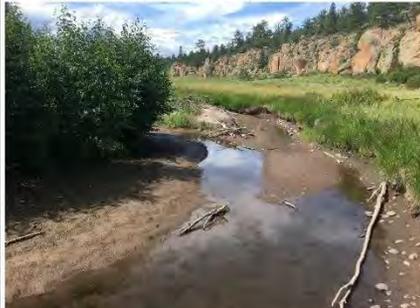
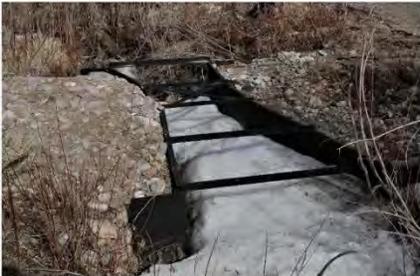
Structure Description: This is the first diversion on Saguache Creek. A stacked rock diversion dam directs water to the headgate, located on the north bank of the stream. A new diversion dam and bank stabilization structures were installed in 2019 in partnership with NRCS. The headgate and flume were not affected as part of those repairs. Bank erosion and meander cutoffs are relatively common on upper Saguache Creek. During spring runoff in 2019, the meander feeding this ditch was cut off, resulting in the stream bypassing the structure (see map below).

Headgate (pre-2019 runoff)	Headgate outlet (post-2019 runoff)

Headgate and diversion dam	Dry channel looking downstream

Dry channel looking upstream	Flume looking downstream

Figure 2.3: Example report card developed for diversion infrastructure inventory (pages 1-2).

Using the information described above, a “report card” containing descriptive statistics, photographs, location, and channel migration maps, and recommended improvements was created for each structure. An example report card for the Chase Peyton Ditch is shown in Figures 2.3 and 2.4.

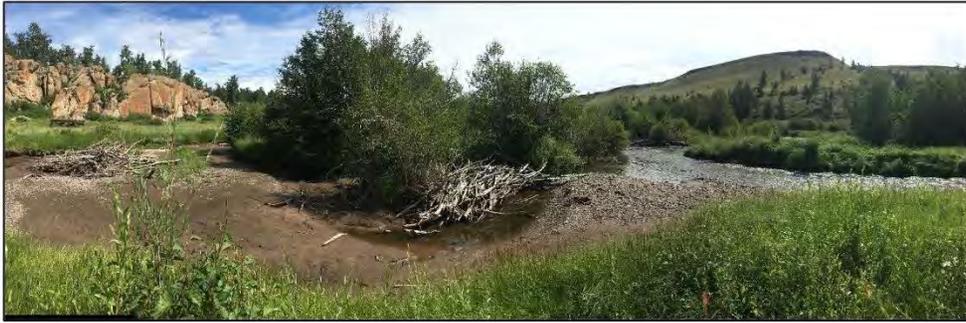
Dry meander, which was cut off during 2019 spring runoff.

Figure 2.4: Example report card developed for diversion infrastructure inventory (pages 3-4).

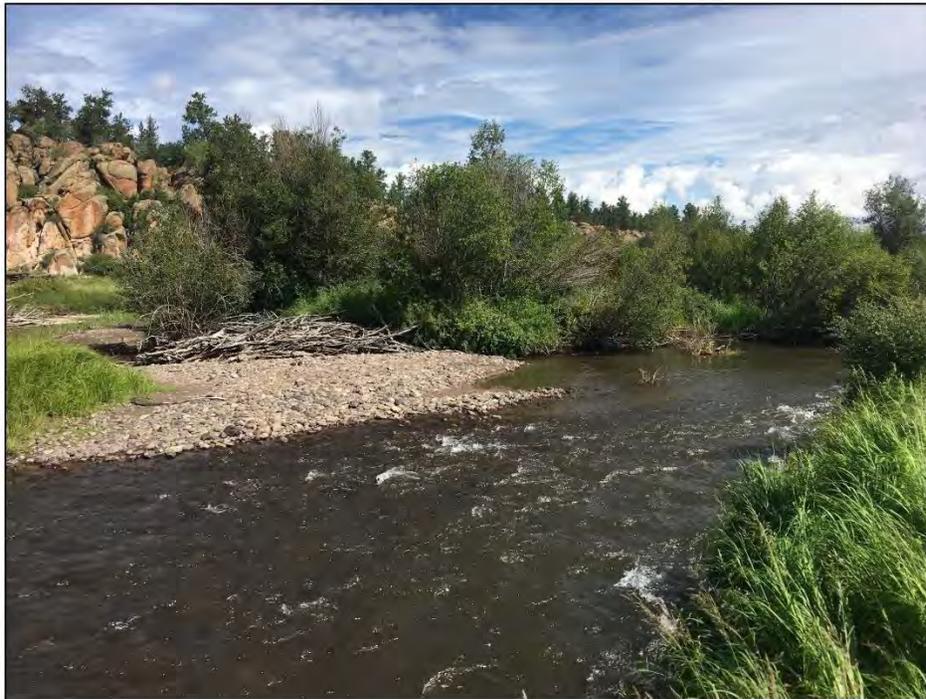
This photo, looking downstream, shows the meander (left) that was cut off during 2019 spring runoff.

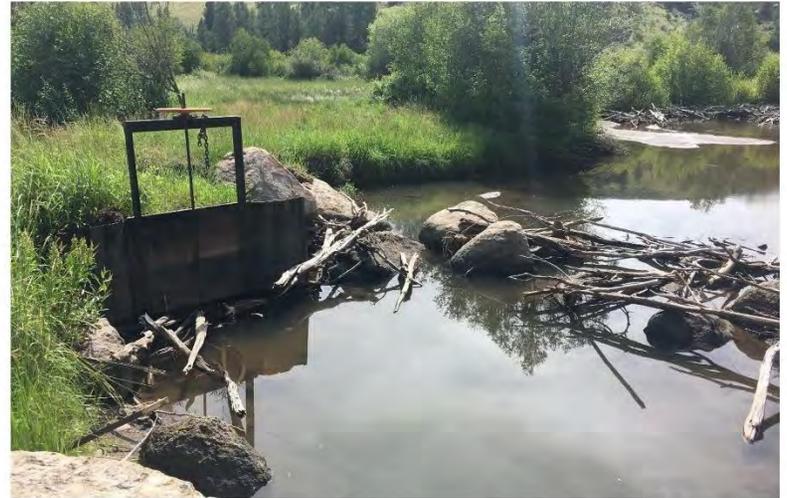
Headgate and diversion looking downstream

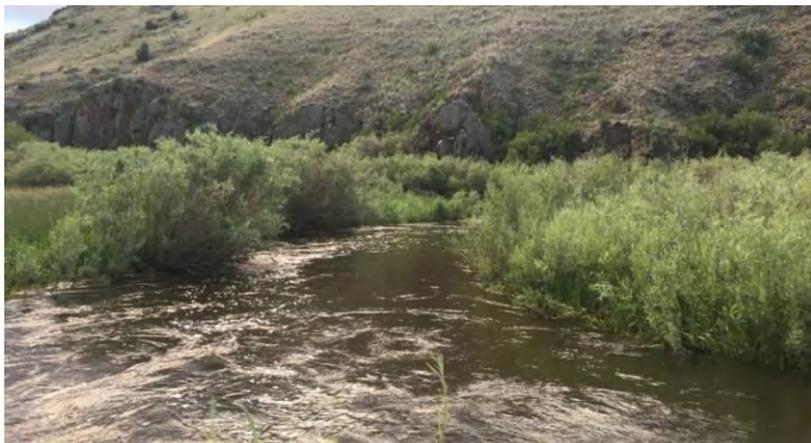
Figure 2.7: Floodplain activation on Saguache Creek, June 2019.

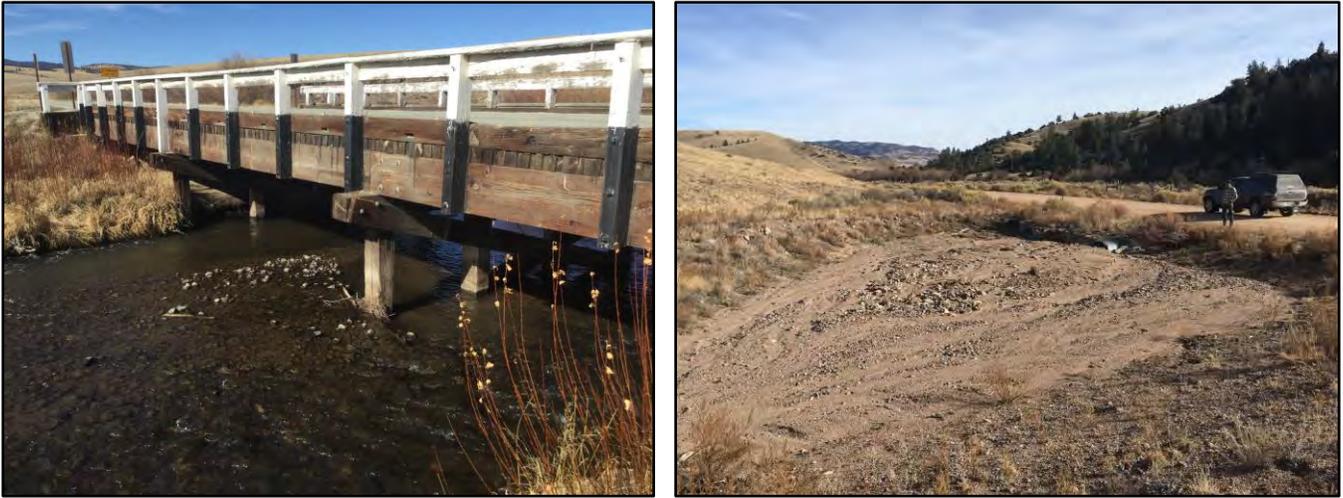
Figure 2.12: (Left) Bridge over Saguache Creek with a pier in the middle of the bridge that may collect debris during a flood. (Right) Undersized culverts failing to transport sediment in a dry wash in Saguache County.

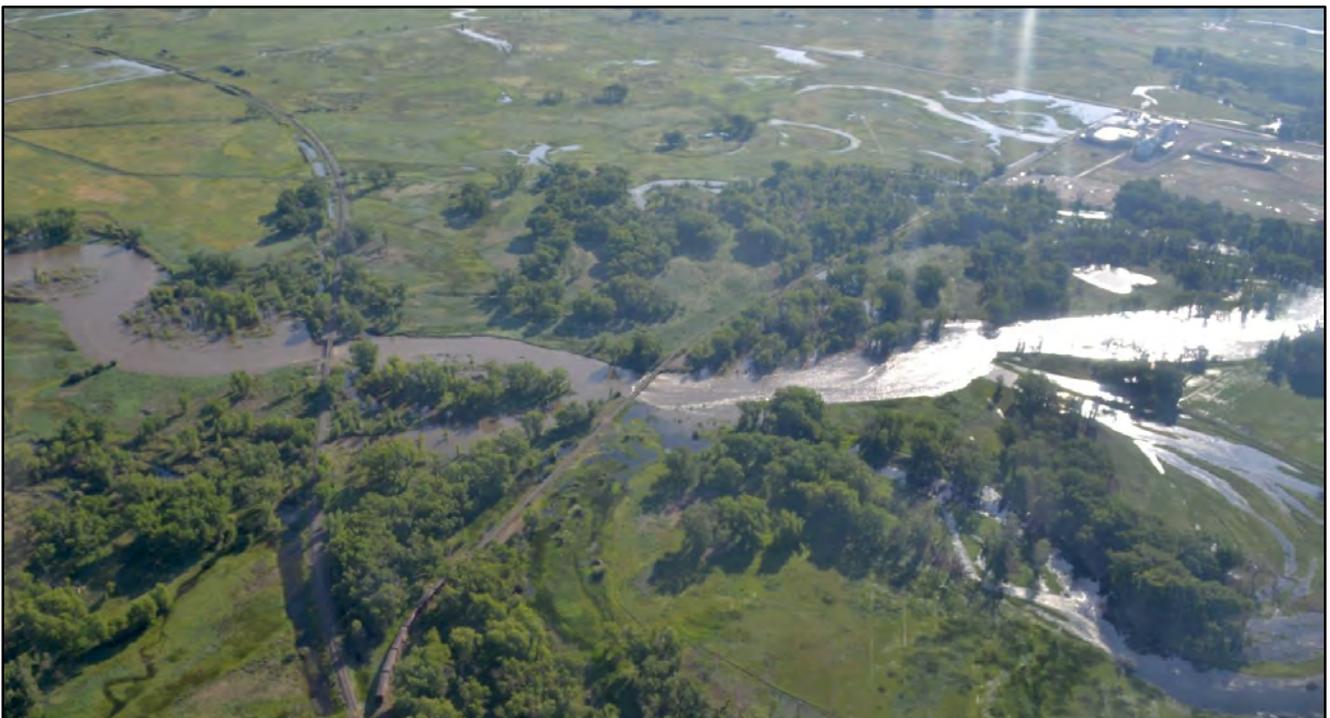
Figure 2.13: Railroad lines and bridges crossing the Rio Grande near flood stage, June 2019.

Roads oriented so they constrict the active river corridor can increase flow depths, shear stresses, and sediment transport capacities of streams. These constrictions can affect reaches upstream and downstream. Road and railroad bed encroachment does not appear to be significantly affecting the geomorphic stability of any of the streams in the SMP study area (Figure 2.13).

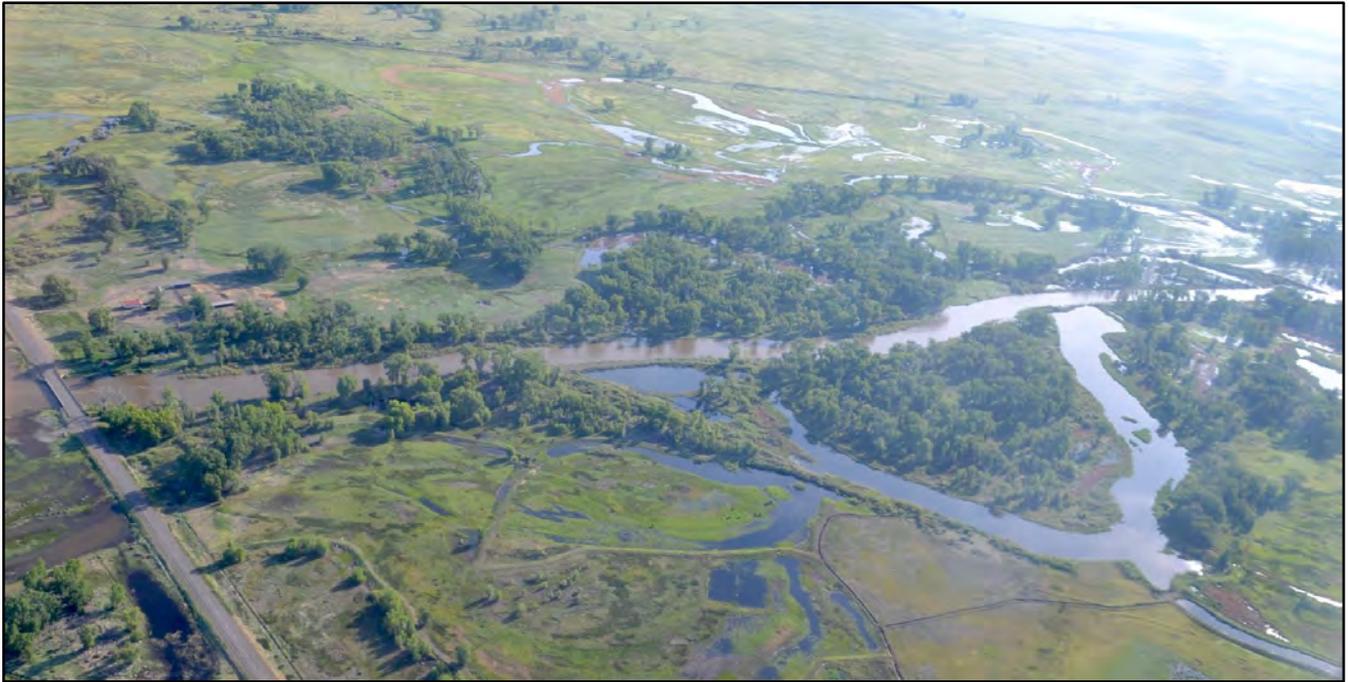
Figure 2.14: Channelization of the Rio Grande at the Soldiers Home Road (County Road 3E).

Channelization (i.e., straightening of channel meanders; removal of large wood and/or beavers; filling of side channels to force a stream into a single-thread) and stream bank armoring (i.e., placement of rock riprap, concrete barriers, or other materials to prevent channel migration or widening) has occurred on the SMP study streams and adversely affects natural channel processes and stream health. Figure 2.14 shows a channelized portion of the Rio Grande.

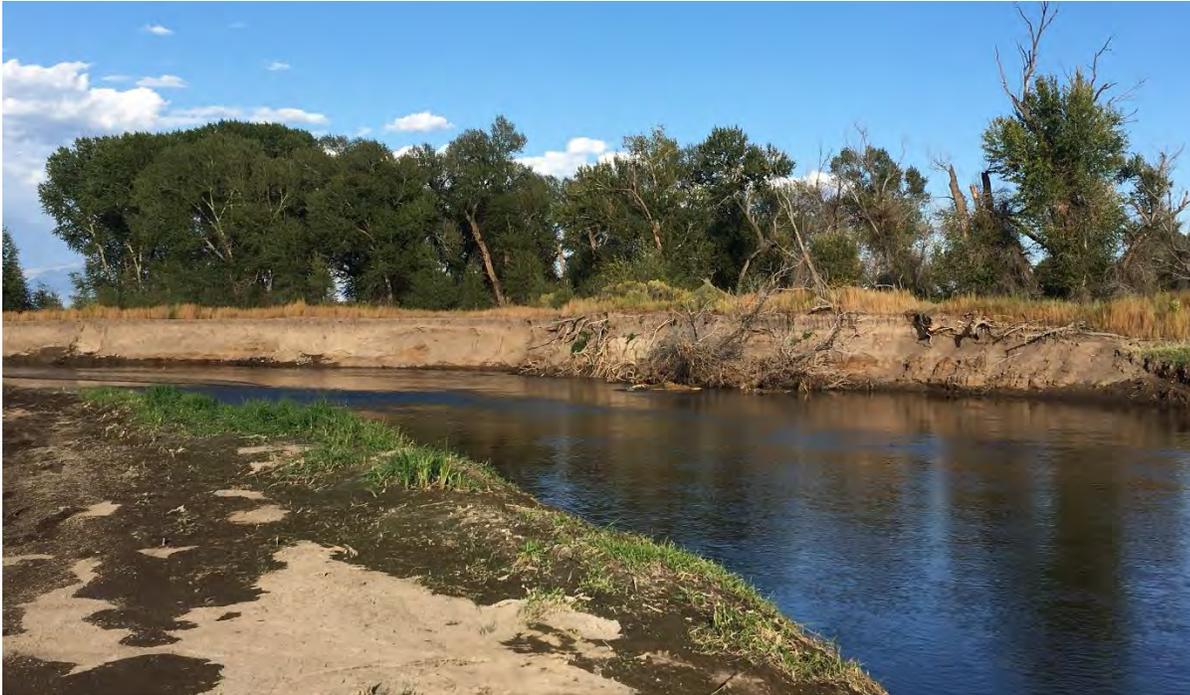
These features can cause river-floodplain disconnection (i.e., the river is unable to access its floodplain at high flows where it otherwise would have). Stream response to floodplain disconnection and/or bank armoring typically results in the transfer of erosive energy to the opposite bank, a downstream reach, or toward the channel bed.

Figure 2.15: River-floodplain disconnection on the Rio Grande upstream of Alamosa.

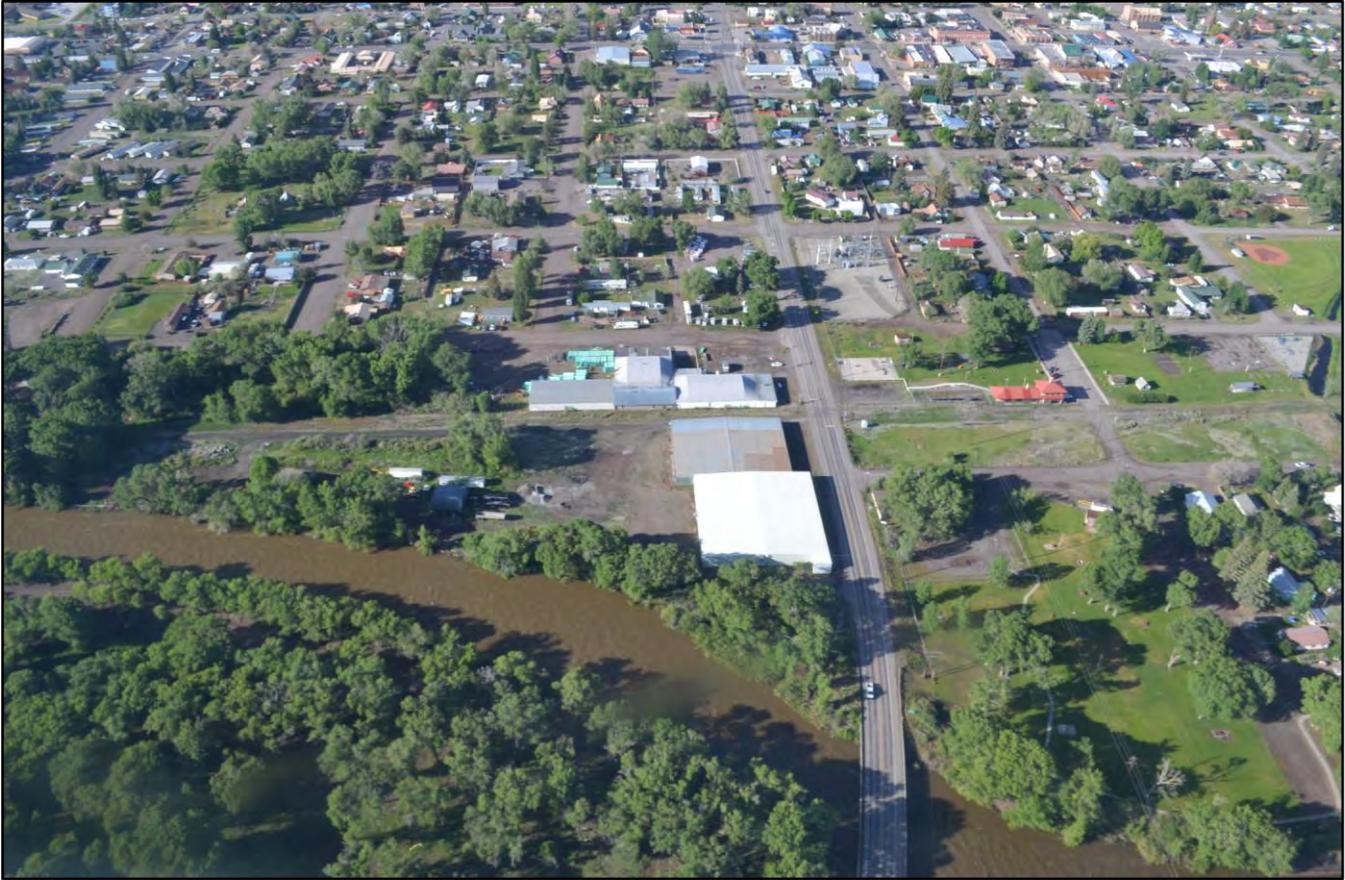
Land conversion can alter or eliminate floodplain complexity, side channels, wetlands, riparian vegetation, overflow relief channels, and other important geomorphic and ecological components of streams. Riparian vegetation and wetlands along some SMP reaches are impacted by fill and/or floodplain/riparian area conversion resulting from development, overgrazing, and nonnative species dominance. Riparian vegetation throughout the floodplain and river corridor, not just along the main channel, is critical to energy dissipation, stream shading, bank stability, wildlife habitat, and many other natural stream processes. Overgrazing and/or development fill brought into the corridor erases the evidence of past channel migration, possibly creating a false sense of protection from fluvial erosion to those that occupy the land. Furthermore, development creates the expectation (e.g., stable banks) that these rivers will remain in their current location indefinitely and therefore current and future generations will be willing and able to invest in the costs (both monetary and ecological) that will be required to resist natural channel processes (e.g., bank erosion and channel migration) (Figure 2.16).

Figure 2.16: Development in the active river corridor of the Rio Grande in the Town of Del Norte.

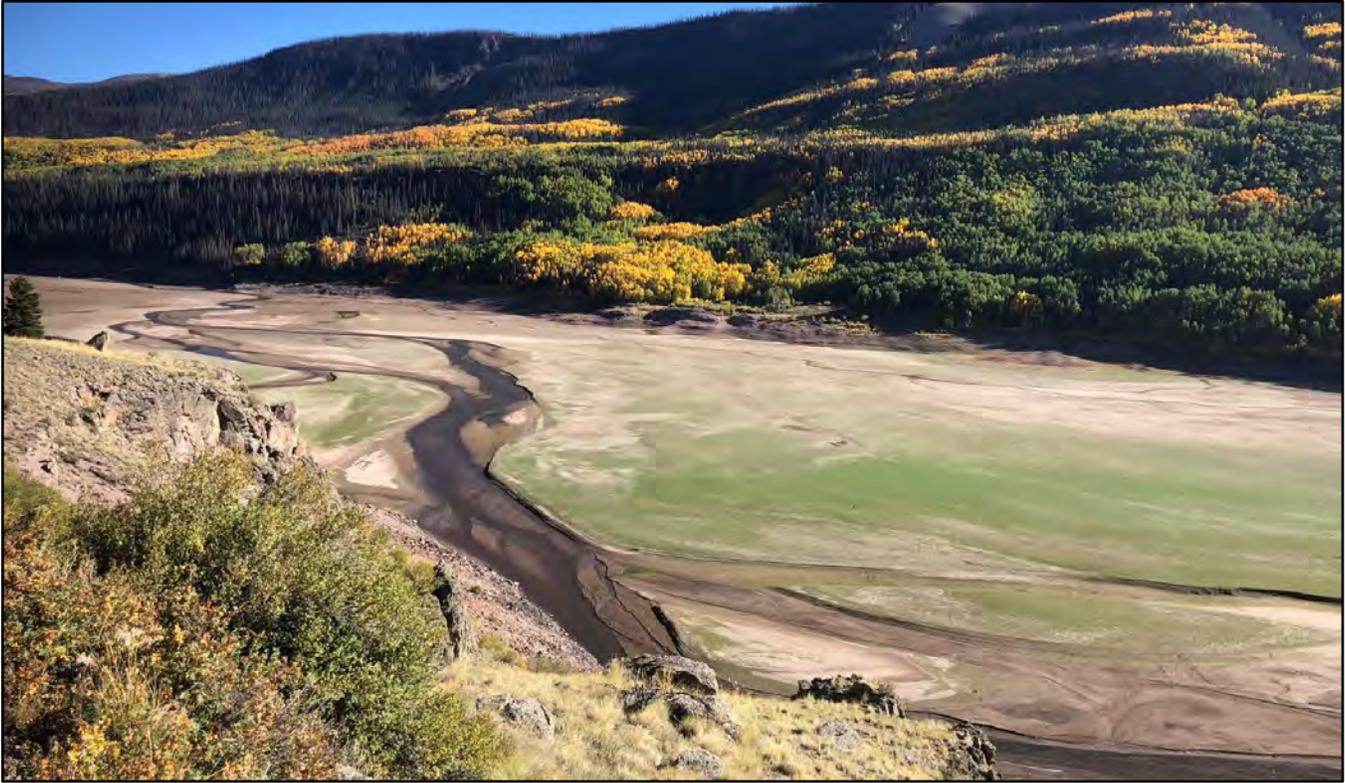
While Saguache Creek is a free-flowing stream, large dams affect both the Rio Grande and Conejos River. Dams affect these rivers both by reducing sediment transport, by trapping sediment behind them (Figure 2.17), as well as by reducing the peak flows that might otherwise provide channel-forming flows to flush fines, mobilize sediments, and do other geomorphic work. The Rio Grande is controlled by the earthen dam of the Rio Grande Reservoir which sits approximately 20 miles west of Creede. To a lesser degree, flows are also affected by Continental and Santa Maria reservoirs, which flow into Clear Creek. The Platoro dam on Conejos River is located roughly 1 mile above the town of Platoro, Colorado. Because these reservoirs are required to pass inflows during spring runoff, peak runoff is only altered when reservoir inflows surpass reservoir outlet capacity.

Figure 2.17: Sediment trapped behind the Rio Grande Reservoir (seen during dam repairs which had the reservoir drained during the fall of 2018).

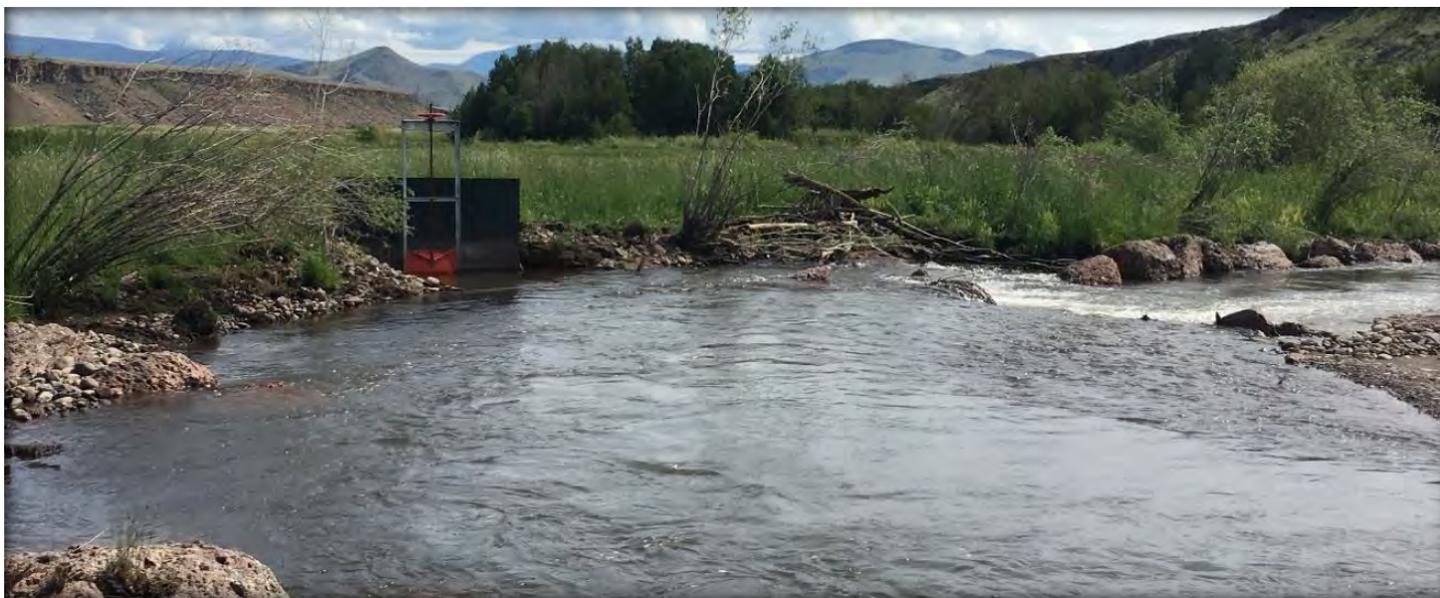
Figure 4.1: Middle D-Curtis Ditch diversion and headgate on Saguache Creek.

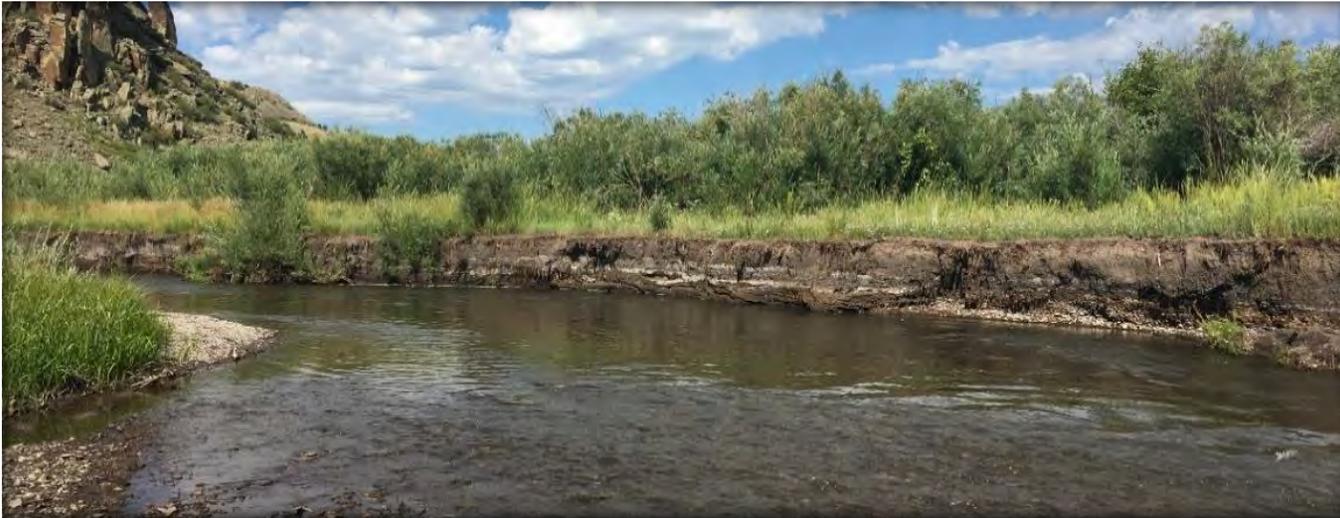
Figure 4.2: Bank and channel instability downstream of the Middle Creek confluence.

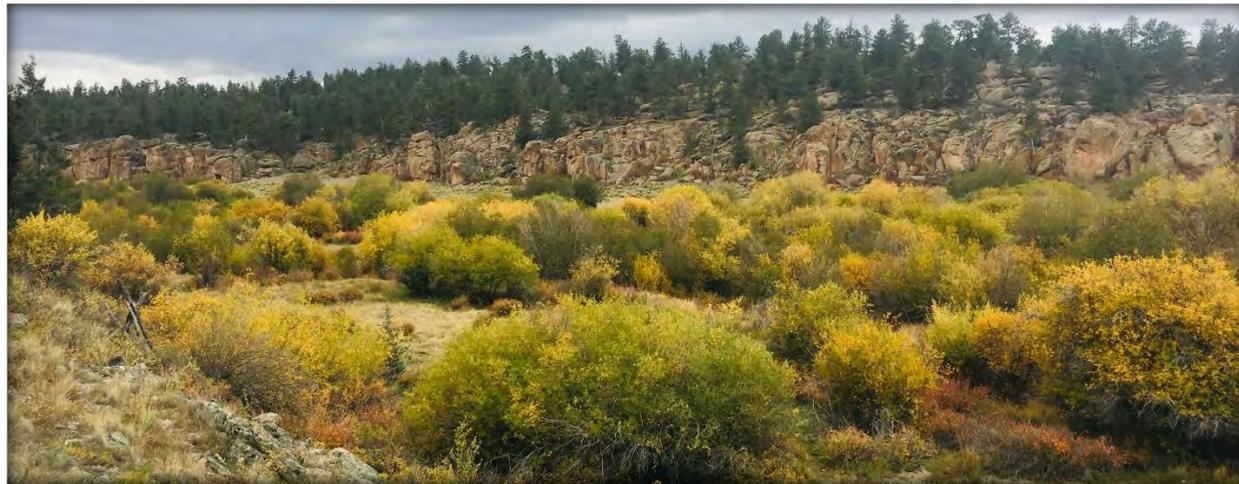
Figure 4.3: Riparian vegetation near the Fourmile Creek confluence.
