## Van Norman Research Lab (V\_N Project)

Prepared for:  
Colorado Watershed Restoration Program  
Attn: Chris Sturm

Applicant: River Science  
Grant Amount: \$99,900.00  
Prepared by: River Science

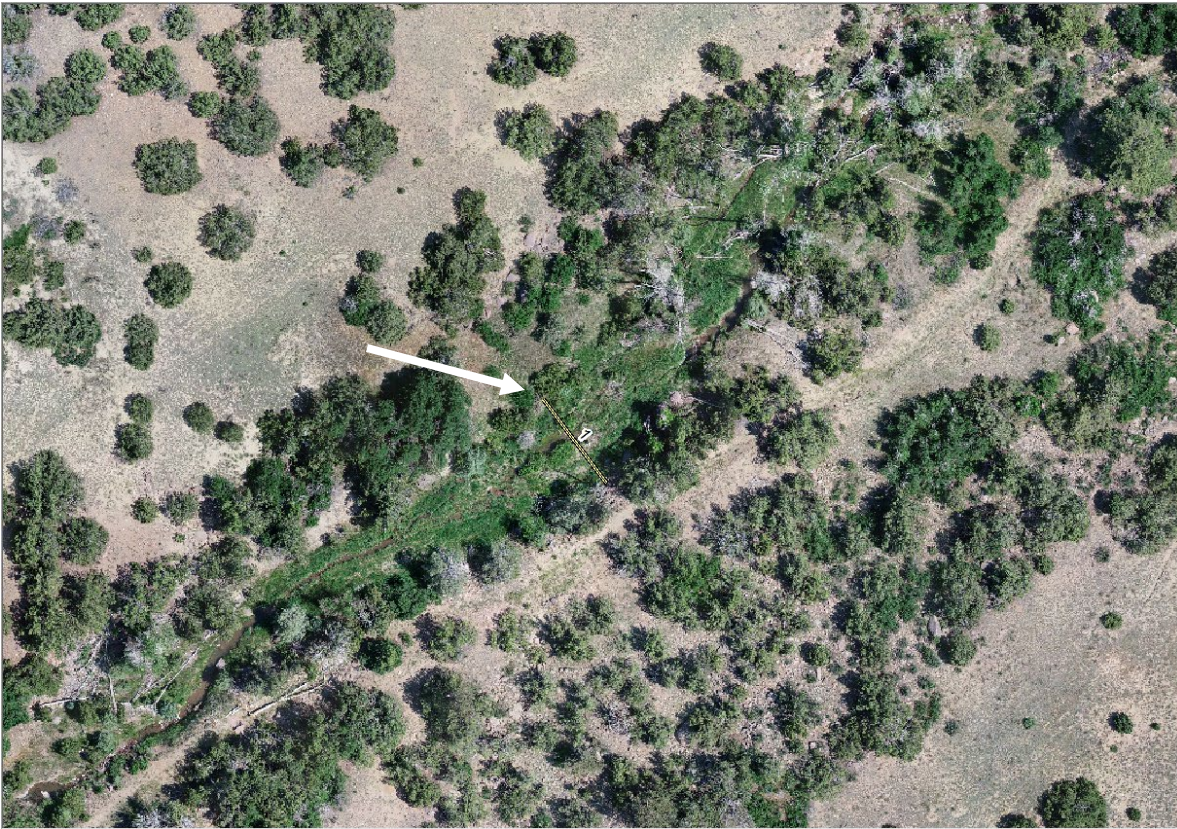
*Figure B1: Location of vegetation transect 1, located in an old beaver habitat (i.e. reference reach).*

Location: Just upstream of Van Norman Home at Colorado River Watch Site #348 (reference Figure B1).

Transect one runs east to west for 34 feet from flood bank potential to flood bank potential. The plot line was intercepted with a pin flag every foot of the transect. Plants anywhere along that intercept above or under the intercept were recorded.

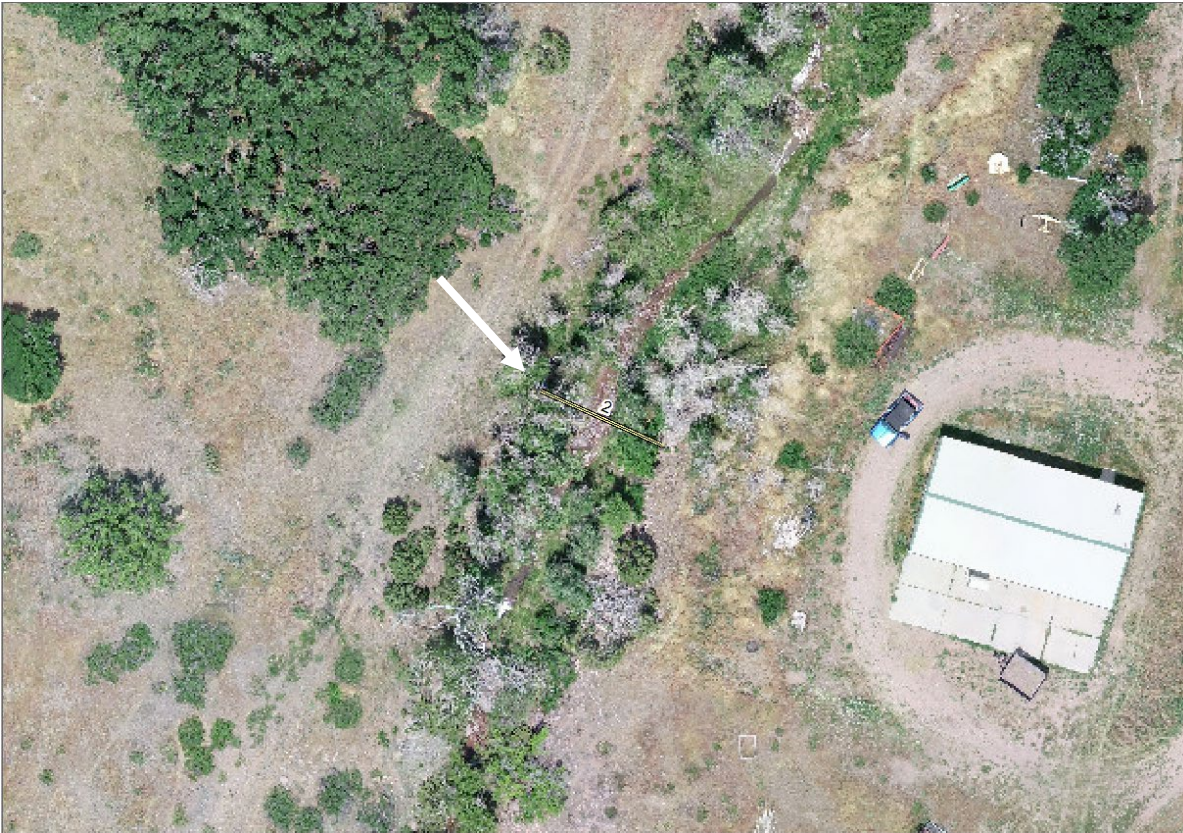
*Figure B2: Location of vegetation transect 2, located 120 feet upstream of the River Watch water quality site as well as the Site 2 flow rate cross section.*

Location: Above Van Norman home at the junction of irrigation ditch. (reference Figure B2)

Transect two runs east to west for 44 feet from flood bank potential to flood bank potential. The plot line was intercepted with a pin flag every foot of the transect. Plants anywhere along that intercept above or under the intercept were recorded.

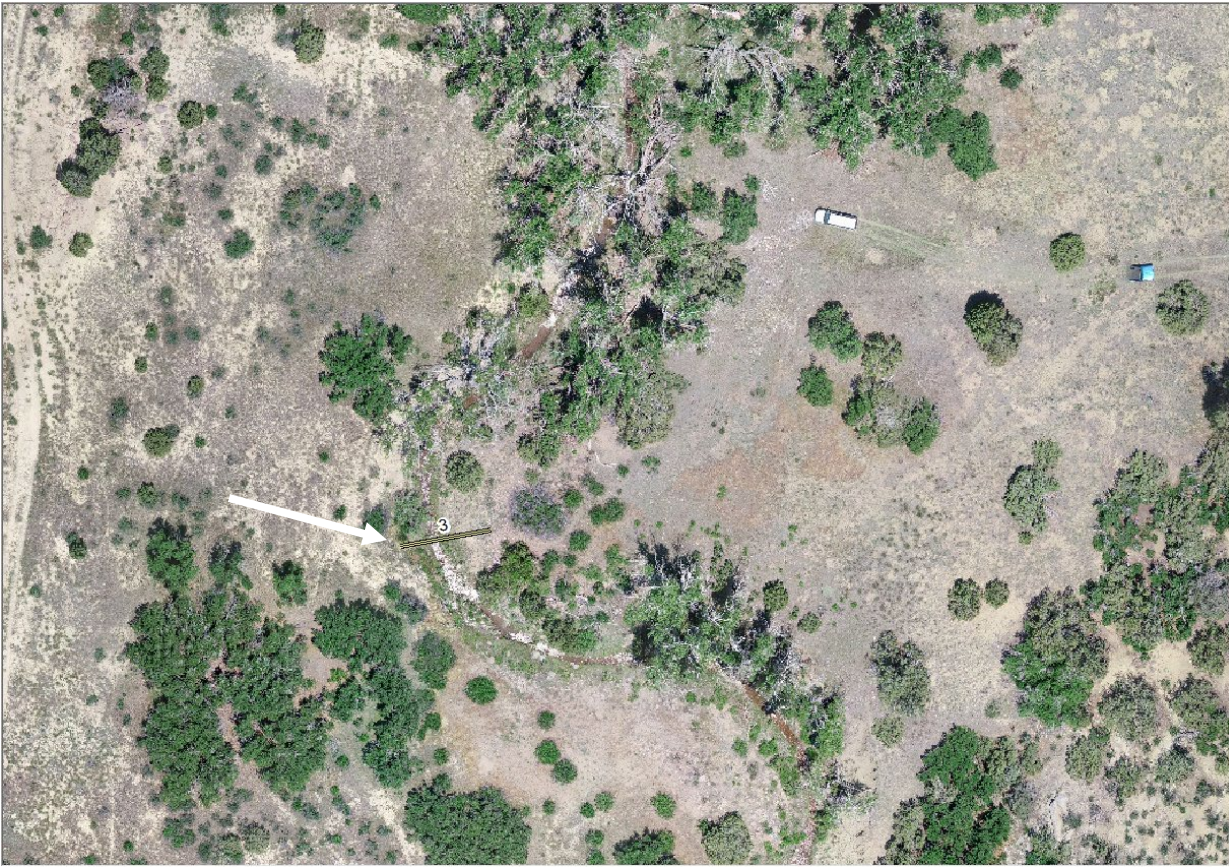
*Figure B3: Location of vegetation transect 3, located near the old Van Norman camping site (1800 feet upstream of the low water crossing).*

Location: Downstream approximately a quarter mile from Van Norman home (reference Figure B3)

Stream width was approximately 7 feet with 4 of those feet containing water and three feet of dry cobble and sand. The willows covered the entire stream bed with shade. Over half of the line is covered with bare soil and stone. Sparse amounts of forbs take are found on 64% of the terrestrial portion of the transect. Forbs consists of Fringed Sage, Clematis, Sand Drops, Pasque Flower, Thistle, Gooseberry, and Tansey Mustard.

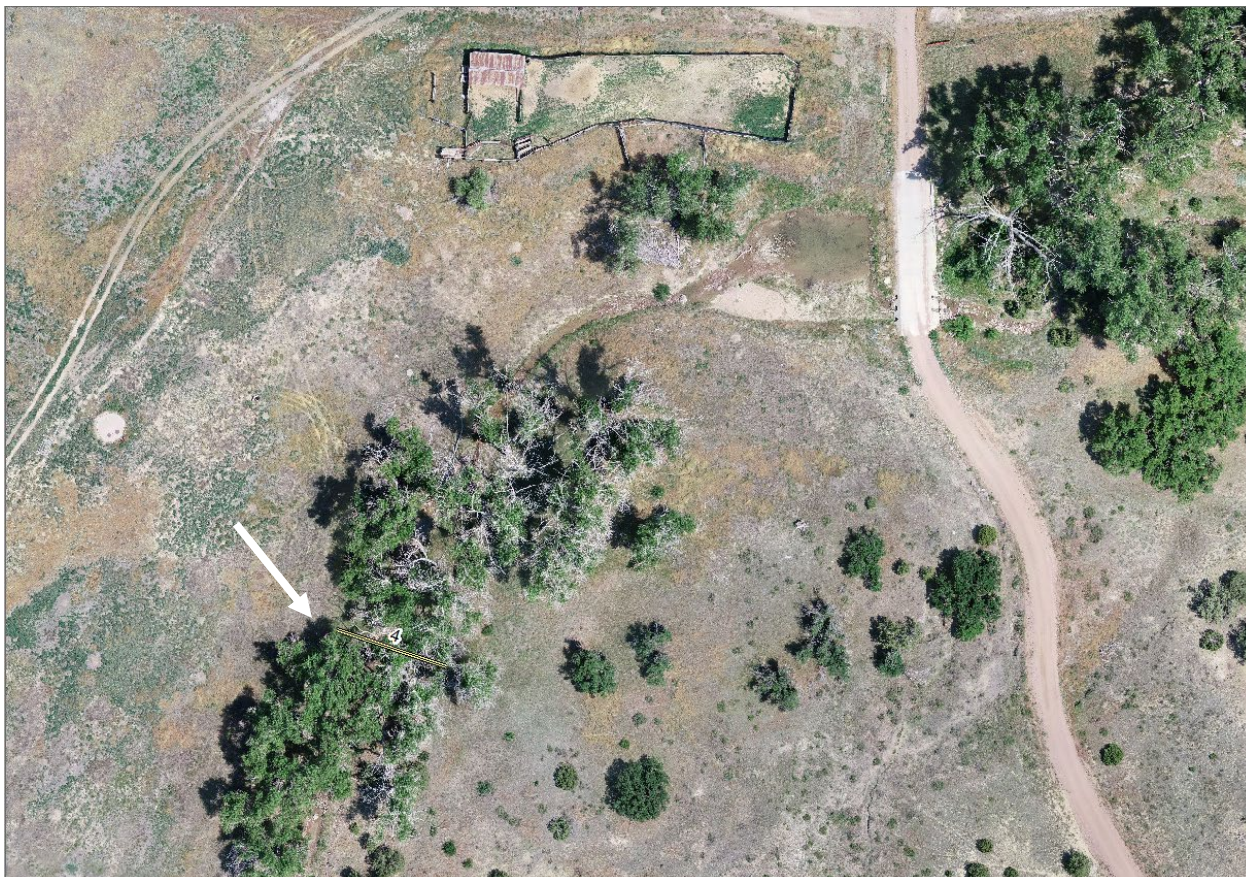
*Figure B4: Location of vegetation transect 4, located 350 feet upstream of the low water crossing, or 400 feet downstream of site 3's flow rate).*

The transect line is 100% covered by canopy of both dead and living Narrow-leaf Cottonwoods. Three incepts had Rocky Mountain Juniper over hangs as well. The area is covered with woody liter because of the trees along the line. No bare soil or stone was discovered along the ling, most of it covered with plenty of woody and herbaceous litter.

Stream bed was sand, gravel, and cobble along its 8-foot width. An unknown aquatic plant was found at intercept 34. Sleepy Grass was the most consistent graminoid, making up 37% of all the species found. The west side of the Oak Creek had more Rye Grass than the east side, making up 35% of species found along line transect. Wheat grass and blue grass were also identified along the fourth segment. No other herbaceous plants were found on the line.

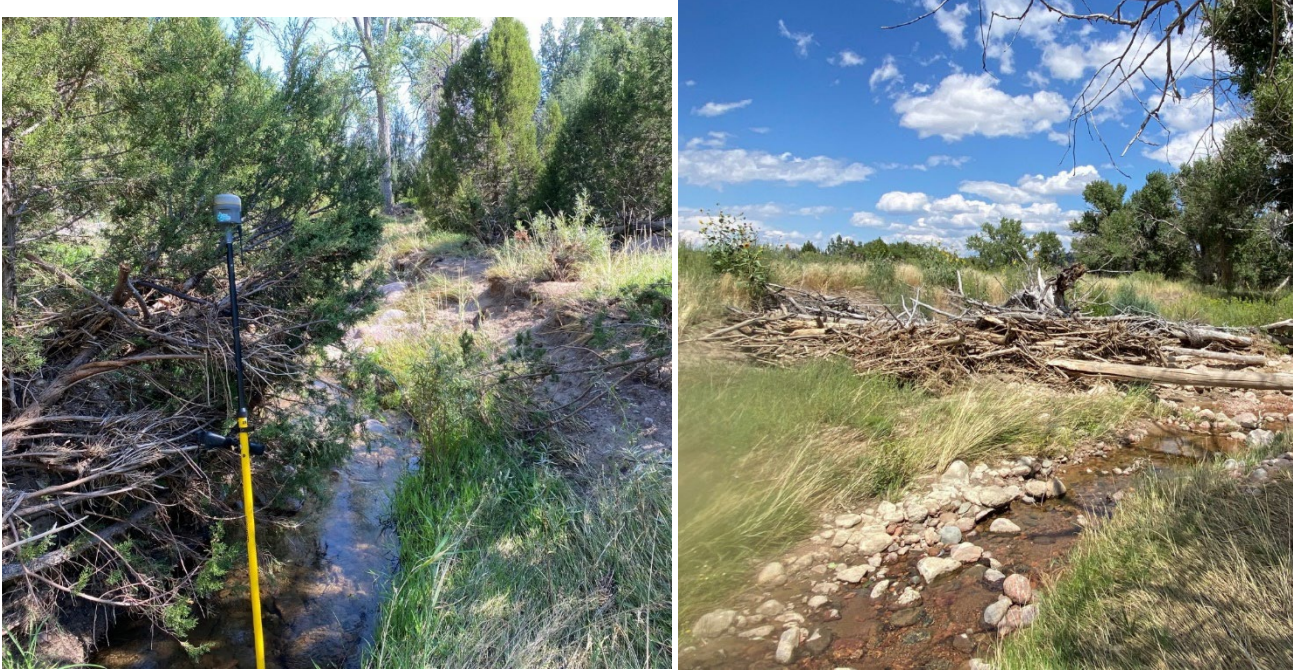
*Figure D1: Site 1 location flood debris lines measure about 6' of water (left) and large debris jams piled up (right).*

In August of 2021, Oak Creek experienced a flood event that resulted in many debris piles and slight channel adjustments. Given that River Science had an elevation model and previous hydraulic modeling (Appendix A), this flood and available data provided the opportunity to quantify this flood event and to use this data for better understanding of the creek's hydrology, hydraulic processes, and floodplain connectivity. Collected flood extents that were surveyed (Figure D1), and hydraulic modeling demonstrated that the August flood was around 400 cfs. This data was helpful and later used to determine the appropriate dimensions of the future treatments size as StreamSTATS data was the only other source.

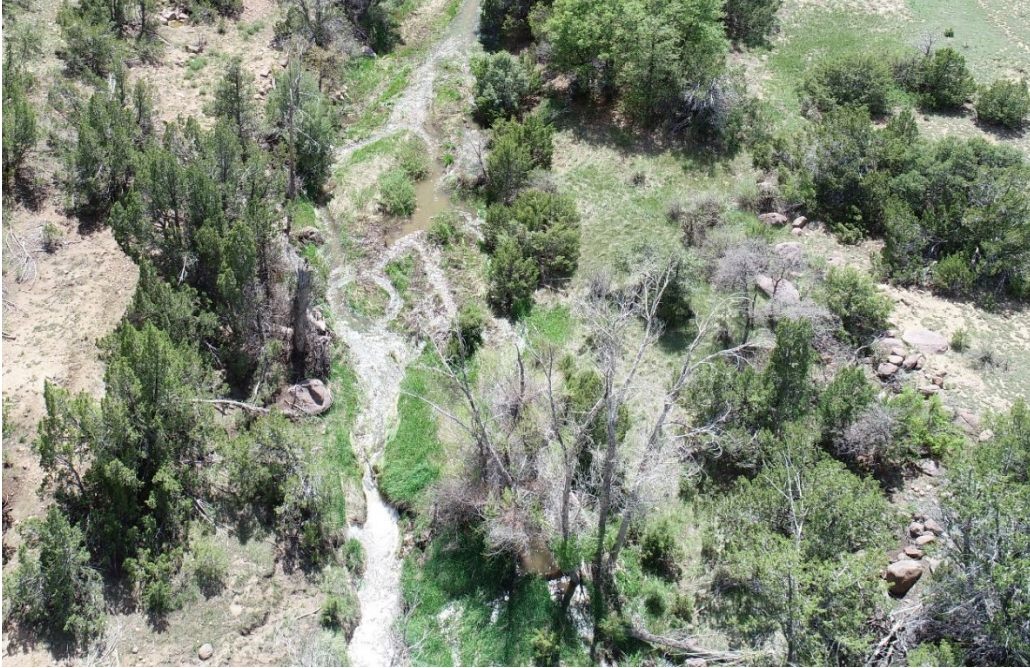
*Figure E1: Aerial view of the reference reach looking upstream*

Located at the upstream-most end of the Van Norman property exists a remnant beaver dam area whose old dam has acted as a temporary grade control – very similar to our proposed PALS influences. This site has become our restoration’s reference site as the width, channel depth, riparian vegetation, and channel grade provide a vision of what the restoration reach may achieve with PALS. To compare and contrast the reference reach to the typical incised restoration reach, the following list of figures are provided.

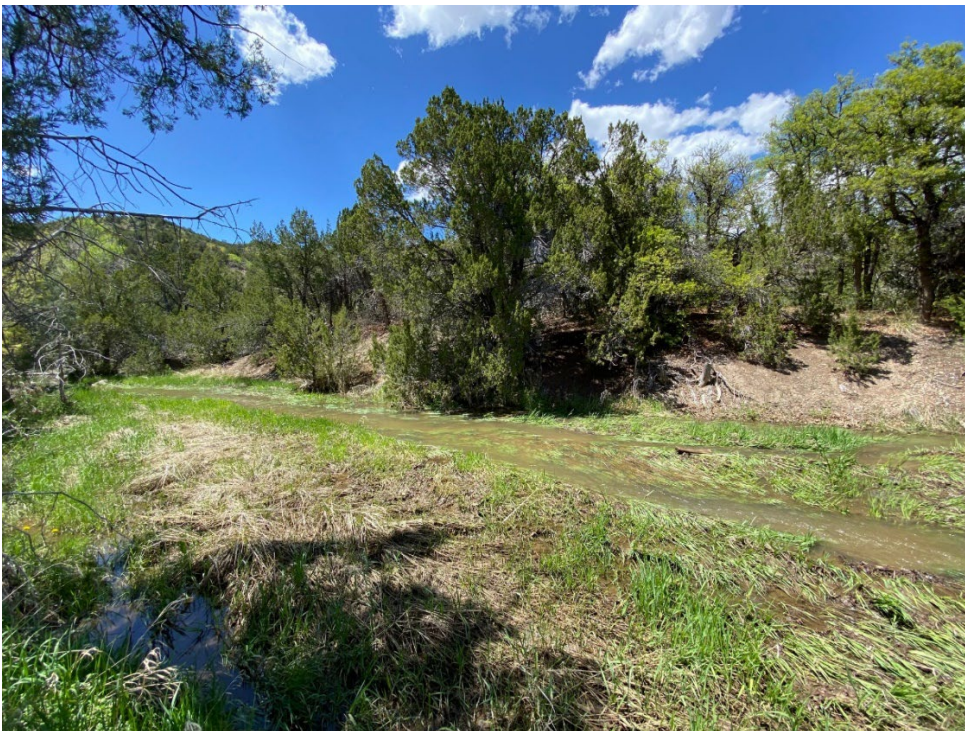
*Figure E2: Ground view of the reference reach looking upstream.*

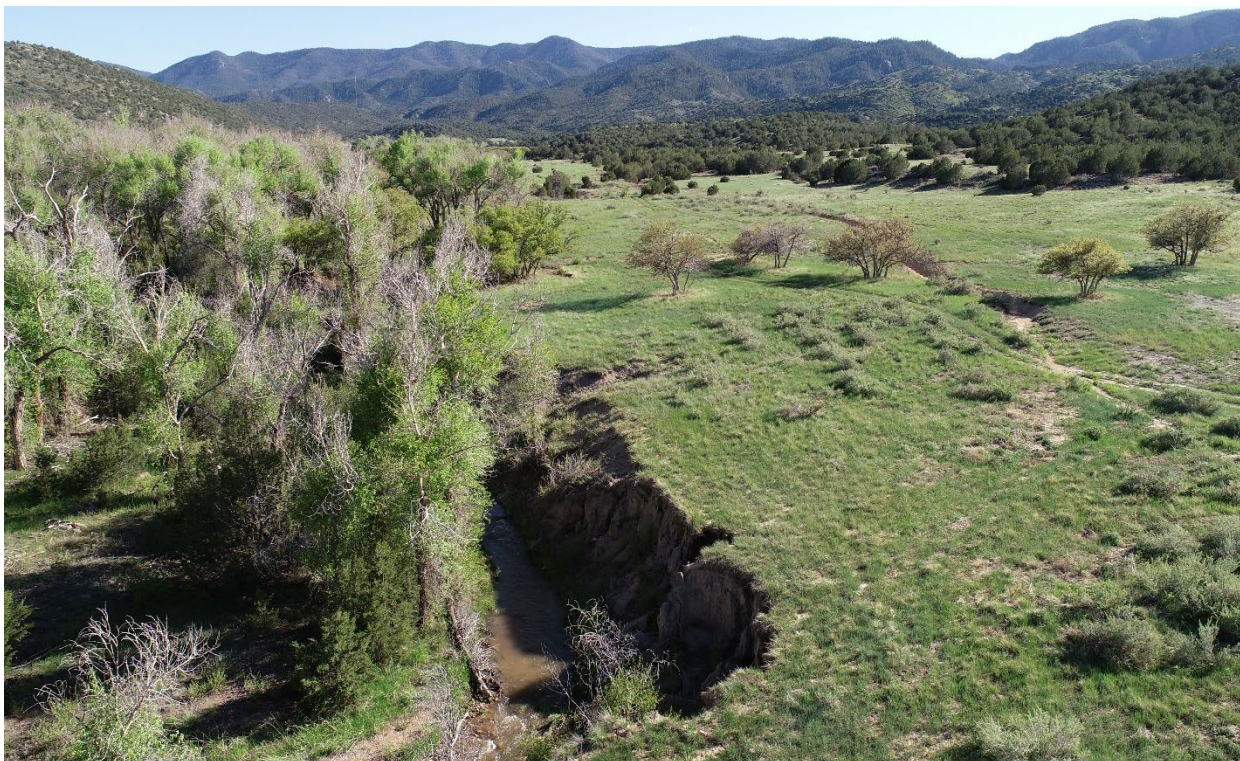
*Figure E3: Aerial view of an incised section of the future restoration reach looking upstream.*

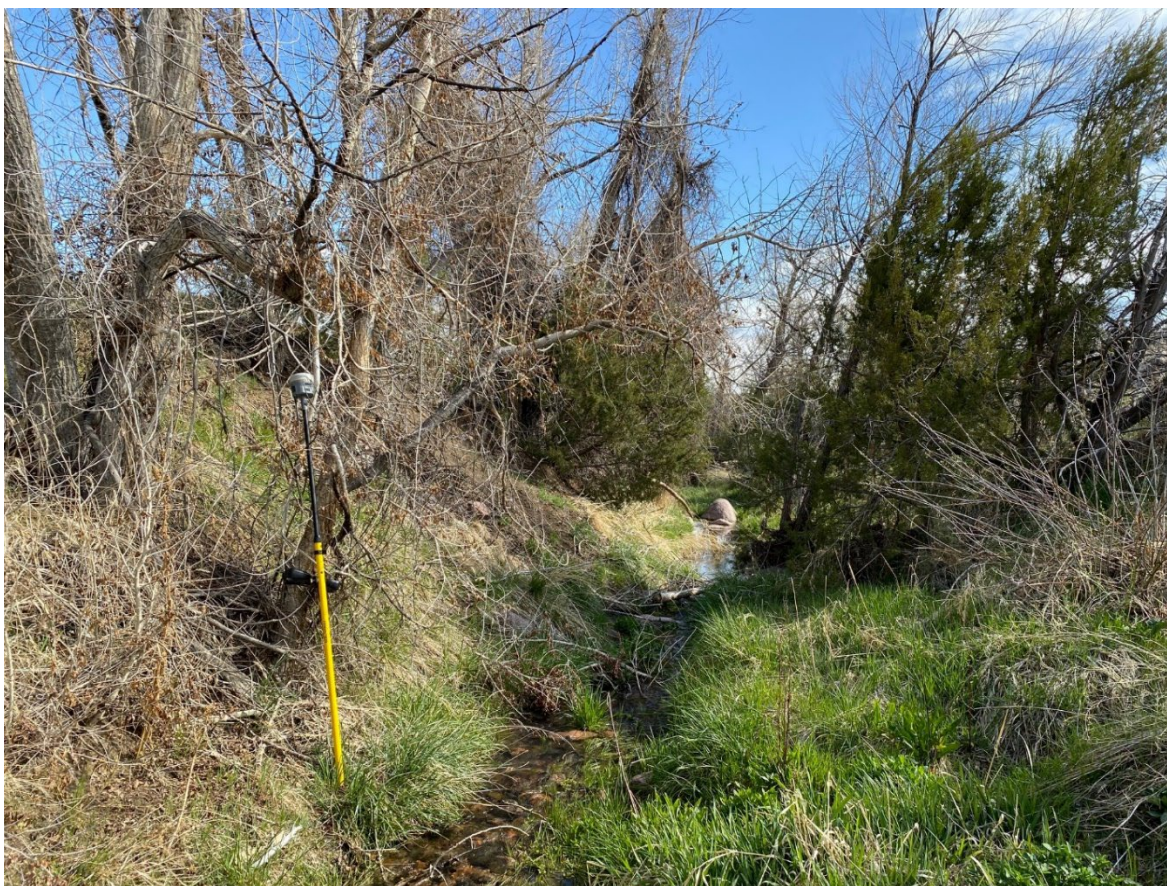
*Figure E4: Ground view of an incised section of the future restoration reach looking downstream.*

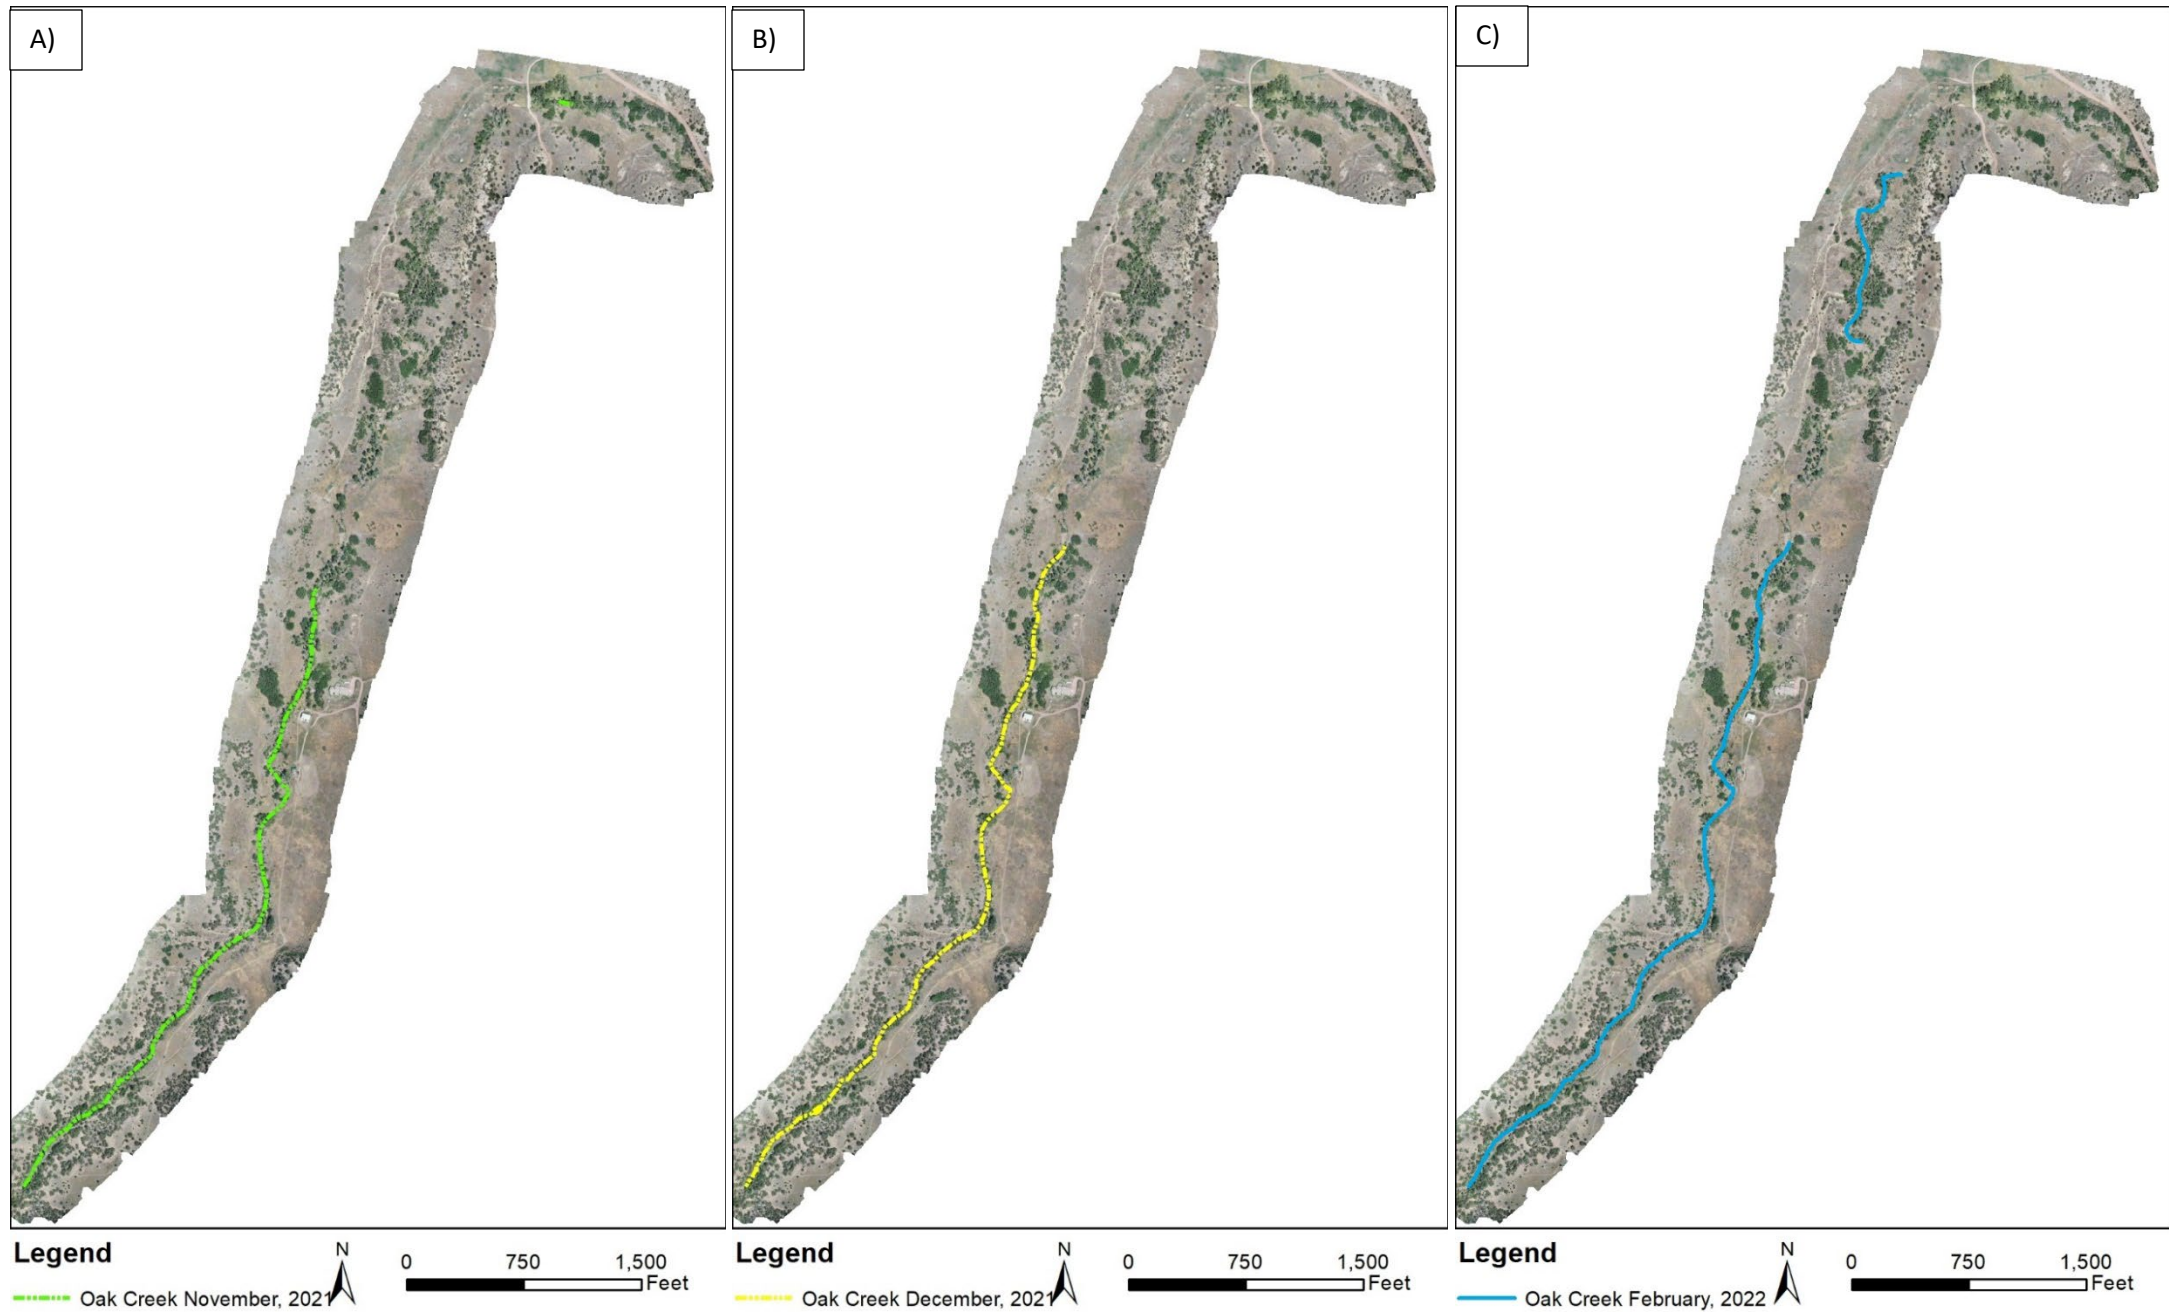
Figure F4: Oak Creek channel depicted for A) visible surface water in November, 2021, B) visible surface water in December, 2021, C) visible surface water in February, 2022.

Surface water presence and absence has been monitored monthly with repeat drone imagery. The Oak Creek channel runs approximately 2 miles through the Van Norman property, and its path is outlined in Figure E1A. The following Figures E1A-F4B show the areas where surface water was visible in aerial imagery. Figure E4C shows where the intersect of all datasets and determined the areas that had surface water in all datasets. As shown, the section near the Van Norman's house (midway on the stream length) is wet in every dataset. This area is known to have a small spring and has been the location of the River Watch water quality data collection as it does provide year-round flow.

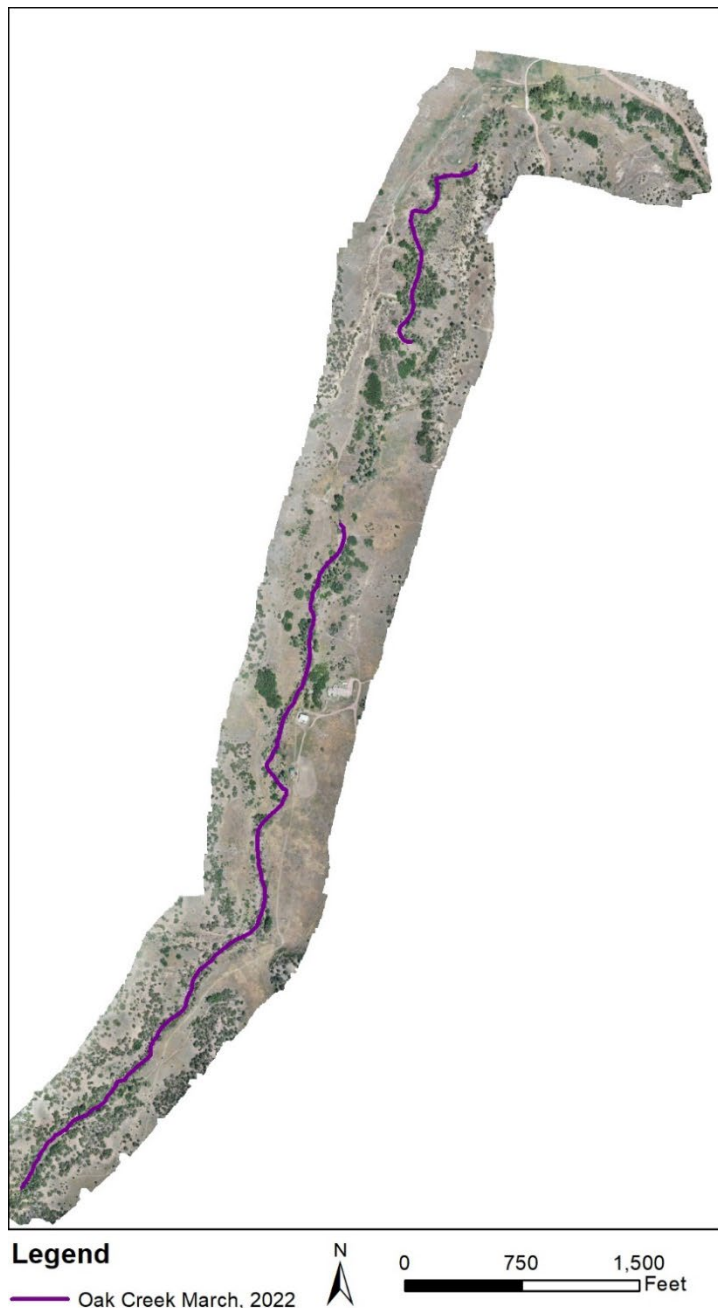
Figure F5: Oak Creek channel depicted for visible surface water in March, 2022

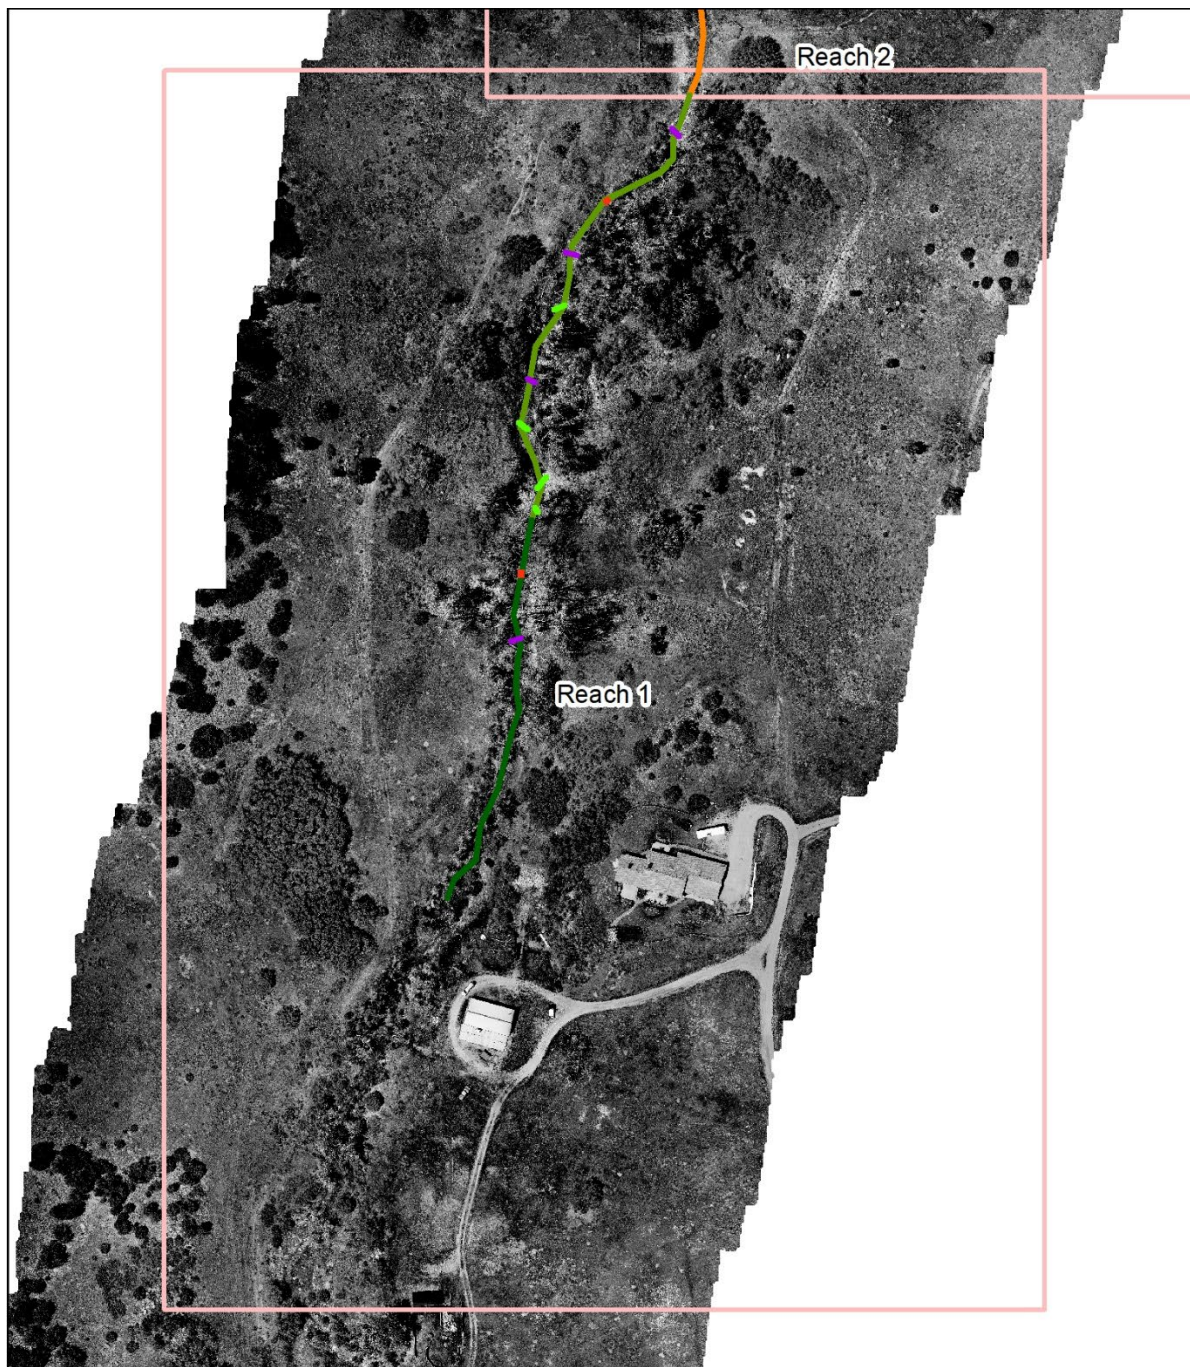
Figure H2: Reach 2 of Van Norman Project Restoration current stream evolution stage and proposed treatments using post assisted log structures (PALS) to induce river processes to induce channel widening and aggrading; thus advance the Stage to improved floodplain connectivity.
