COLORADO DIVISION OF RECLAMATION, MINING AND SAFETY
MINERALS PROGRAM INSPECTION REPORT
PHONE: (303) 866-3567

MINE NAME: Golden Wonder Mine	MINE/PROSPECTING ID#: M-1978-091-UG	MINERAL: Gold	COUNTY: Hinsdale
INSPECTION TYPE: Monitoring	INSPECTOR(S): Bob Oswald	INSP. DATE: August 20, 2013	INSP. TIME: 12:30
OPERATOR: LKA International Inc.	OPERATOR REPRESENTATIVE: Mike Schell	TYPE OF OPERATION: 110d - Designated Limited Impact

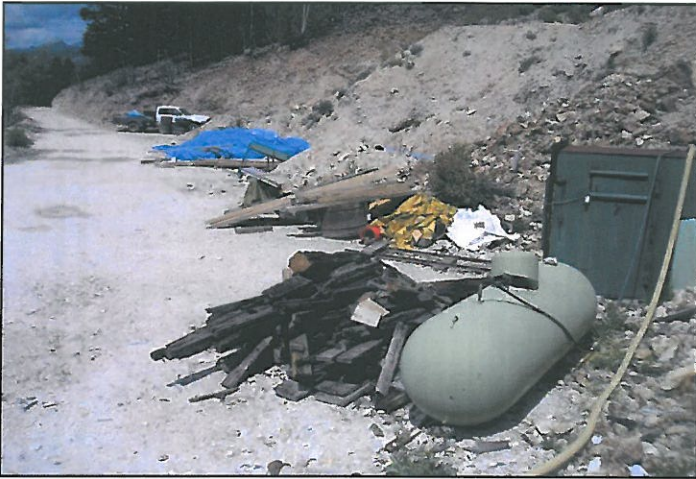
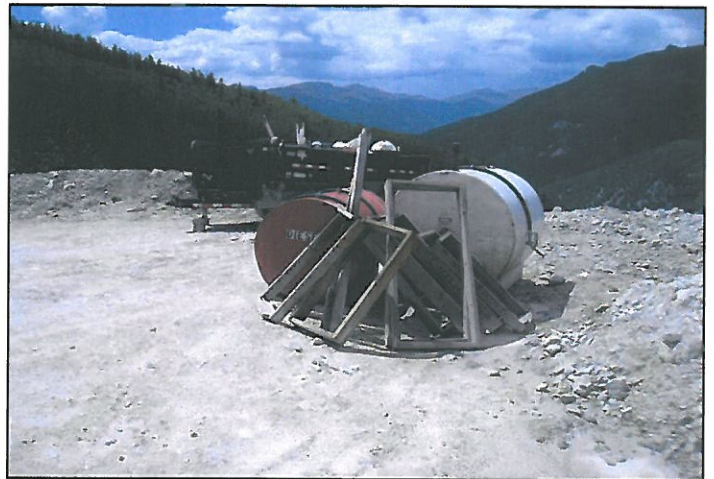
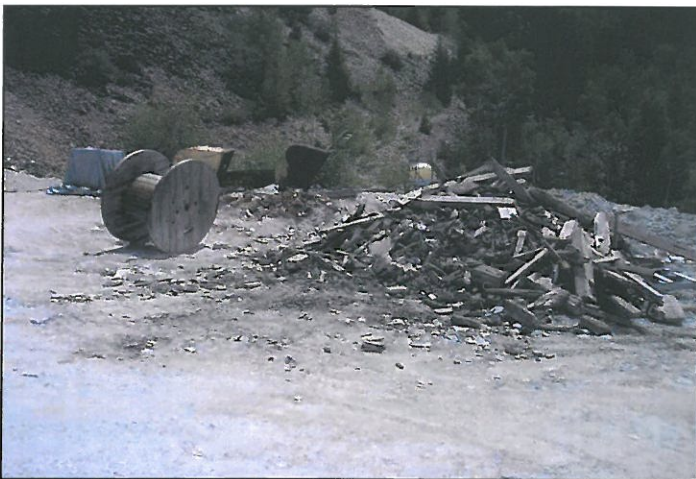
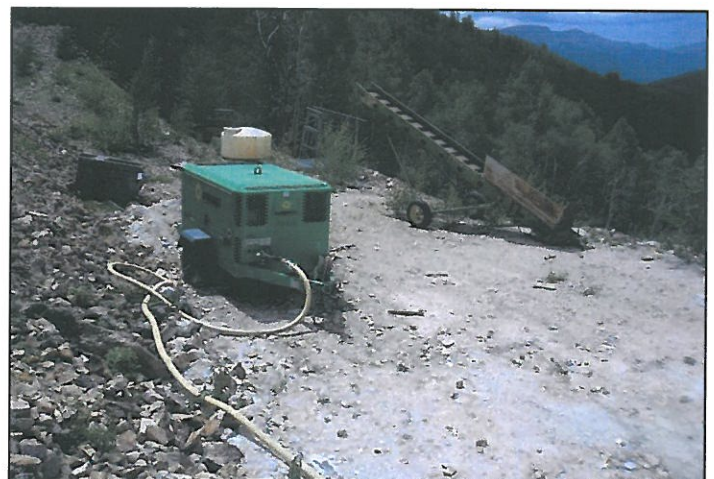
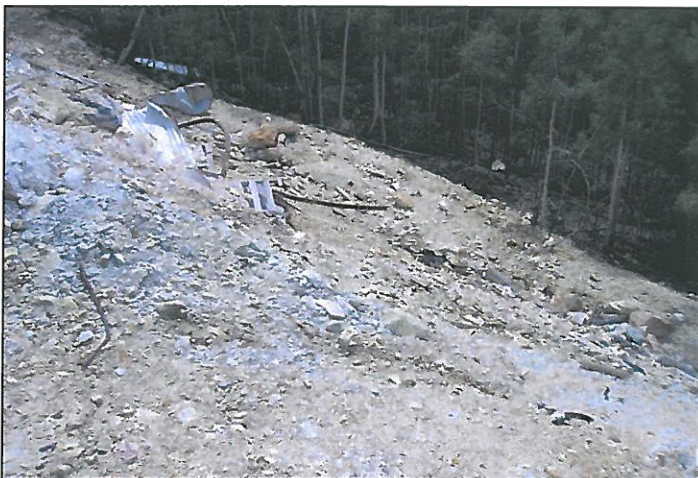
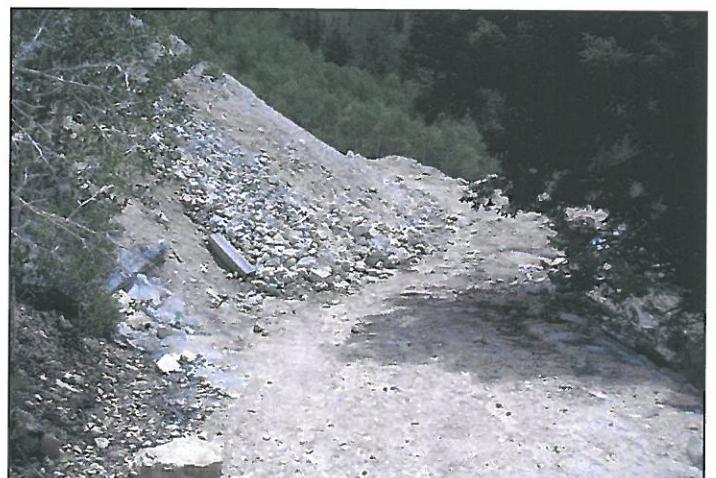
Photos from the inspection are on the following two pages: 3 Level on page 4, and 6 Level on page 5.

3 Level: Entrance gate was locked and there was no personnel or activity. The grate at the portal was locked and secure. The only equipment present were a trailer that was loaded with debris to dispose of, a wheeled diesel compressor, and a pickup. There were several debris piles and about 20 old vehicle tires to be removed. Also observed were two empty diesel fuel tanks, empty propane tank, and about 30 1-ton super sacks of low-grade ore. The tarp over the super sacks of ore needs to be replaced promptly (before winter weather) since it has deteriorated and does not provide good protection. The tops of the sacks by themselves do not provide any weather protection. The operator has placed more waste rock and select debris on the 3 level dump since the last inspection, but the placement has been much more careful. Site cleanup and waste dump management have improved the stability and containment of the site, and the operator is to be commended. The office encourages the operator to continue the cleanup and the careful and selective placement of items and materials at this level.
