**COLORADO DIVISION OF RECLAMATION, MINING AND SAFETY**  
**MINERALS PROGRAM INSPECTION REPORT**  
**PHONE: (303) 866-3567**

<b>MINE NAME:</b> Neglected Mine	<b>MINE/PROSPECTING ID#:</b> M-1981-165	<b>MINERAL:</b> Gold	<b>COUNTY:</b> La Plata
<b>INSPECTION TYPE:</b> Monitoring	<b>INSPECTOR(S):</b> Kate A. Pickford	<b>INSP. DATE:</b> September 5, 2013	<b>INSP. TIME:</b> 11:00
<b>OPERATOR:</b> Mine Development Inc	<b>OPERATOR REPRESENTATIVE:</b> Harold Luzar	<b>TYPE OF OPERATION:</b> 110(2) - Hard Rock Limited Impact

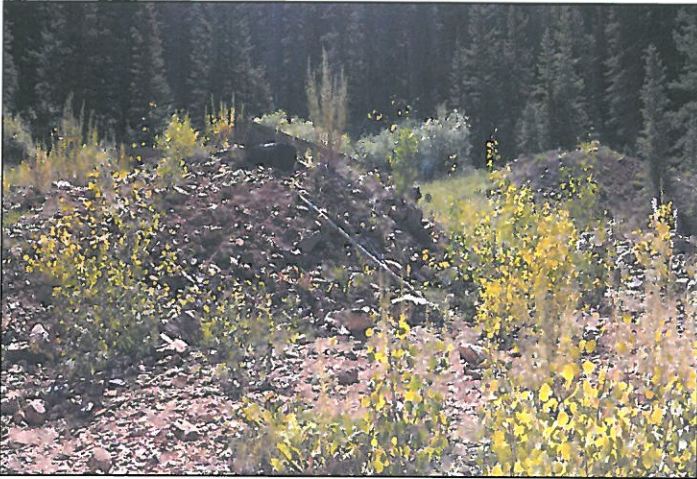
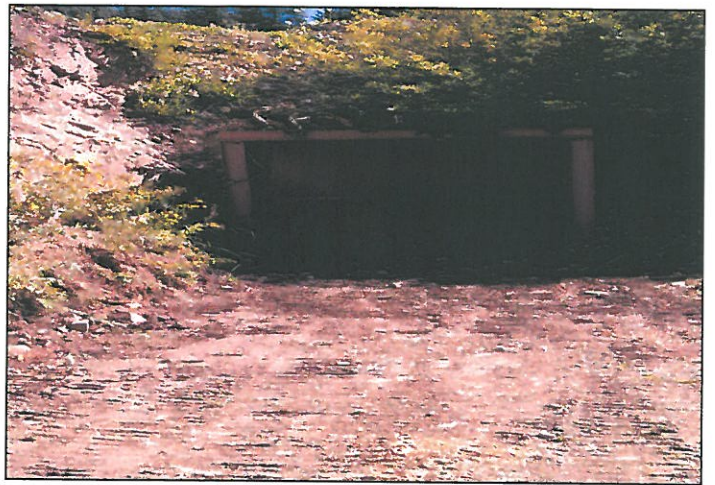
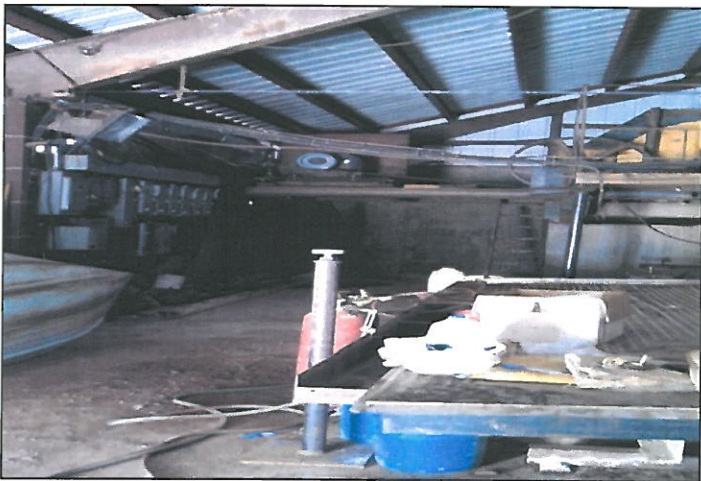
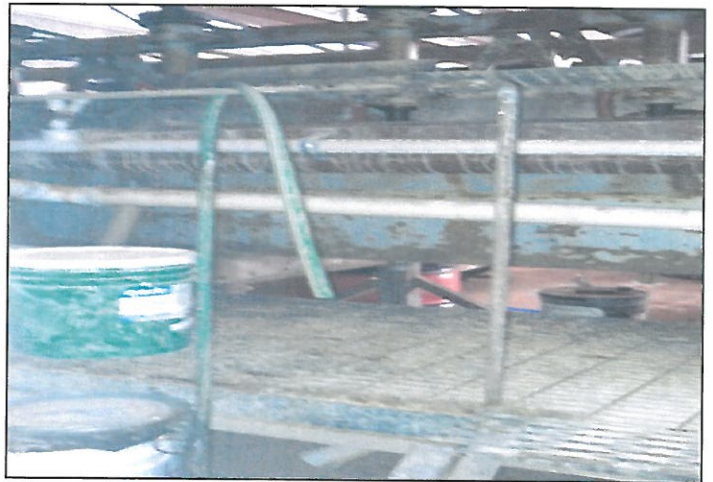
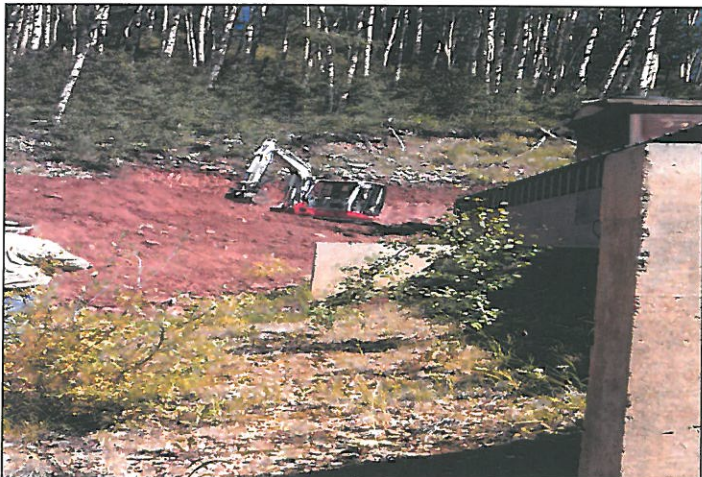
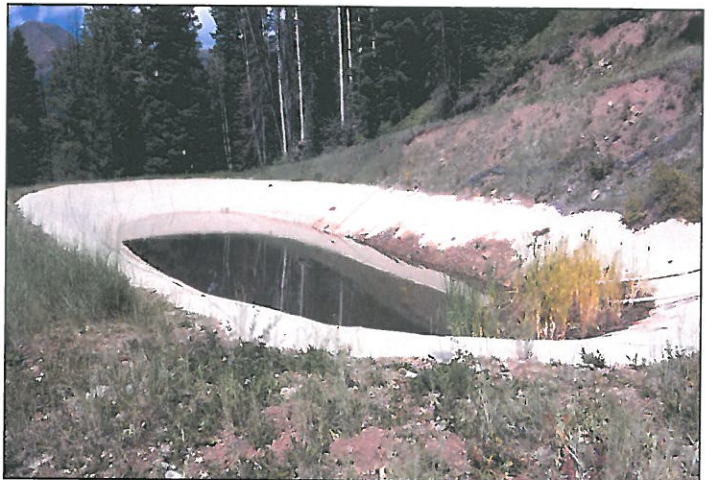
PHOTOGRAPHS

This inspection was conducted as part of the Division of Reclamation, Mining and Safety monitoring program. Maintenance was being conducted at the time of this inspection, in the form of repairs to the retaining wall behind the mill building.
