**COLORADO DIVISION OF RECLAMATION, MINING AND SAFETY**  
**MINERALS PROGRAM INSPECTION REPORT**  
**PHONE: (303) 866-3567**

<b>MINE NAME:</b> N Farm Rd Pit No 1	<b>MINE/PROSPECTING ID#:</b> M-1977-140	<b>MINERAL:</b> Sand and gravel	<b>COUNTY:</b> Rio Grande
<b>INSPECTION TYPE:</b> Monitoring	<b>INSPECTOR(S):</b> Bob Oswald	<b>INSP. DATE:</b> January 21, 2014	<b>INSP. TIME:</b> 13:30
<b>OPERATOR:</b> Mathias Concrete Inc	<b>OPERATOR REPRESENTATIVE:</b> Marshall Mathias	<b>TYPE OF OPERATION:</b> 112c - Construction Regular Operation

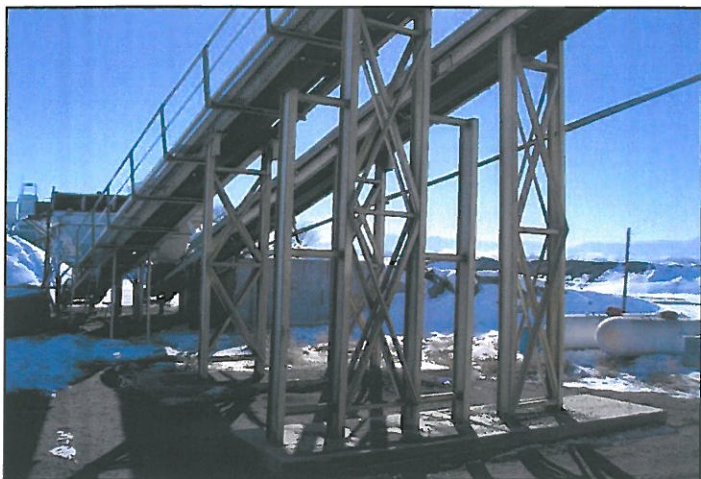
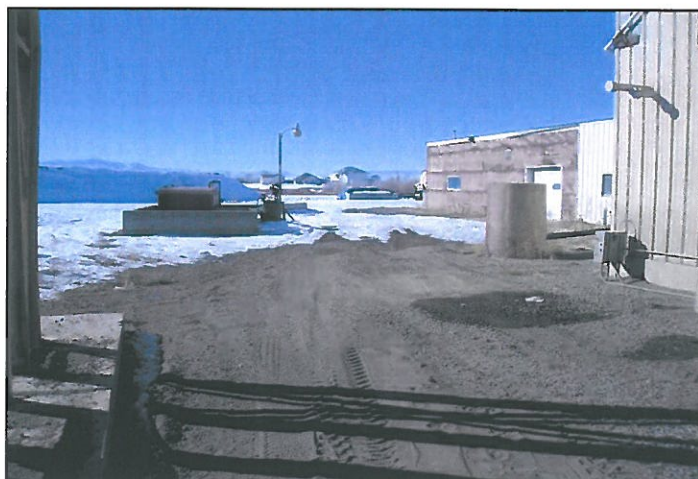
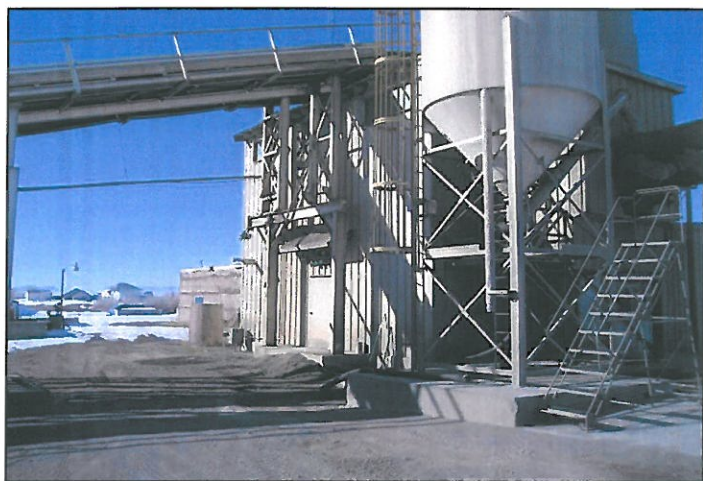
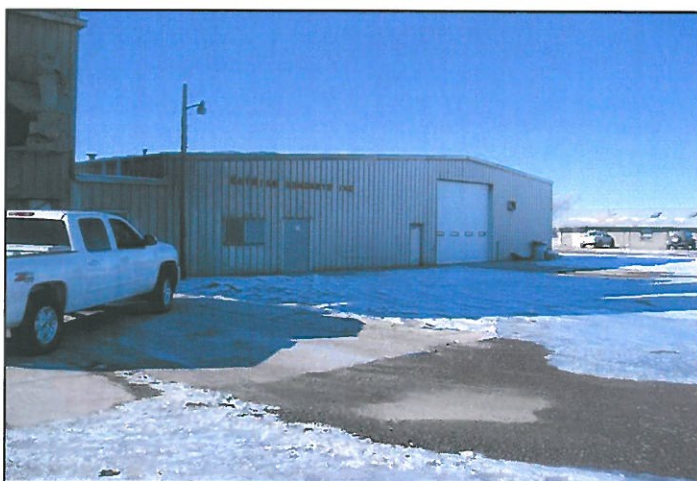
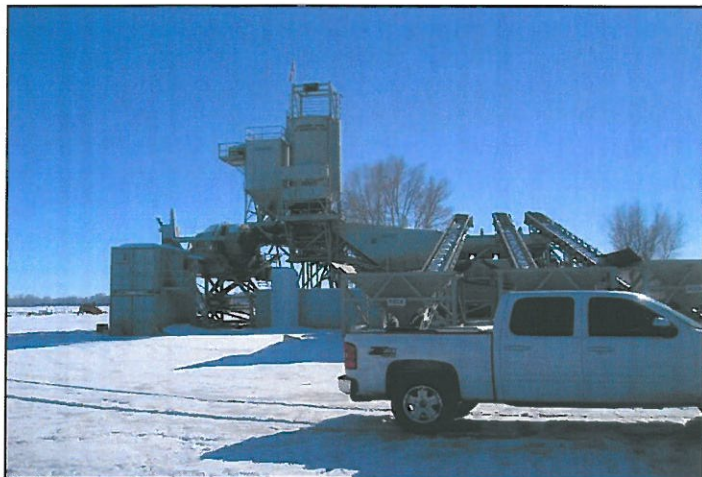
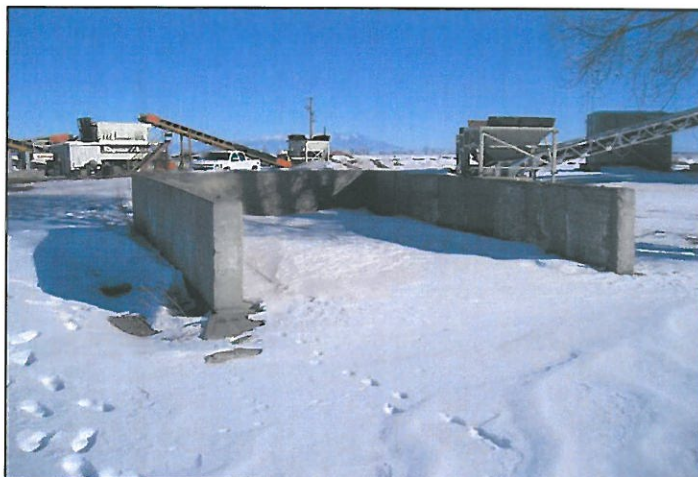
**PHOTOGRAPHS**

Inspection photographs are on the following two pages.

The permit is approved for excavation and material processing, which mainly consists of screening, crushing and concrete batching. The site consists of a large pond located against the western side of the permit and occupying most of the permit area, and the stockpile and processing area on the eastern end. Many of the old massive concrete footers and foundations have been removed from the processing area. There are several buildings, concrete footers and conveyors still present, however, and a few of these structures will be permanent. The pond was created by excavating material with a Sauerman dragline and exposing the shallow groundwater. The operator has sufficient water rights for this pond. The Sauerman equipment has all been removed and the pond is not being excavated further. The pond level was low, exposing much of the banks; the banks were graded to 5:1, and portions of them now contain willow thickets and cottonwoods.

The fluids stored on the site include concrete admixtures, diesel and lubricants, and waste oil. The fluids are stored in tanks in designated areas. The admixture tanks are large and inside the concrete batch facility on concrete floor. If ruptured the fluids would spread but congeal before percolating into the ground. The diesel and other hydrocarbons are in outside tanks, in a concrete secondary containment structure. The waste oil is stored temporarily in minor amounts behind the shop building, and is regularly picked up and removed. There is no sign of spillage yet, but since this is a continuously used storage location, the operator should consider installing an impermeable berm under and around the barrels or vessels.
