**COLORADO DIVISION OF RECLAMATION, MINING AND SAFETY
MINERALS PROGRAM INSPECTION REPORT
PHONE: (303) 866-3567**

MINE NAME: Kagie Gravel Pit	MINE/PROSPECTING ID#: M-1979-102	MINERAL: Sand and gravel	COUNTY: Routt
INSPECTION TYPE: Monitoring	INSPECTOR(S): Dustin M. Czapla	INSP. DATE: May 6, 2014	INSP. TIME: 11:30
OPERATOR: Cross Mountain Ranch Ltd. Partnership	OPERATOR REPRESENTATIVE: None	TYPE OF OPERATION: 110c - Construction Limited Impact

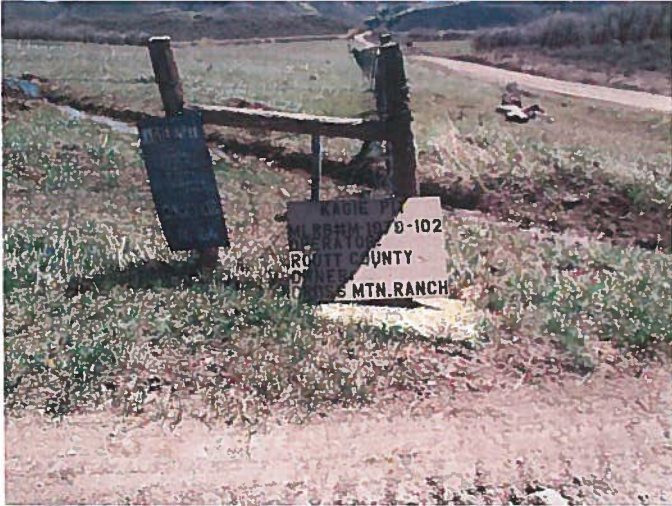
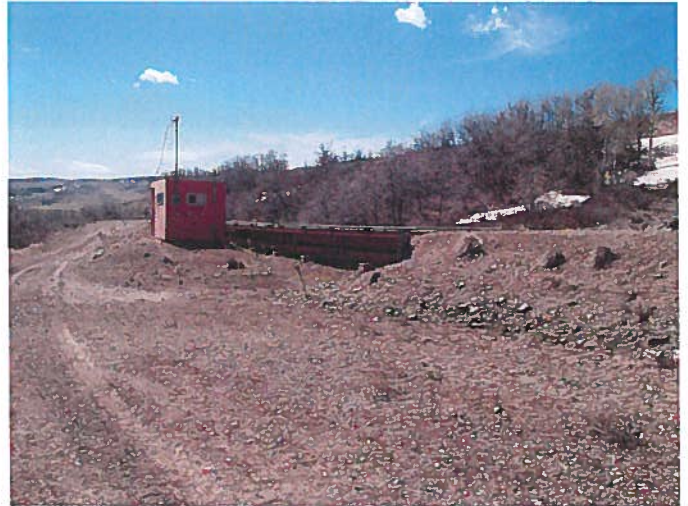
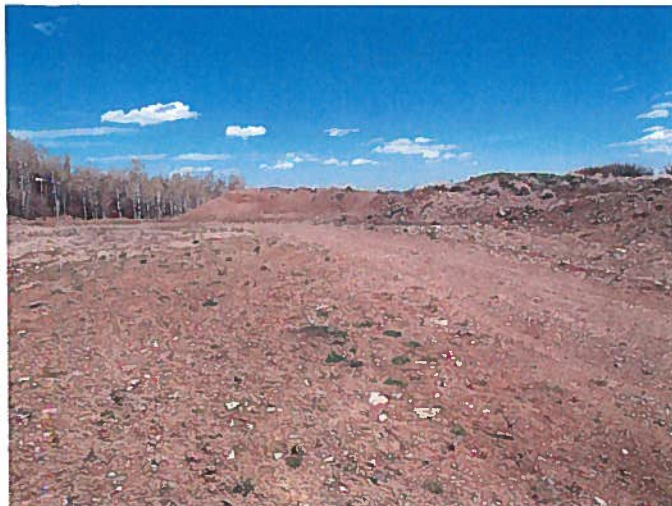
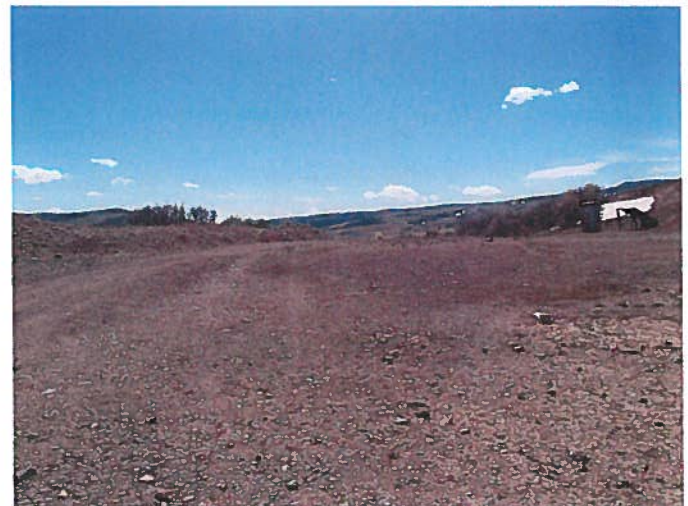
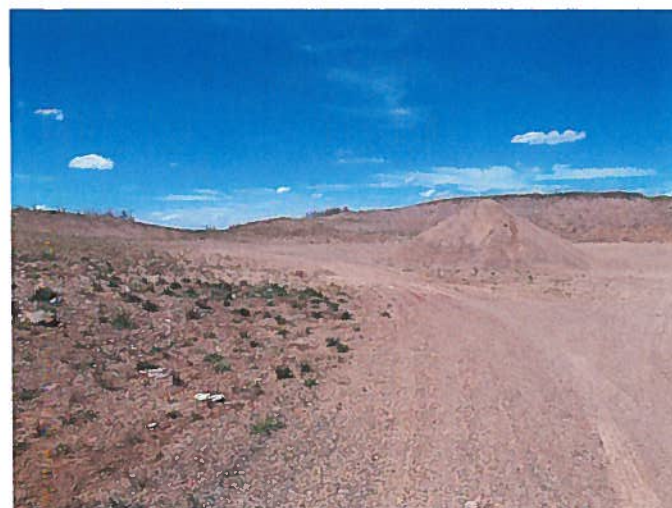
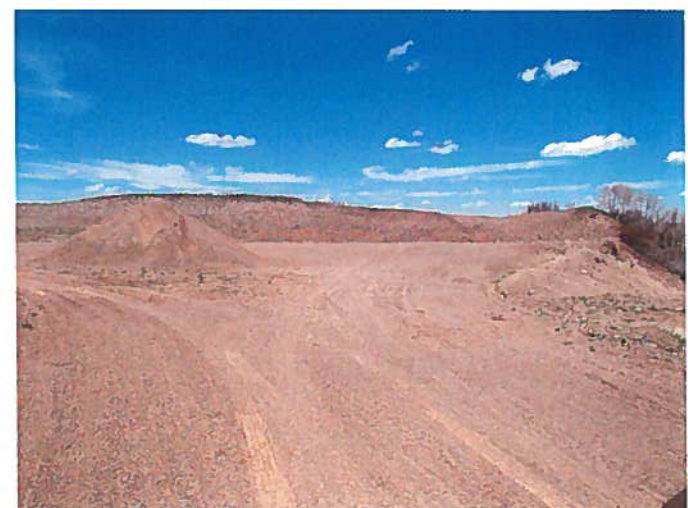
PHOTOGRAPHS

This inspection was conducted as part of the Division of Reclamation, Mining and Safety's (Division) normal monitoring program. A representative for the Operator was not present during this inspection. Photographs are included with this report in order to illustrate some of the conditions observed.

Conditions in the lower mine area appear similar to those observed during the Division's 2010 inspection. The fuel tanks were removed in November 2010. Topsoil is stockpiled around the north and east perimeter of this area.

The mined slopes in the upper mine area have been left at approximately 2H:1V in the north portion and 3H:1V on the west and south sides. Only one small stockpile of fine material was observed on the pit floor. Mining was not occurring during this inspection. There was no equipment located on site.
