COLORADO DIVISION OF RECLAMATION, MINING AND SAFETY
MINERALS PROGRAM INSPECTION REPORT
PHONE: (303) 866-3567

MINE NAME: Seven Mile Plaza	MINE/PROSPECTING ID#: M-1978-065	MINERAL: Sand and gravel	COUNTY: Rio Grande
INSPECTION TYPE: Monitoring	INSPECTOR(S): Bob Oswald	INSP. DATE: May 29, 2014	INSP. TIME: 16:00
OPERATOR: Rio Grande County	OPERATOR REPRESENTATIVE: None	TYPE OF OPERATION: 110c - Construction Limited Impact

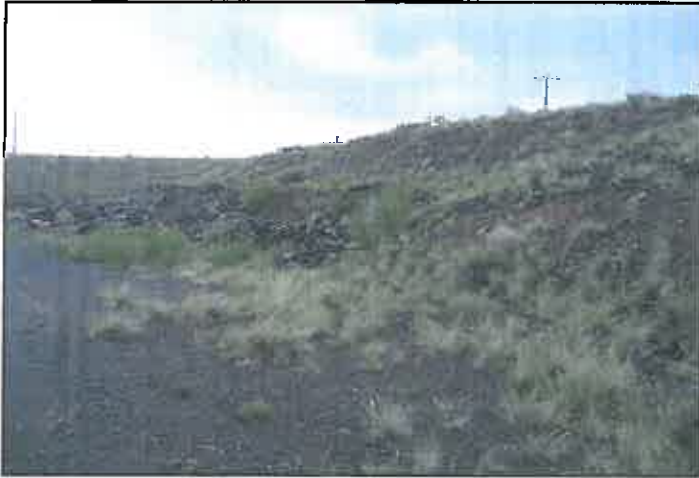
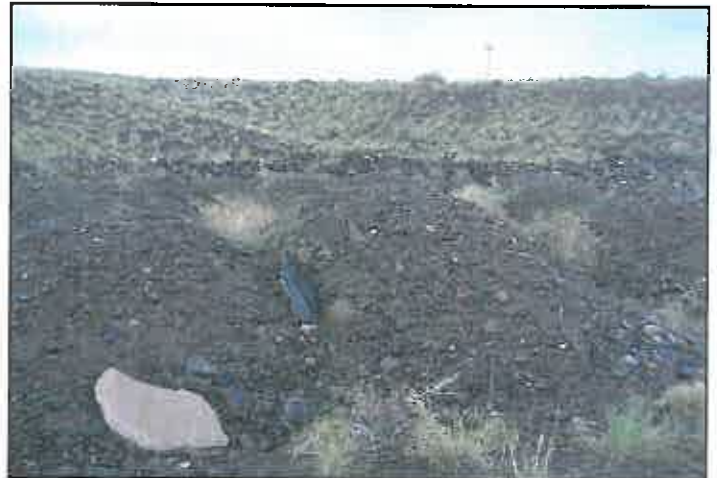
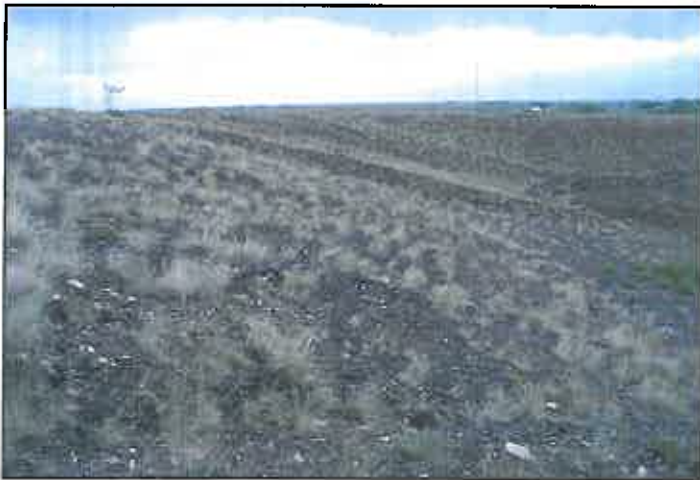
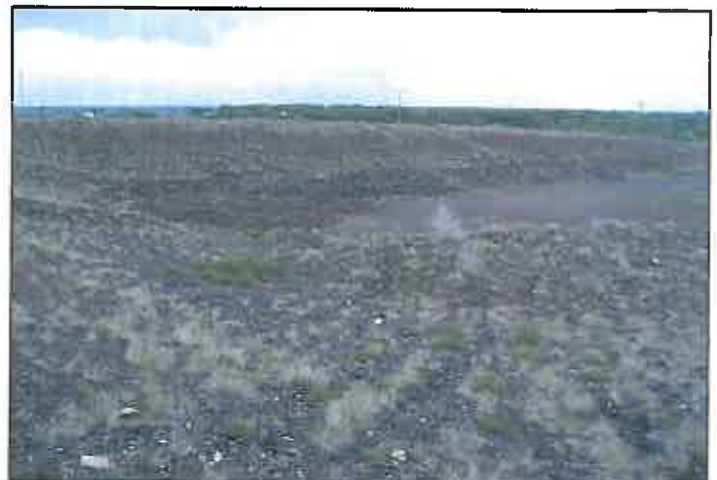
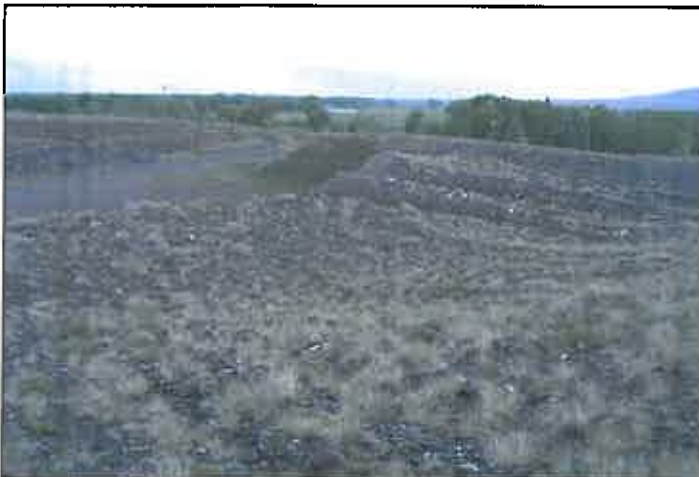
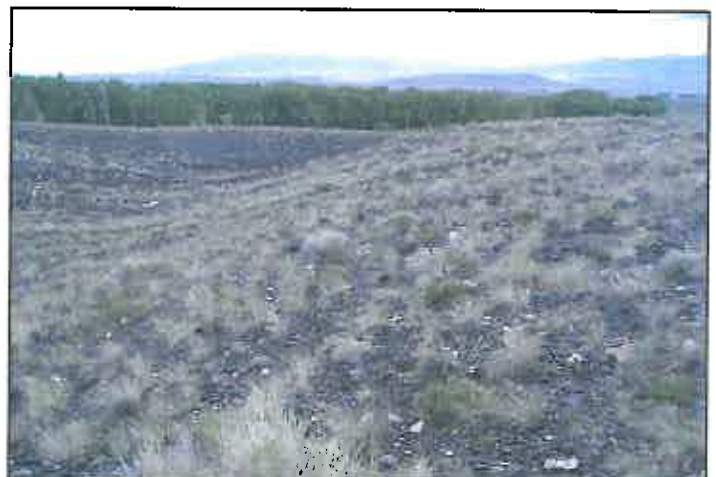
PHOTOGRAPHS

Inspection photographs appear on the following page.

The topsoil is very thin at this site, and the subsoil and aggregate are very cobbly with very little clay content. The east and north walls of the pit are graded to approximately 3:1, and though no topsoil has been replaced on them, they are becoming vegetated mainly with Indian ricegrass. There are some small narrowleaf cottonwoods growing in the pit, indicating subsurface moisture, but there is no evidence of seeps or ponding of water.

There are numerous truck-dumped piles of imported soil, which the operator has hauled here from county projects, for use in mixing with the processed aggregate to create a suitable road surfacing product. This type of activity can be approved for one-time importations by submitting a Notice to the Division which complies with Rule 3.1.5(9). Stockpiled imported material was observed and discussed during a past inspection, and becomes an issue if importation of offsite generated material occurs without it being included in the permit-approved activities in the mining plan.
