**COLORADO DIVISION OF RECLAMATION, MINING AND SAFETY**  
**MINERALS PROGRAM INSPECTION REPORT**  
**PHONE: (303) 866-3567**

<b>MINE NAME:</b> Sunday Mine	<b>MINE/PROSPECTING ID#:</b> M-1977-285	<b>MINERAL:</b> Uranium & vanadium	<b>COUNTY:</b> San Miguel
<b>INSPECTION TYPE:</b> Monitoring	<b>INSPECTOR(S):</b> Bob Oswald	<b>INSP. DATE:</b> July 16, 2014	<b>INSP. TIME:</b> 12:30
<b>OPERATOR:</b> Energy Fuels Resources (USA) Inc.	<b>OPERATOR REPRESENTATIVE:</b> David Turk	<b>TYPE OF OPERATION:</b> 112d-2 - Designated Mining Operation	
<b>REASON FOR INSPECTION:</b> Normal I&E Program	<b>BOND CALCULATION TYPE:</b> None	<b>BOND AMOUNT:</b> \$304,184.00	
<b>DATE OF COMPLAINT:</b> NA	<b>POST INSP. CONTACTS:</b> U.S. BLM	<b>JOINT INSP. AGENCY:</b> U.S. BLM	
<b>WEATHER:</b> Cloudy	<b>INSPECTOR'S SIGNATURE:</b> <i>Bob Oswald</i>	<b>SIGNATURE DATE:</b> August 5, 2014

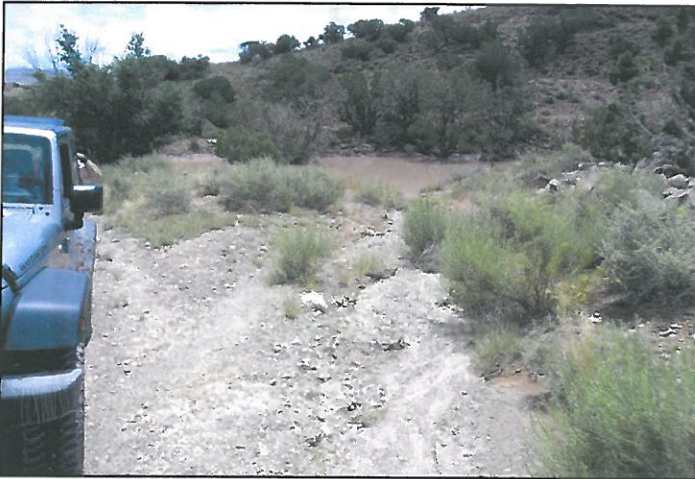
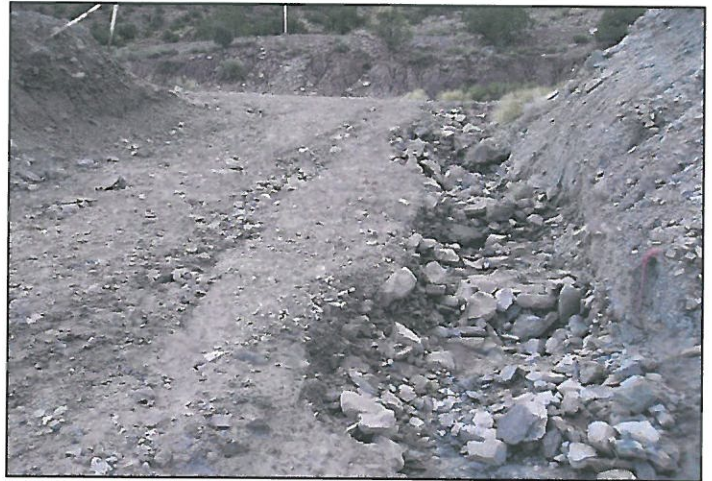
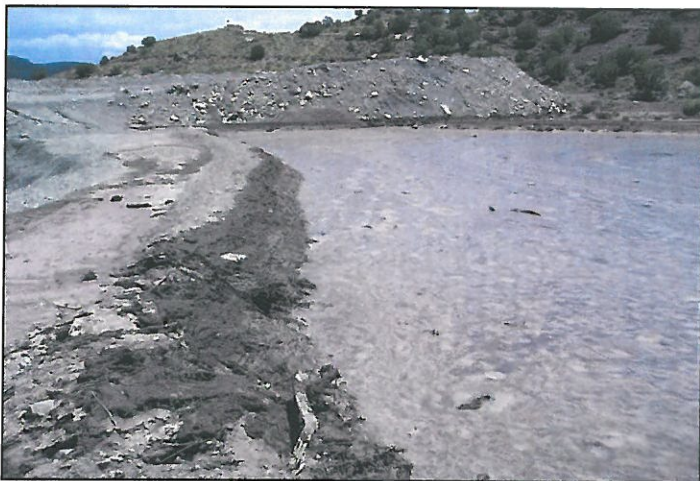
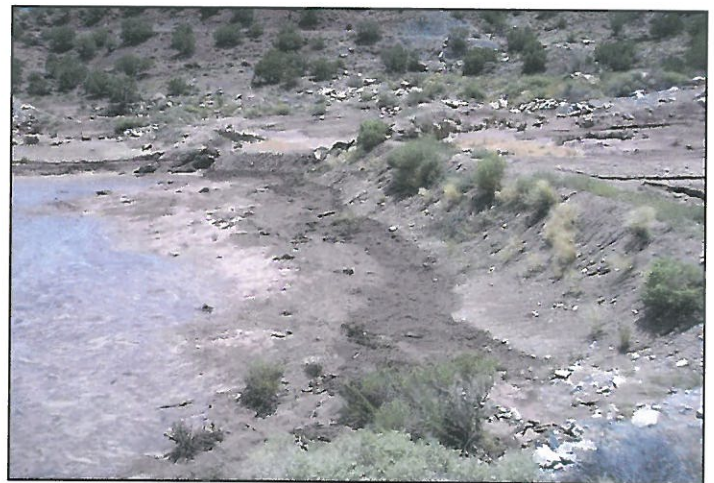
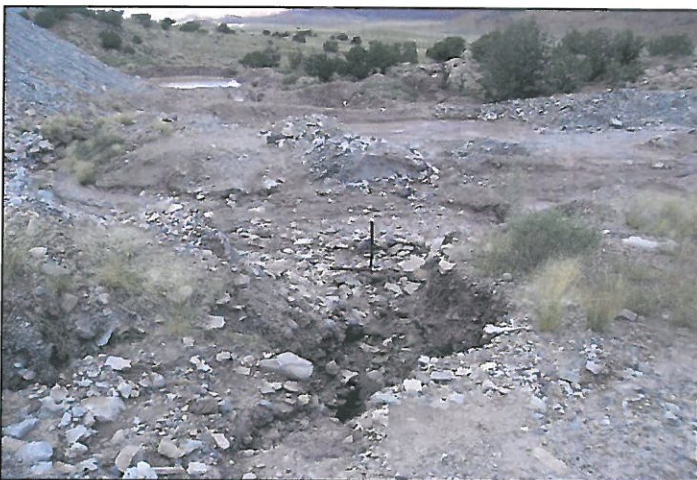
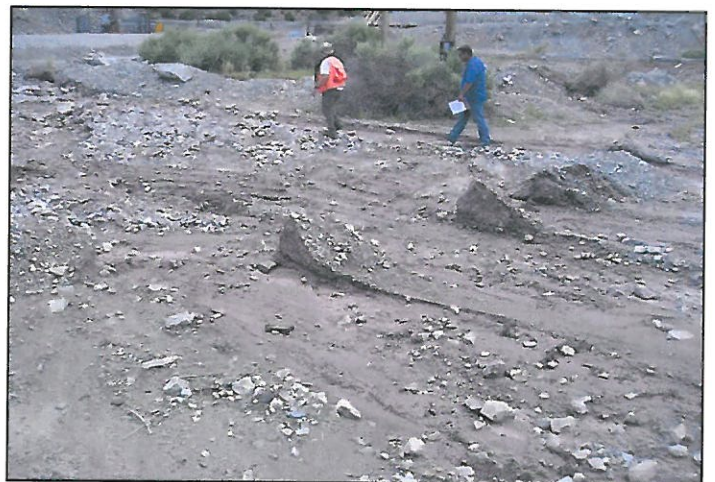
**PHOTOGRAPHS**

Photographs from the inspection are on the following page.

An intense precipitation event occurred the night before the inspection, which resulted in the partial or complete failure of nearly every stormwater control structure on the site. The structures were designed by the operator's engineers during the formulation of the Environmental Protection Plan (EPP) several years ago, to provide sufficient capacity for the design storm. They were installed and maintained regularly as required. However, the intensity and/or total amount of precipitation in this event was beyond the design capacity of most of the structures. Only a few of the structures were intact (and full) at the time of the inspection.

The range of stormwater controls observed during this inspection includes upland diversion ditches, safety berms along the crests of the waste rock dumps, catchments at the upper edges of the dumps, cells and control dikes on the pad surfaces, sediment ponds below the toe of the dumps, culverts, waterbars and ditches along the roads. This report will not list all of the individual items observed, because they were so numerous and similarly affected. What was apparent about the damage was that all the structures appeared to have functioned properly up to a point of maximum capacity and strength, evident by a visible high-water mark of organic debris (indicating impoundment) and one or several locations of vertical down-cutting through each impoundment. In some cases, failure of one impoundment caused a slug of water and sediment to overwhelm one or more lower structures, resulting in a series of breaches.
