**COLORADO DIVISION OF RECLAMATION, MINING AND SAFETY**  
**MINERALS PROGRAM INSPECTION REPORT**  
**PHONE: (303) 866-3567**

<b>MINE NAME:</b> Nahcolite Project	<b>MINE/PROSPECTING ID#:</b> M-1983-194	<b>MINERAL:</b> Carbonates	<b>COUNTY:</b> Rio Blanco
<b>INSPECTION TYPE:</b> Monitoring	<b>INSPECTOR(S):</b> Travis H. Marshall	<b>INSP. DATE:</b> May 21, 2015	<b>INSP. TIME:</b> 10:30
<b>OPERATOR:</b> Natural Soda, Inc.	<b>OPERATOR REPRESENTATIVE:</b> Kirk Daehling and Jerry Daub	<b>TYPE OF OPERATION:</b> 112d-3 - Designated Mining Operation	
<b>REASON FOR INSPECTION:</b> Normal I&E Program	<b>BOND CALCULATION TYPE:</b> Complete Bond	<b>BOND AMOUNT:</b> \$3,067,525.80	
<b>DATE OF COMPLAINT:</b> NA	<b>POST INSP. CONTACTS:</b> None	<b>JOINT INSP. AGENCY:</b> None	
<b>WEATHER:</b> Clear	<b>INSPECTOR'S SIGNATURE:</b>

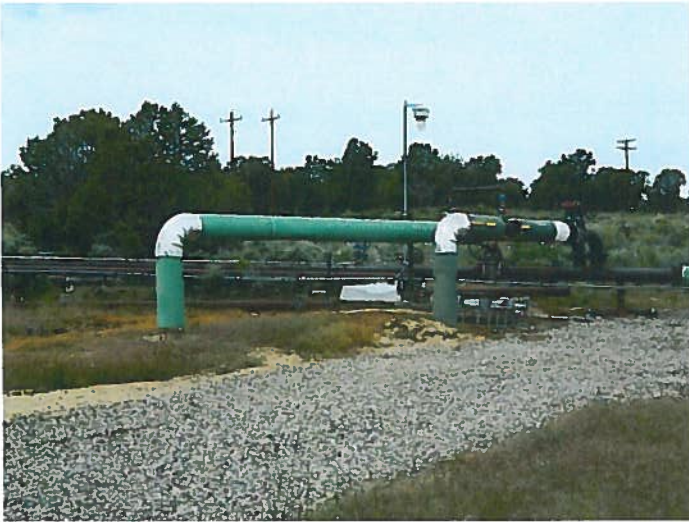
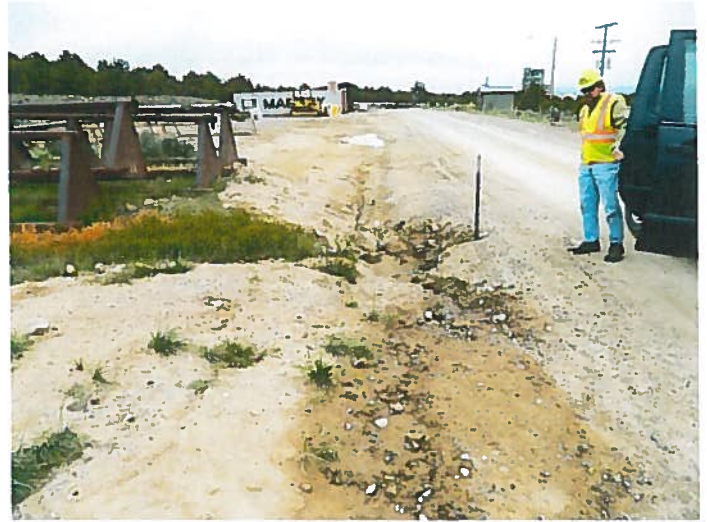
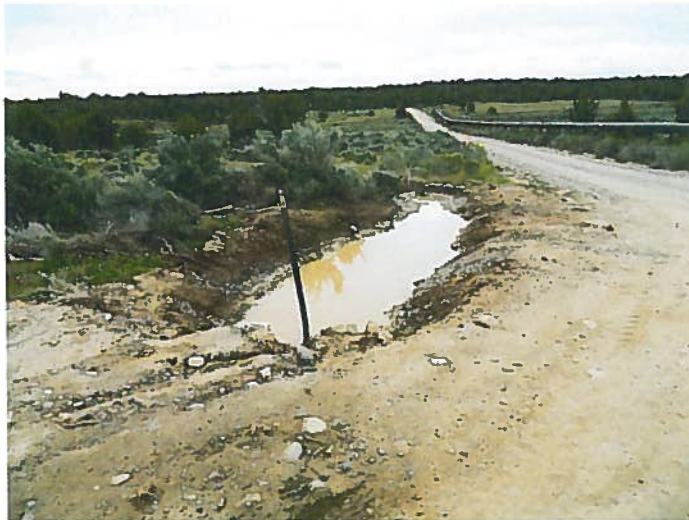
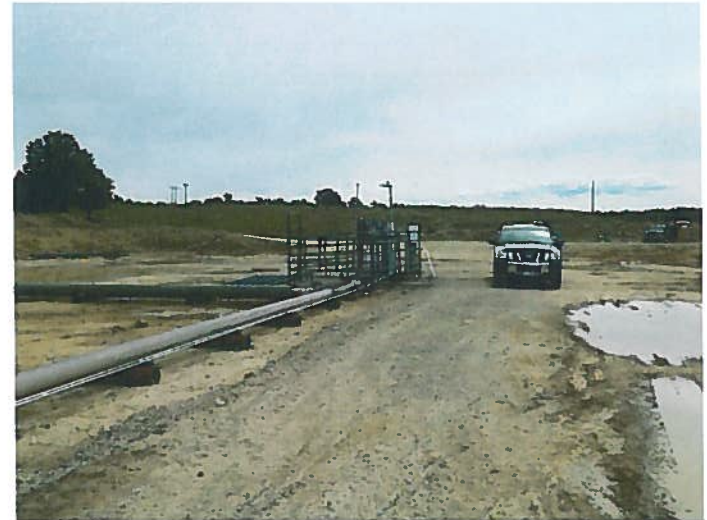
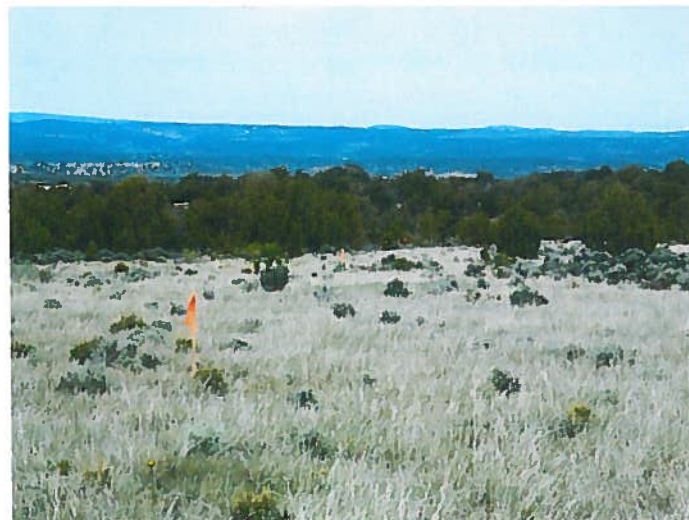
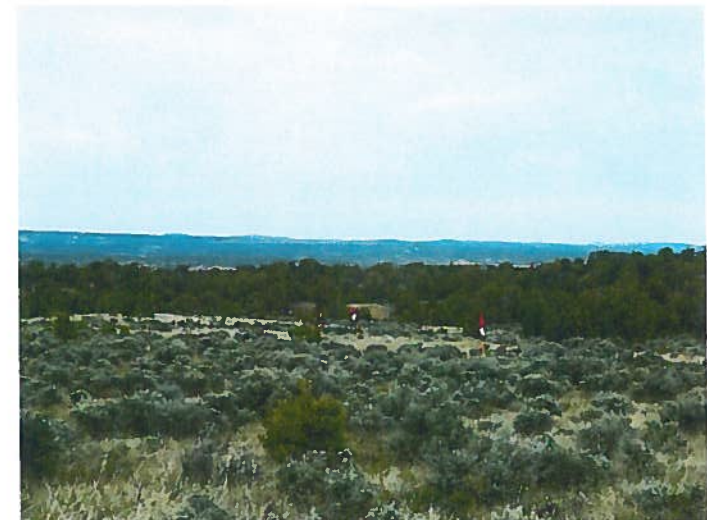
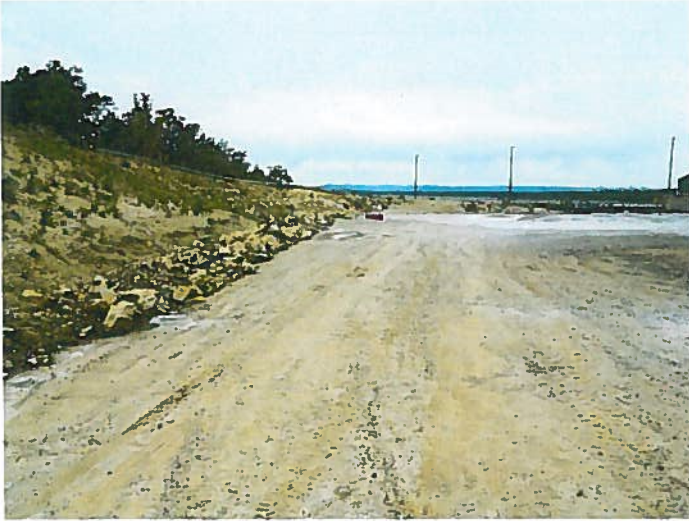
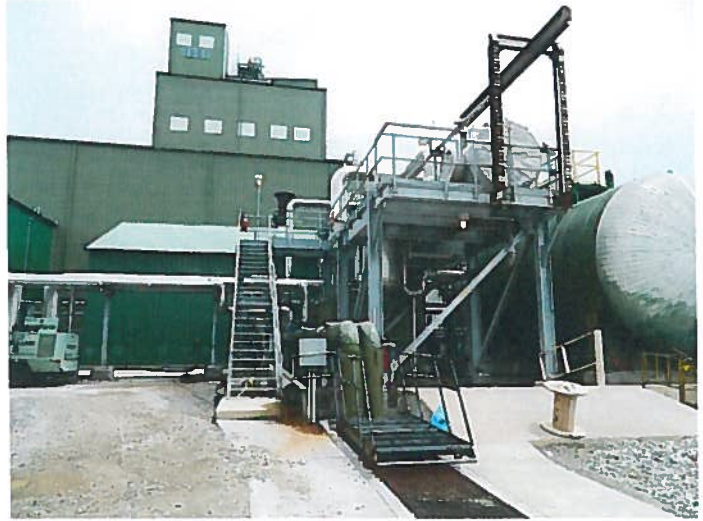
**PHOTOGRAPHS**

Photos of the conditions observed during the inspection are located at the end of this inspection report.

The spill occurred when a flange on a process water pipeline was loosened at a gate valve in order to clean out a pipeline restriction. Approximately 600 gallons of process brine was released during the event. The Operator stated that 500 gallons of the estimated 600 gallons spilled was recovered. The location of the spill was clean and free of any evidence that a spill occurred during the inspection.

The pad location for well pairs 15H, 16H and 17H was observed during the inspection. The survey markers for the well head locations were observed. The Operator stated that they are discussing different access routes with the BLM. According to the Operator the BLM prefers that Natural Soda accesses the pad from an existing road located to the southwest of the pad. The Operator stated that they would prefer to access the pad from the north/northeast. The Operator's preferred access point significantly reduces travel time to access the pad and would also restrict potential public trespass due to a greater ability to control access. The Division believes that a reduced travel time to access the pad in the event of a spill would greatly increase protection of adjacent non-disturbed land due to a faster response time.

The proposed plant expansion was observed and no issues associated with the expansion were noted during the inspection.
