Greg Lewicki and Associates, PLLC

✓ **RE: Revenue Mine, Permit M-2012-032, Amendment AM-1
Adequacy Review #1 Response**

Exhibit C — Mine Plan Maps

Maps C-11, C-12, and C-13 have been added to this exhibit. Maps C-7 through C-10 have been removed, and are not part of the EPA Action Order. To avoid confusion, the numbering for these maps has been maintained.

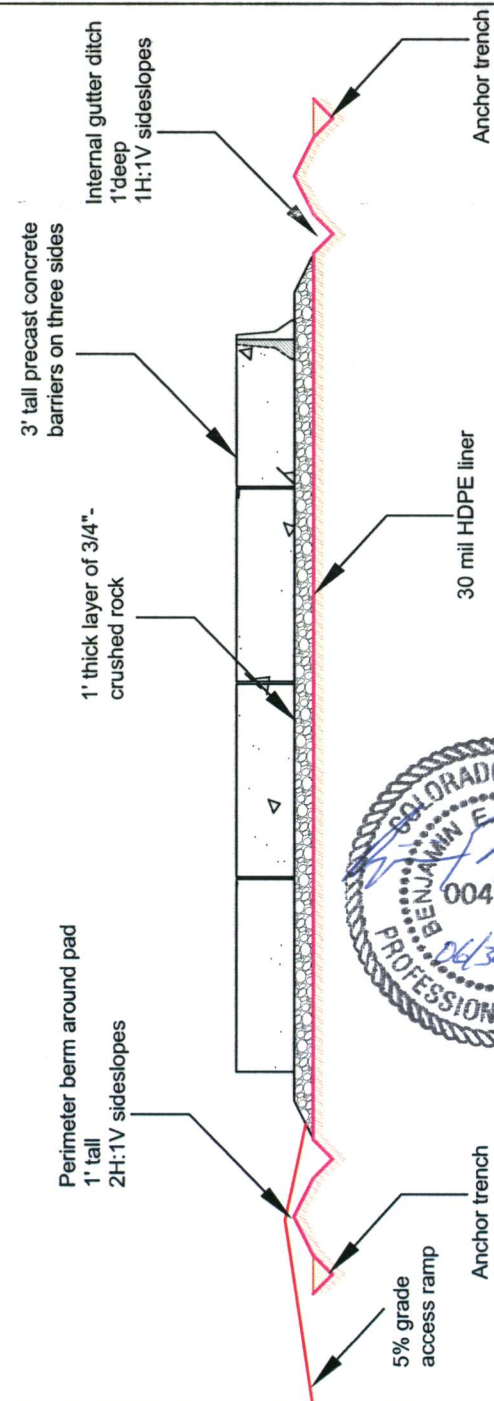
Map C-12: Tailings Transfer Pad
Revenue Mine
Fortune Revenue Silver Mines, Inc.

-   Berm top
-   Gutter bottom
-   Crushed rock pad
-   HDPE Liner
-   Existing ground
-   Precast Concrete Barriers

Plan View

Notes: See Map C-4 for the Tailings Transfer Pad location.

Longitudinal View

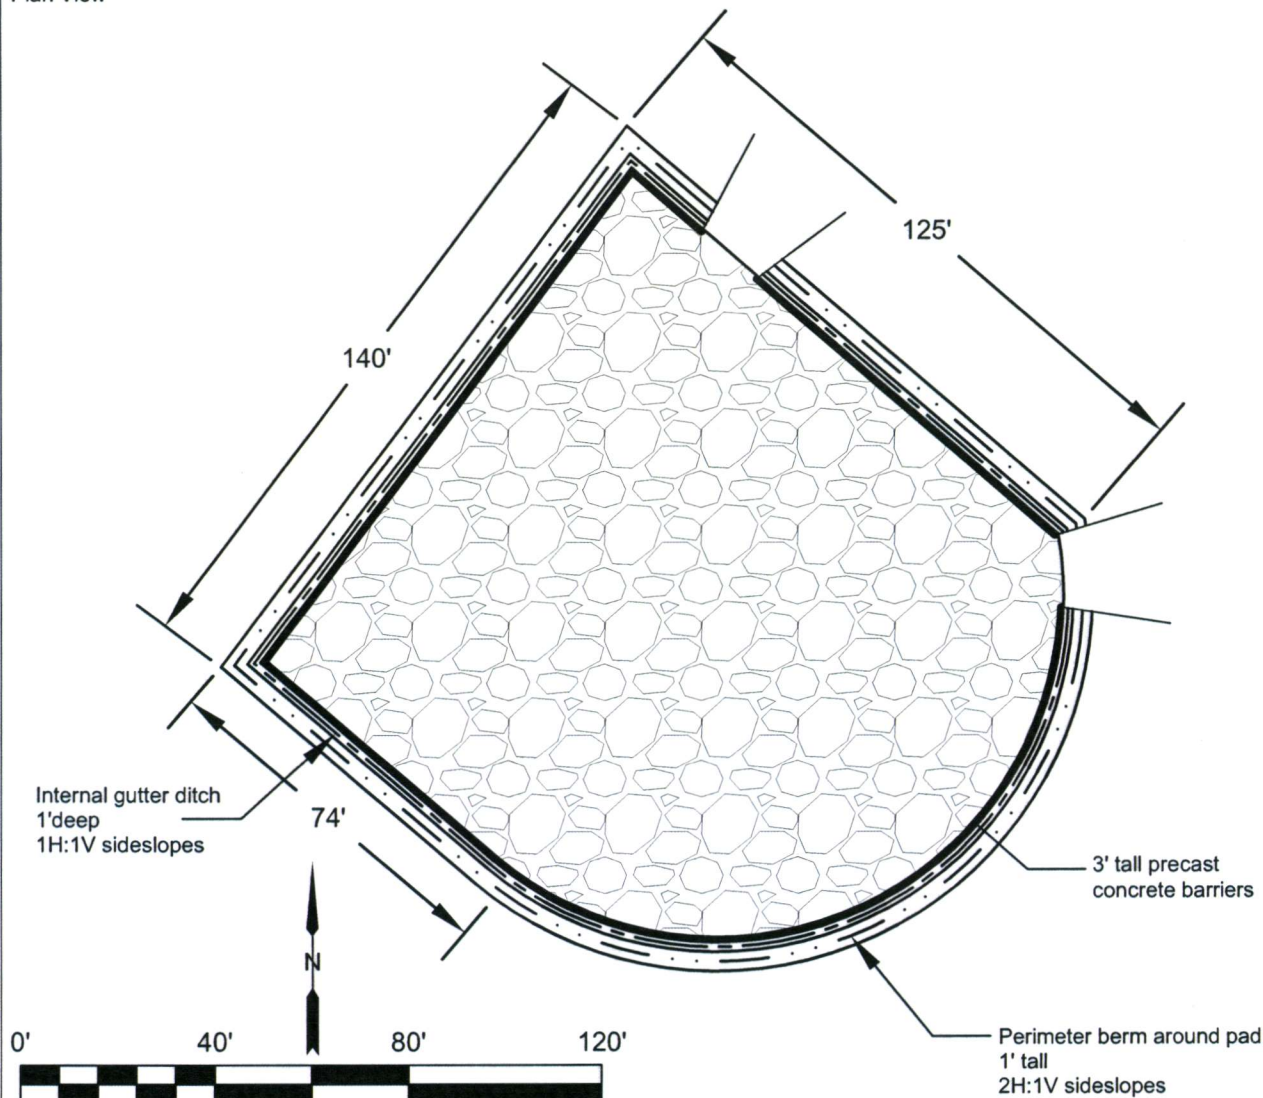
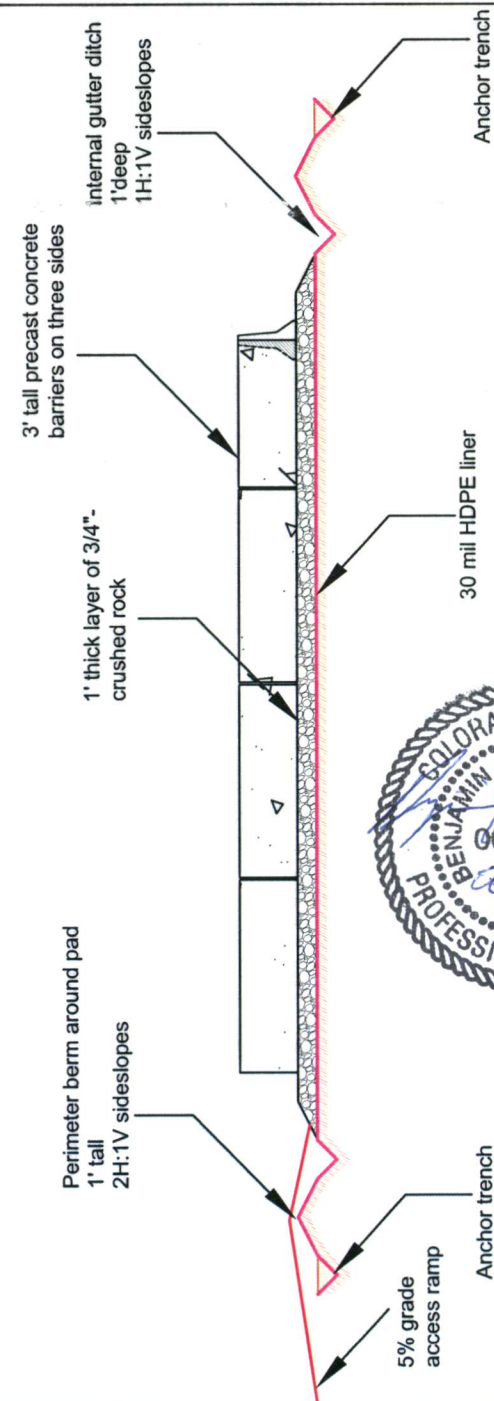
Map C-13: Ore Pad
Revenue Mine
Fortune Revenue Silver Mines, Inc.

-   Berm top
-   Gutter bottom
-   Crushed rock pad
-   HDPE Liner
-   Existing ground
-   Precast Concrete Barriers

Plan View

Notes: See Map C-4 for the Tailings Transfer Pad location.

Longitudinal View

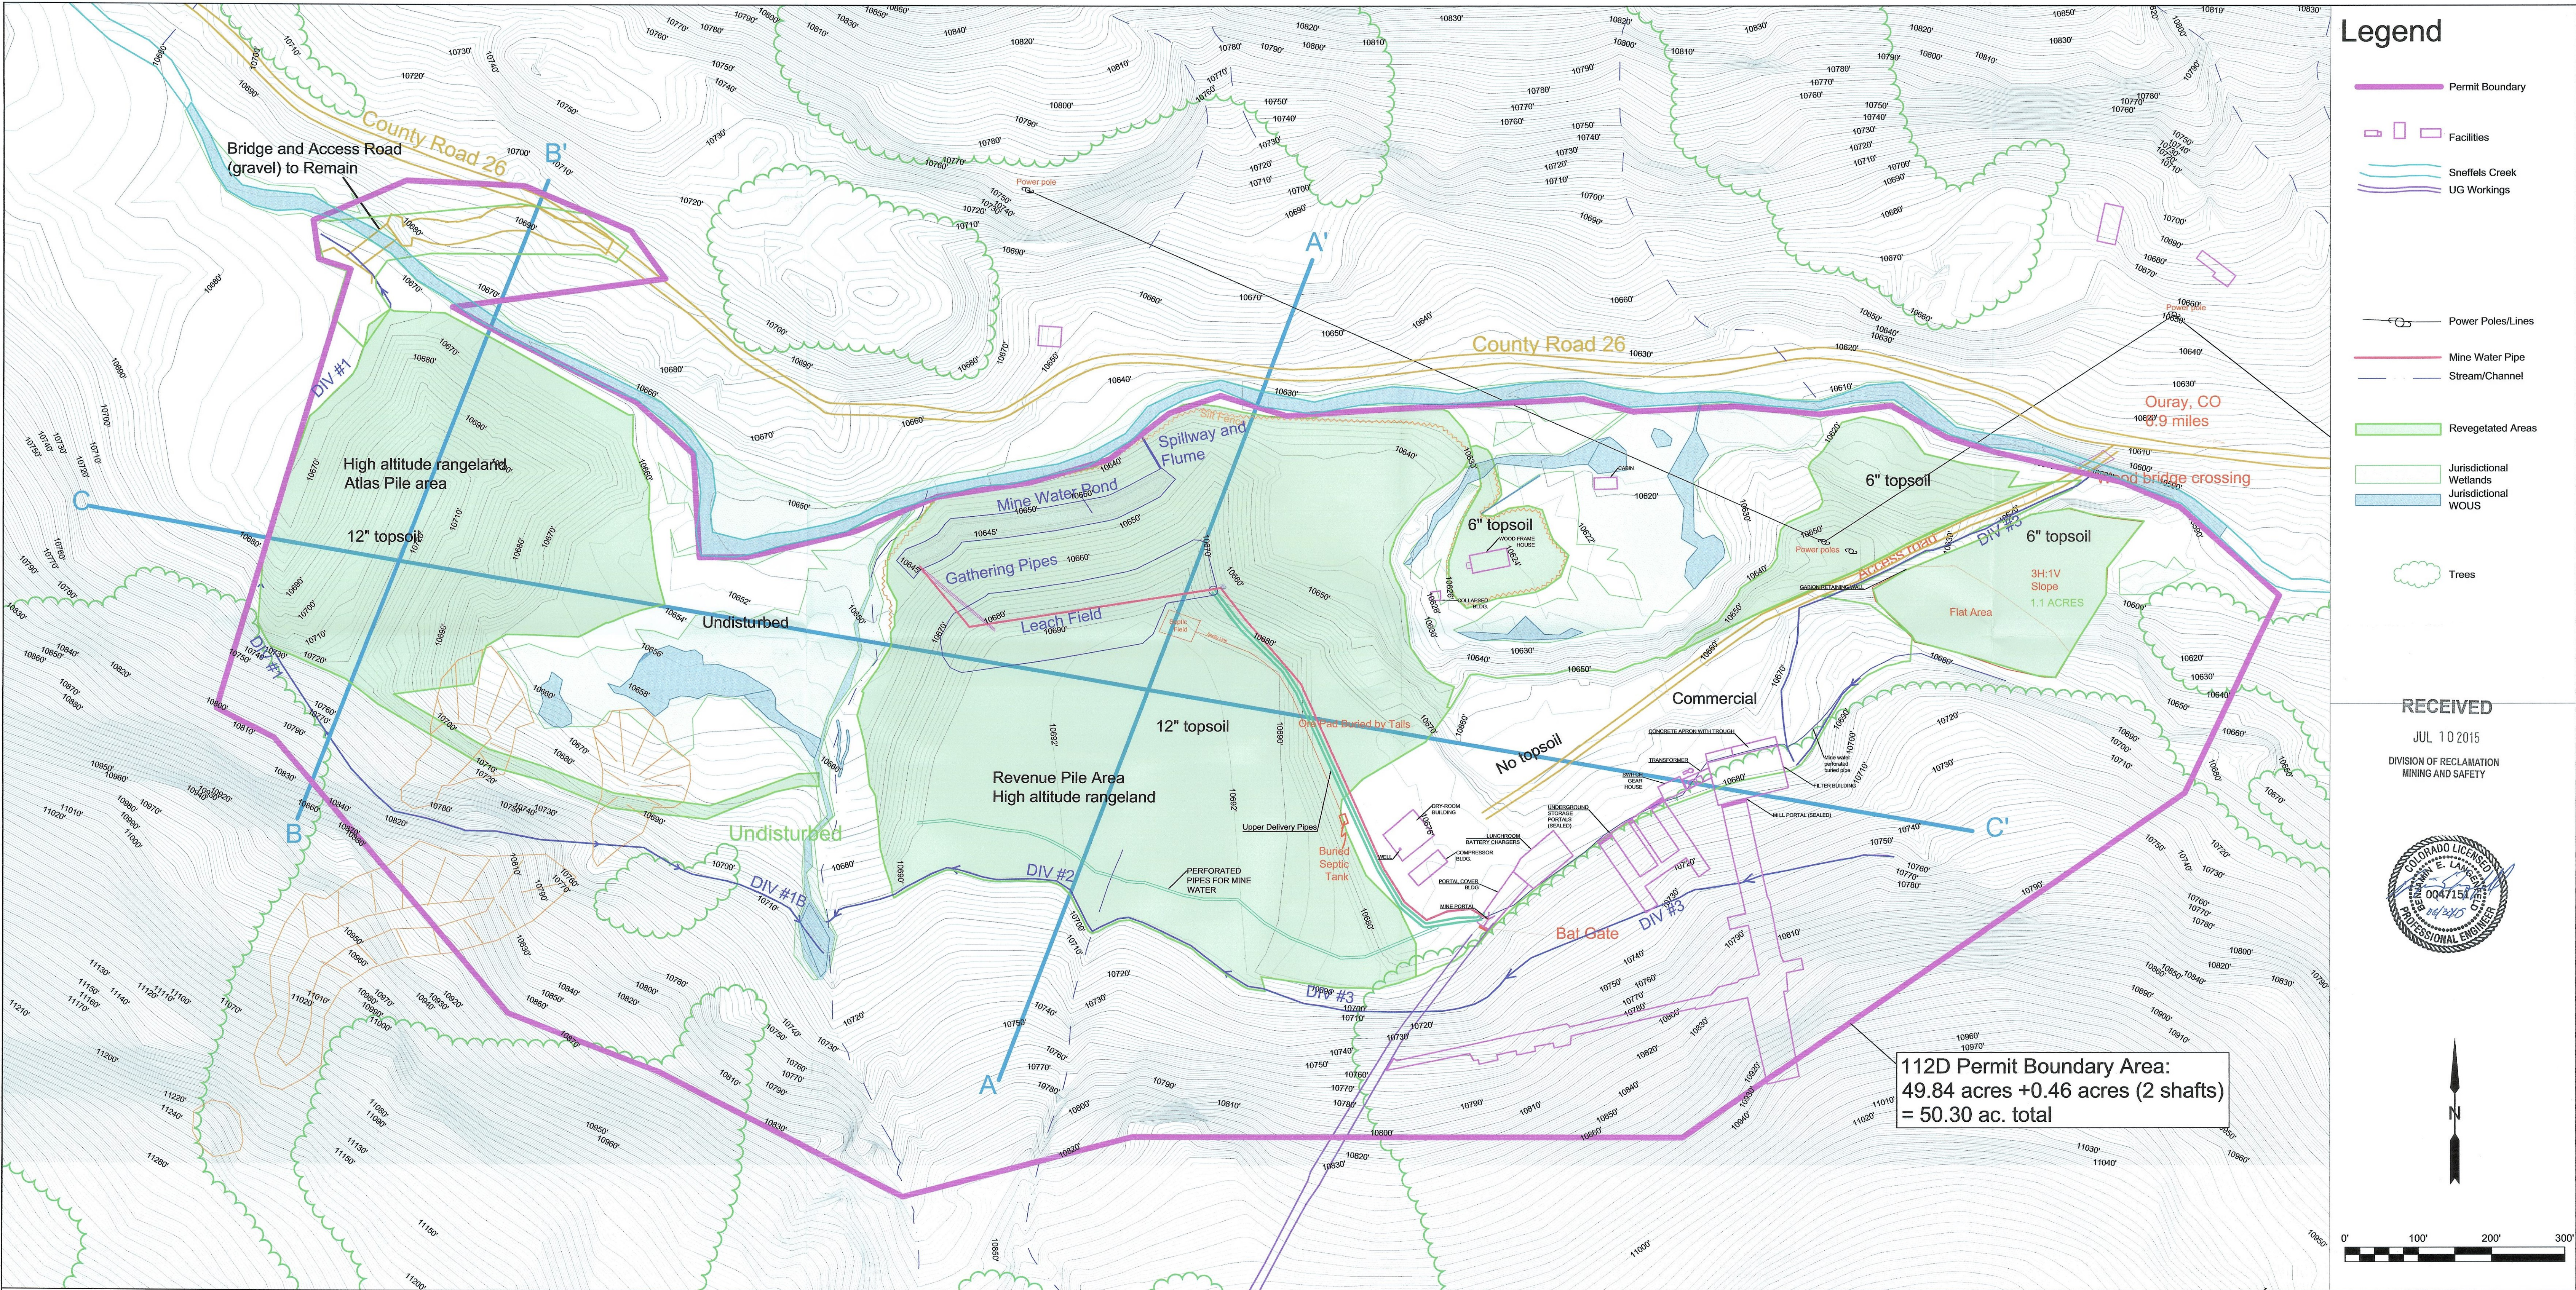
Map F-1: Reclamation Plan
Revenue Mine
Fortune Revenue Silver Mines, Inc.
M-2012-032 AM01
Adequacy Review #1 Response

NOTES:
AFTER SUCCESSFUL RECLAMATION, COLLECTION DITCHES ARE REMOVED.

Most of the disturbed areas will be reclaimed to a post-mine land use of high altitude rangeland. The Operations Area and the Atlas Access Road will be left for use by the landowner. Map F-1 shows the final reclamation topography and conditions of the site. Map C-6 shows cross sections for the site.

All of the facilities have a 12 inch concrete foundation. As shown on Map F-1, various structures will remain as part of the post-mine land use.

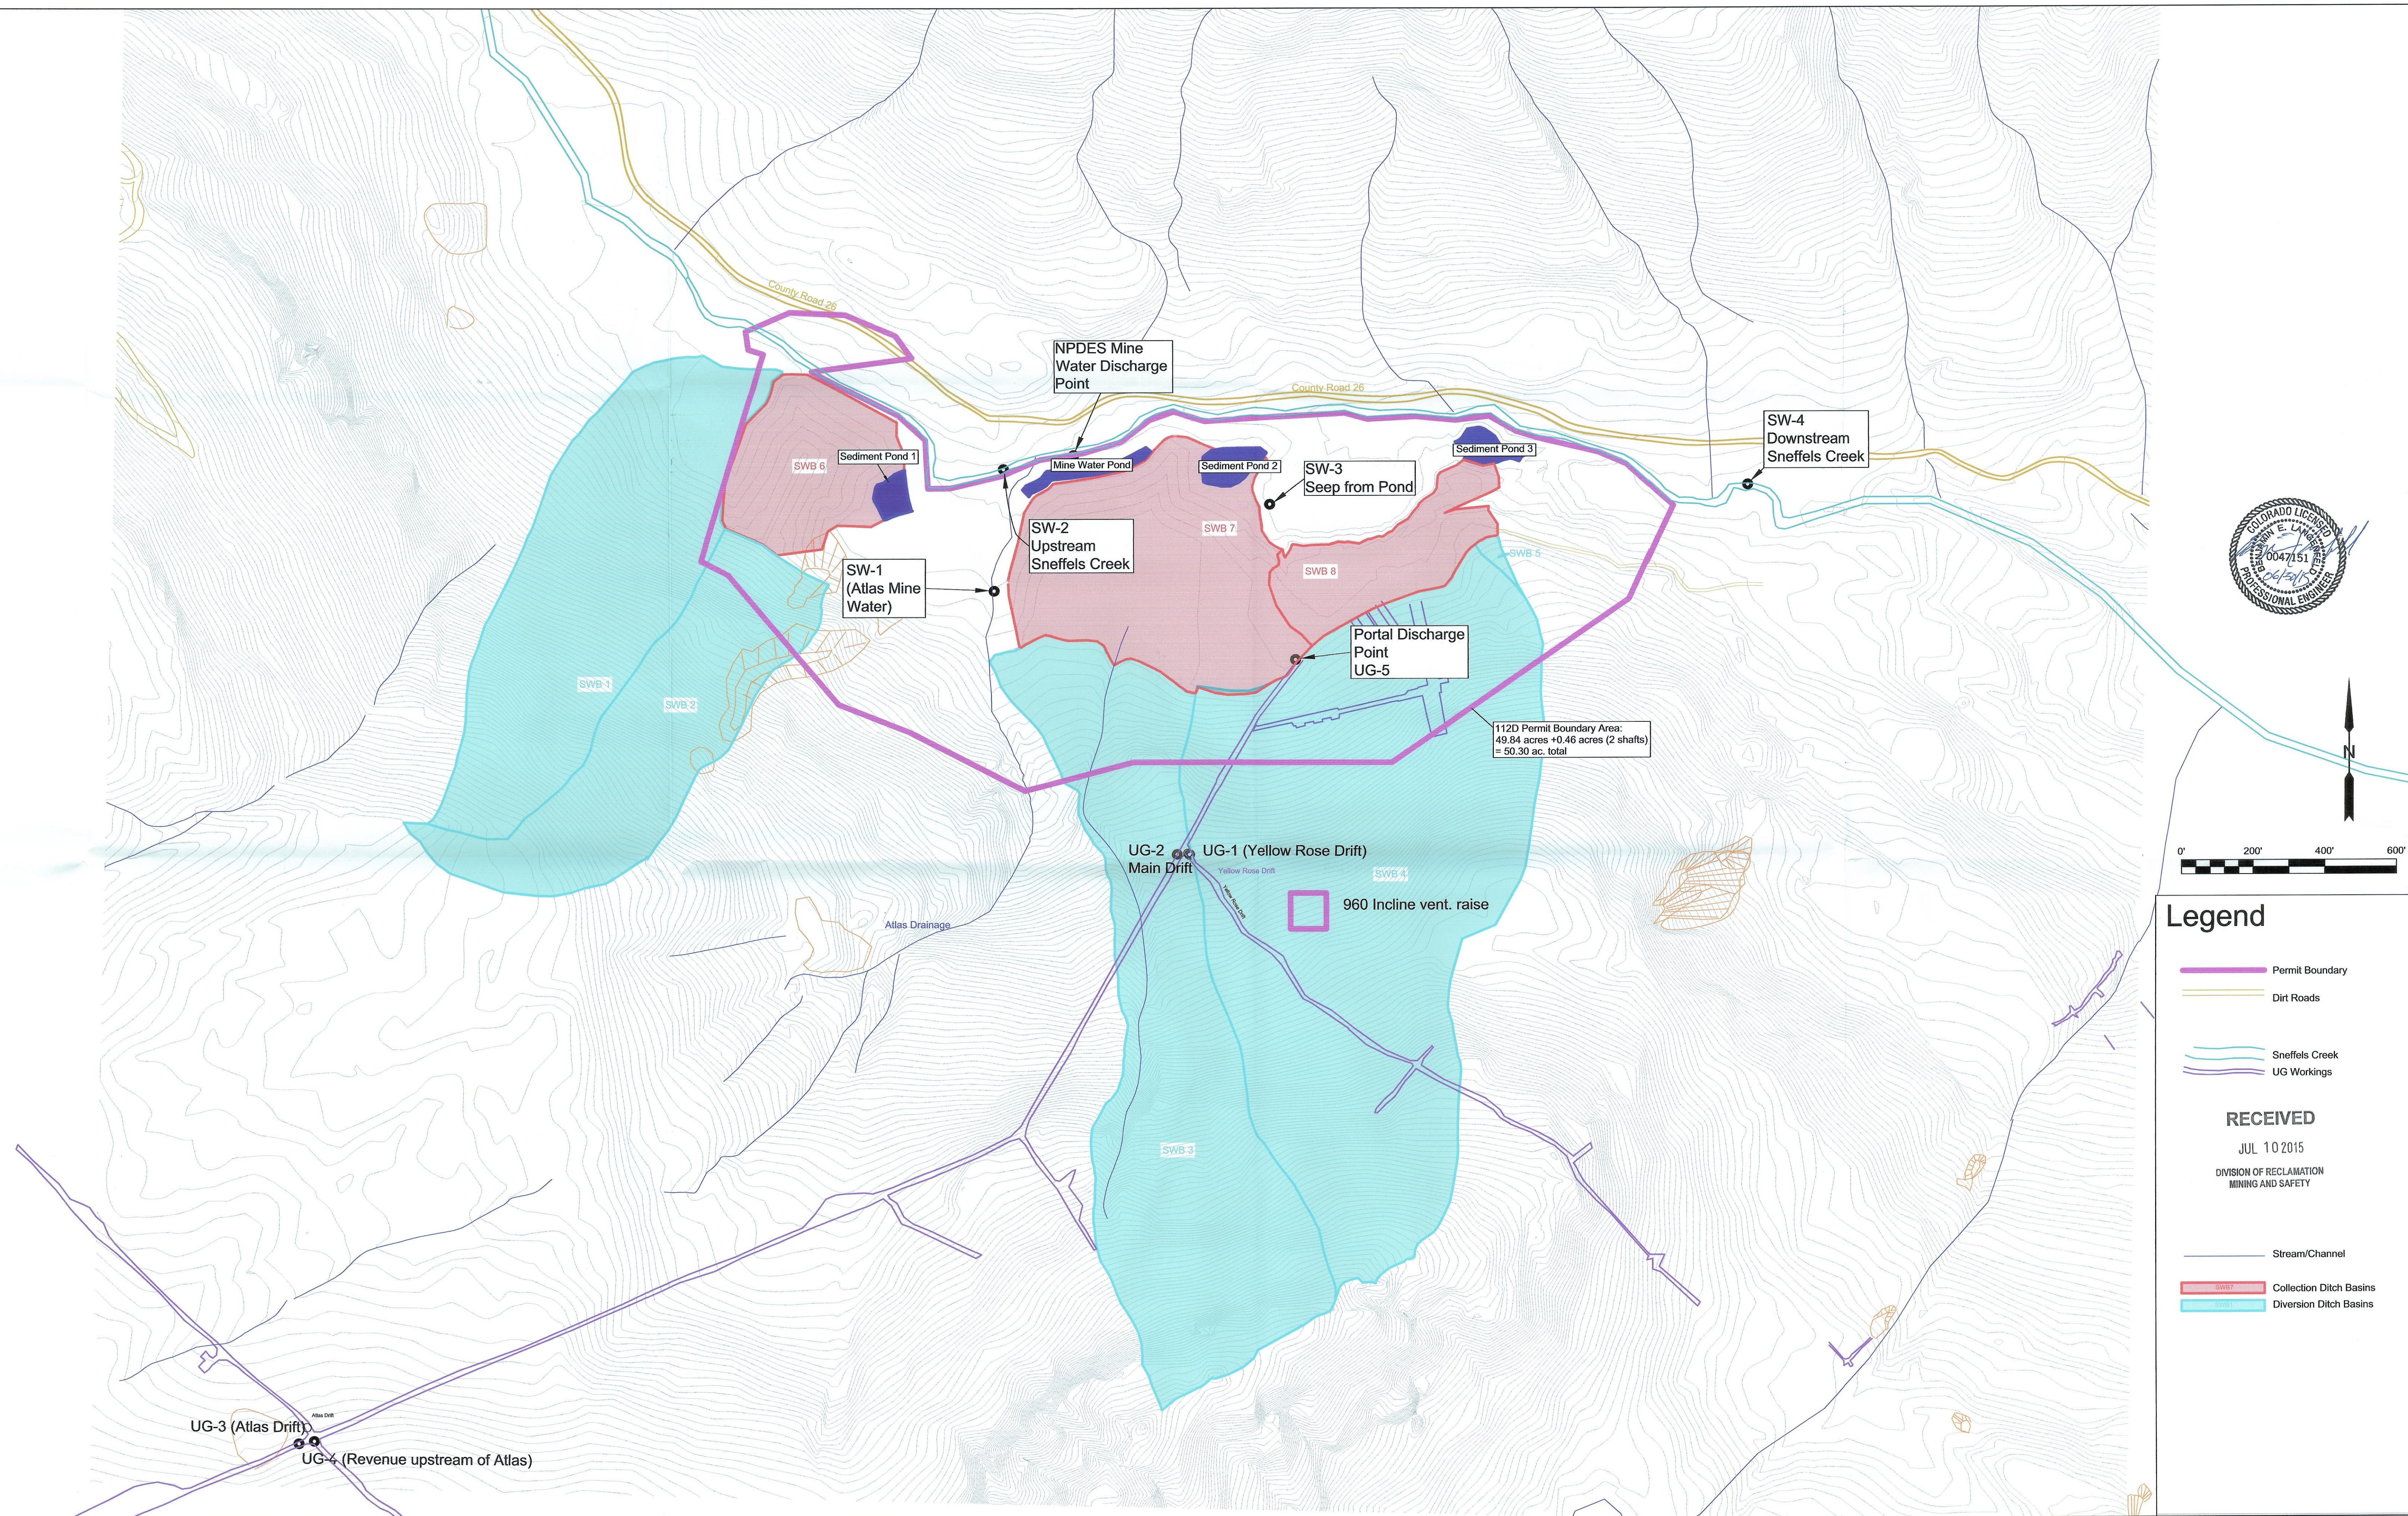
**Map G-1B: Mine Area
Surface Hydrology
Revenue Mine
Fortune Revenue Silver Mines, Inc.**
M-2012-032 AM01
Adequacy Review #1 Response

- Permit Boundary
- Dirt Roads
- Sneffels Creek
- UG Workings
- Diversion Ditch
- Collection Ditch
- Existing Tailings Piles
- Power Poles/Lines
- CN Areas
- Mine Water Pipe
- Stream/Channel
- Water
- Collection Ditch Basins
- Diversion Ditch Segments
- Collection Ditch Segments
- Trees

Surface drainage will be controlled by a system of collection and diversion ditches as well as sediment ponds. The detail designs for all of these structures, as well as the surface water data used to design them can be found in Exhibit G.

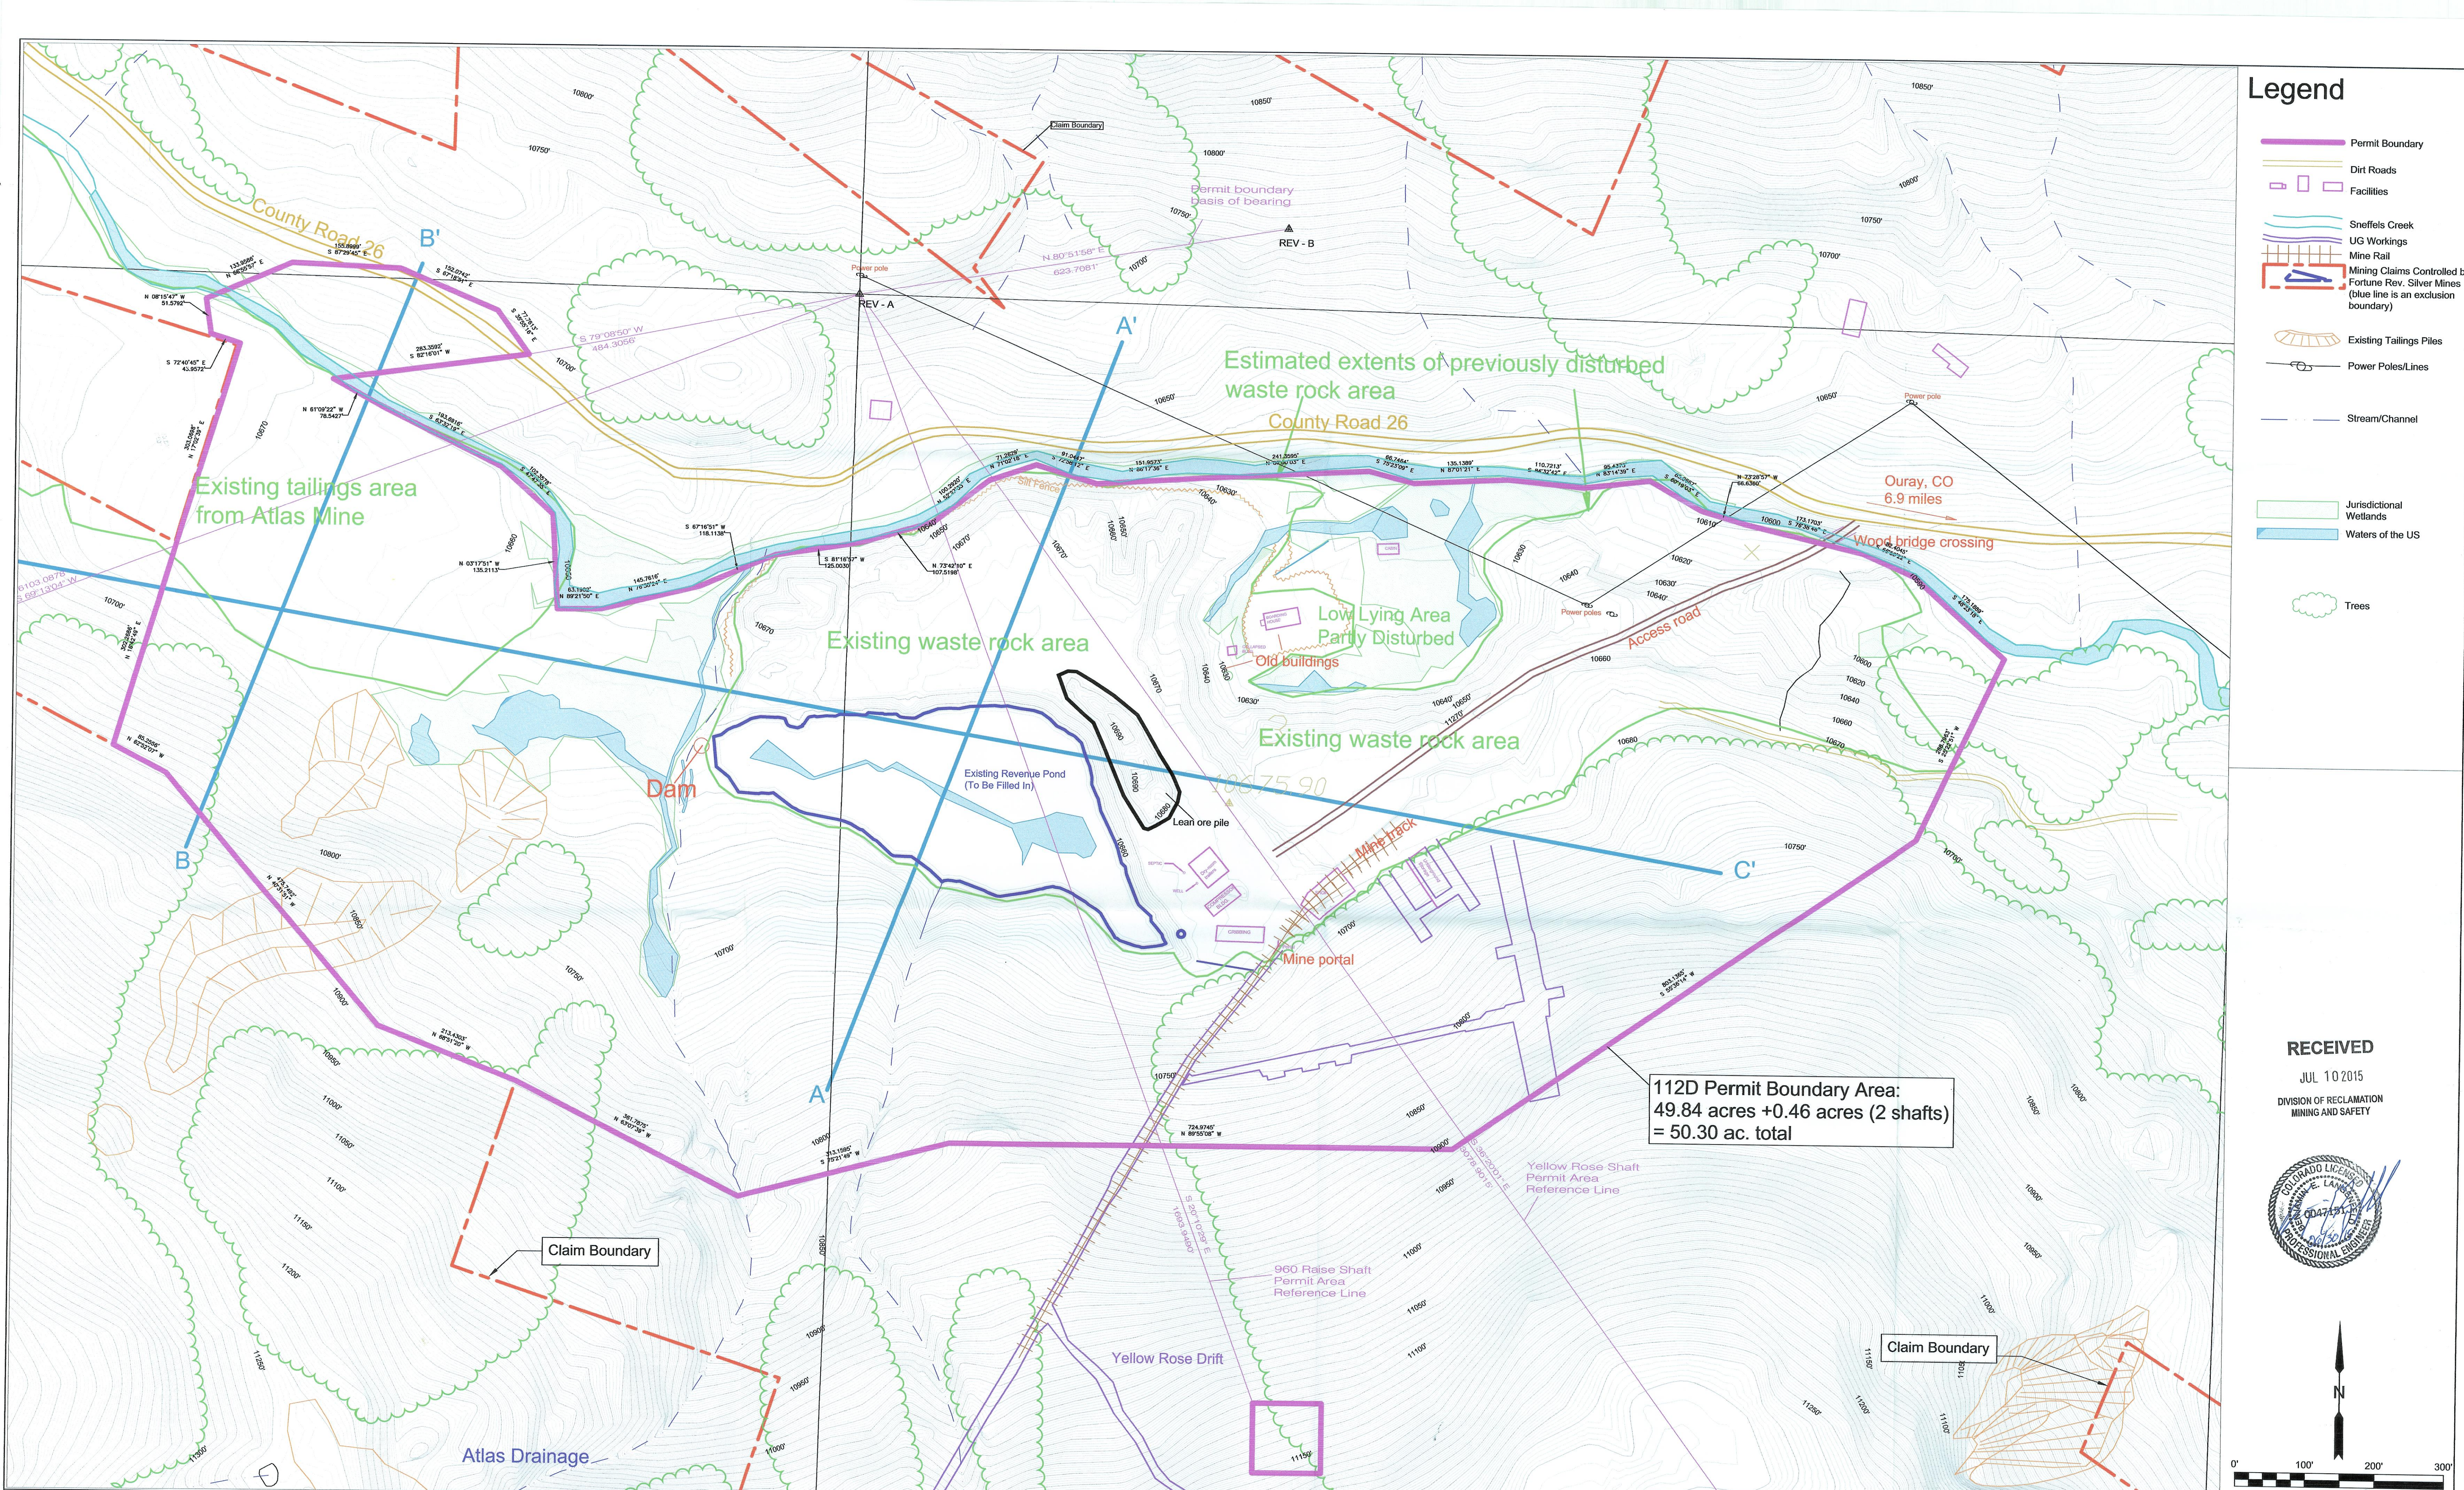
Map C-1: Baseline Conditions
Revenue Mine
Fortune Revenue Silver Mines, Inc.
M-2012-032 AM01
Adequacy Review #1 Response

NOTES:
1. TOPOGRAPHY FROM SITE SPECIFIC SURVEY IN NOVEMBER 2011.
