**Reclamation Plan Technical Revision No. 6**  
**(Clarification and Response to Comments)**

**Front Range Aggregates Parkdale Quarry**  
**Freemont County, Colorado**

**Colorado Division of Reclamation, Mining, and Safety Permit #M-1997-054**

### **Reclamation Slope Design Schematic and Groundwater Drain Schematic Design Detail**

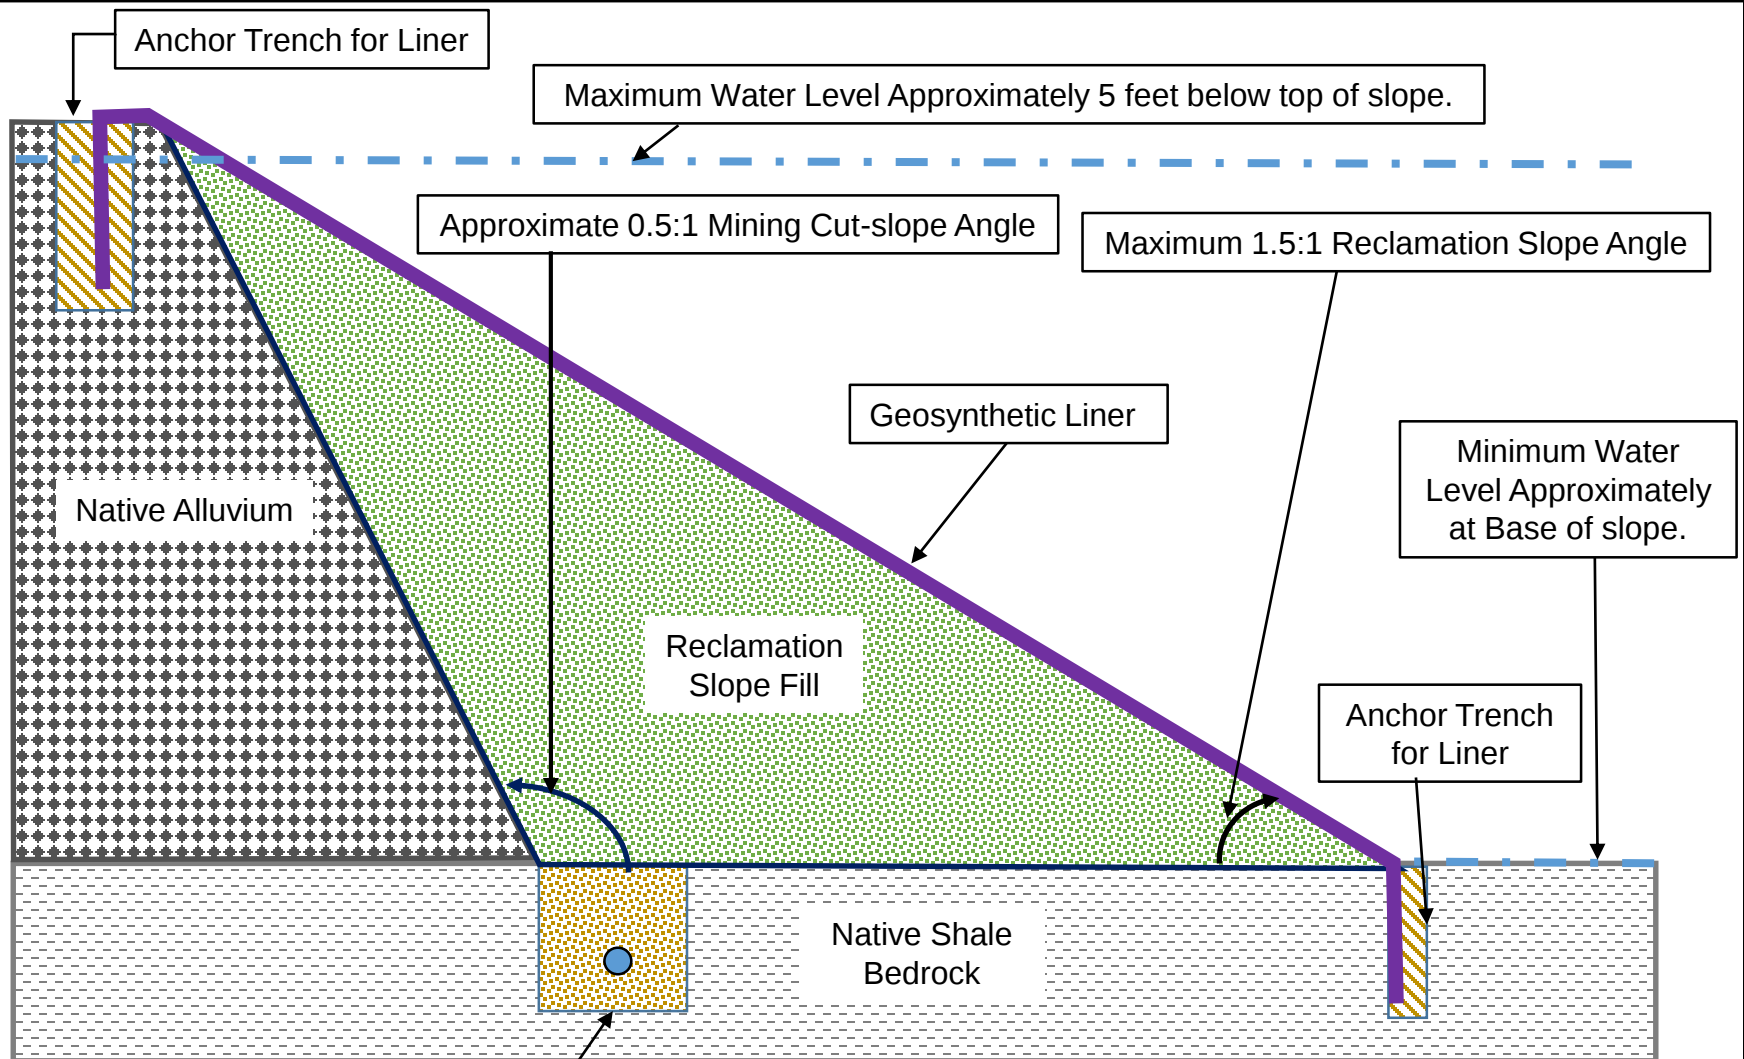
Groundwater Drain – 4' x 4' Trench lined with filter fabric, filled with ¾ x 2-inch drain rock, and with 10-inch slotted drain pipe.

**NOT TO SCALE**

The design capacity of the drain system assumes 95,000 square feet of wall below the maximum observed high ground water (9,500 linear feet of wall with average water depth of 10 feet), and an average hydraulic conductivity of 1.0 foot per day, which yields 2.18 acre-feet of water per day.

Drainage pipe is 10-inch diameter, schedule 40 polyvinyl chloride with 0.10 slots on an approximate slot spacing of 0.50 inches, and with a total length of approximately 9,500 feet, draining to a central sump on the southeast edge of the mined area. The total passive flow capacity of the drainage pipe = approximately 2.5 acre-feet per day (580 gallons per minute, or 1.29 cubic feet per second).

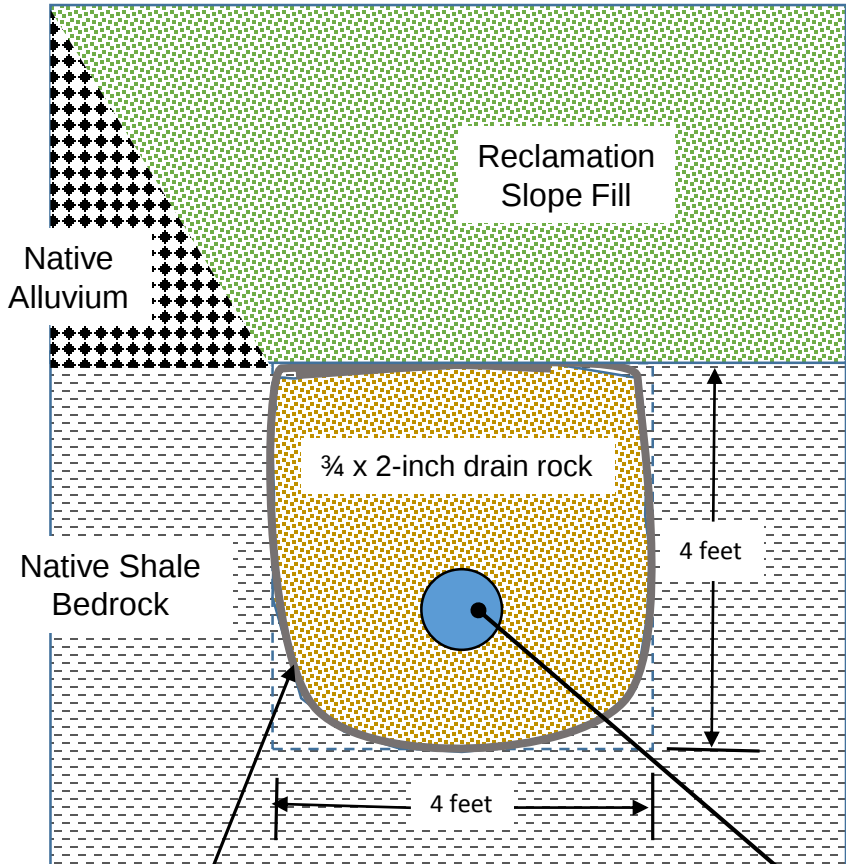
The 4-foot by 4-foot, gravel filled groundwater drain system with 10-inch drain pipe, filter fabric wrapping, draining by gravity to a central sump at the east end of the pit.

Mirafi 140N Filter Fabric, or equal.

10-inch Schedule 40 PVC Drain Pipe

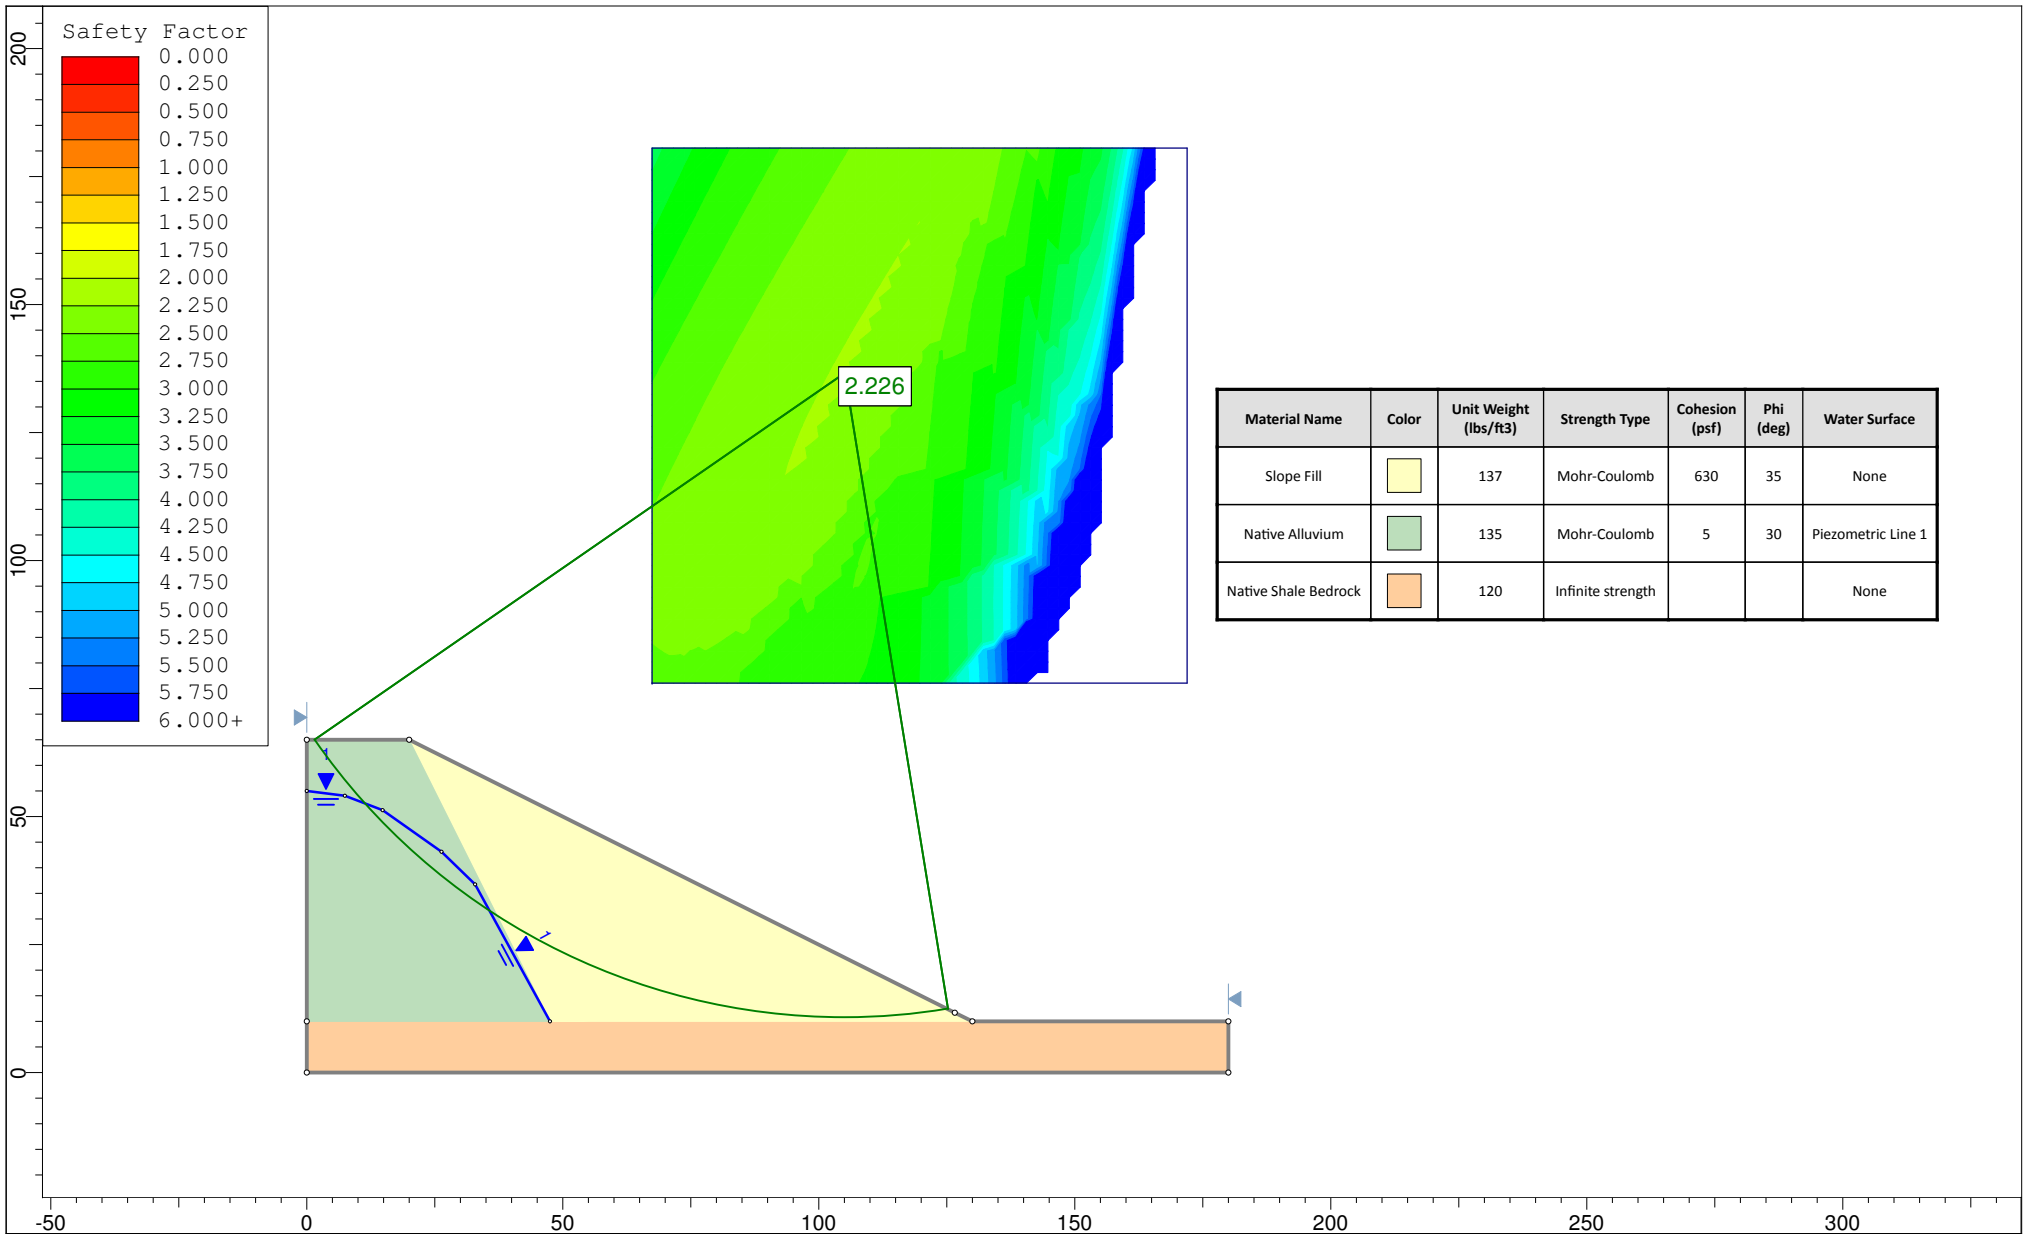
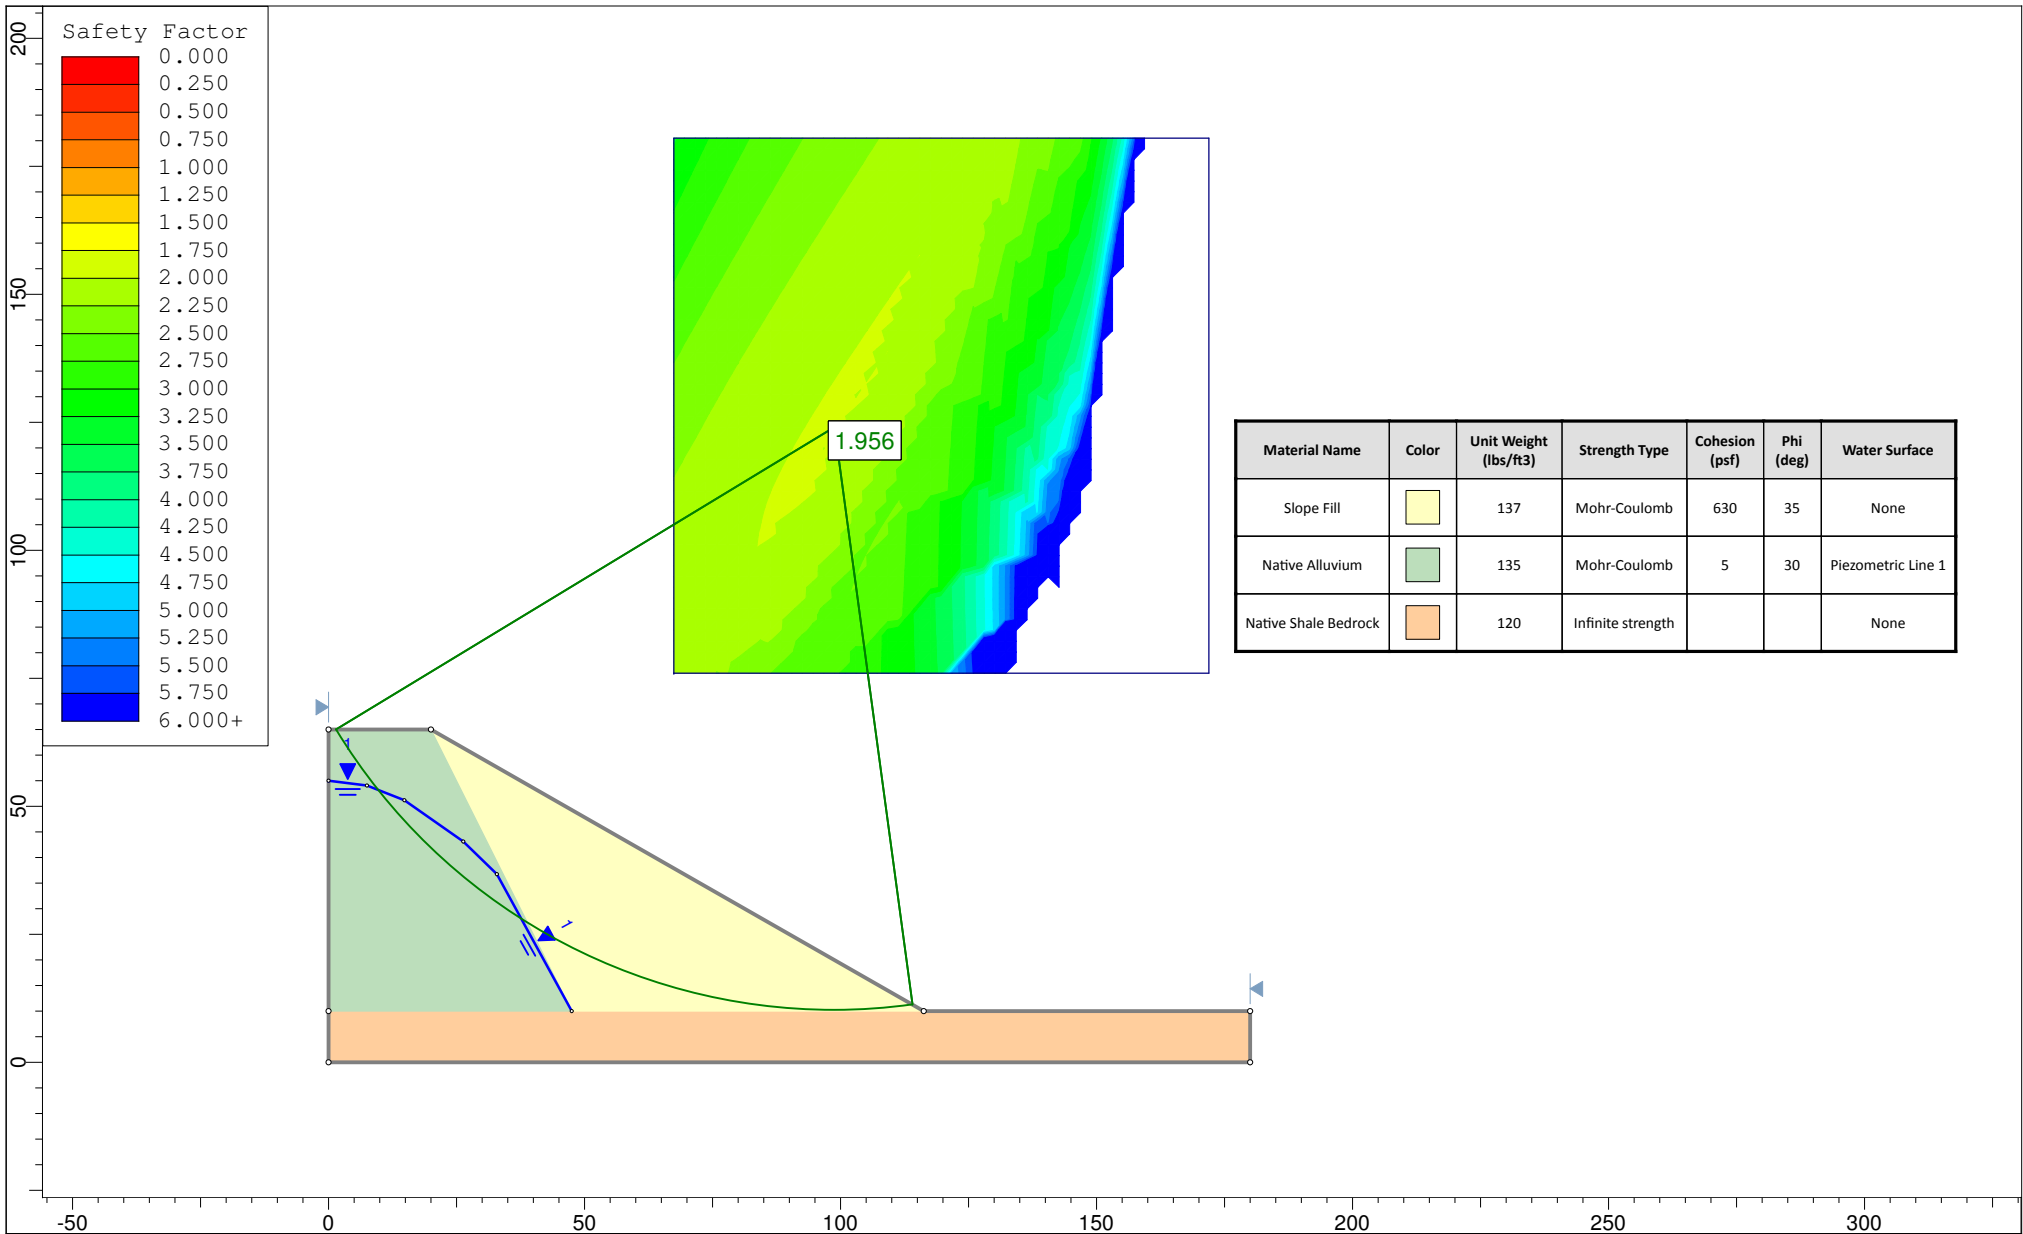
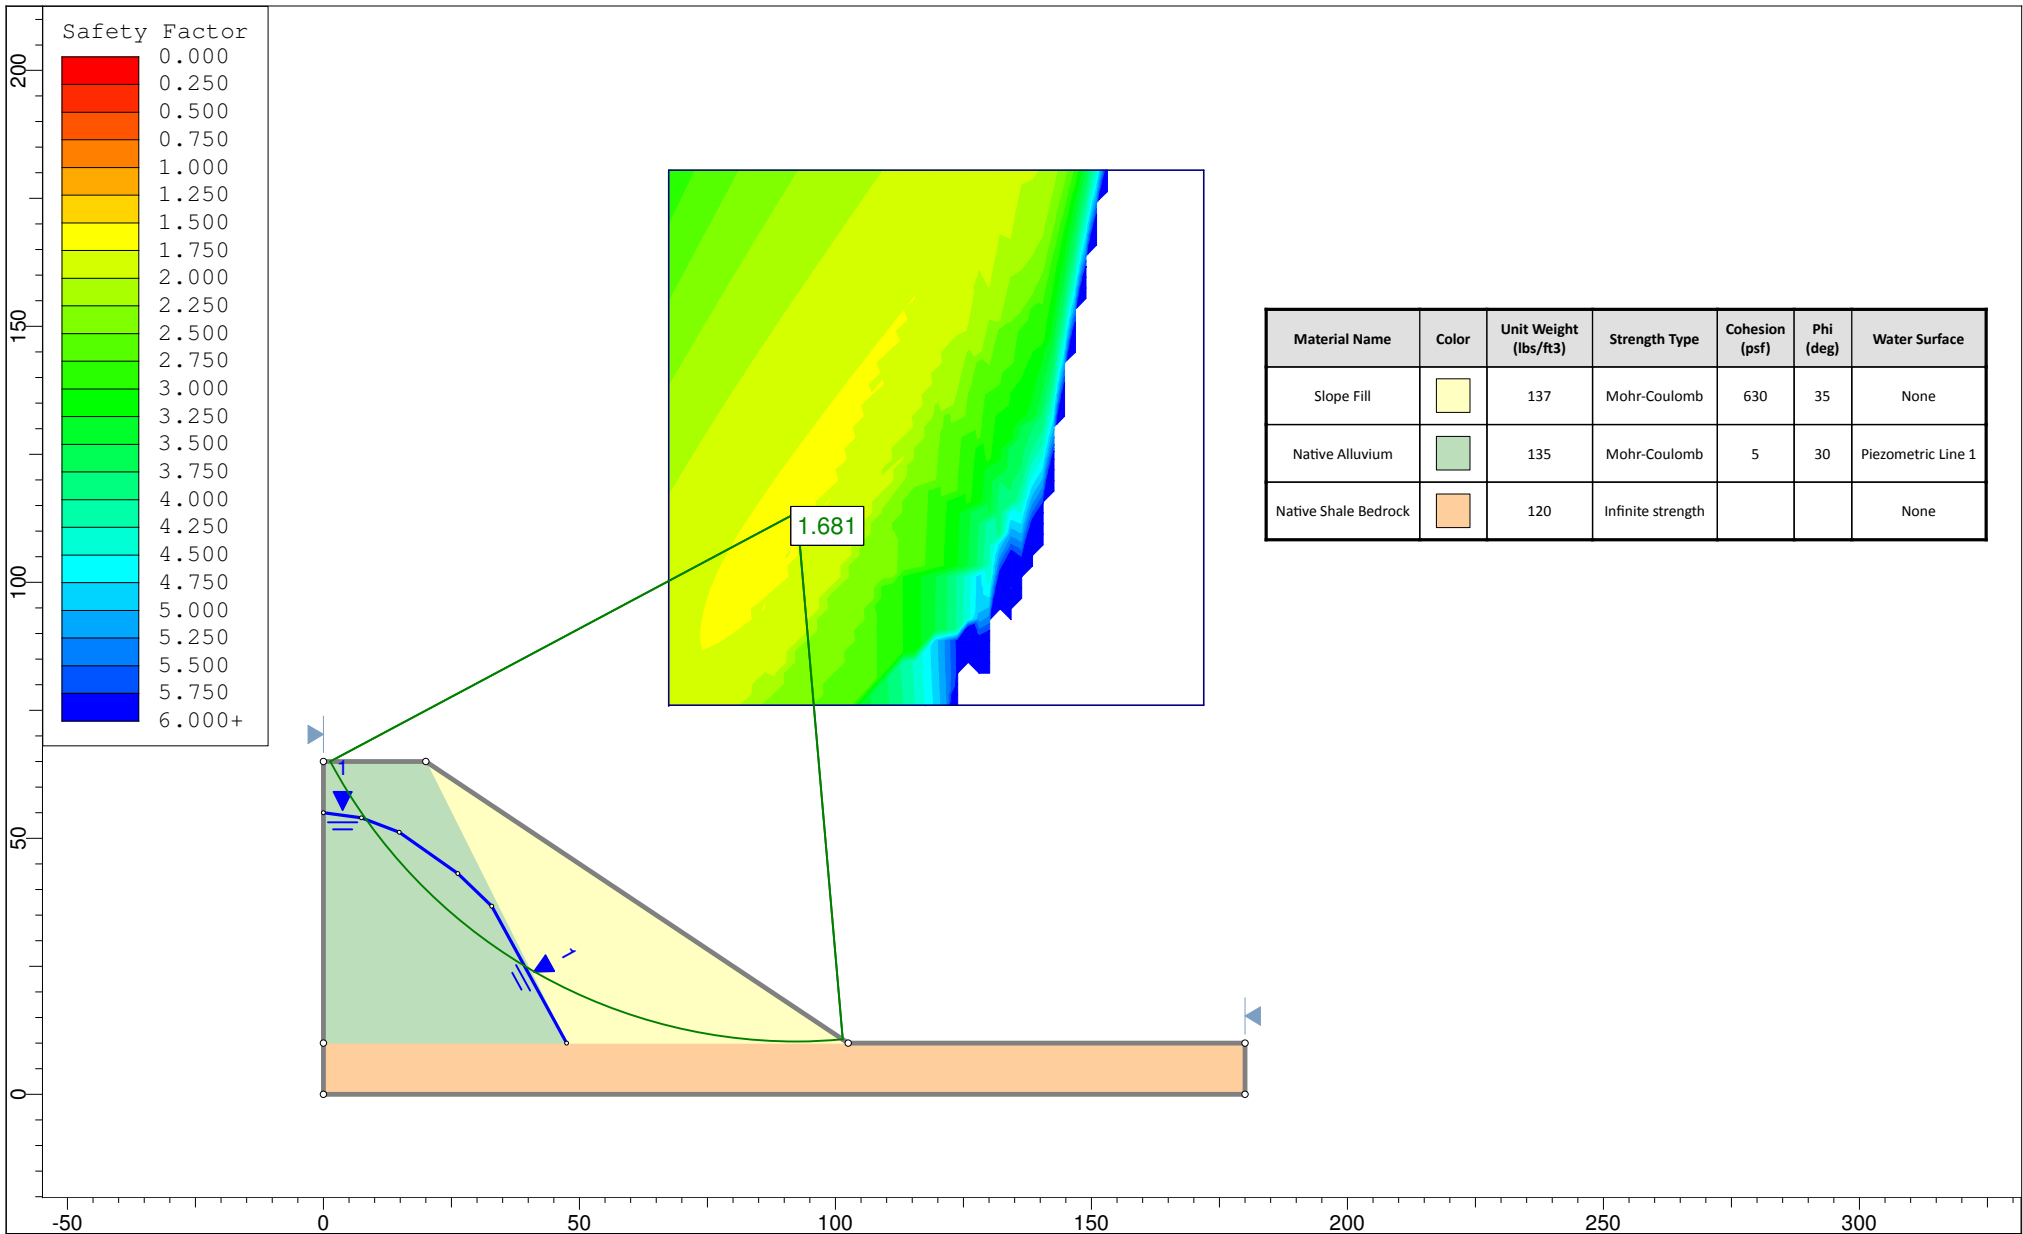
The model was originally performed at a slope of 2:1 and subsequent models were performed at slopes of 1.75:1 and 1.5:1.

1. The groundwater drain indicated on the provided drawing will be able to reduce the surrounding groundwater to at least the levels shown on the slope stability results. We have not reviewed the design of this drain but are available to do so upon request.
2. The impermeable liner is fully intact.
3. Soil Parameters for the undisturbed alluvium and bedrock were based on our previous analysis
4. The failure was assumed to not go through the bedrock.
