**Re: Technical Revision (TR-8) Request**

Reclamation of Little Deadwood Gulch and Chief Portal  
May Day Idaho Mine Complex  
Permit No. M-1981-185  
112d-1 Reclamation Permit  
Board Order Signed-March 3, 2016

The following is Wildcat Mining Corporation (Wildcat) technical Revision (TR-8)<sup>1</sup> requesting approval of the proposed Little Deadwood Gulch drainage modification to the April 1, 2013 approved remedial plan (TR-5). The original drainage plan was designed by Carroll & Lange-Manhard (Manhard) and submitted to the Division on March 18, 2013.

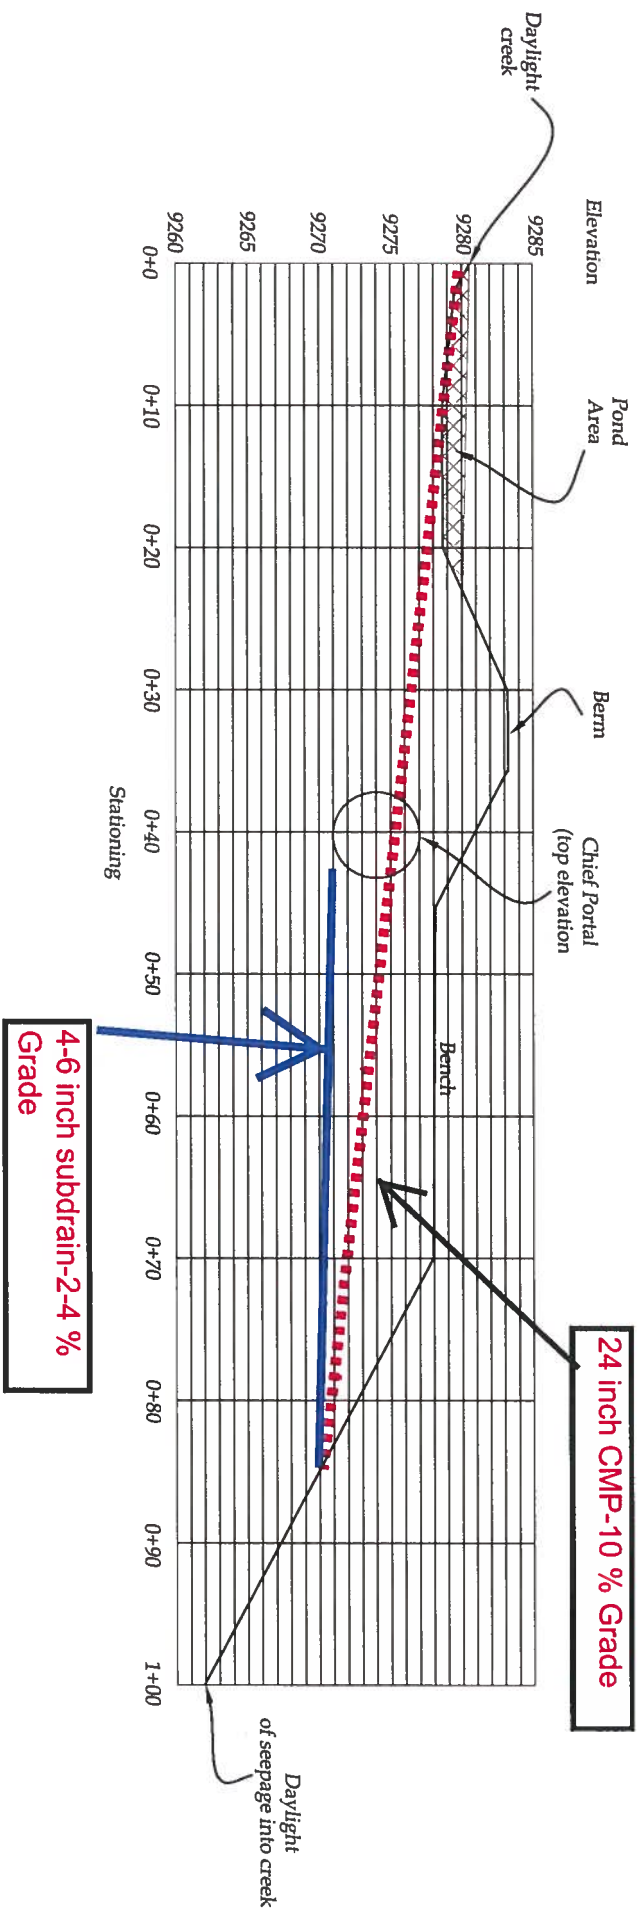
Figure 1  
24 inch CMP and 4-6 inch sub drain Installation Alignment  
Chief-Little Deadwood Gulch Drainage

4. Because the manway (portal) depth exceeded original design depth estimates, Wildcat proposes to install the 24 inch culvert in LDG to a depth approximately 2 to 7 feet at average grade of 10 percent. (See Figure 1 and 2) The 24 inch culvert will convey upgradient water (10year 24 hour storm) through the fill.

Figure 1- 24 inch CMP and 4-6 inch sub drain alignment, Little Deadwood Gulch Drainage

Figure 1- 24 inch CMP and 4-6 inch sub drain installation alignment, Little Deadwood Gulch Drainage

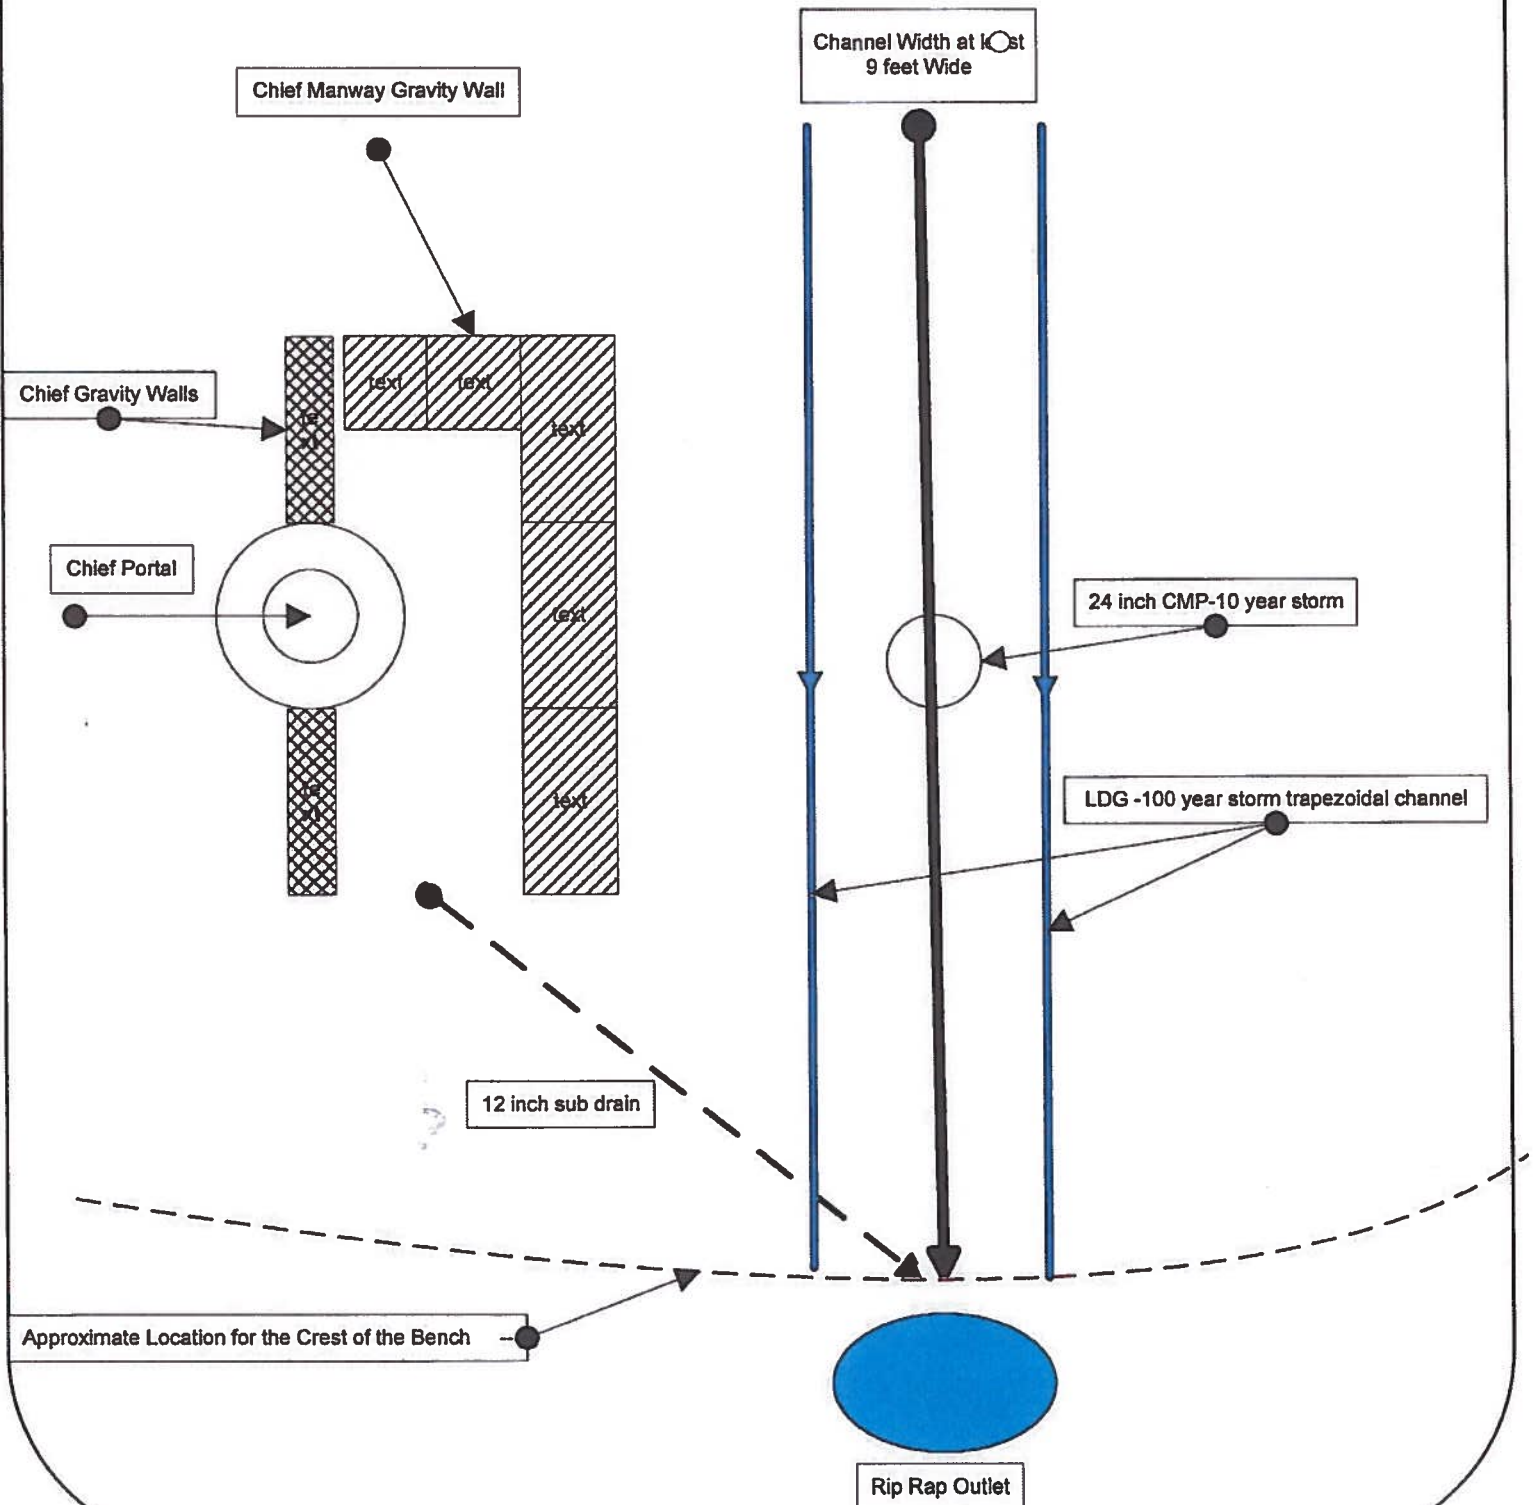
**Figure 3**  
**Little Deadwood Gulch Drainage Conceptual Plan View Illustration**

6. Alter the TR-05 culvert alignment to the east approximately 10 feet (away from the 66 inch manway entrance) to accommodate the installation of gravity blocks (Photo 1) in front of the manway (Figure 3) See Photo 2;

Figure 3 –Little Deadwood Gulch Drainage Conceptual Plan View Illustration

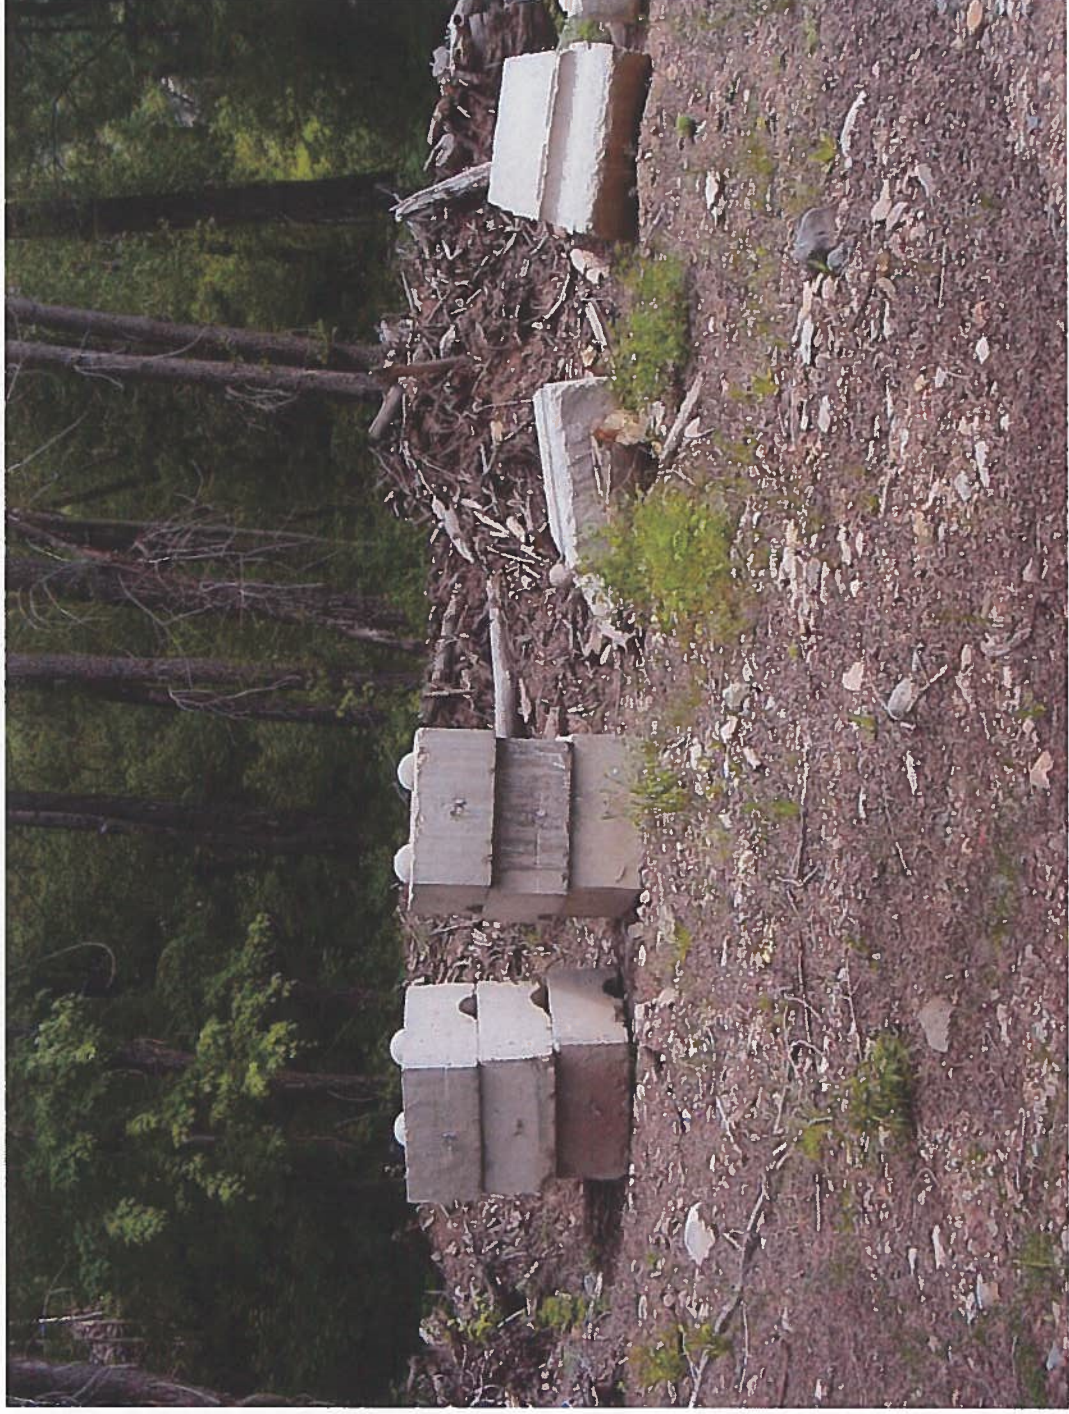
# Photo 1

## Gravity Blocks

7. To provide stability to LDG alluvial materials outside of the portal manway, gravity blocks will be placed immediately upgradient and parallel to of the manway portal. The upgradient block extension will be approximately 4 feet and approximately 16 feet long to be constructed at an angle of 20-30 degrees away from the manway portal. (See photo 2 and Figure 3). No blocks will be placed on the down gradient side of the 66 inch culvert to allow a ramp to be constructed to permit rescue crews to gain access to the manway.

Photo 1-Little Deadwood Gulch Gravity Blocks

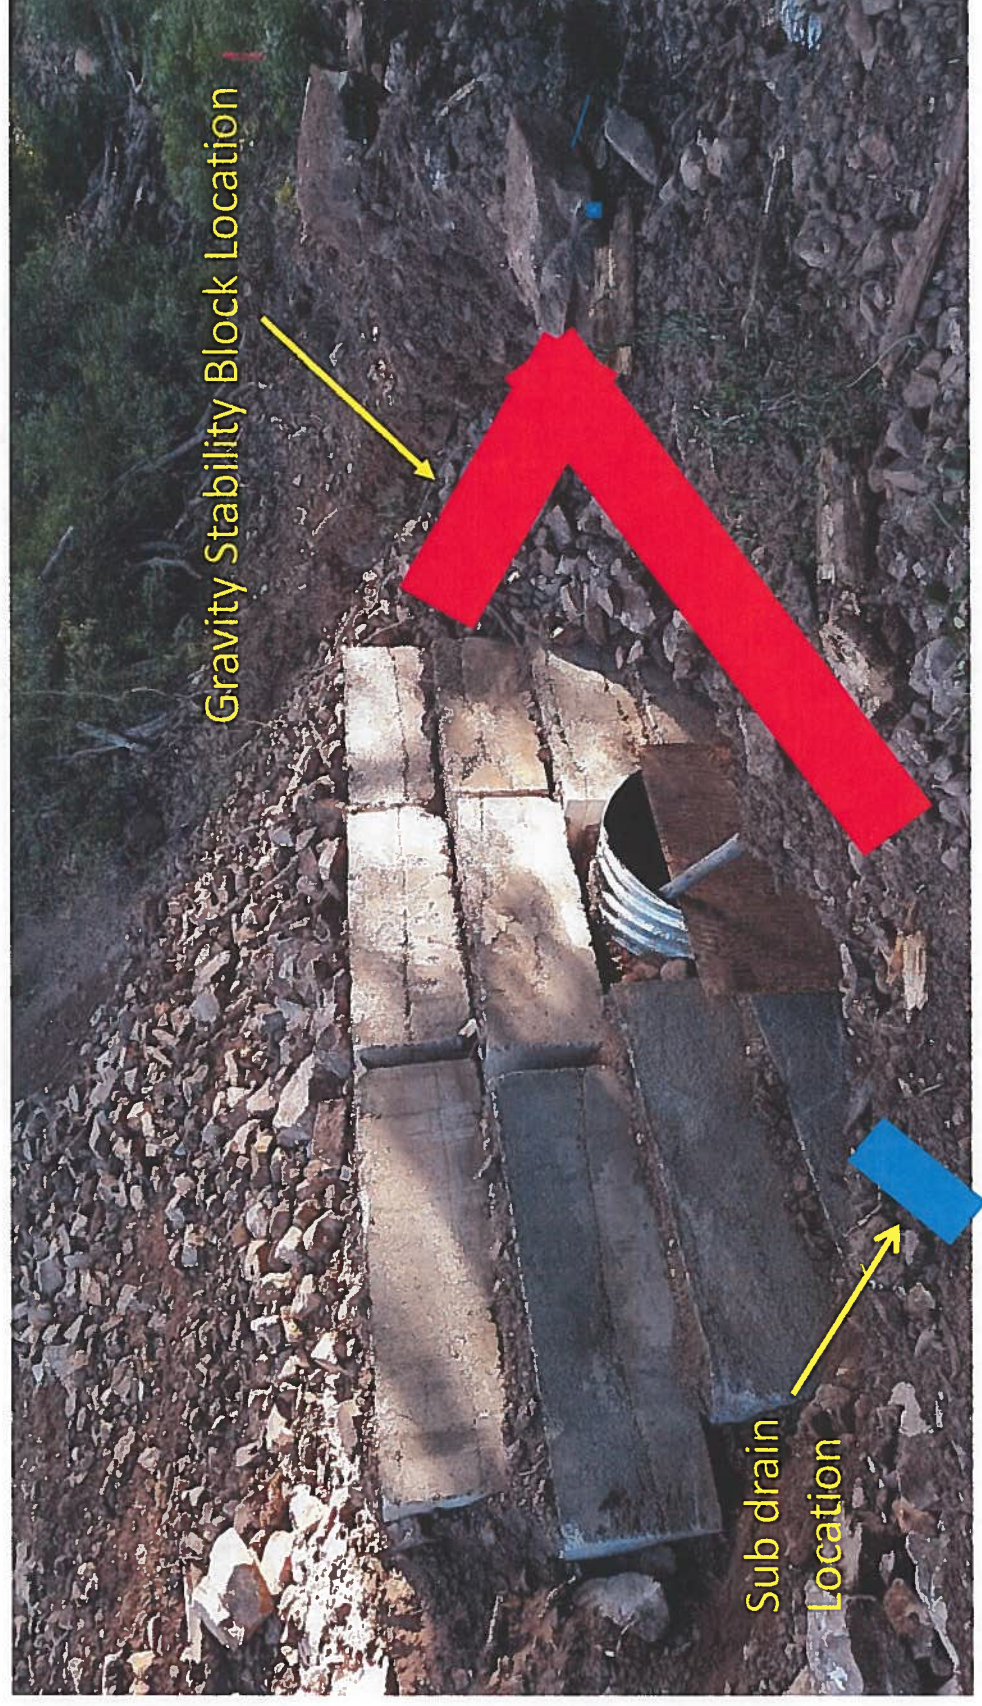
# Photo 2

## Manway –Drainage Control

the manway entrance will be gravity drained a downgradient point near the crest of the LDG bench. (See Photo 2)

Photo 2-Manway Drainage Control

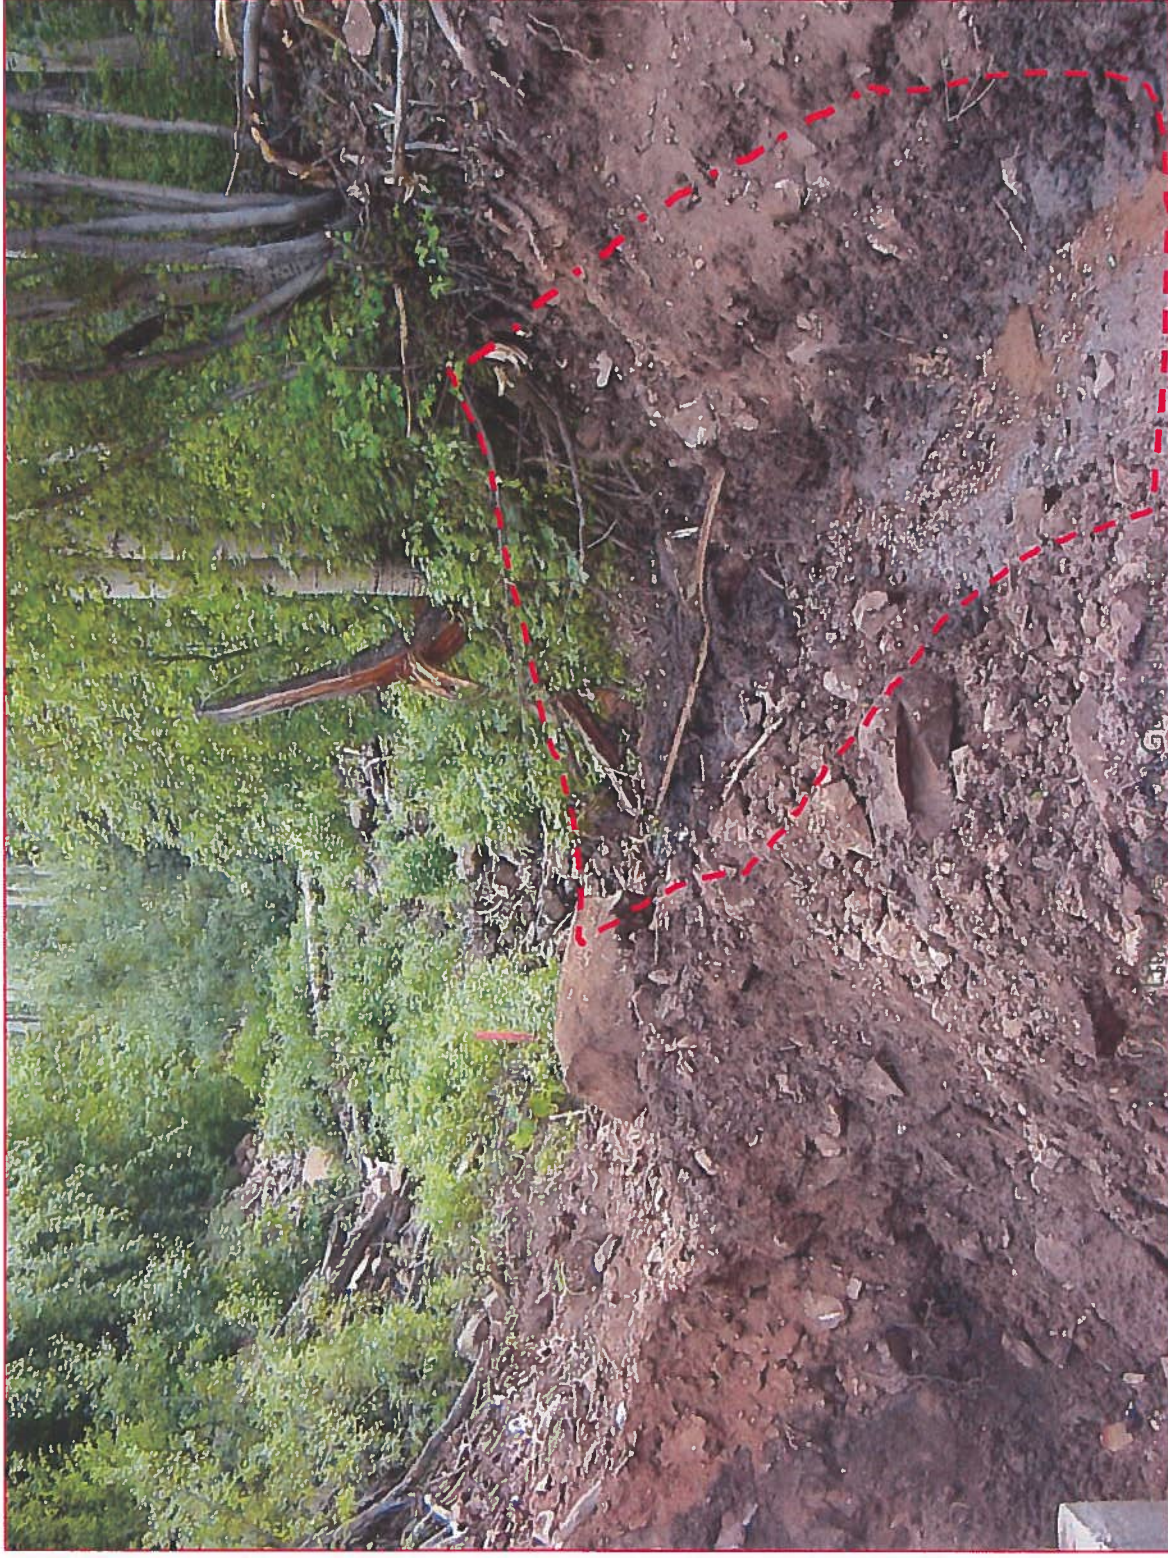
## Photo 3

### Little Deadwood Gulch-Upgradient Drainage Alignment

9. A trapezoidal channel (Table 2)) (Photo 3 and 4) will be constructed to convey the 87 cfs peak flow of from the 100 year-24 hour storm (Manhard, 2013). The bottom width will be approximately 9 feet, side slopes 4H:1V, 2 feet deep and with a channel bottom width of 2 feet;
10. The disturbed area will be reclaimed as approved in accordance with TR-5 approved design;
11. BMPs (wattles, silt fences, rip rap) will be installed to stabilize the reclaimed surface and in accordance with the original plan (TR-05-April 1, 2013).
12. Debris and wood will be removed and disposed off-site.

Photo 3-Little Deadwood Gulch Upgradient Alignment

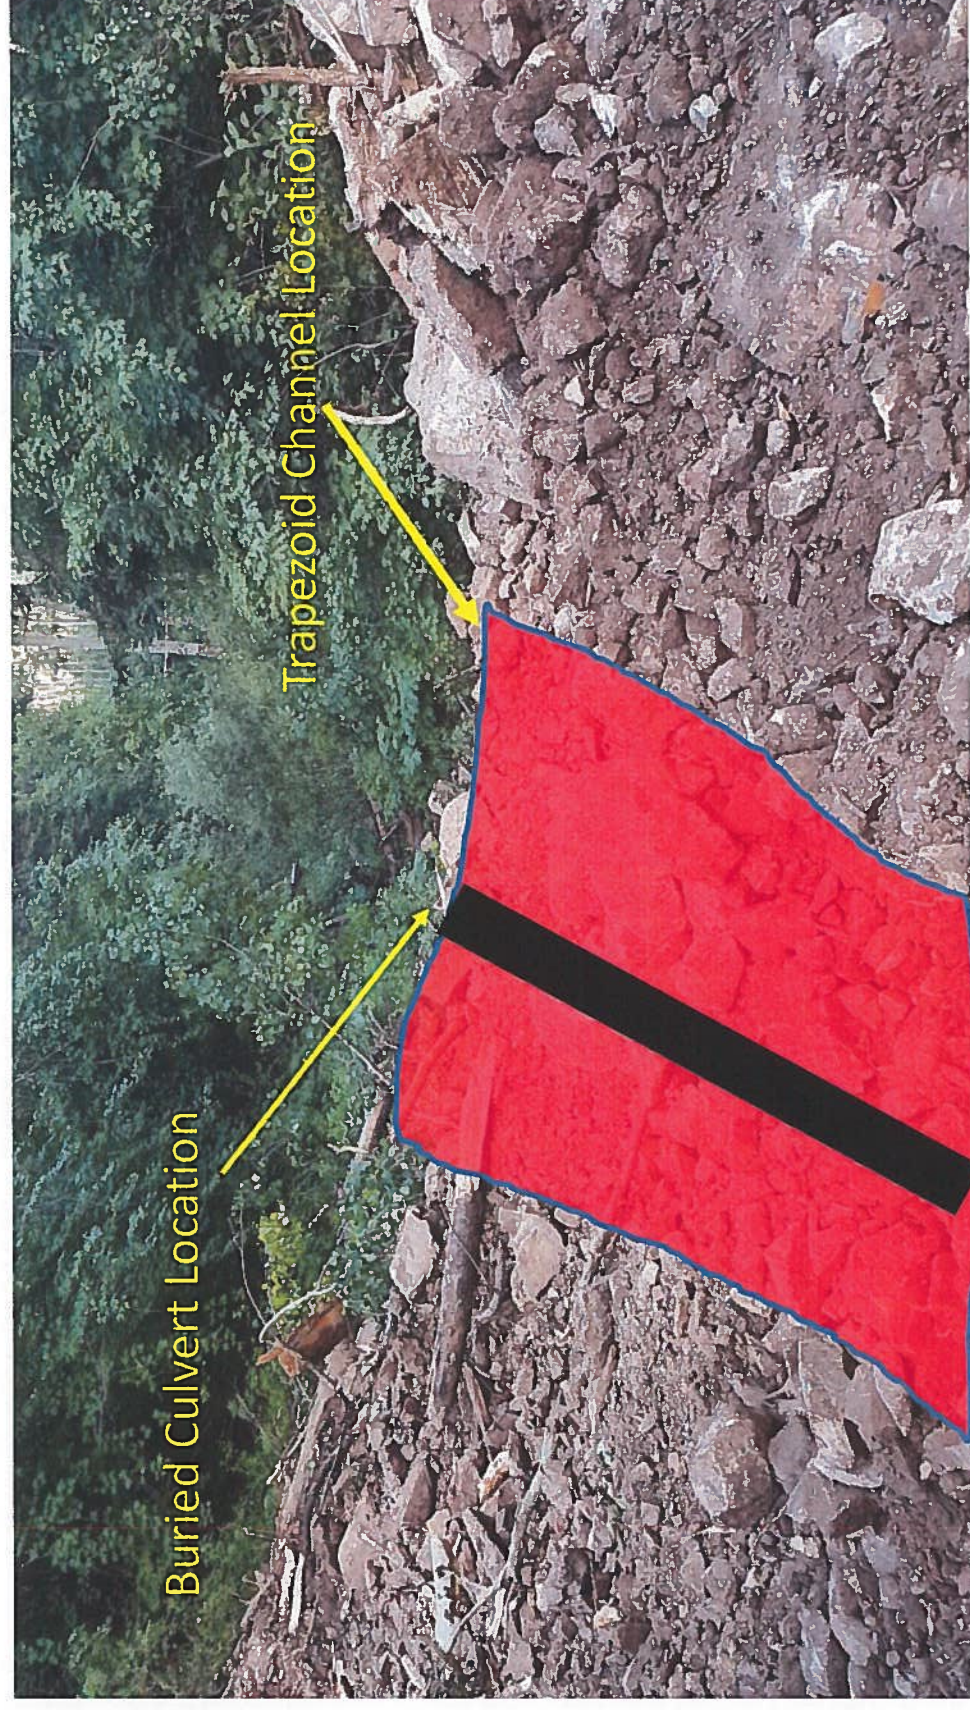
## Photo 4

### Little Deadwood Gulch-Down Gradient Drainage Alignment

Photo 4-Little Deadwood Gulch Downgradient Alignment
