**COLORADO**Division of Reclamation,
Mining and Safety

MINERALS PROGRAM INSPECTION REPORT**PHONE: (303) 866-3567**

MINE NAME: SR-13A Mine	MINE/PROSPECTING ID#: M-1977-311	MINERAL: Uranium and vanadium	COUNTY: San Miguel
INSPECTION TYPE: Monitoring	INSPECTOR(S): G. Russell Means	INSP. DATE: August 31, 2016	INSP. TIME: 12:00
OPERATOR: Cotter Corporation	OPERATOR REPRESENTATIVE: Jim Sheridan, DOE	TYPE OF OPERATION: 110d - Designated Limited Impact	
REASON FOR INSPECTION: Normal I&E Program	BOND CALCULATION TYPE: IT.Bondcalculationtype.CD.Desc	BOND AMOUNT: \$100.00	
DATE OF COMPLAINT: NA	POST INSP. CONTACTS: None	JOINT INSP. AGENCY: U.S. Energy	
WEATHER: Clear	INSPECTOR'S SIGNATURE:

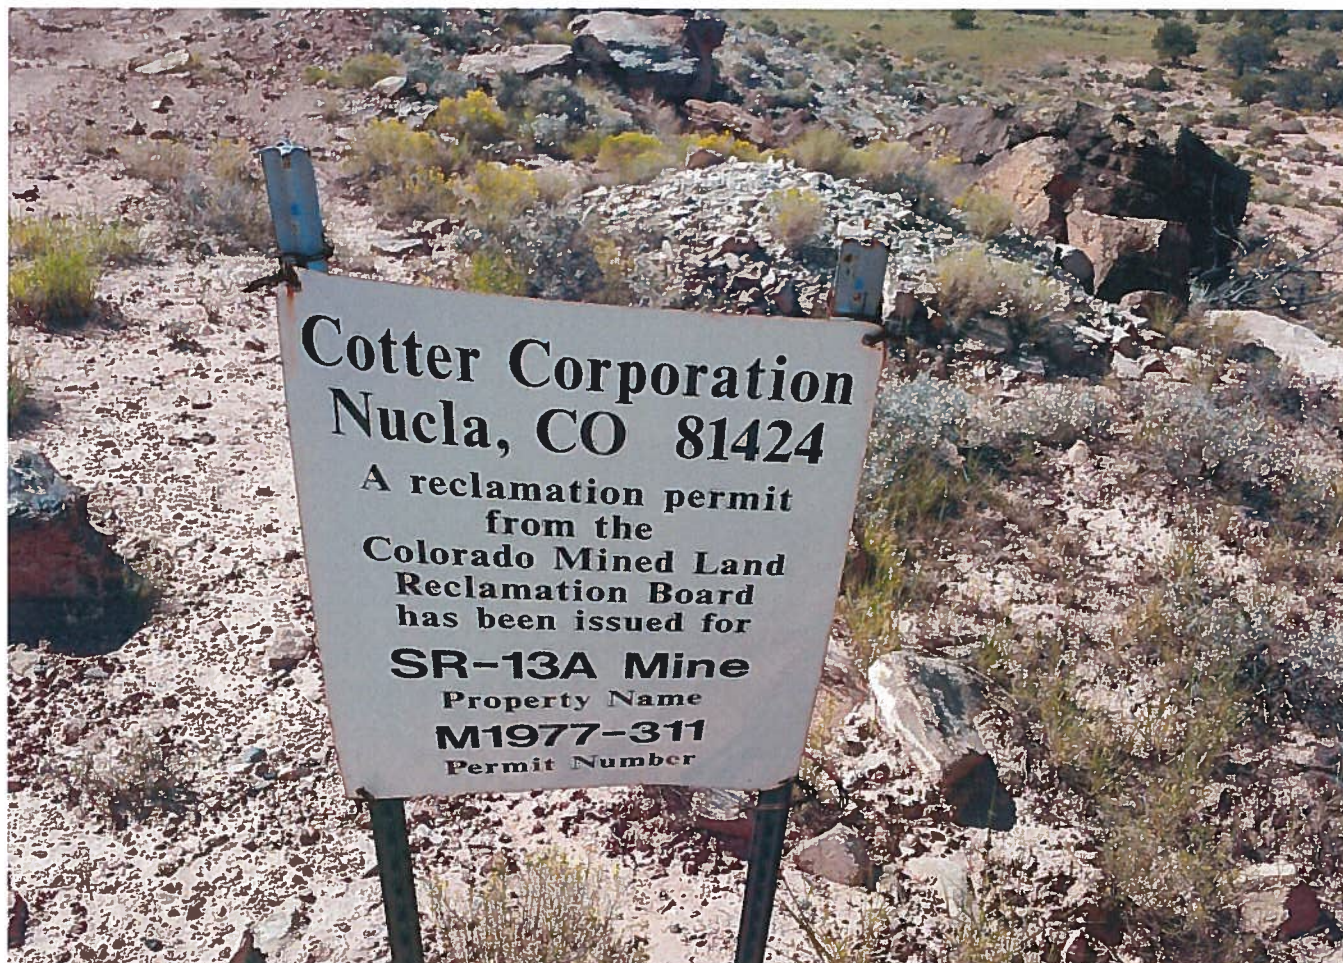
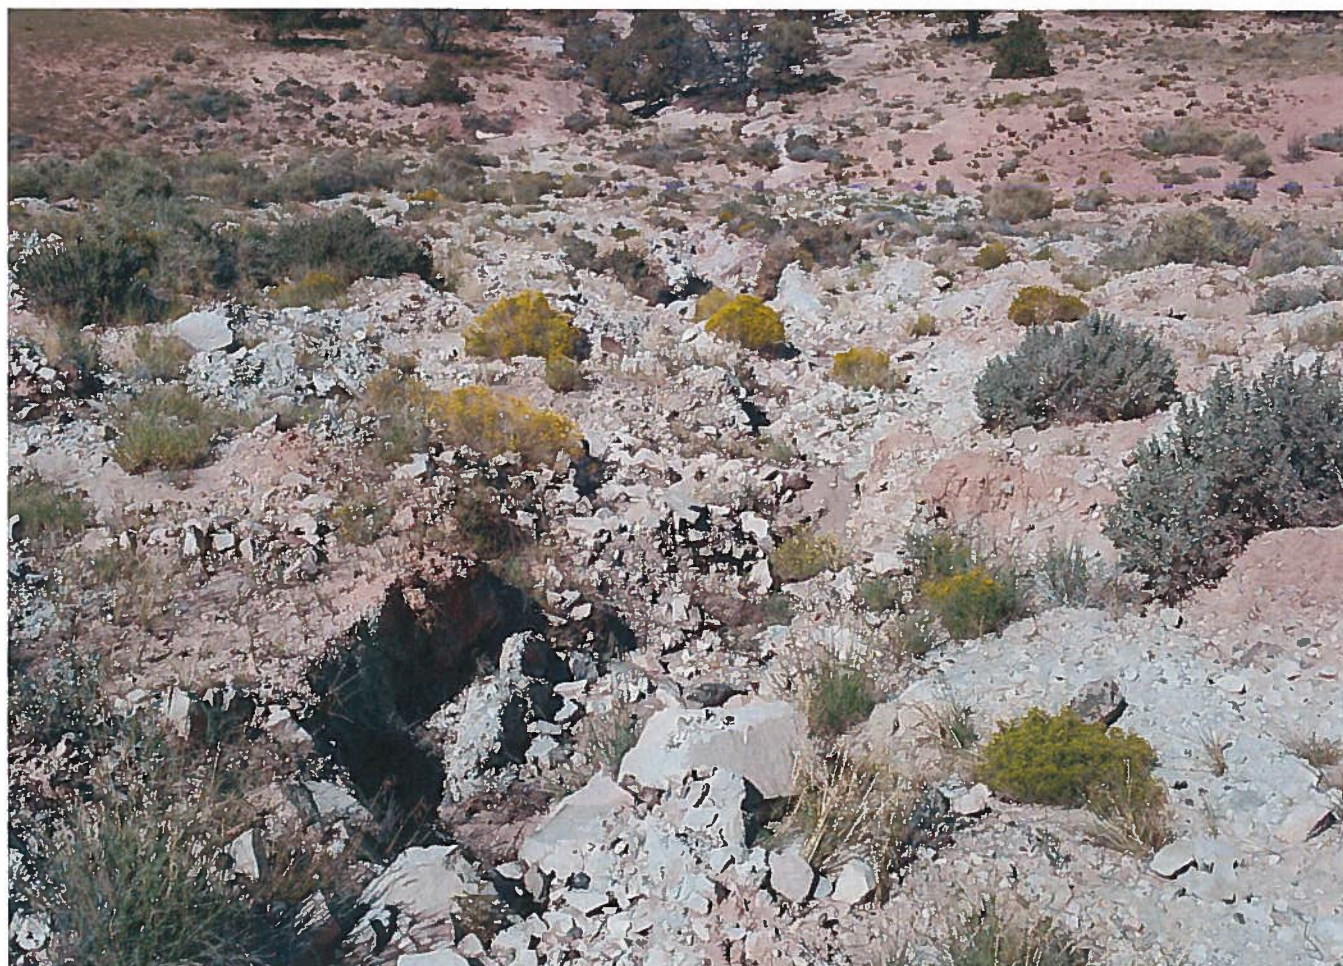
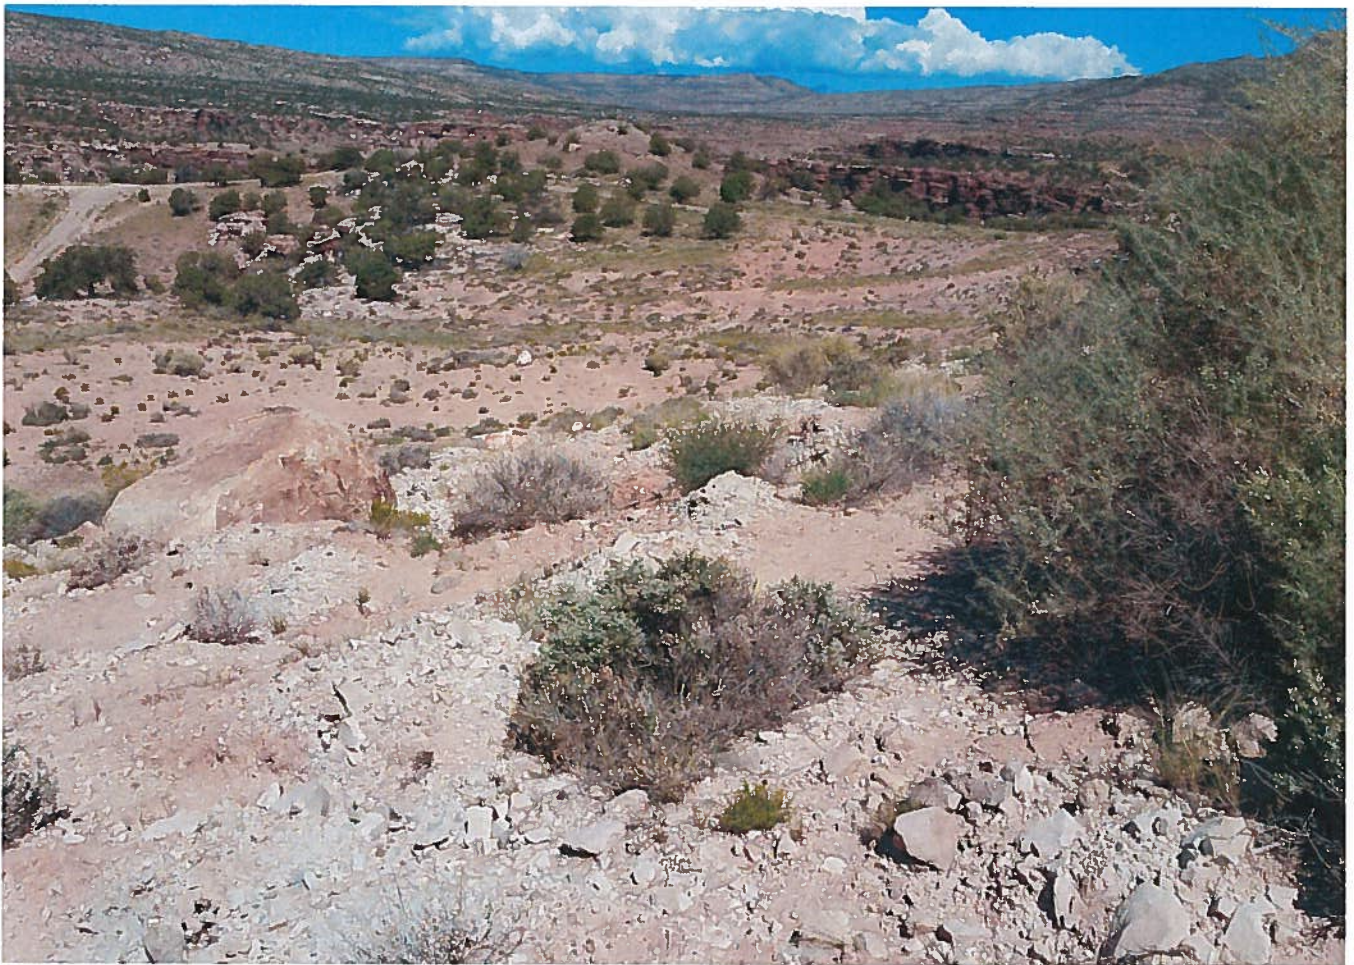
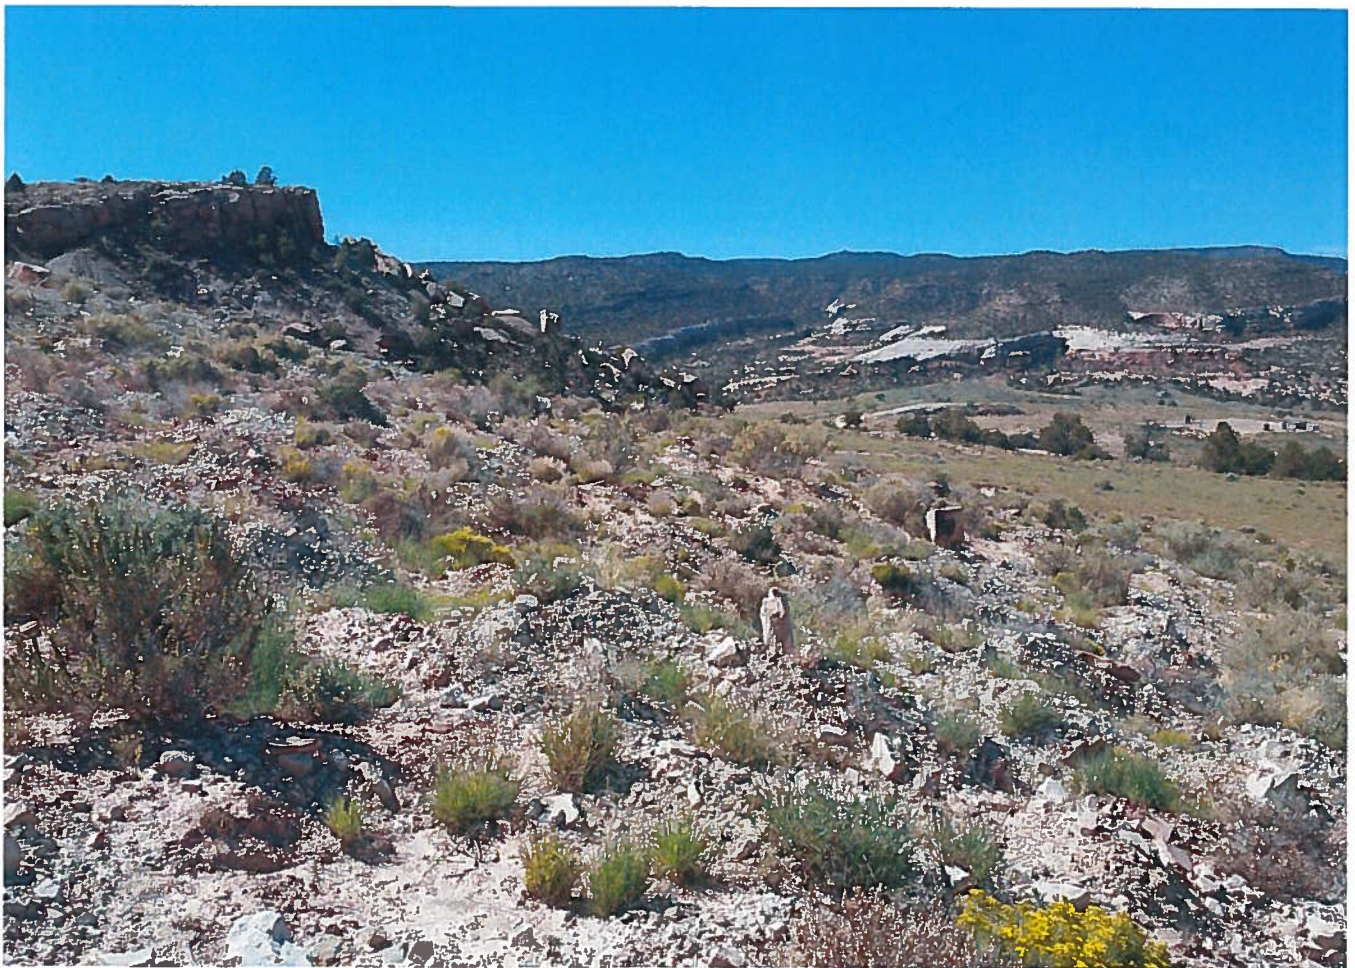
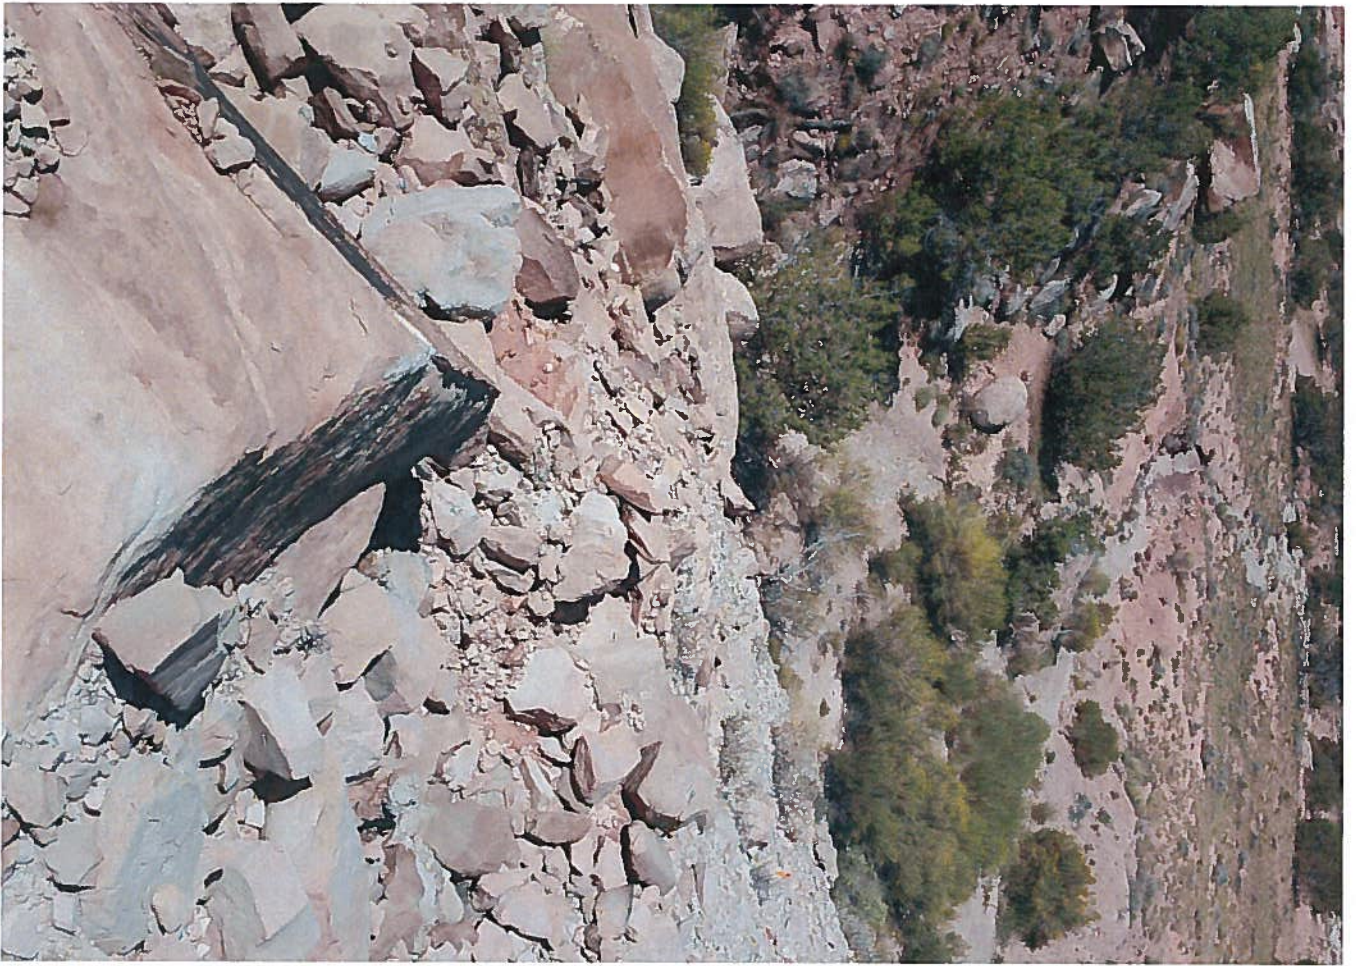
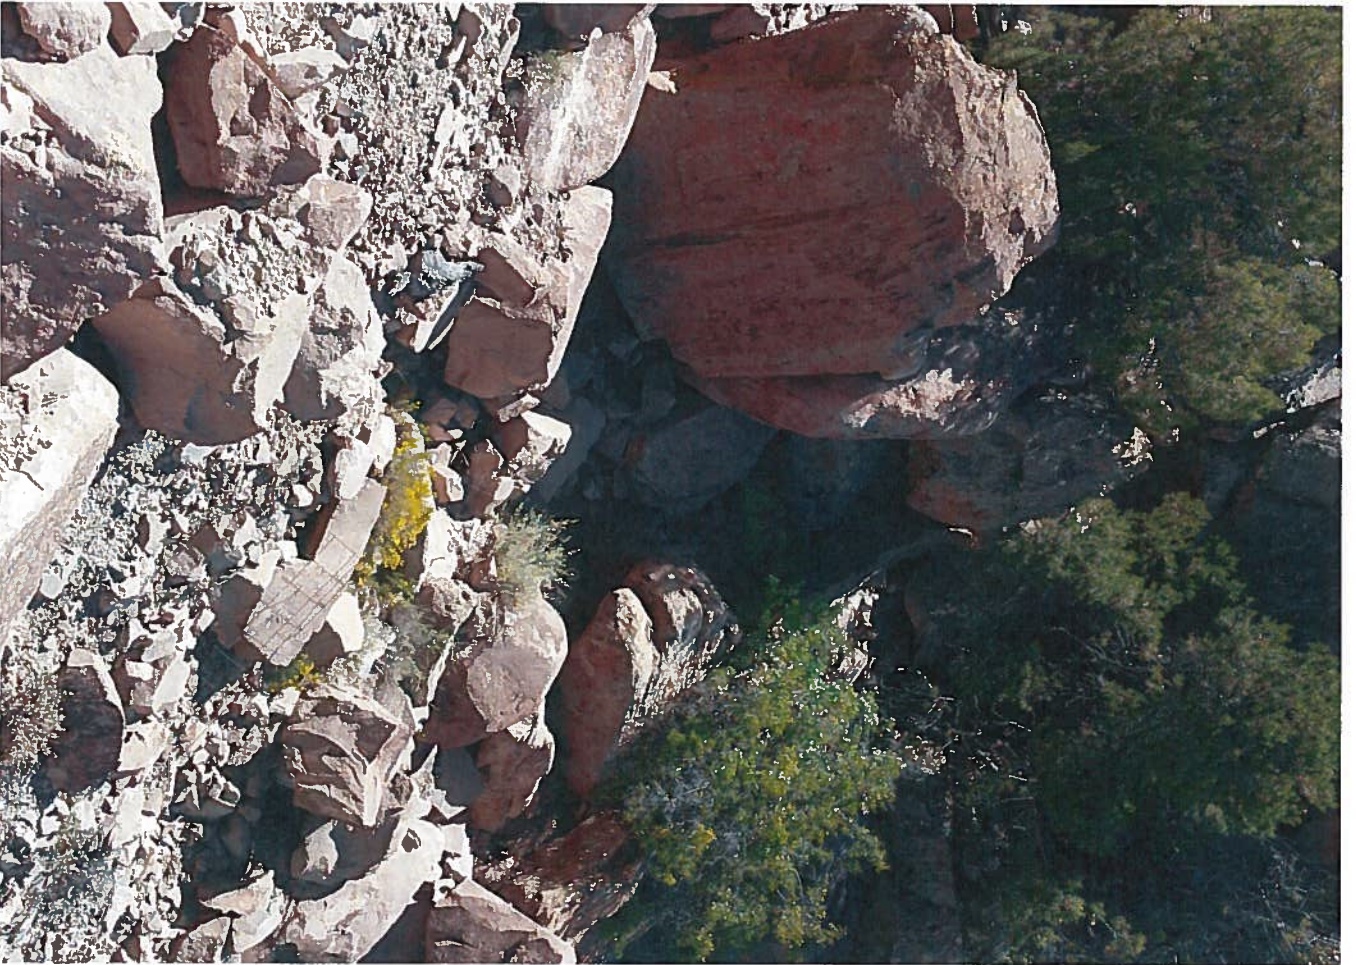
The access road into the site is reclaimed across non-permitted, historic mining areas into the permitted area. No erosion or sedimentation issues are noted. Revegetation is primarily four winged salt bush, rabbit brush, and some native grasses.

The waste piles were sloped at 2:1 or better. The entire site has been pocked which has resulted in micro-environments for vegetation and is very good for sedimentation and erosion control. The slopes are noted as being very stable with some riling and gulying in a few spots that appear to be stable. Continued monitoring of the erosion features will occur and if necessary repairs will be done. No sediments from these areas are noted as leaving the site. Revegetation of the slopes is equal to or better than the surrounding area. Density and diversity of vegetation is very good. Four winged and rabbit brushes are doing very well with native grasses and minor shrubs like Winter Fat filling in.

Most of the access portals have been backfilled and are not identifiable. The lone exposed portal has a secured steel gate that meets Division specifications. A large boulder is being held in place by steel cable supports above the mine portal. DOE, DRMs, and Cotter discussed monitoring to ensure further degradation does not create an unsafe condition.
