MINERALS PROGRAM INSPECTION REPORT
PHONE: (303) 866-3567

MINE NAME: Burros Mine	MINE/PROSPECTING ID#: M-1977-297	MINERAL: Uranium and vanadium	COUNTY: San Miguel
INSPECTION TYPE: Monitoring	INSPECTOR(S): G. Russell . Means	INSP. DATE: September 7, 2016	INSP. TIME: 13:00
OPERATOR: Gold Eagle Mining, Inc.	OPERATOR REPRESENTATIVE: None	TYPE OF OPERATION: 110d - Designated Limited Impact	
REASON FOR INSPECTION: Normal I&E Program	BOND CALCULATION TYPE: IT.Bondcalculationtype.CD.Desc	BOND AMOUNT: \$100.00	
DATE OF COMPLAINT: NA	POST INSP. CONTACTS: None	JOINT INSP. AGENCY: U.S.Energy	
WEATHER: Clear	INSPECTOR'S SIGNATURE:

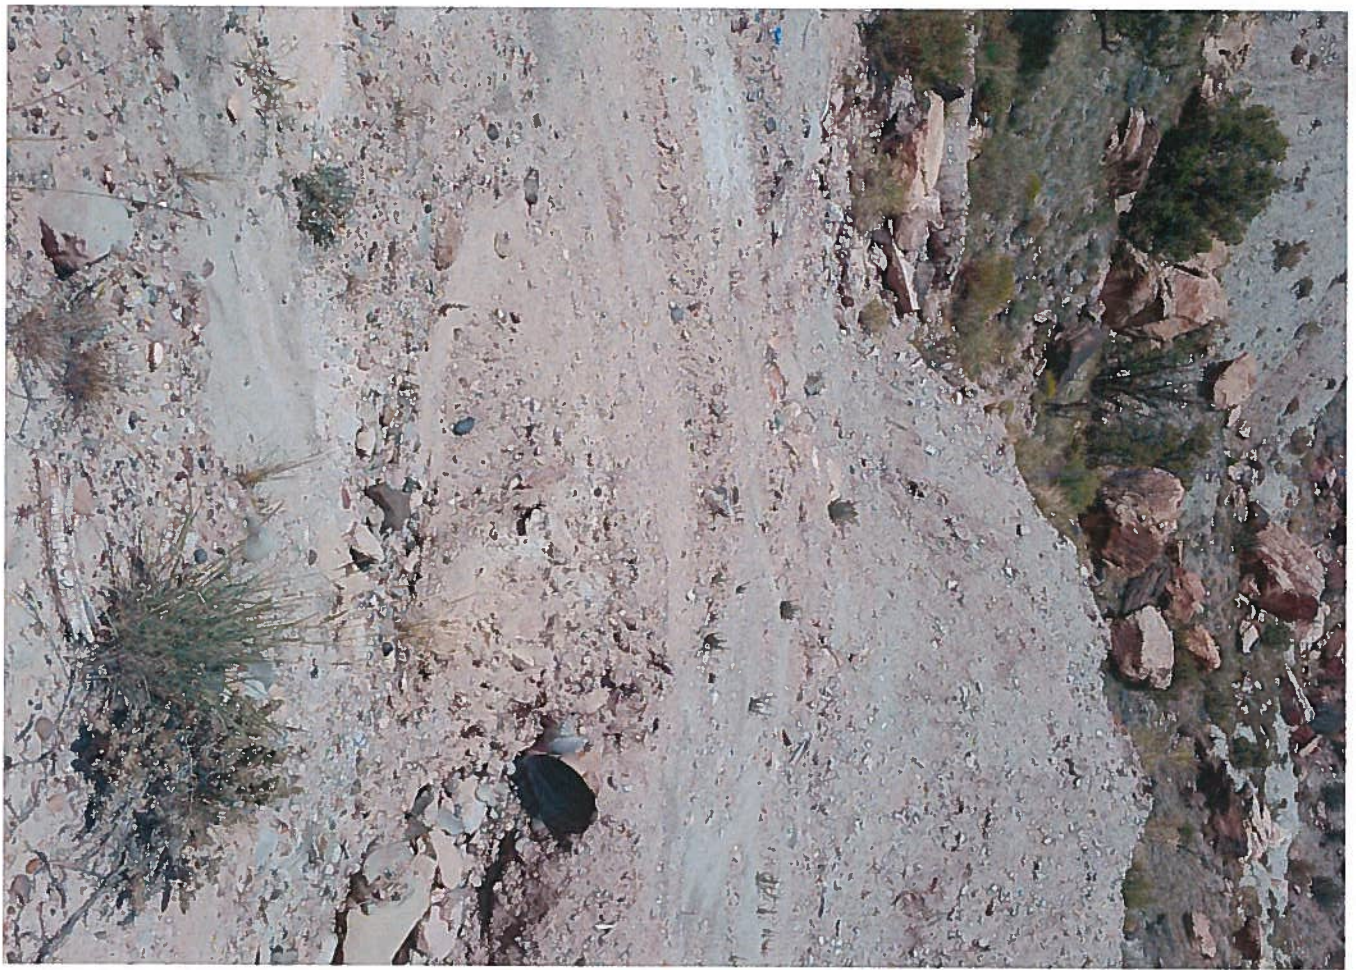
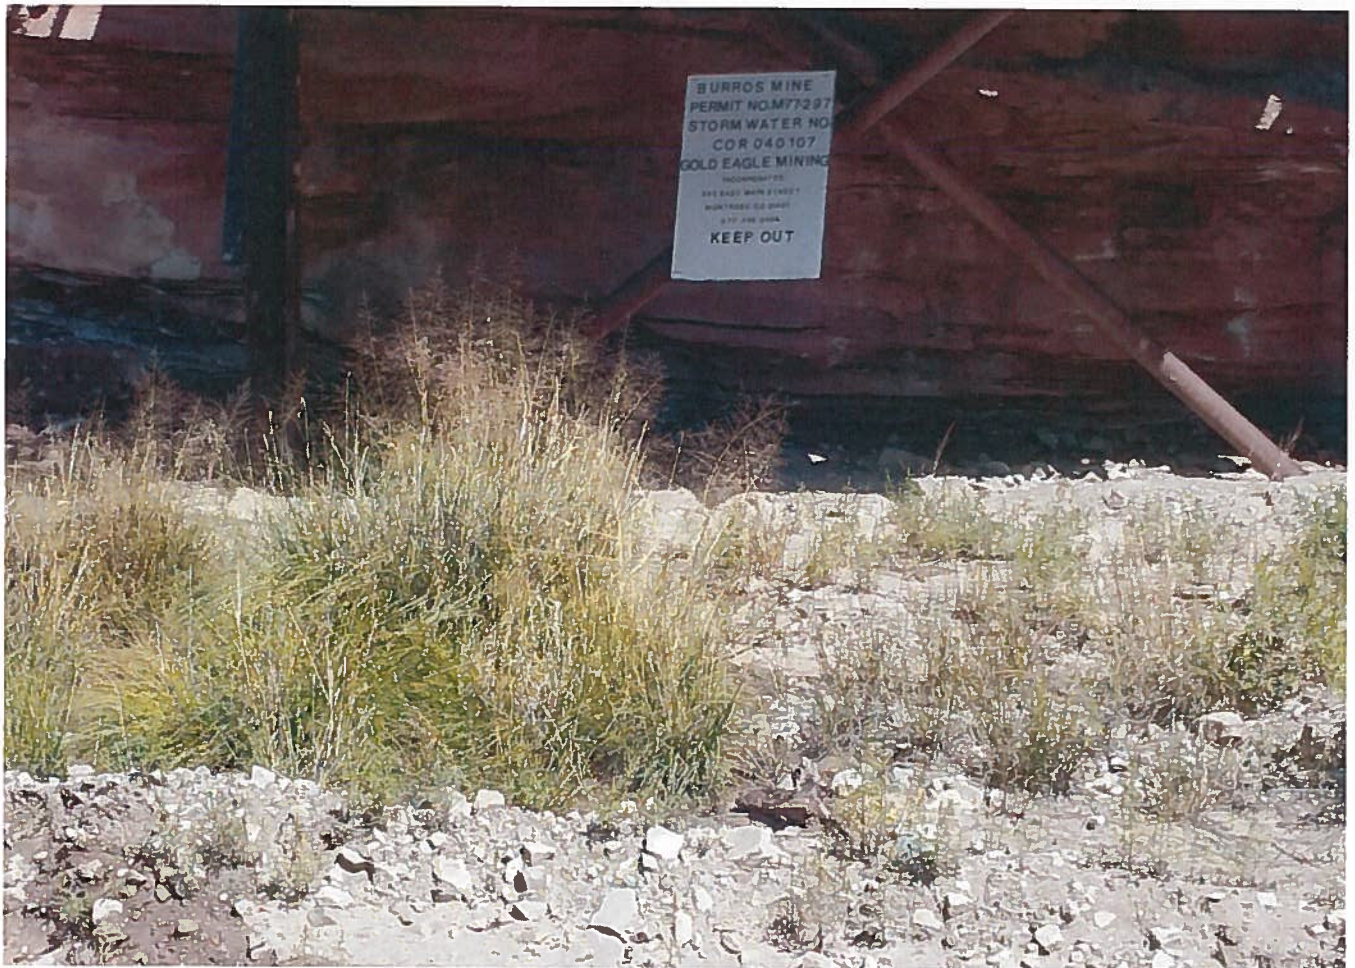
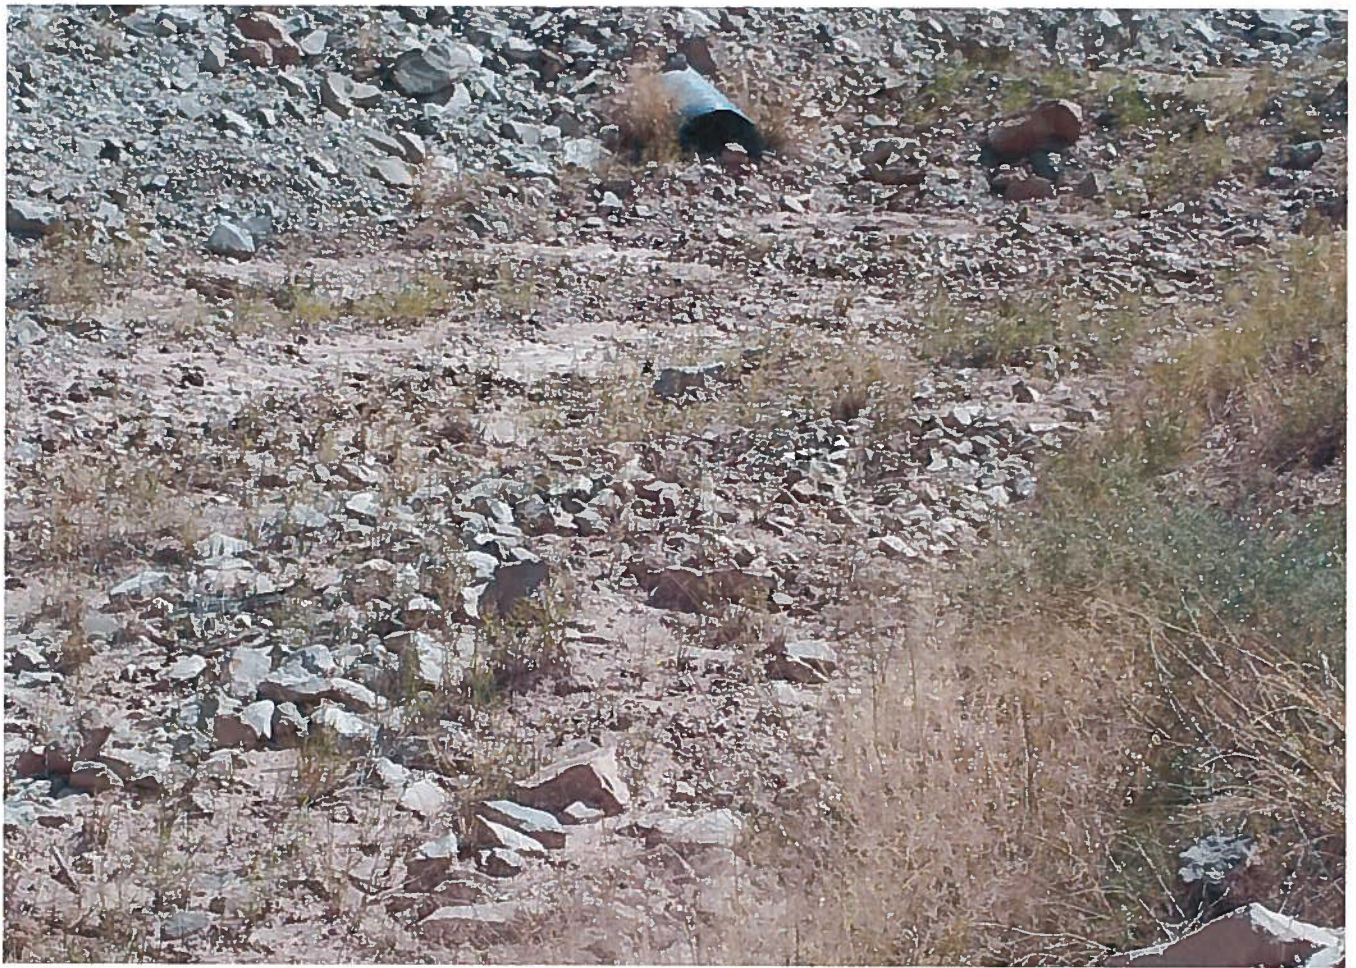
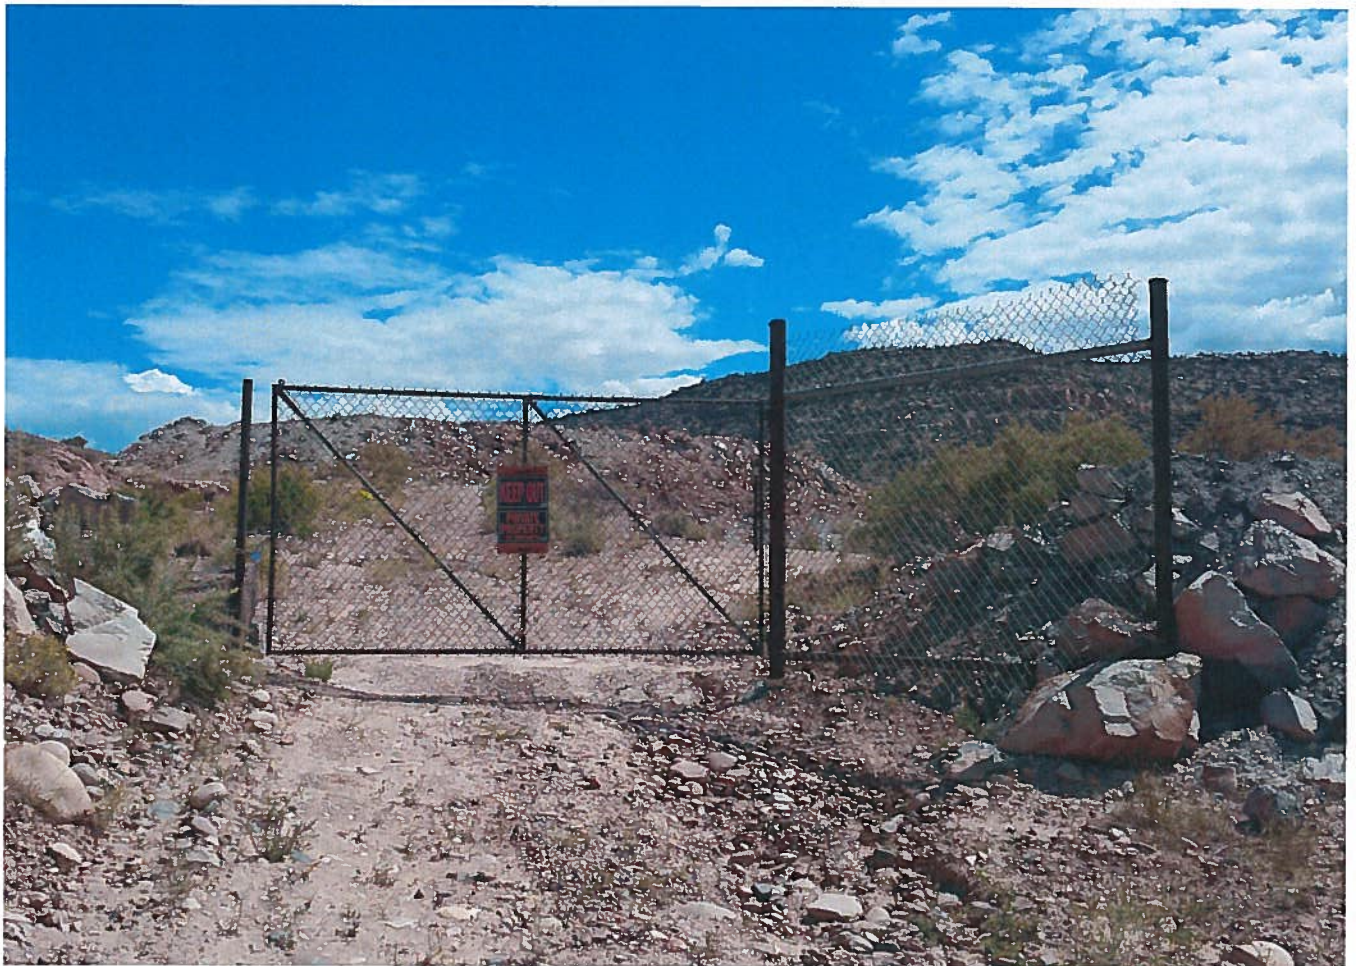
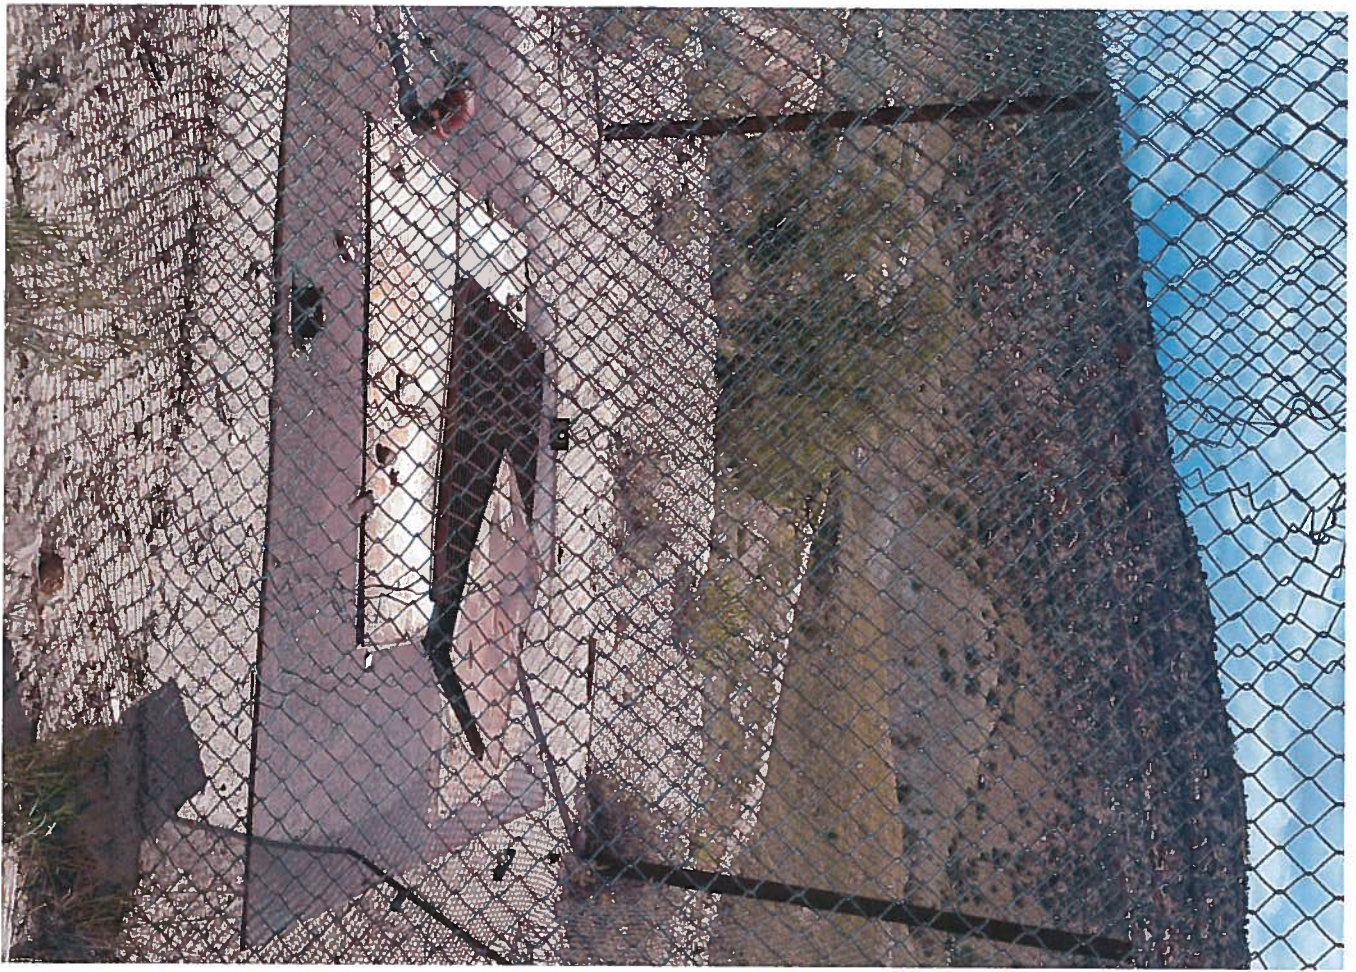
The required permit ID sign was observed posted near the entrance to the permitted area. A new gate was installed this spring at the lower access road that helps prevent unauthorized entry to the site.

Along with a new gate, the operator under the supervision of the DOE did storm water management repairs. A temporary holding / sedimentation structure was constructed at the edge of the permit boundary near the county road. It appears to be functioning well given recent precipitation events. Other directional ditches and berms appear to be functioning to help control run-on and run-off .
