MINERALS PROGRAM INSPECTION REPORT

MINE NAME: Myrin Pit	MINE/PROSPECTING ID#: M-1979-148	MINERAL: Sand and gravel	COUNTY: Routt
INSPECTION TYPE: Monitoring	INSPECTOR(S): Amy C. Yeldell	INSP. DATE: September 20, 2016	INSP. TIME: 10:00
OPERATOR: Colorado Department of Transportation	OPERATOR REPRESENTATIVE: Tina Hayes and Dennis Sanchez	TYPE OF OPERATION: 110c - Construction Limited Impact	
REASON FOR INSPECTION: Normal I&E Program	BOND CALCULATION TYPE: None	BOND AMOUNT: No Bond Held	
DATE OF COMPLAINT: NA	POST INSP. CONTACTS: None	JOINT INSP. AGENCY: None	
WEATHER: Cloudy	INSPECTOR'S SIGNATURE:

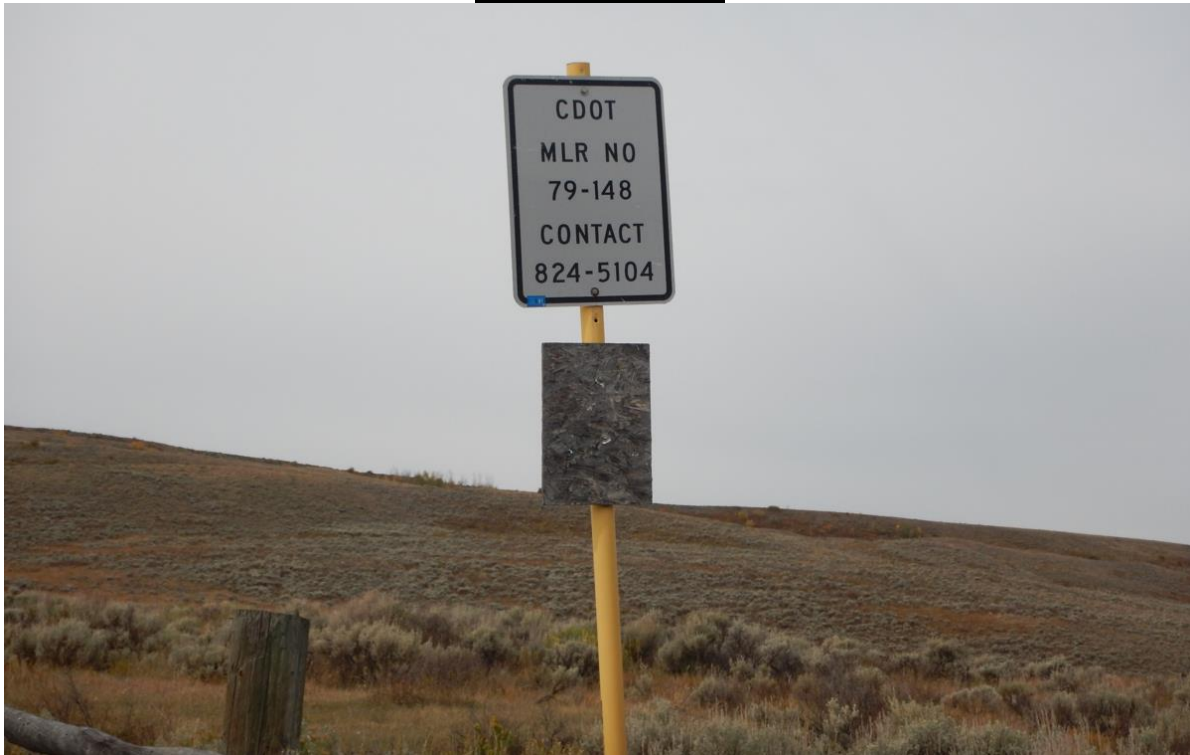
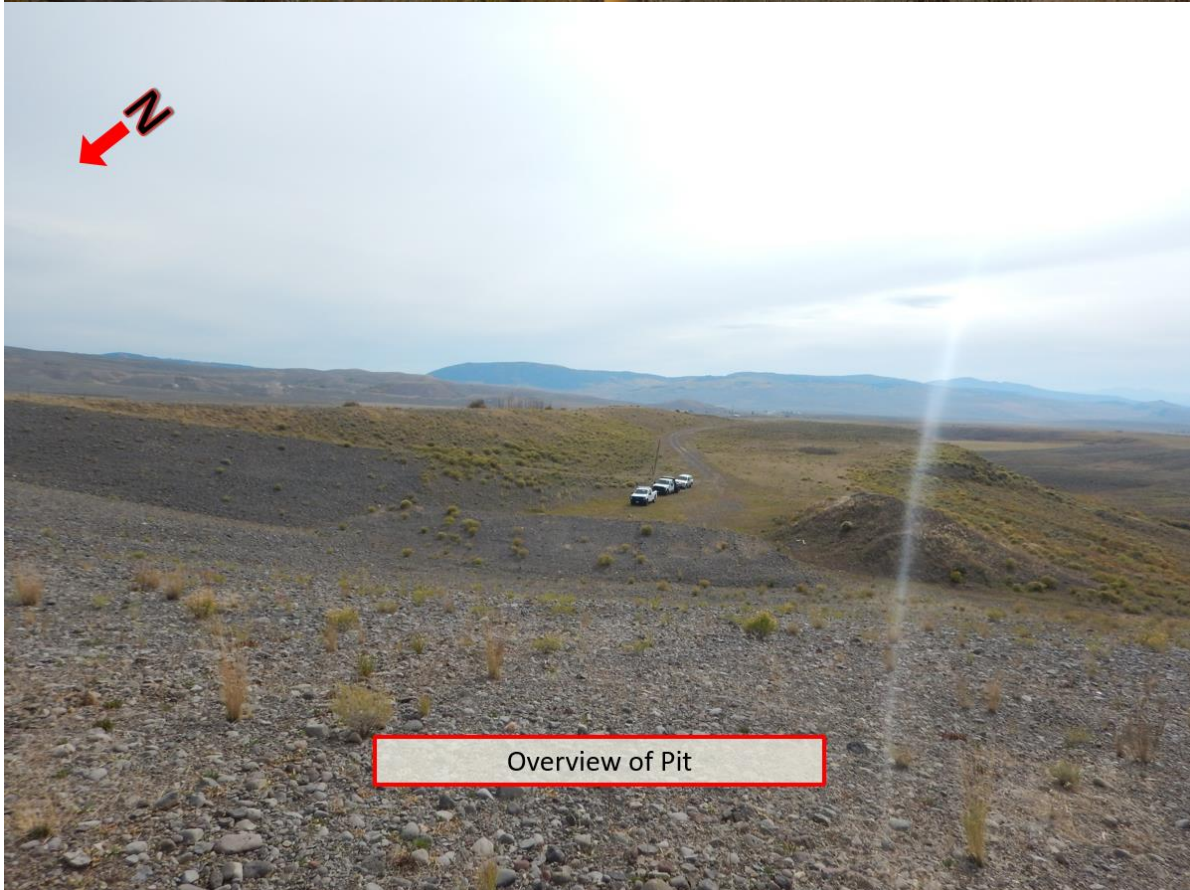
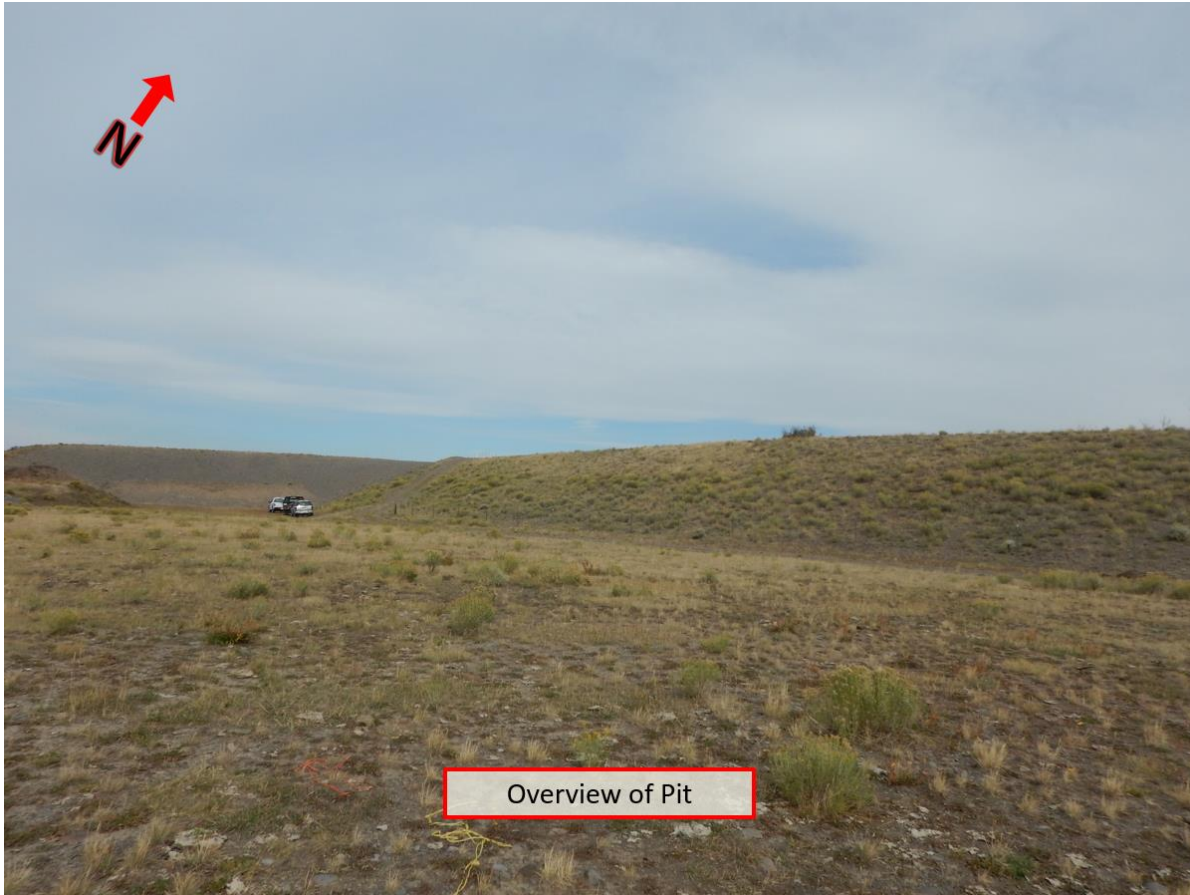
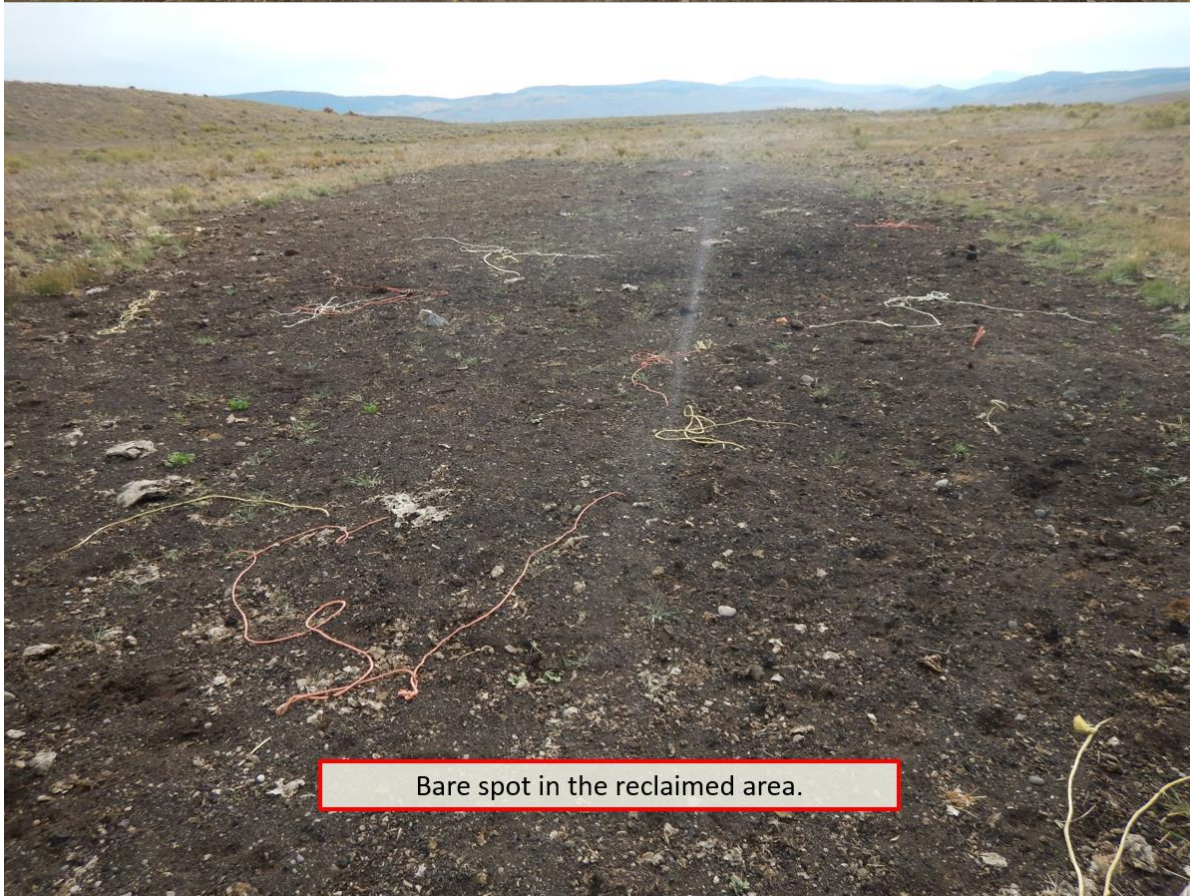
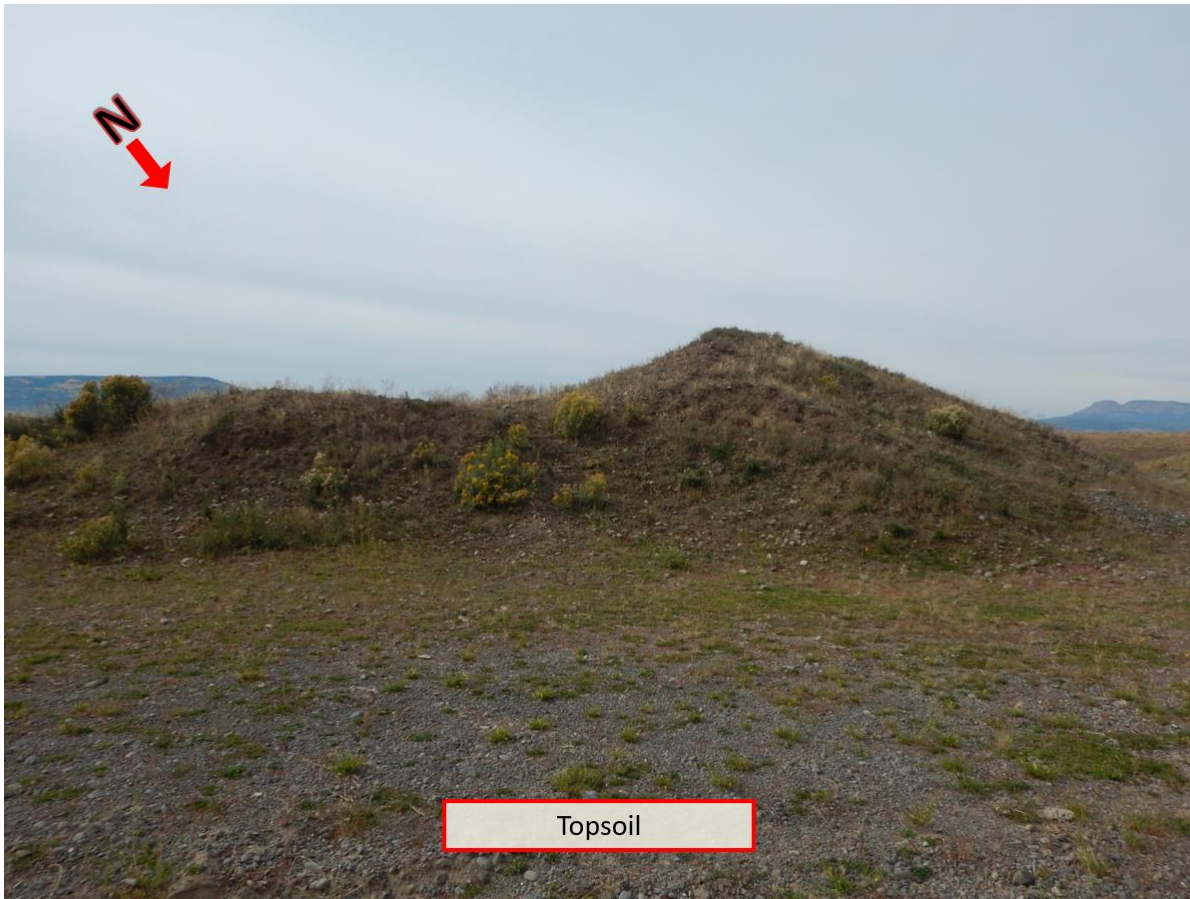
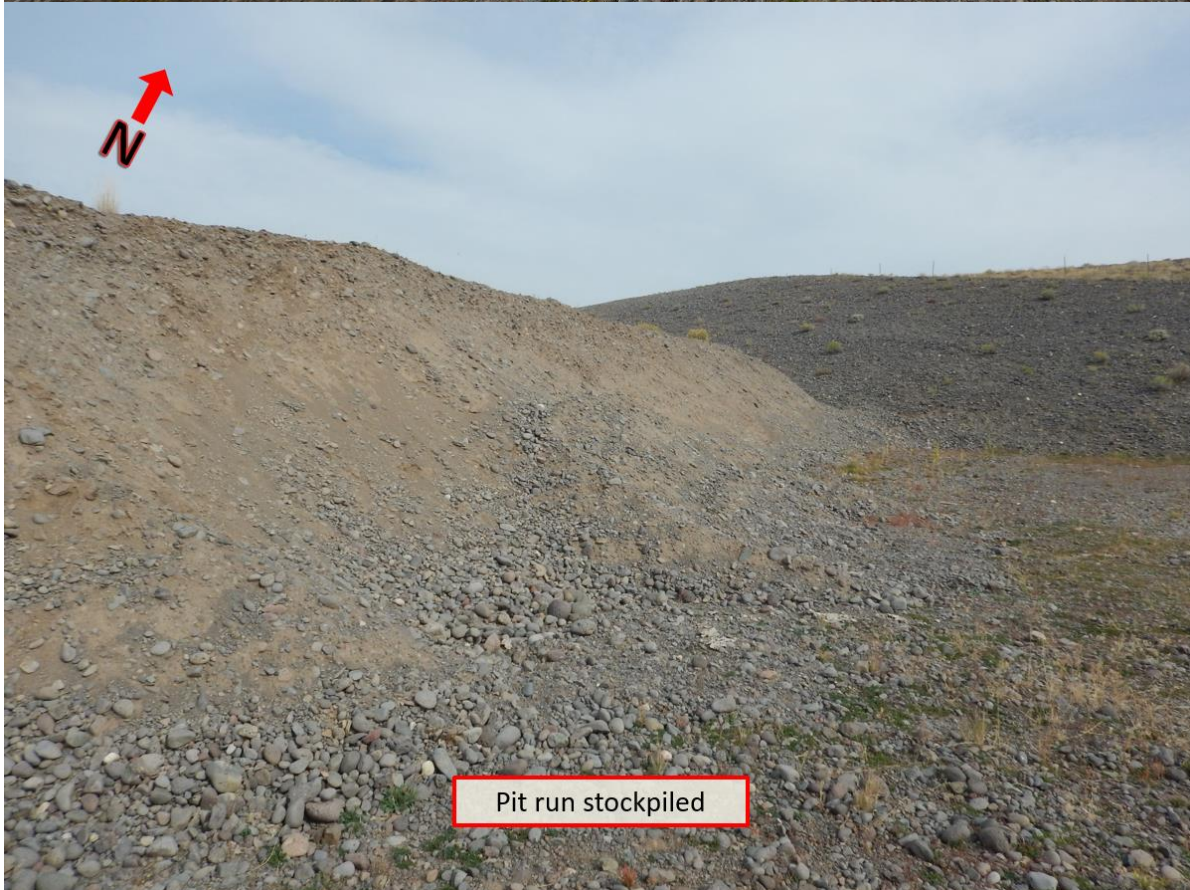
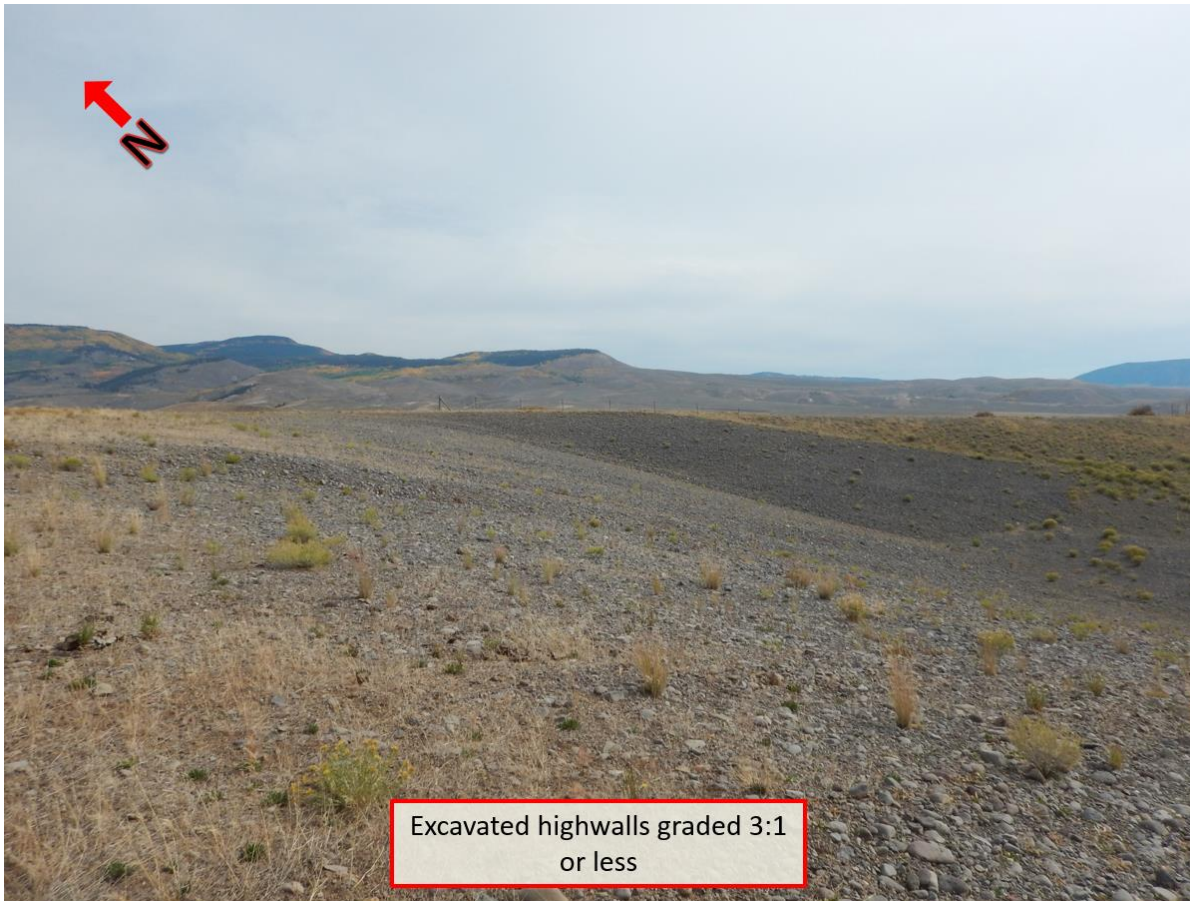
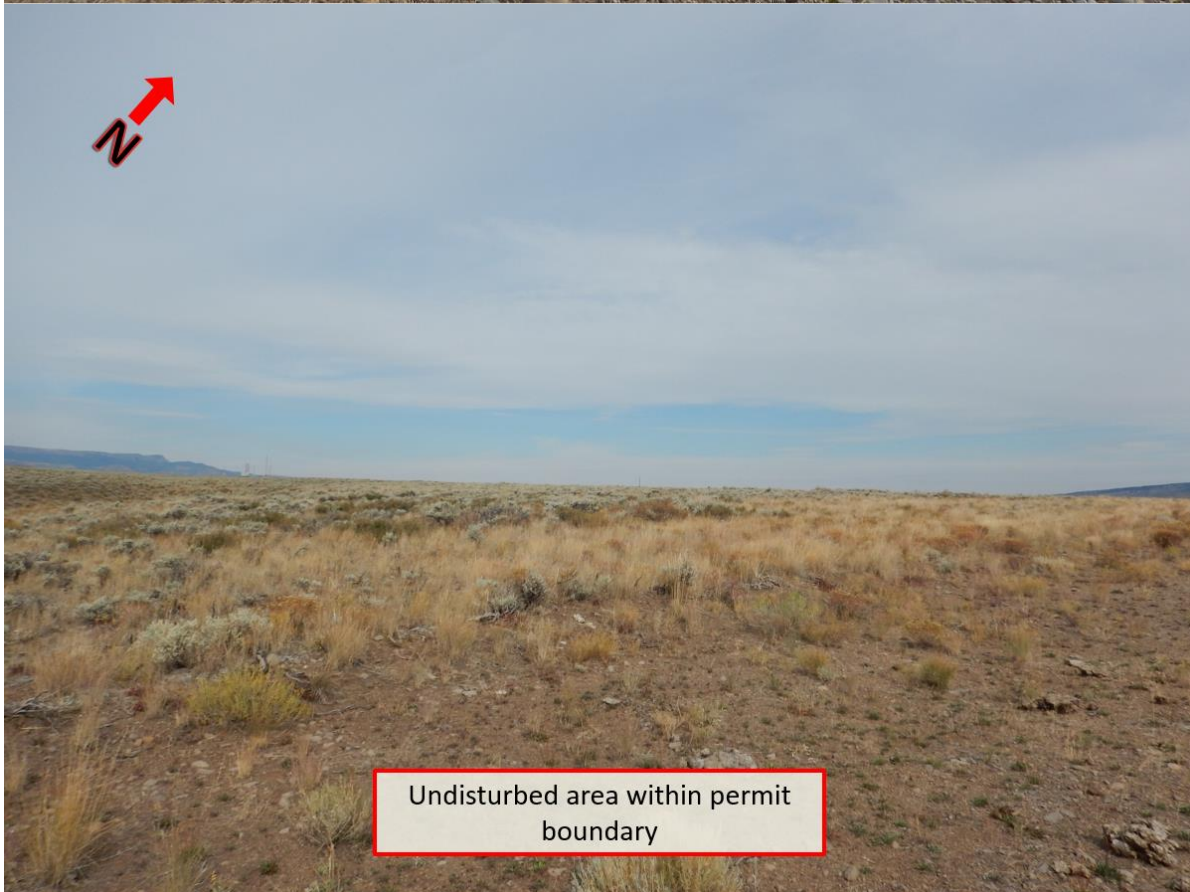
PHOTOGRAPHS

The site is currently not active but well maintained. This pit is used on a needed basis. The pit has one main highwall that is sloped approximately 3:1. Material is dozed down in to stockpiles and is then crushed. There are a few small stockpiles located throughout the site. All of which are stabilized with volunteer vegetation. No erosion problems were observed. No equipment, fuel or structures were observed.
