MINERALS PROGRAM INSPECTION REPORT
PHONE: (303) 866-3567

MINE NAME: Schmalz Const Pit	MINE/PROSPECTING ID#: M-1984-069	MINERAL: Sand and gravel	COUNTY: Gunnison
INSPECTION TYPE: Monitoring	INSPECTOR(S): Dustin M. Czaplá	INSP. DATE: September 15, 2016	INSP. TIME: 10:30
OPERATOR: Schmalz Construction Ltd	OPERATOR REPRESENTATIVE: None	TYPE OF OPERATION: 110c - Construction Limited Impact	
REASON FOR INSPECTION: Normal I&E Program	BOND CALCULATION TYPE: Complete Bond	BOND AMOUNT: \$21,654.00	
DATE OF COMPLAINT: NA	POST INSP. CONTACTS: None	JOINT INSP. AGENCY: None	
WEATHER: Clear	INSPECTOR'S SIGNATURE:

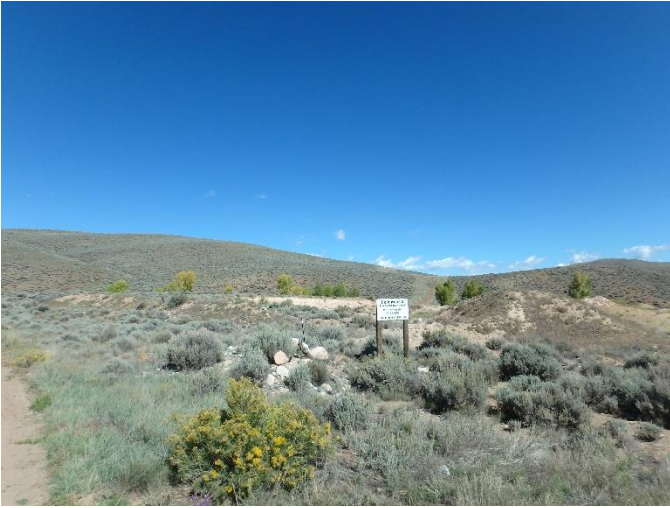
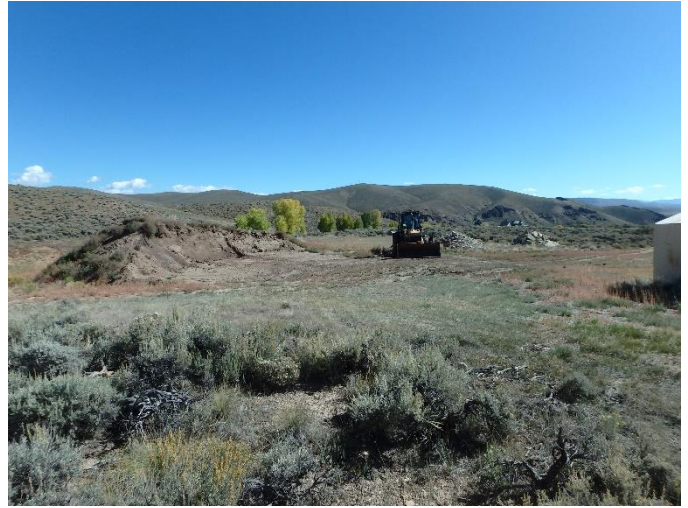
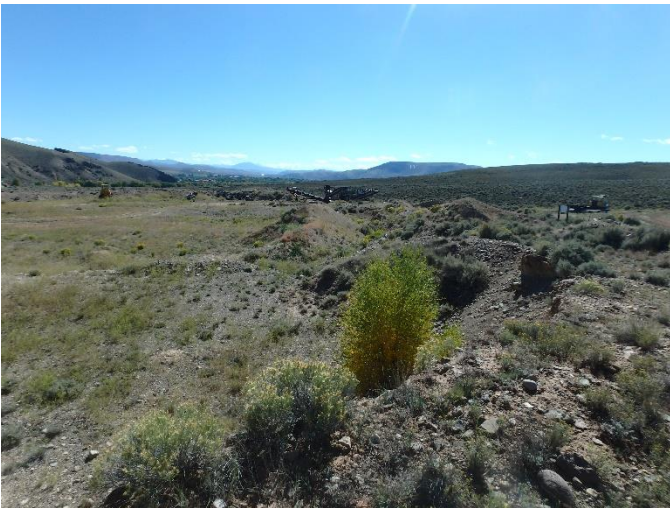
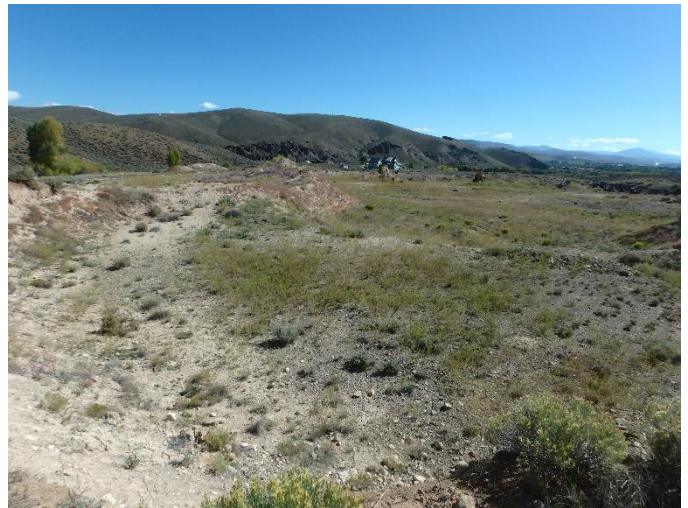
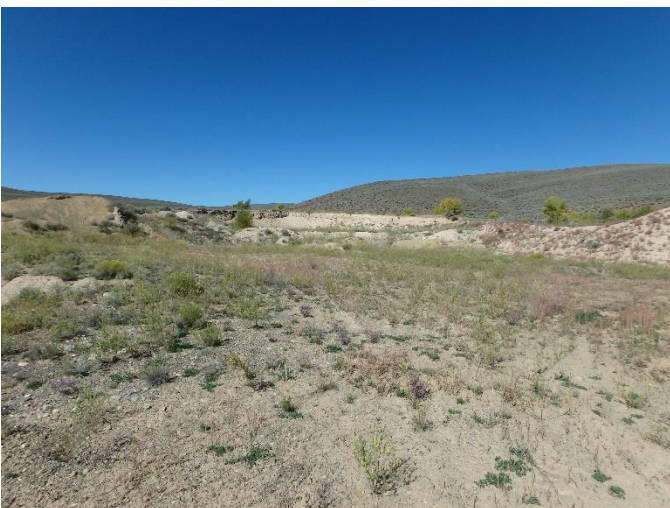
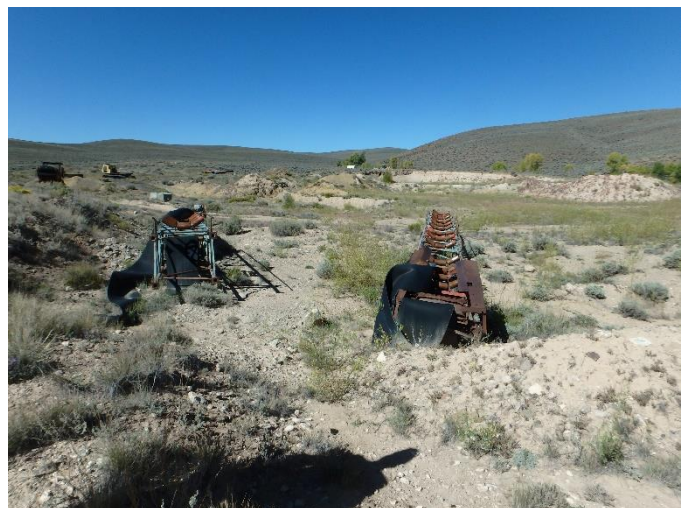
PHOTOGRAPHS

This inspection was conducted as part of the Division of Reclamation, Mining and Safety's (Division) normal monitoring program. A representative for the operator was not present. Photographs are included with this report in order to illustrate some of the conditions observed.

There has been little change at the site since the Division's last inspection. There is a highwall along the west end of the pit. Material has sloughed from the highwall resulting in an approximately 0.5H:1V slope. Several topsoil stockpiles were noted around the perimeter of the pit, and various product piles within the pit. Various old equipment was noted around the pit area, some mine related some not.
