RE: Dawson Gold Project P-2013-002
Future ground water and surface water baseline study

RE: Zephyr Gold USA LTD - Recommendations for Future Ground and Surface Monitoring Point Locations Resulting from Mine Plan Updates at the Dawson Property

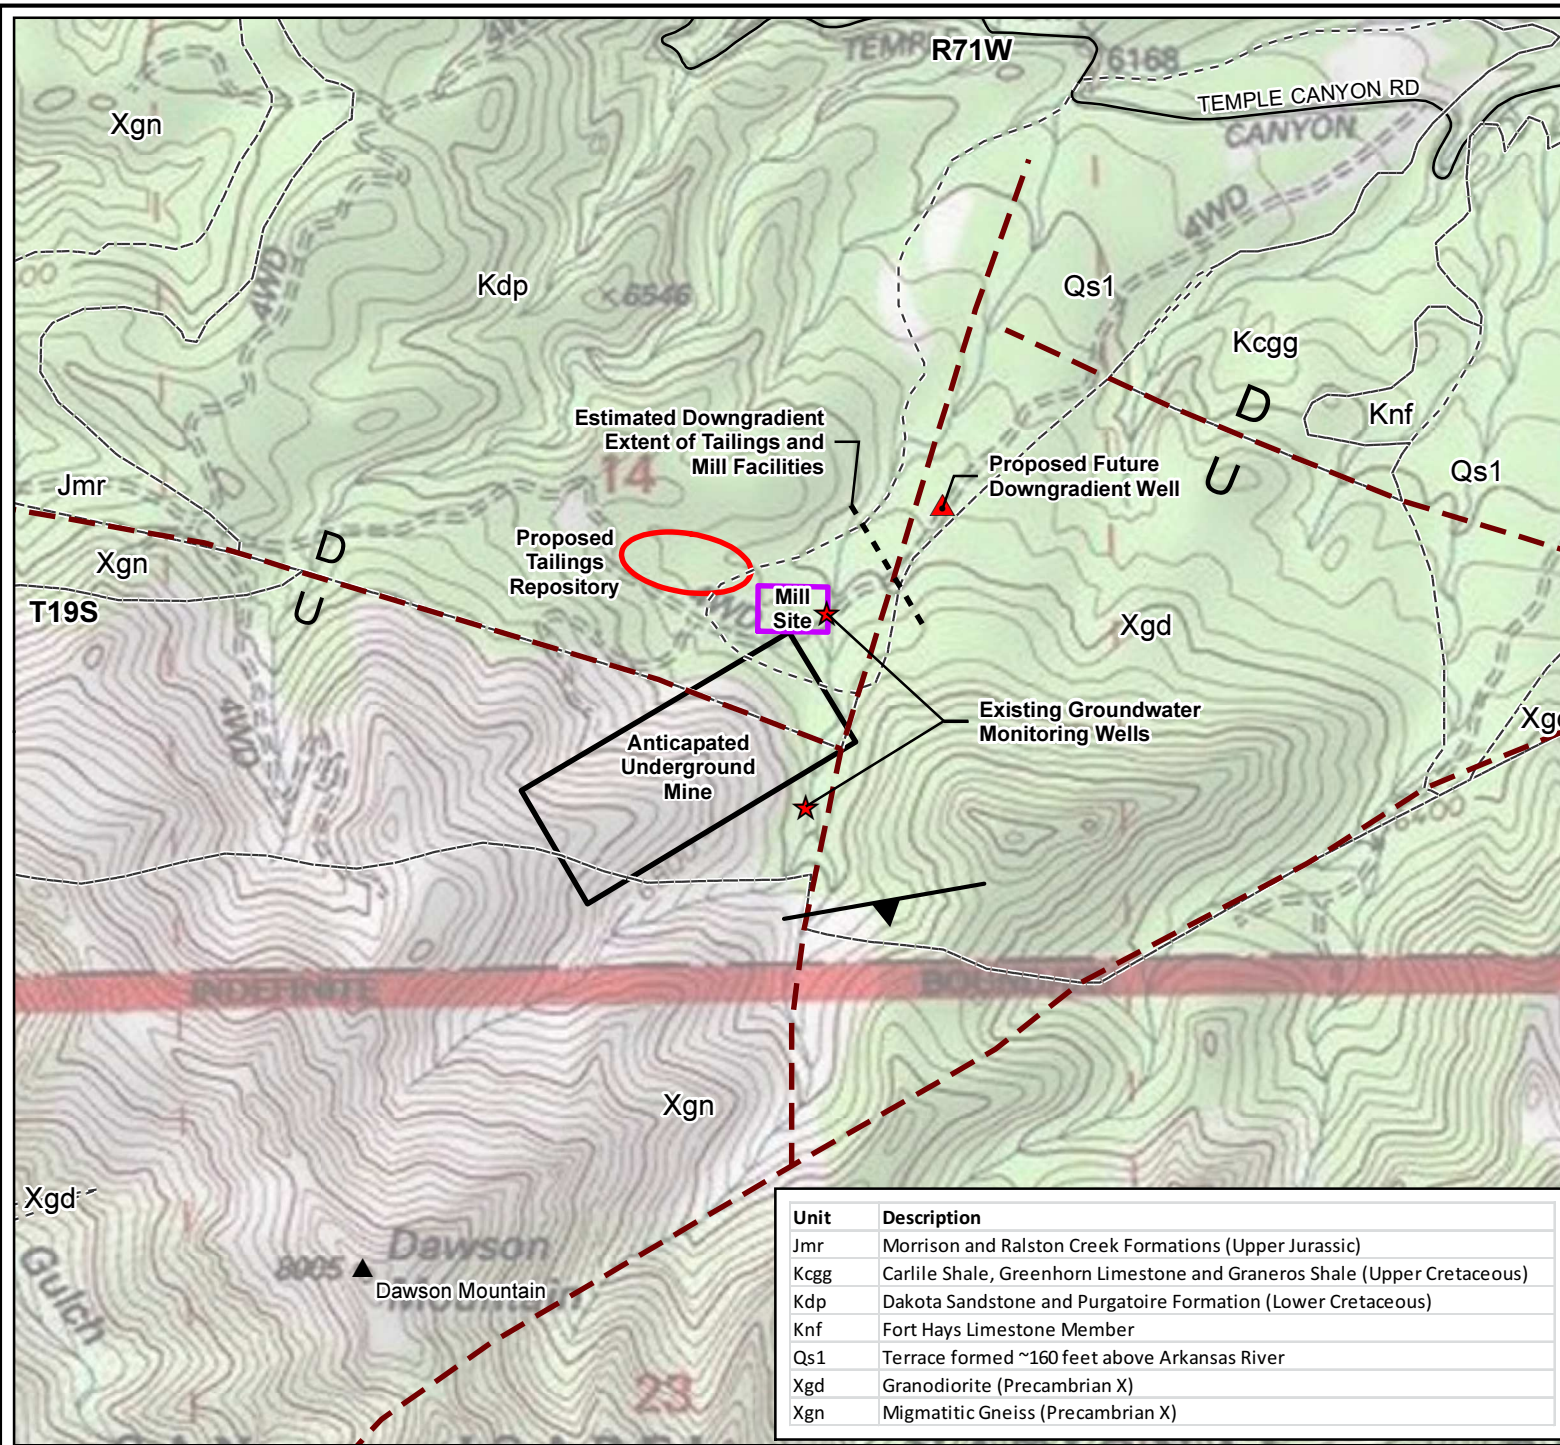
Figure 1 presents the locations of the existing ground water monitoring points and the conceptual / generalized locations of the future tailing repository and the mill site. We have also shown on the map the estimated downgradient extent of tailings and mill facilities. When we met and visited the site, you demonstrated to me your understanding of downgradient extent of these facilities. To be conservative and to maximize our confidence that the proposed monitoring locations adequately capture downgradient impacts, we shifted the estimated downgradient extent slightly (approximately 400 feet) farther to the north and east of the location identified in the field. We recommend that a future ground and surface water monitoring point is located slightly downgradient of this estimated downgradient extent of tailings and mill facilities.

Figure 1 shows the “Proposed Future Downgradient Well Location”, which is the location at which we propose to construct a future monitoring well. We staked a location in the field and confirmed that this location should be accommodating for a monitoring well, including site and rig access. It is our opinion that the existing monitoring points provide adequate baseline data for down gradient impacts, and this proposed new well does not need to be constructed until the time at which tailings are placed at the proposed repository or the mill is constructed at the site.

Since the existing monitoring points were installed, we have learned that the updated mine plan will result in milling facilities and tailing piles farther to the northeast than was previously anticipated. As a result, the existing ground water and surface water monitoring points may not be located to adequately sample and monitor for possible impacts resulting from all planned milling and tailing activities. We are providing recommendations for future ground and surface water monitoring points located farther down gradient, intended to monitor ground and surface water for any changes resulting from all of the planned mining activities, including the mill and tailings.

- Section 14, T19S, R71W, 6th P.M., 862 ft. west of the east section line and 2,373 ft. north of the south section line
- X-UTM: 47,4297, Y-UTM: 4,249,578
