RE: Zephyr Gold USA Ltd (Zephyr)
Dawson Gold Project P-2013-002
NOI Modification, Revision No. MD-3
Response to Second Notice of Deficiencies dated January 24, 2017

- Figure 3: Proposed Exploration Roads
- Figure 4: Proposed Drill Road Typical Cross Section
- Figure 5: Proposed Drill Road Reclaimed Road Ballast Cross Section
- Figure 6: Proposed Drill Road Reclamation
- Jesik Consulting geotechnical memo
- New Form 2 page 7 of 14
- Photos 1 and 2: 2016 Exploration Activity
- Table 1: Reclamation Cost Estimate Summary

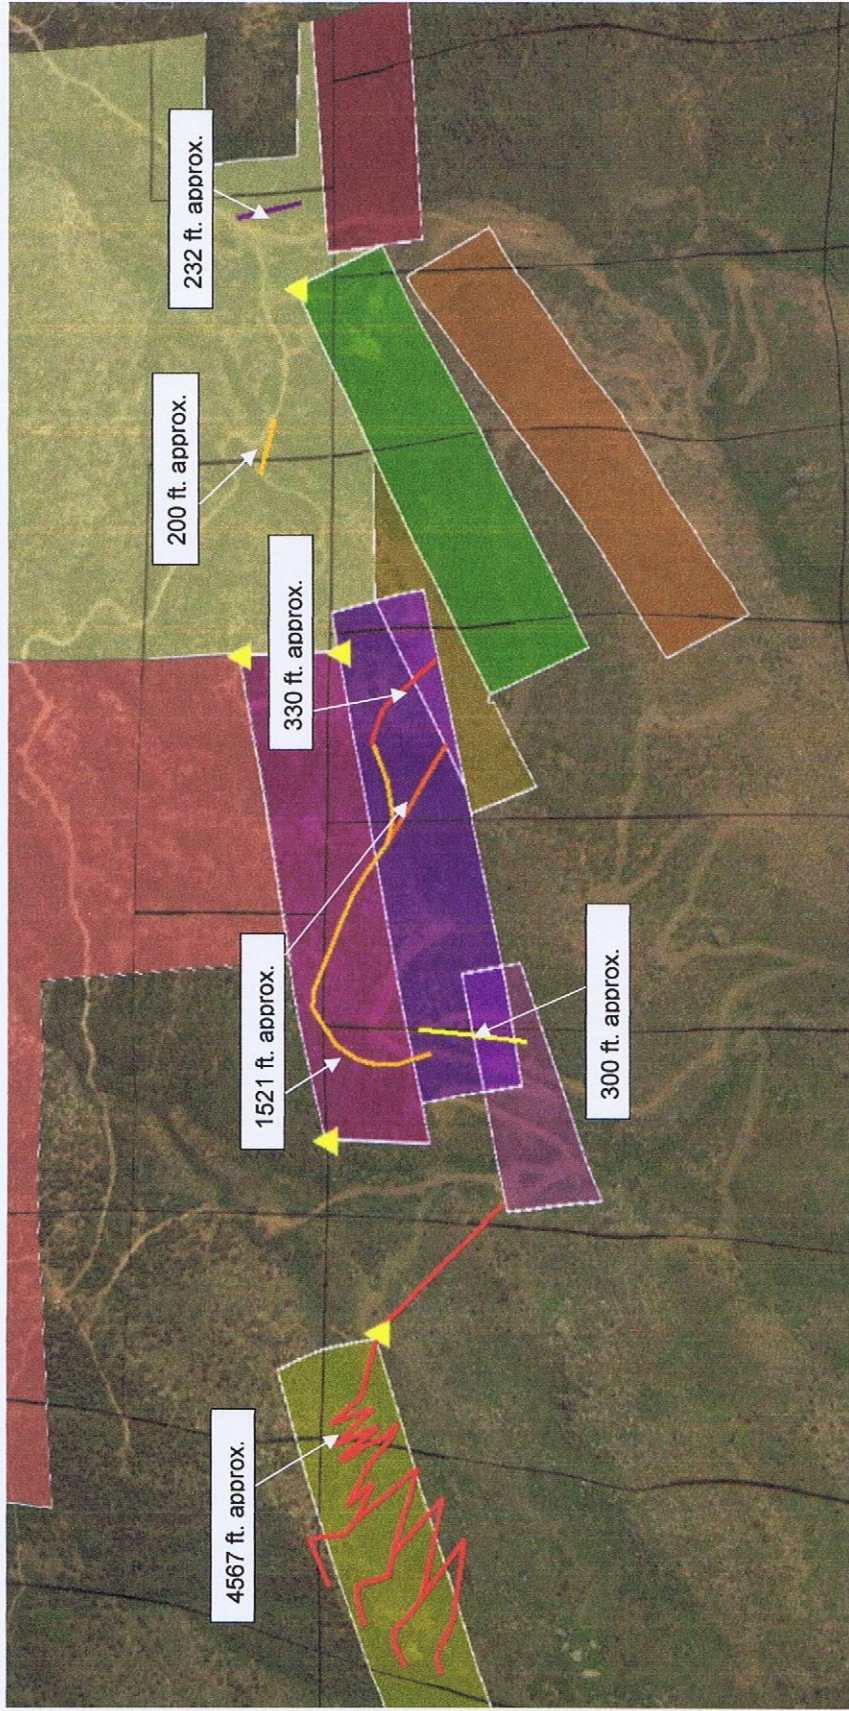
Figure 3: Estimated proposed new exploration roads lengths. Based on exploration activity performed to date, actual road constructed will likely be 25% less than projections.

- a. The proposed road length was revised to 7,150 linear feet (Figure 3) with approximately 540 ft. (0.5 acres) proposed on public land. Approximately 1,330 ft. of the bonded 1700 ft. of road has been constructed to date. The proposed maximum total disturbance for all exploration, performed to date and proposed, is approximately 7.8 acres.

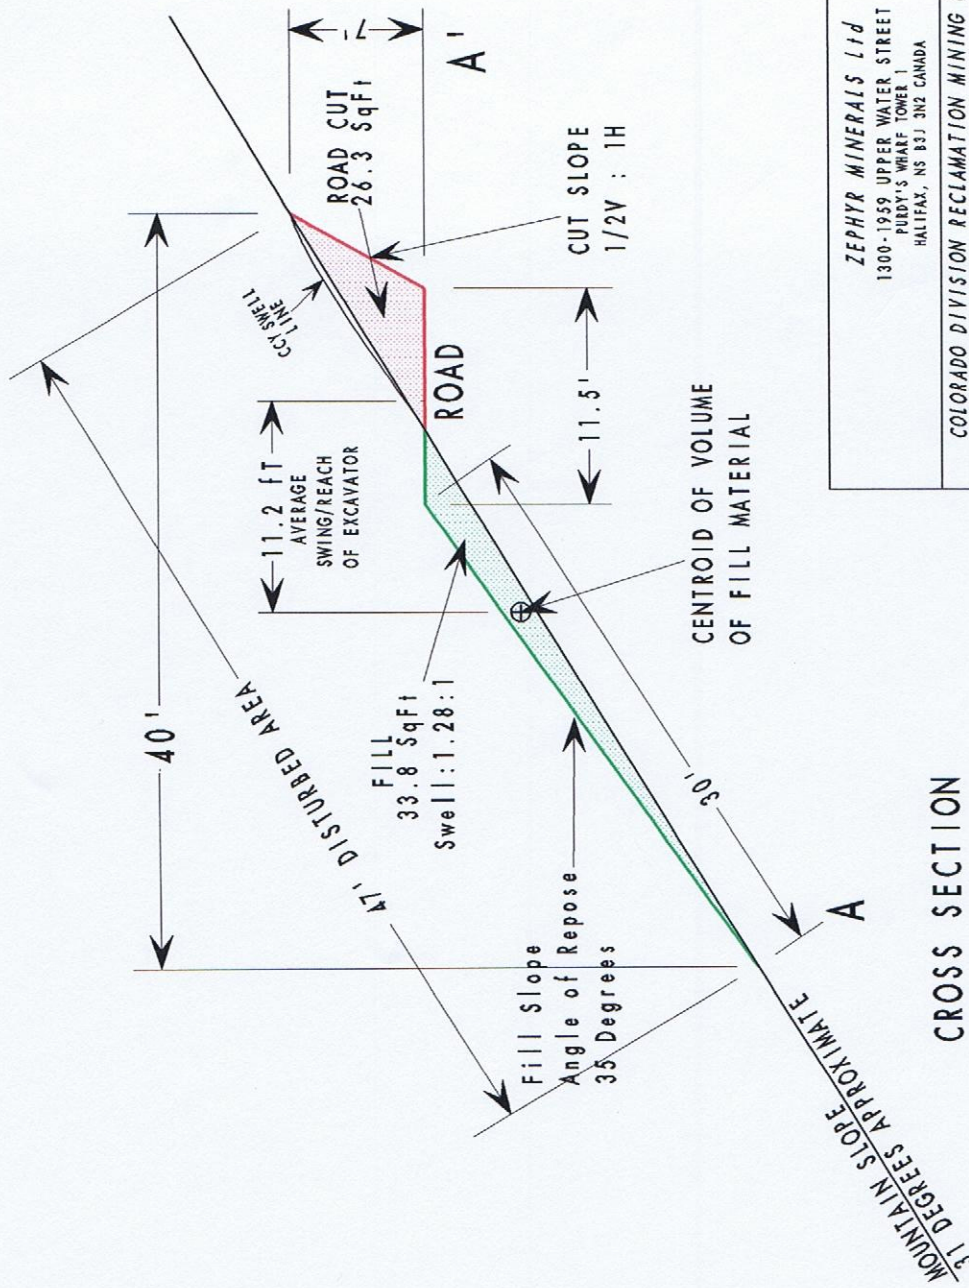
Figure 4

ZEPHYR MINERALS LTD 1300-1959 UPPER WATER STREET PURDY'S WHARF TOWER 1 HALIFAX, NS B3J 3N2 CANADA			
COLORADO DIVISION RECLAMATION MINING & SAFETY			
PROPOSED DRILL ROAD TYPICAL CROSS SECTION DAWSON MINE			
SCALE	JOB NO.	DATE	DRAWN BY / REVISED BY
1" = 10'		02-18-17	EAI/GVP
			GVP

Because the project is located in an area of Cathedral rock outcrop, the majority of the road cuts are stable rock faces. During reclamation, road cut material that was pushed onto the repose area during construction will be pulled from the slope, placed in the road cut using a 324DL excavator with a 60 ft. reach, compacted and shaped with the excavator bucket. The mountainside road scenario limits operating space for what would typically utilize multiple pieces of equipment to perform reclamation. The 324DL excavator was chosen not only for its reach capability but also for its maneuverability in tight situations (Figures 4, 5 and 6).

- 4. Road cut material will be placed down slope at the angle of repose as presented on Figure 4. The material will be replaced on the road cut and contoured to the natural slope during reclamation. Photo 1 is the drill pad constructed in 2013 showing natural revegetation of the repose material. Photo 2 is the same drill pad from the road below illustrating the steep grade, natural revegetation success and minimal erosion.

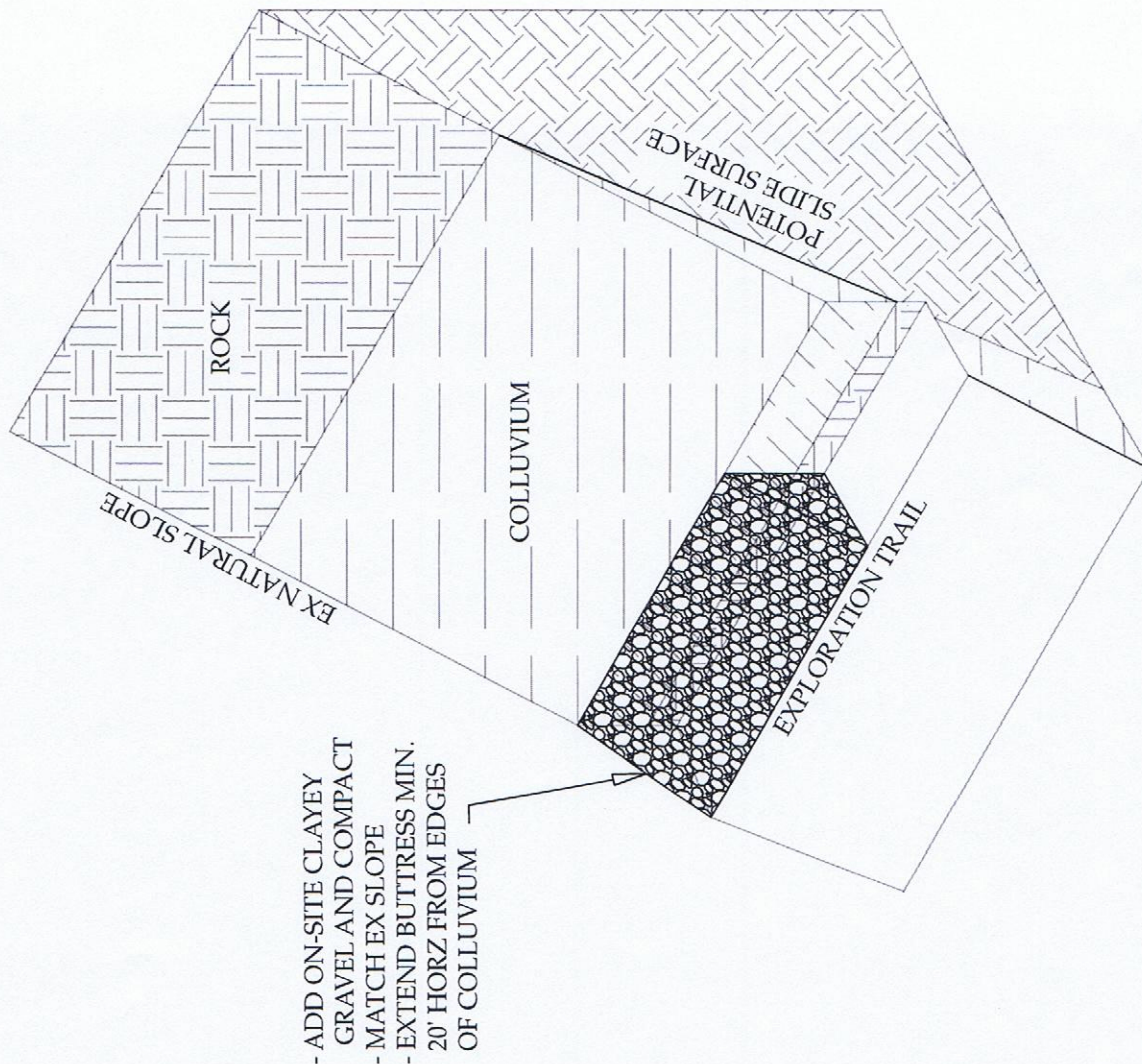
Attachment A – Rock Buttress Figure

PROJECT NUMBER:	17-7244	SHEET:	FIG 1
DATE:	2/9/2017	SCALE:	NTS

TRAIL STABILIZATION SECTION FOR:	ZEPHYR GOLD
	FREMONT COUNTY, COLORADO
	SOIL/ROCK FILL BUTTRESS
	DETAIL

To minimize colluvium/rock contact slippage a soil and rock buttress should be placed in the areas of the exploration trails that extend through the colluvium material. The rock buttresses should extend a minimum of 20 feet from each side of the colluvium material. An example rock buttress is shown on the attached Figure 1.

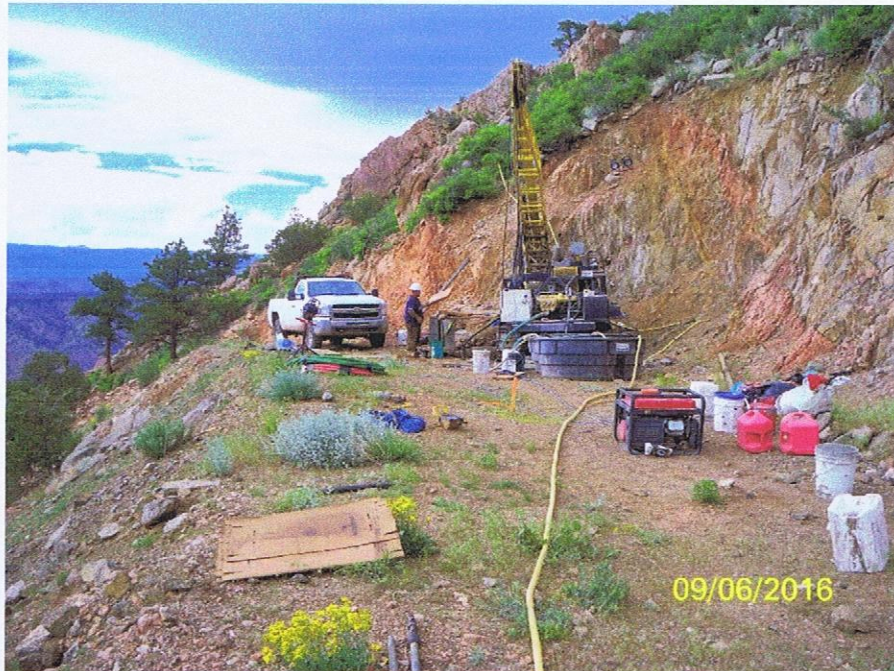
Photo 1: 2013 drill pad reused in 2016. Note natural revegetation of road surface, road cut material and road cut. Erosion channels are not present on the drill pad or road cut material. Drill cuttings are contained in plastic tubs

- 6. As presented in Photo 1, exploration drillers use plastic tubs for mud cuttings and water storage. Mud pits have not been used and will not be used.

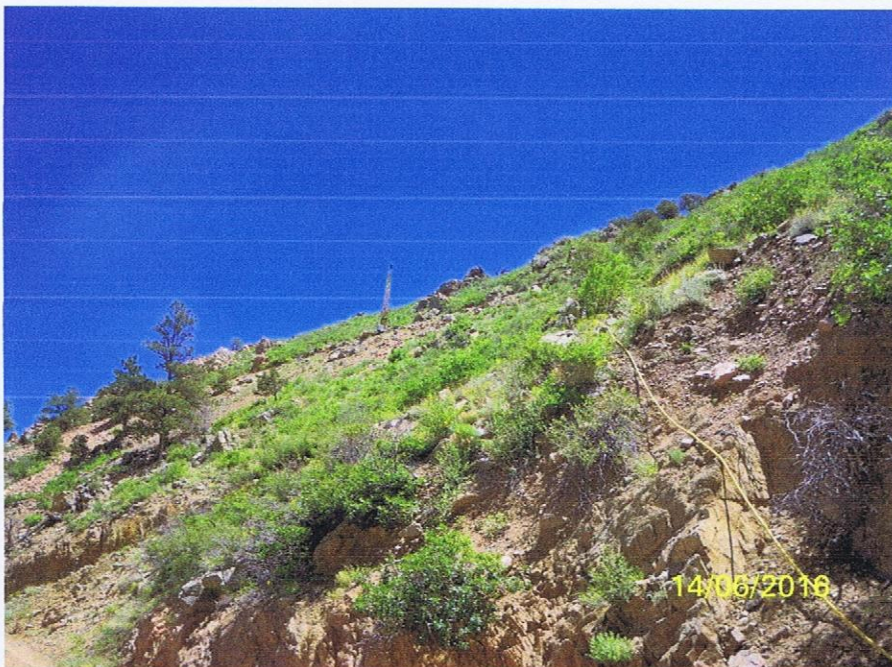
Photo 2: 2013 drill pad in Photo 1 viewed from exploration road below the drill pad. The steep slope and road cut material do not show signs of erosion and are naturally revegetating.
