MINERALS PROGRAM INSPECTION REPORT
PHONE: (303) 866-3567

MINE NAME: Corey Gravel Pit #3	MINE/PROSPECTING ID#: M-1987-024	MINERAL: Sand and gravel	COUNTY: Montrose
INSPECTION TYPE: Monitoring	INSPECTOR(S): Dustin M. Czaplá	INSP. DATE: March 16, 2017	INSP. TIME: 11:30
OPERATOR: Western Gravel, Inc.	OPERATOR REPRESENTATIVE: Shauna Hovey	TYPE OF OPERATION: 112c - Construction Regular Operation	
REASON FOR INSPECTION: Normal I&E Program	BOND CALCULATION TYPE: Partial Bond	BOND AMOUNT: \$63,000.00	
DATE OF COMPLAINT: NA	POST INSP. CONTACTS: None	JOINT INSP. AGENCY: None	
WEATHER: Clear	INSPECTOR'S SIGNATURE:

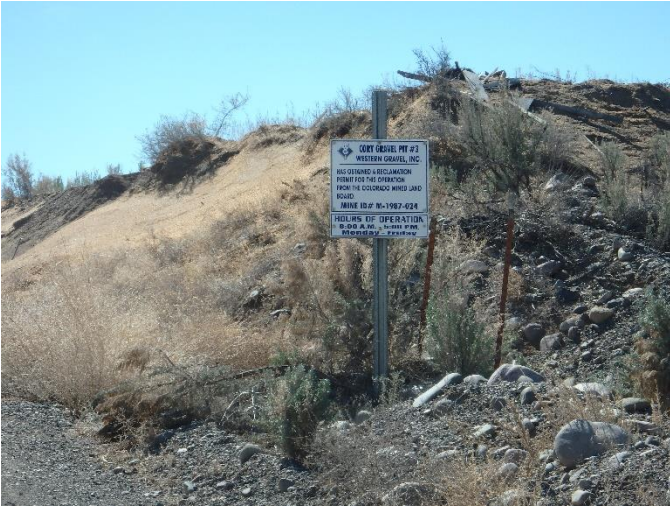
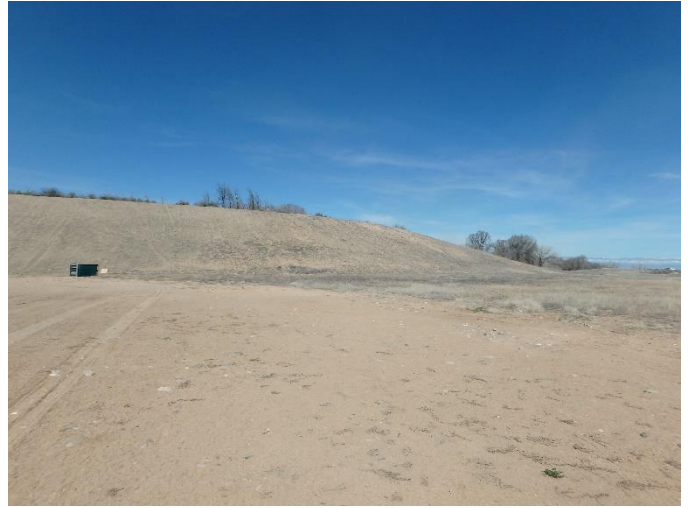
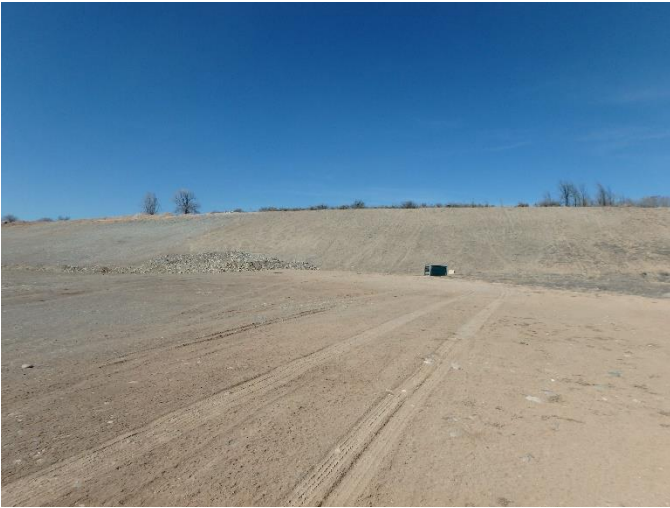
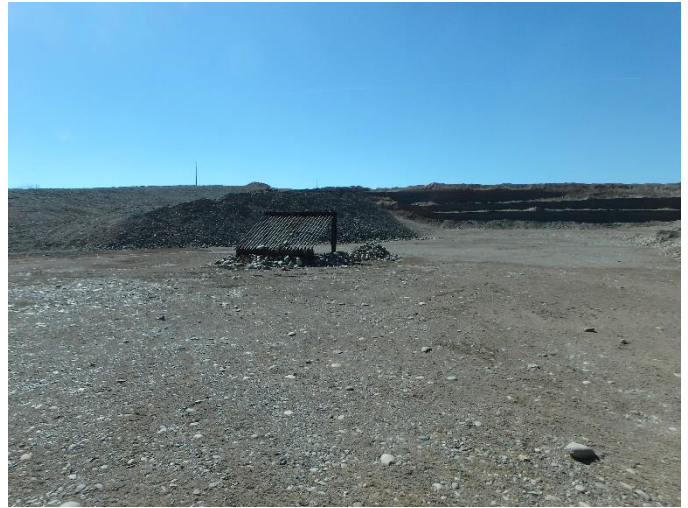
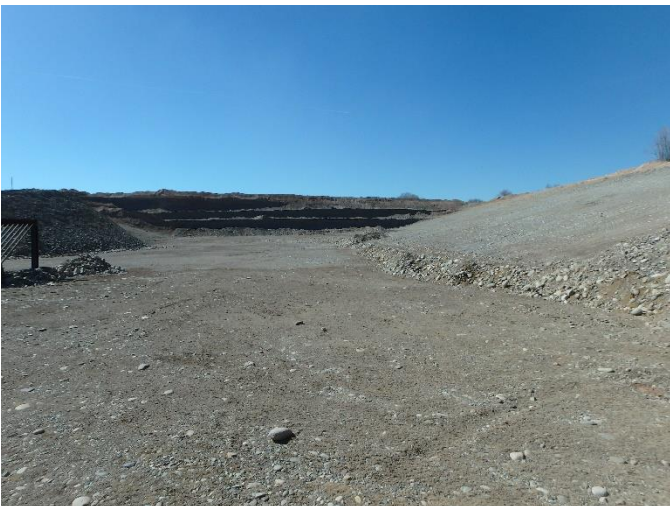
PHOTOGRAPHS

This inspection was conducted as part of the Division of Reclamation, Mining and Safety's (Division) normal monitoring program. Shauna Hovey, representing the Operator, was present during this inspection. Photographs are included with this report in order to illustrate some of the conditions observed.

The reclamation slope work that was completed on the north end of the pit still looks good. No signs of excessive erosion were noted. The slope was graded to 3H:1V and the floor area was graded flat. The area has been seeded but vegetation is still nearly nonexistent. It was recommended to the operator to complete a soil analysis and to consult the local NRCS in order to determine if the current seed mix will be suitable for the site.
