MINERALS PROGRAM INSPECTION REPORT

MINE NAME: Glen's Pit	MINE/PROSPECTING ID#: M-2005-075	MINERAL: Gravel	COUNTY: Garfield
INSPECTION TYPE: Monitoring	INSPECTOR(S): Amy C. Yeldell	INSP. DATE: April 13, 2017	INSP. TIME: 10:30
OPERATOR: Oldcastle SW Group, Inc. dba United Compai County	OPERATOR REPRESENTATIVE: Jason Burkey	TYPE OF OPERATION: 112c - Construction Regular Operation

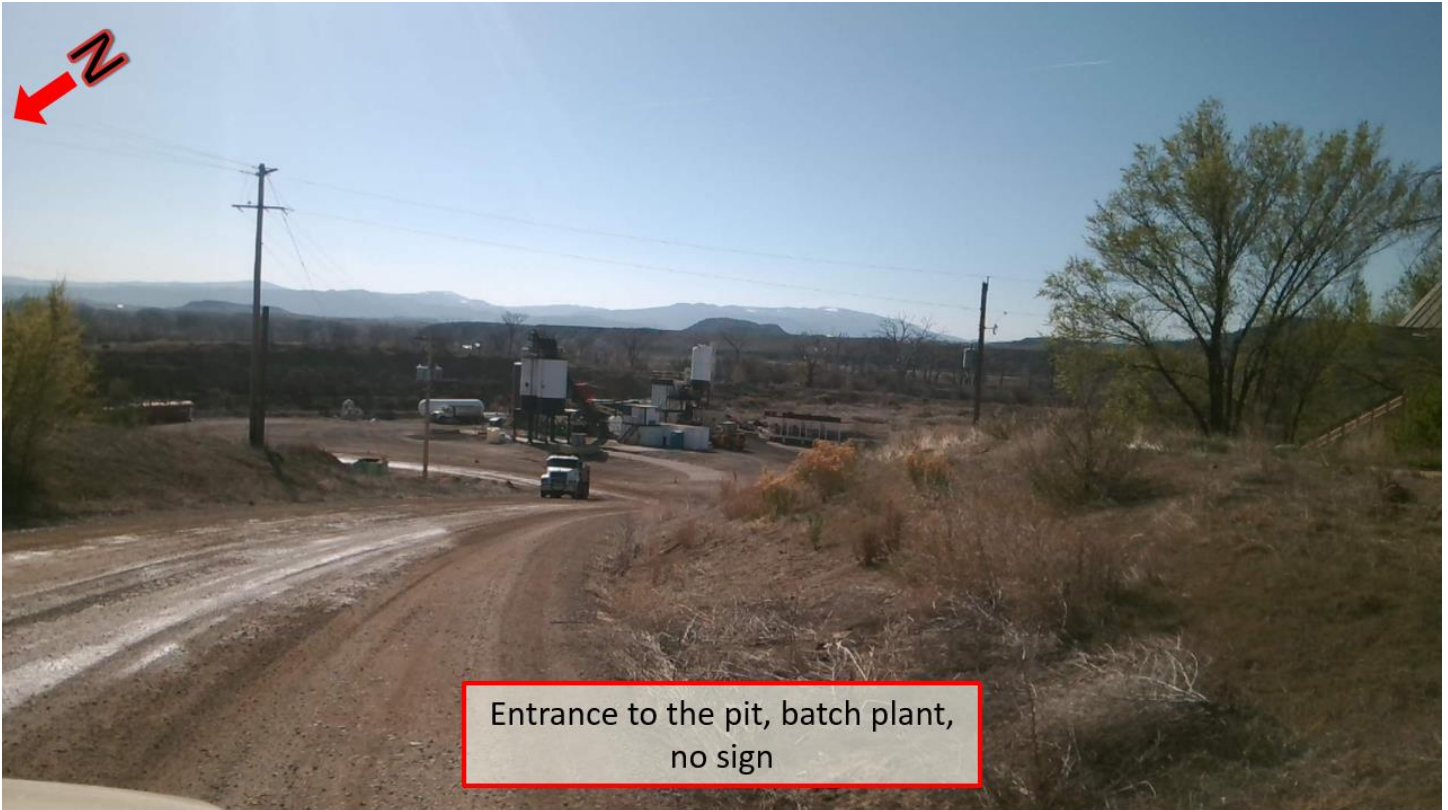
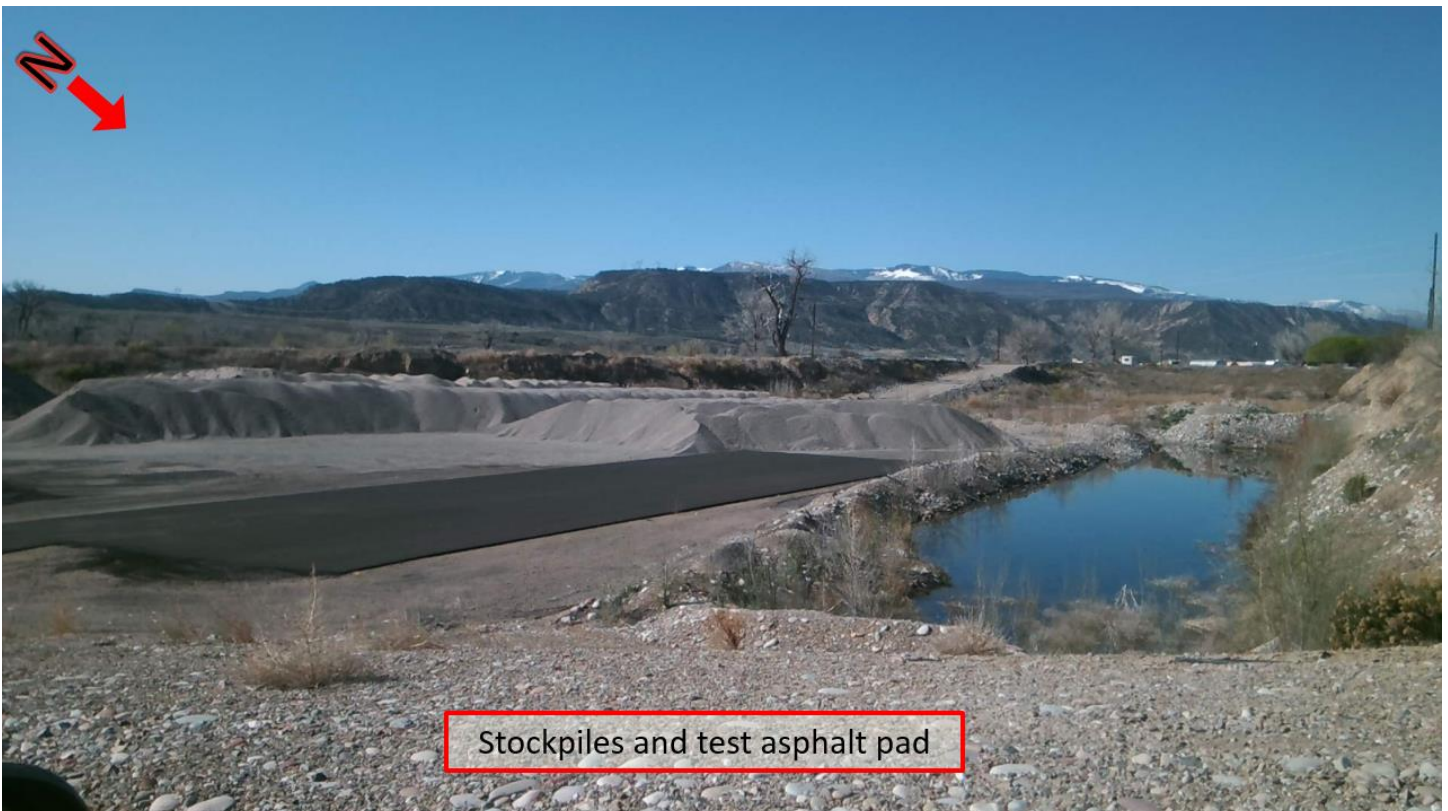
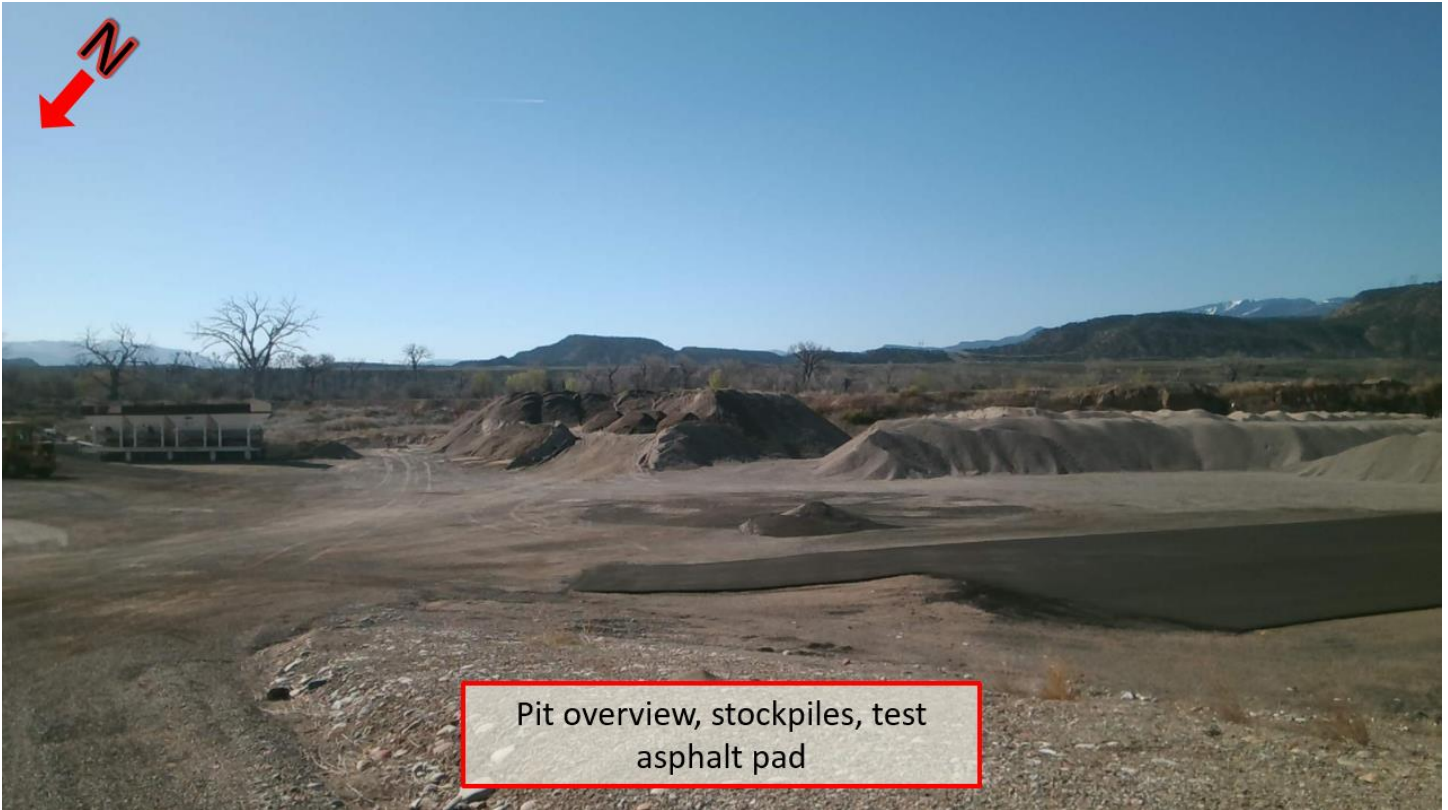
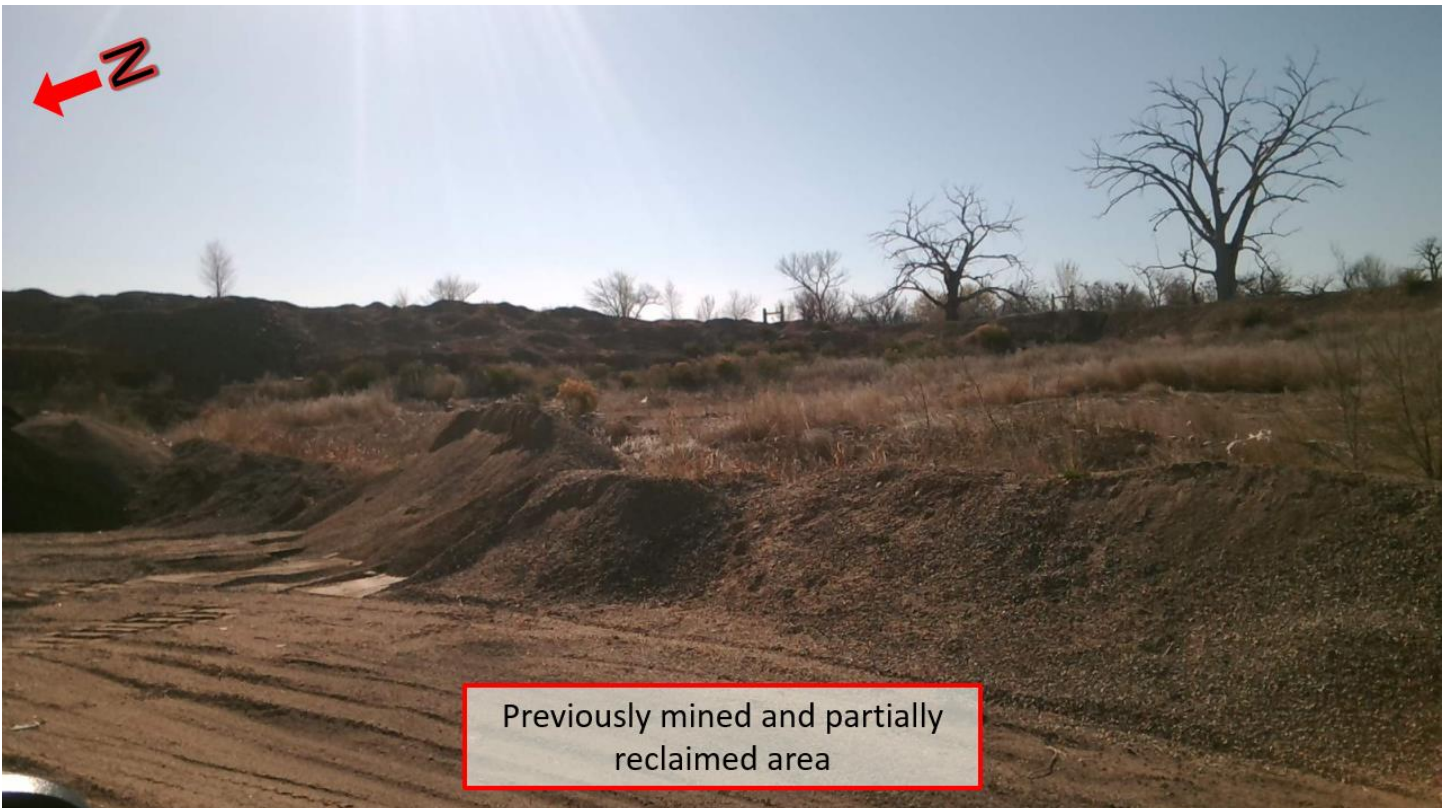
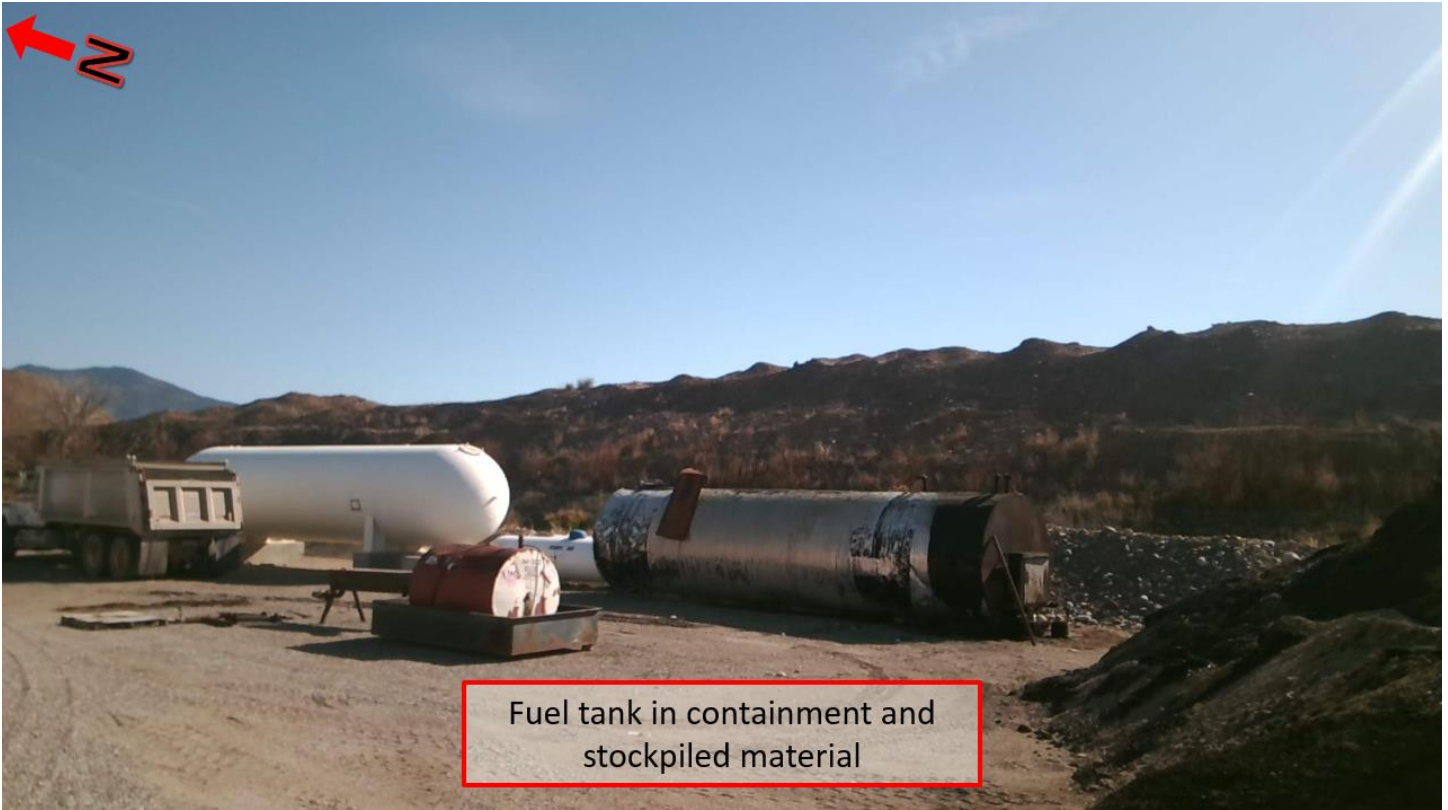
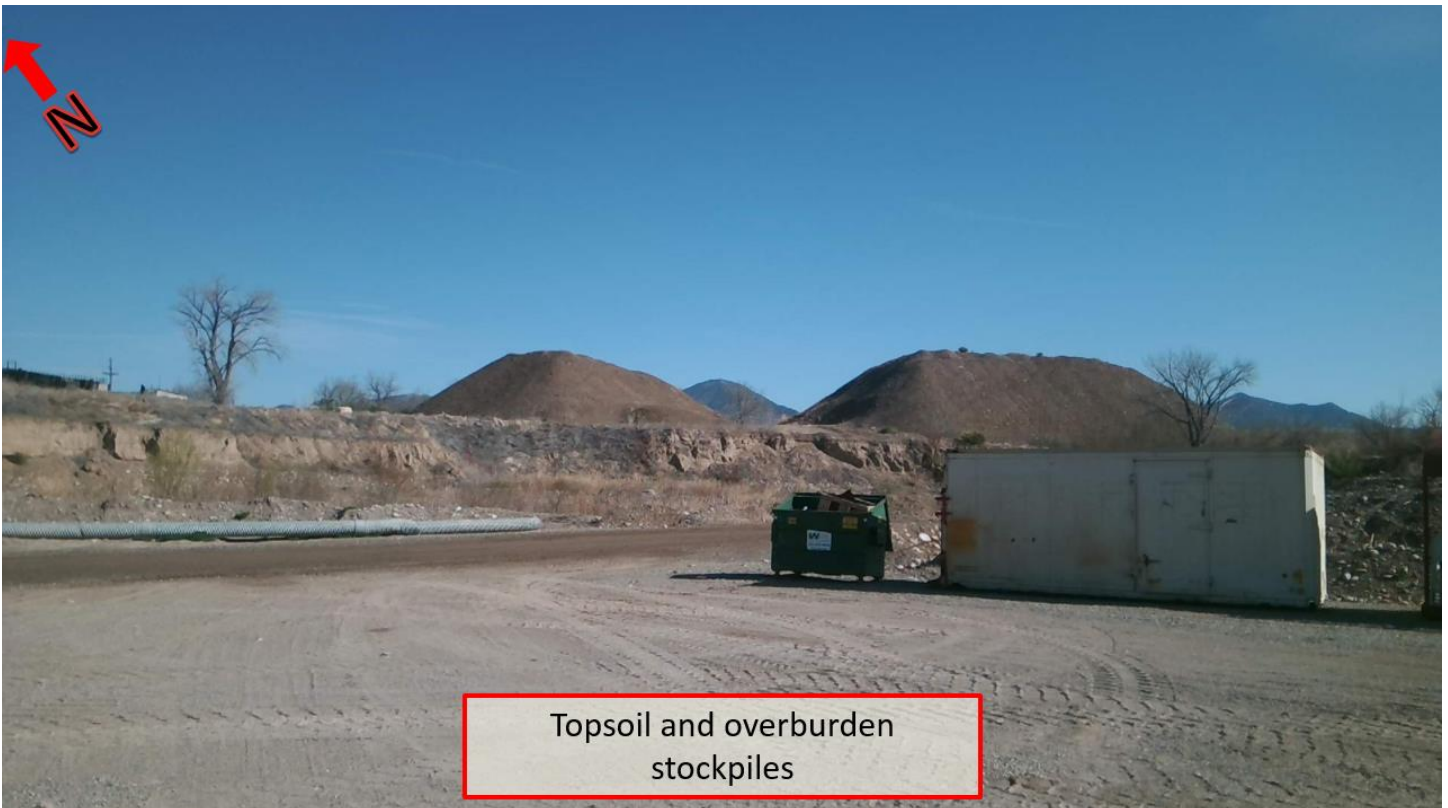
PHOTOGRAPHS

There is an asphalt plant located on the pit floor. Several fuel tanks are in secondary containment and located adjacent to the plant. Topsoil and overburden are stored in a large pile on the north side of the pit. Several stockpiles are located on the pit floor. A large asphalt test pad was also observed.
