**MINERALS PROGRAM INSPECTION REPORT**  
**PHONE: (303) 866-3567**

<b>MINE NAME:</b> Colony Shale Oil Project	<b>MINE/PROSPECTING ID#:</b> M-1980-047	<b>MINERAL:</b> Oil shale	<b>COUNTY:</b> Garfield
<b>INSPECTION TYPE:</b> Monitoring	<b>INSPECTOR(S):</b> Travis H. Marshall	<b>INSP. DATE:</b> May 23, 2017	<b>INSP. TIME:</b> 10:00
<b>OPERATOR:</b> Exxon Mobil Corporation	<b>OPERATOR REPRESENTATIVE:</b> Paul Caponigro	<b>TYPE OF OPERATION:</b> 112 - Hard Rock Regular Operation	
<b>REASON FOR INSPECTION:</b> Normal I&E Program	<b>BOND CALCULATION TYPE:</b> None	<b>BOND AMOUNT:</b> \$30,000,000.00	
<b>DATE OF COMPLAINT:</b> NA	<b>POST INSP. CONTACTS:</b> None	<b>JOINT INSP. AGENCY:</b> None	
<b>WEATHER:</b> Clear	<b>INSPECTOR'S SIGNATURE:</b>

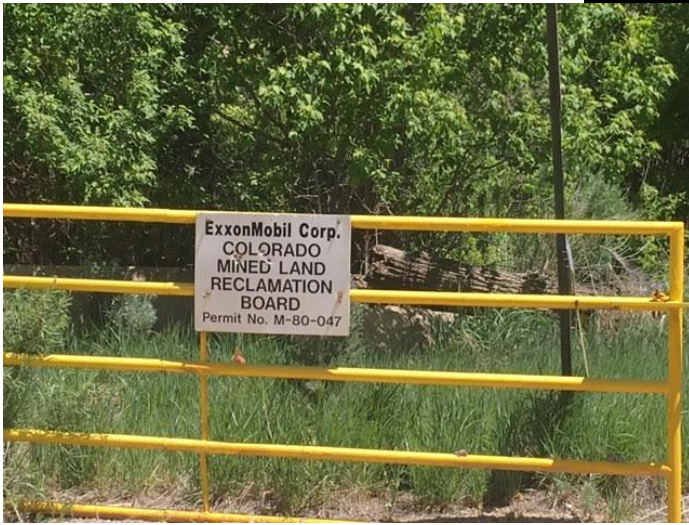
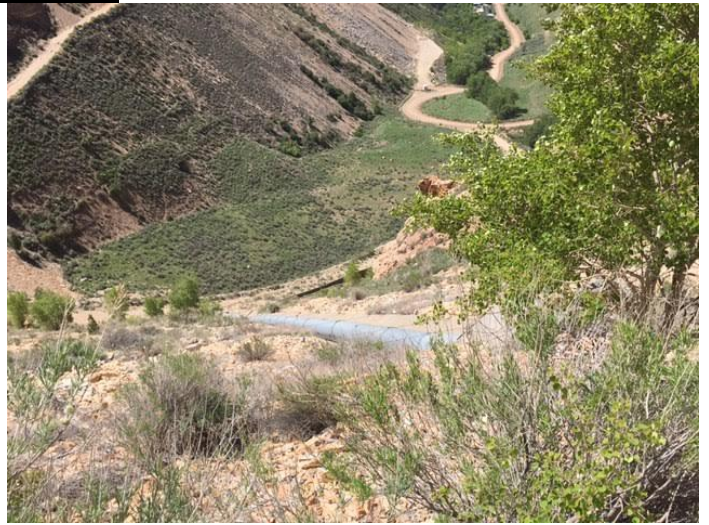
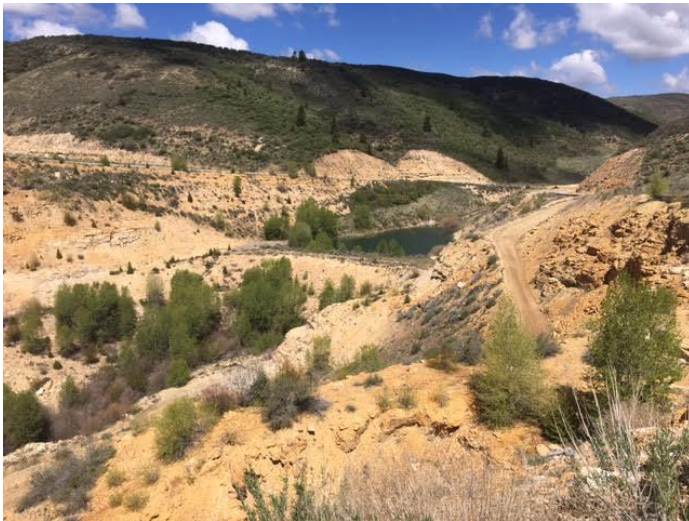
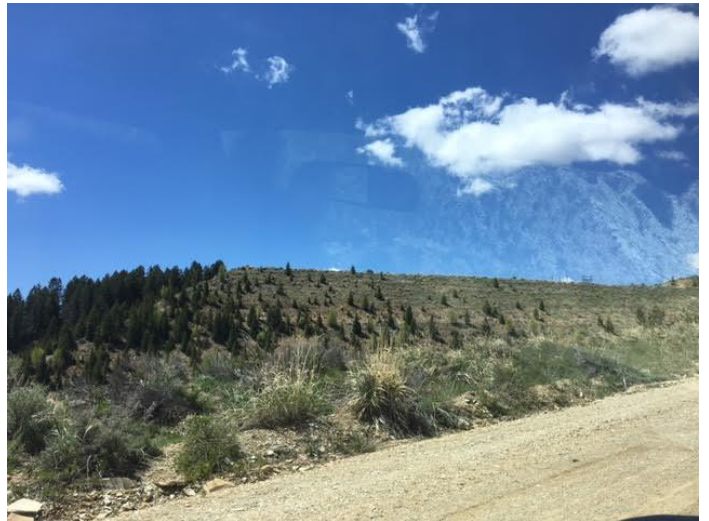
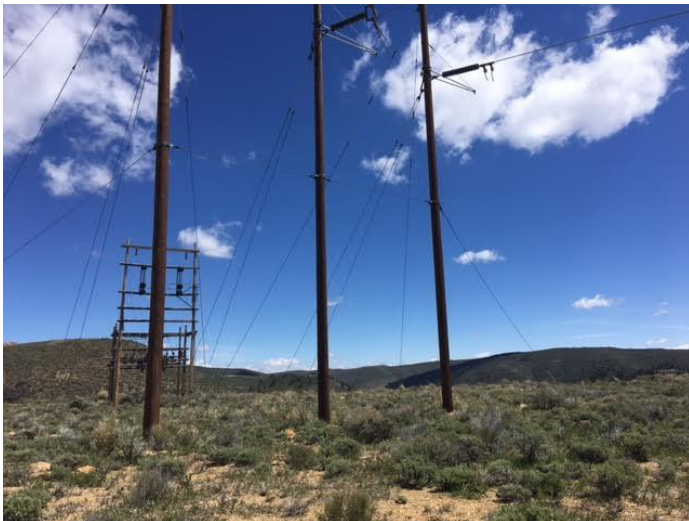
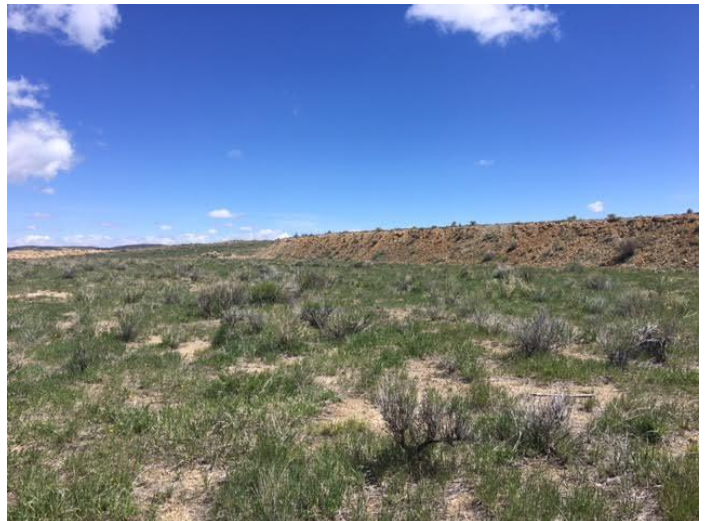
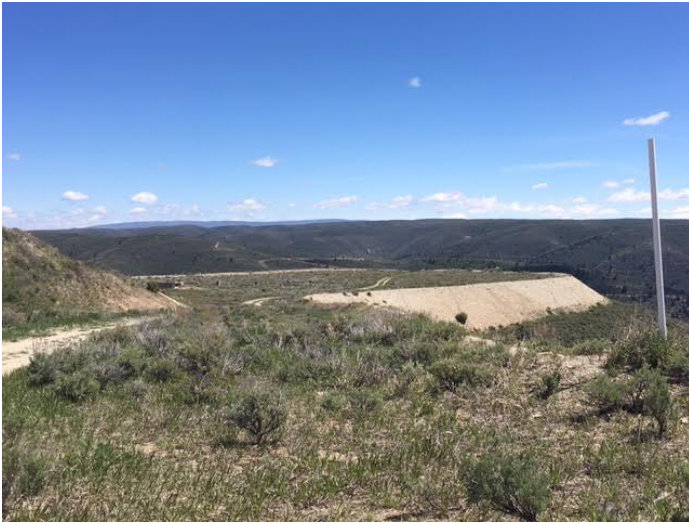
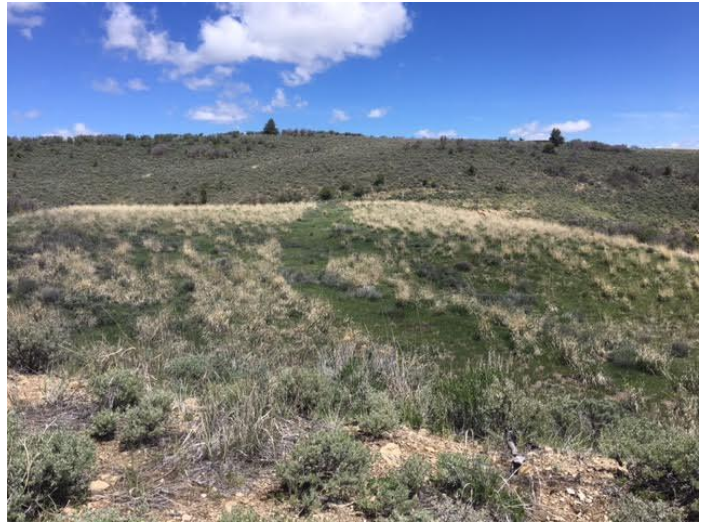
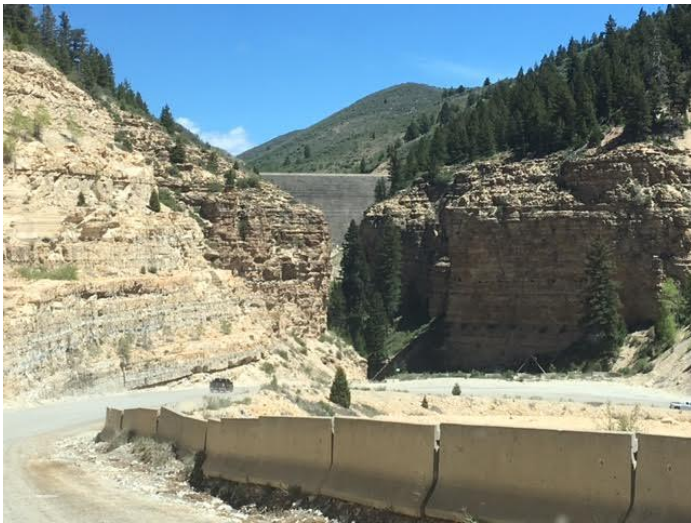
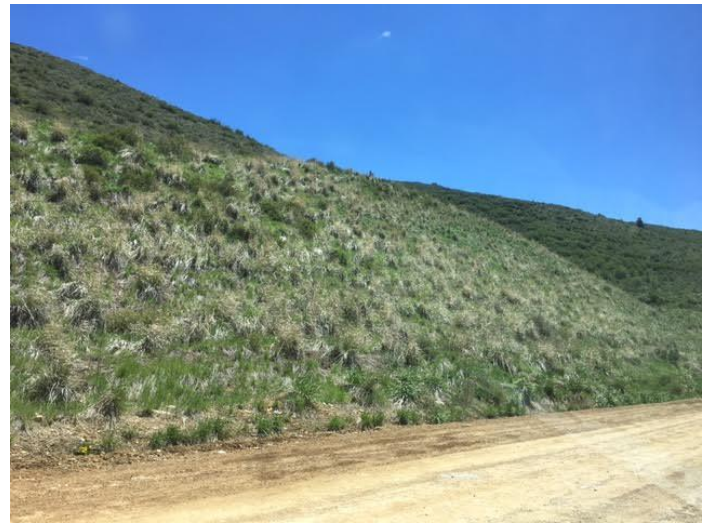
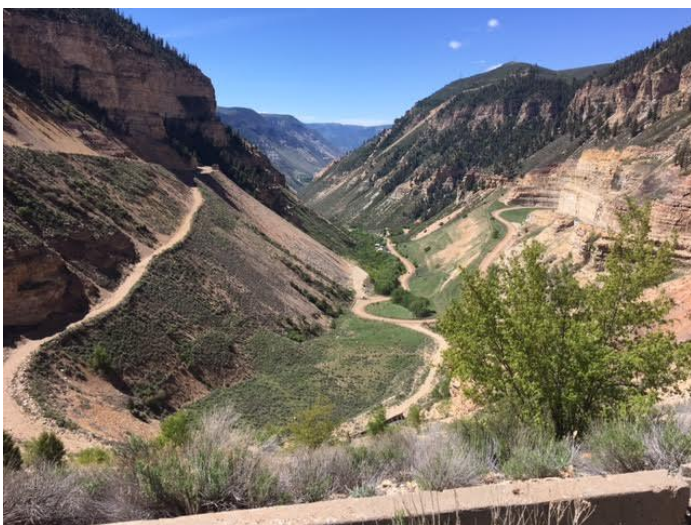
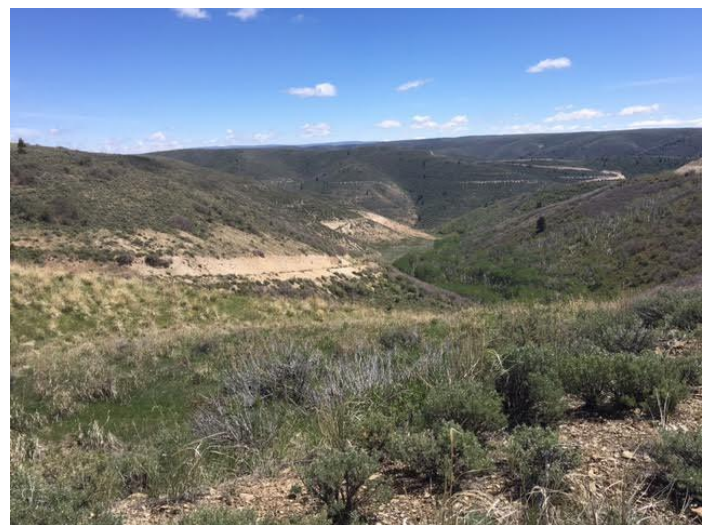
## PHOTOGRAPHS

Photos that show the conditions observed are included with this report.

The first area inspected, Area 6B, was the pipe that conveys water that flows through a culvert under the mine bench and then descends down a steep embankment approximately 200 vertical feet. The pipe that is located on the embankment has been slightly bent and it was stated that the pipe may be replaced in the near future.

The next area observed was the Davis Gulch cofferdam / sediment pond (Area 9 on the enclosed map). This area was vegetated and there was minimal evidence of any prior disturbance observed. The dam was never completely constructed but a large amount of material was removed and bedrock was exposed on the slopes where the dam was to be constructed.

Area 10B was then observed which is a large amount of stockpiled material that was to be used to construct the Davis gulch cofferdam. This material is to be moved to Area 17A upon final reclamation.

Area 17A, a coarse ore stockpile area, was observed and was void of any significant vegetation. The area was free of any unnecessary debris.

Areas 18E, 18F and 18G were observed. These areas were where the process plant and secondary crusher were going to be located. The areas were graded and appeared to be stable due to the primarily flat grade and the adequate volunteer vegetation present. The remaining steep slopes are to be regraded and 12 inches of topsoil replaced upon final reclamation.

Area 16A is located north of a valley that's proposed use was a laydown area. 16A is flat graded and also had adequate interim vegetation. The outslopes and topsoil replacement upon final reclamation is required.

Topsoil areas 12, 14 and 10D were all observed and appeared to have adequate interim vegetation.
