**Re: Northern Colorado Constructors, Inc.; Bennett Pit; File No. M-2016-085;
112c Permit Application Second Adequacy Review**

Project Bennett Pit
Case 1 - Full

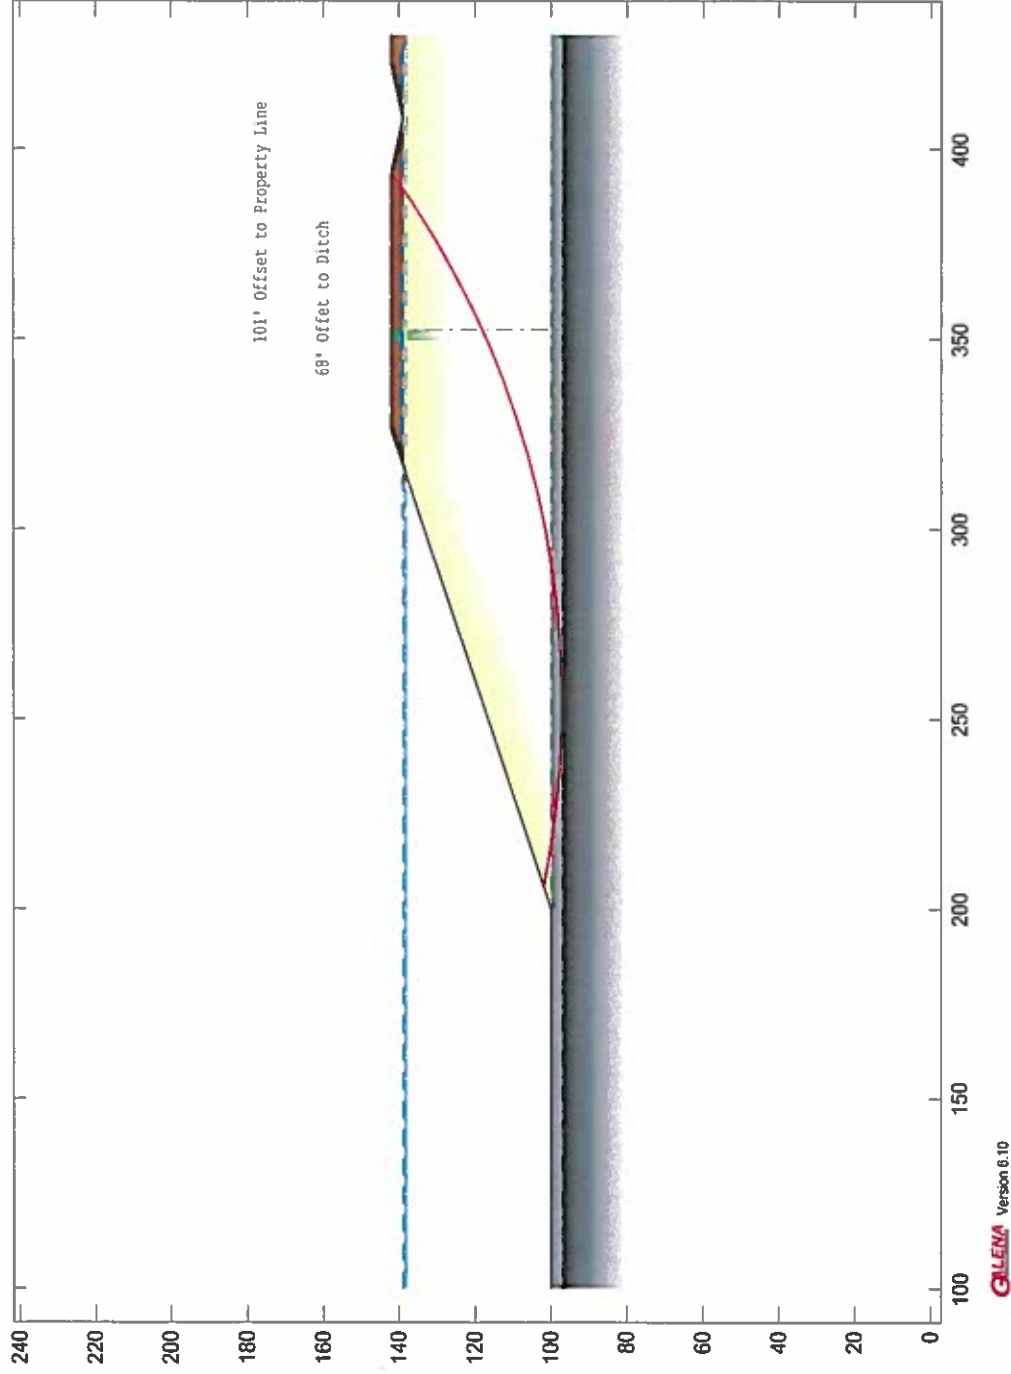
Single Stability Analysis
Method: Bishop Simplified
Surface: Circular

Factor of Safety: 2.68

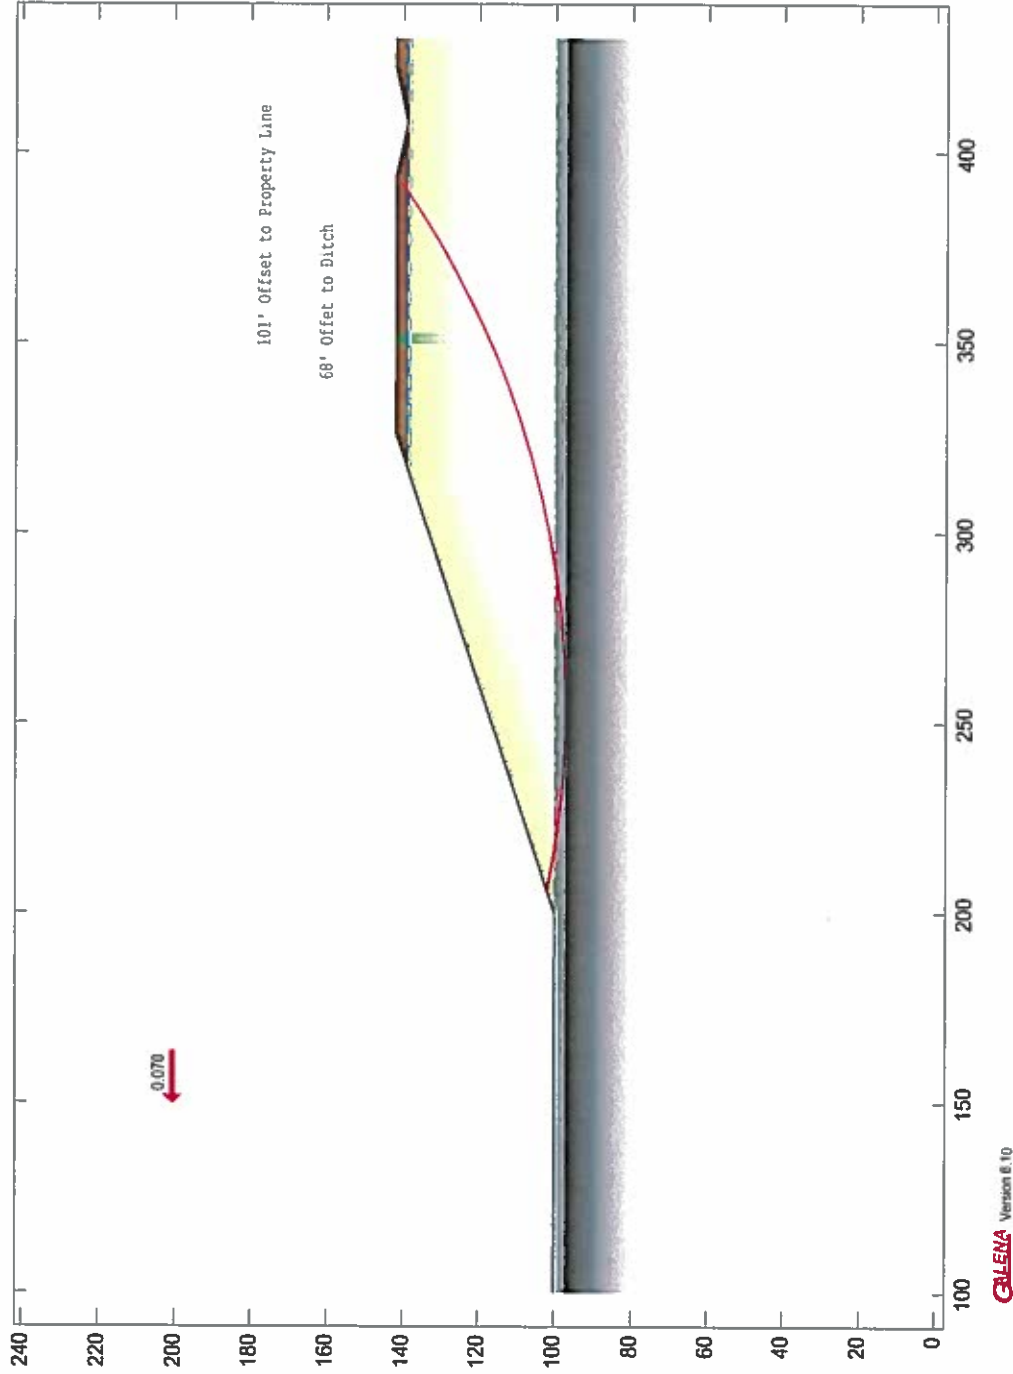
Project Bennett Pit
Case 1 - Rapid Drawdown

Single Stability Analysis
Method: Bishop Simplified
Surface: Circular

Factor of Safety: 1.05

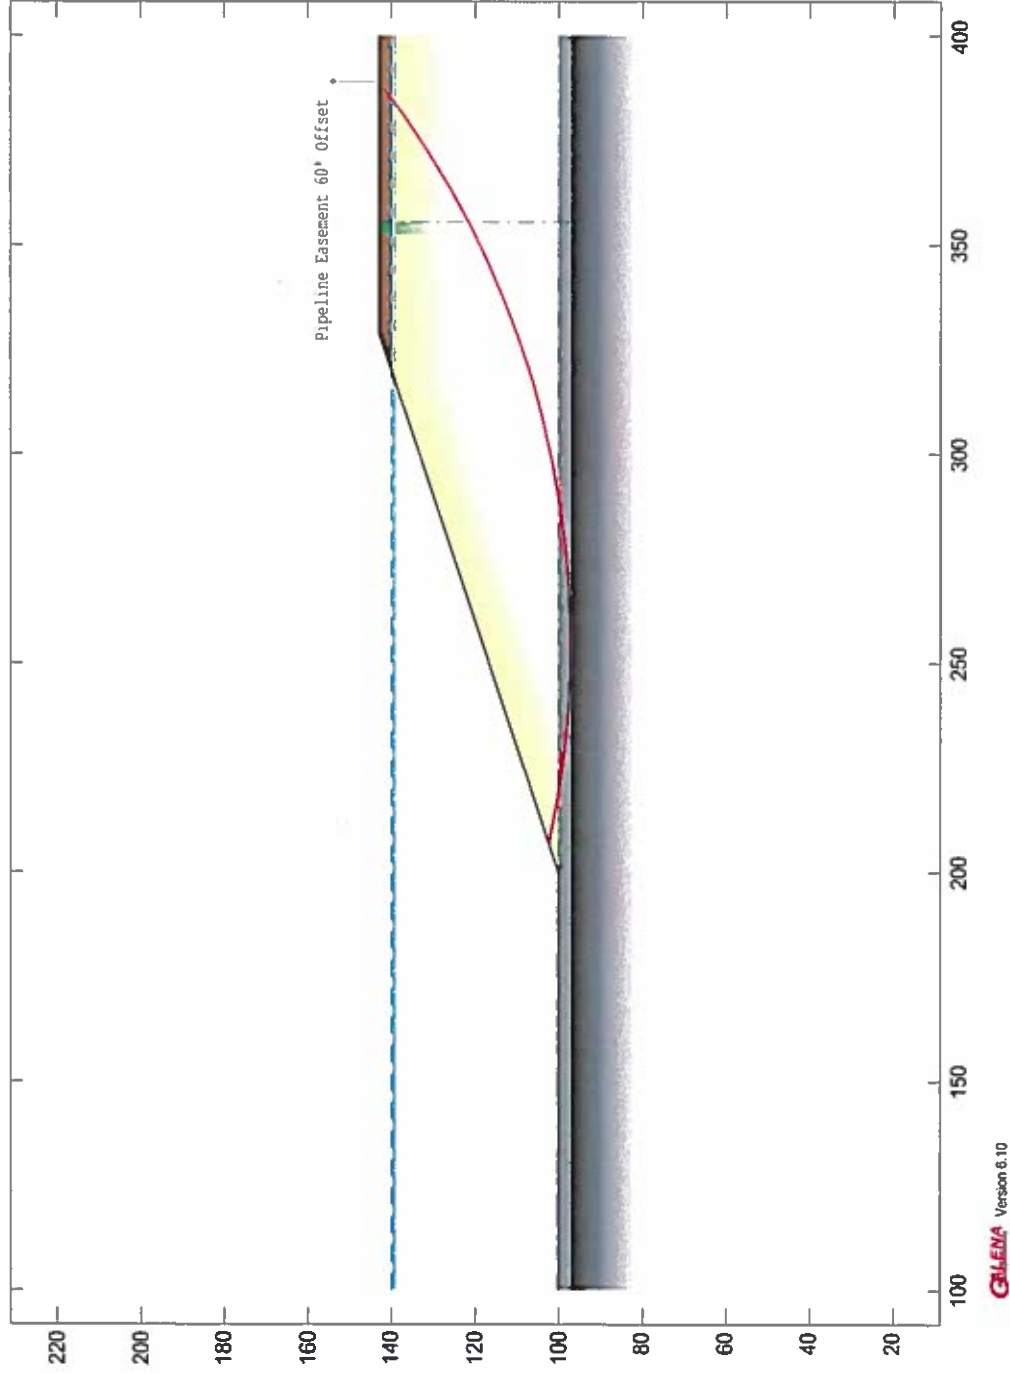
Project Bennett Pit
Case 5 Full

Method: Bishop Simplified

2.56
