Objection Letter to Permit M2017-049

Subject: Objection to the Hitch Rack Ranch Quarry, Permit Number M2017-049

Details related to Objections to the Hitch Rack Ranch Quarry Application

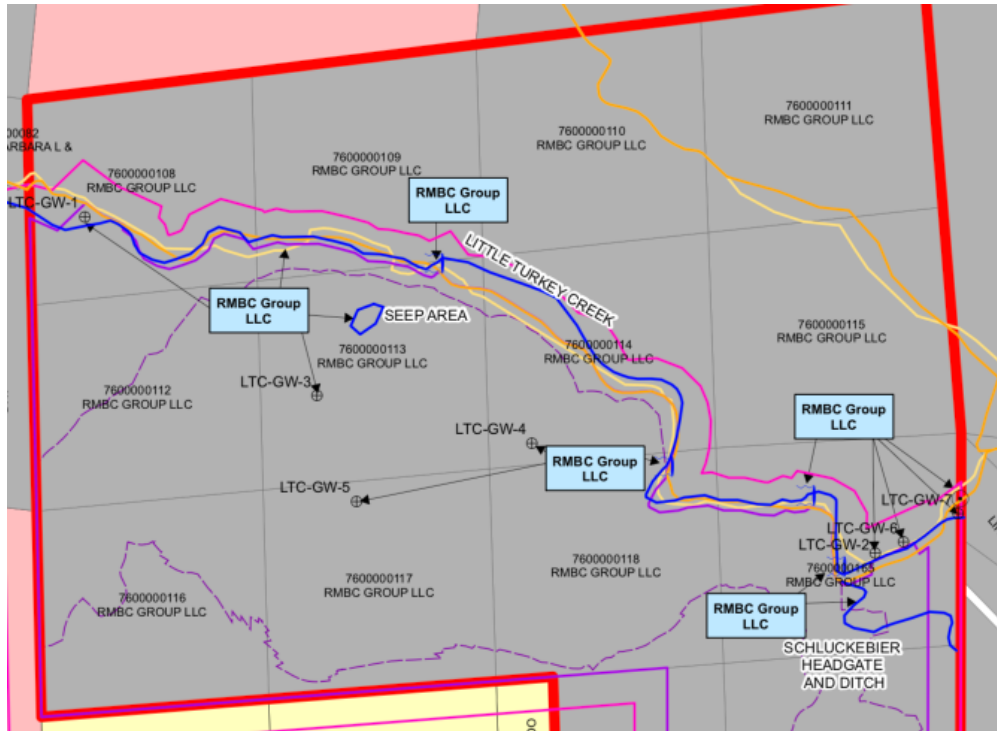
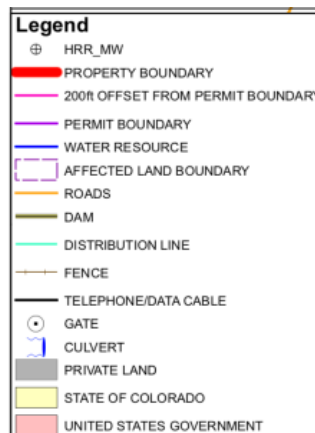
d. Figure C-2

The figure on the next page is an extract from Figure C-2, as amended in the 30 October submission. It depicts the portion of the map that includes Section 16, where the majority of the mining activity will be occurring.

There are numerous omissions and inaccuracies in this map:

- 1) The map includes two different colors for roads within Section 16 (orange and yellow). There are NOT two roads.
- 2) Several segments of the line depicting the northern boundary of the permit area within Section 16 are missing. Knowing the EXACT location of the permit boundary with respect to Little Turkey Creek Road is critical to owners of the road easement.
- 3) A segment of the line depicting the northern boundary of the affected land area within Section 16 is missing. Knowing the EXACT location of the boundary of the affected lands with respect to Little Turkey Creek Road is critical to owners of the road easement.

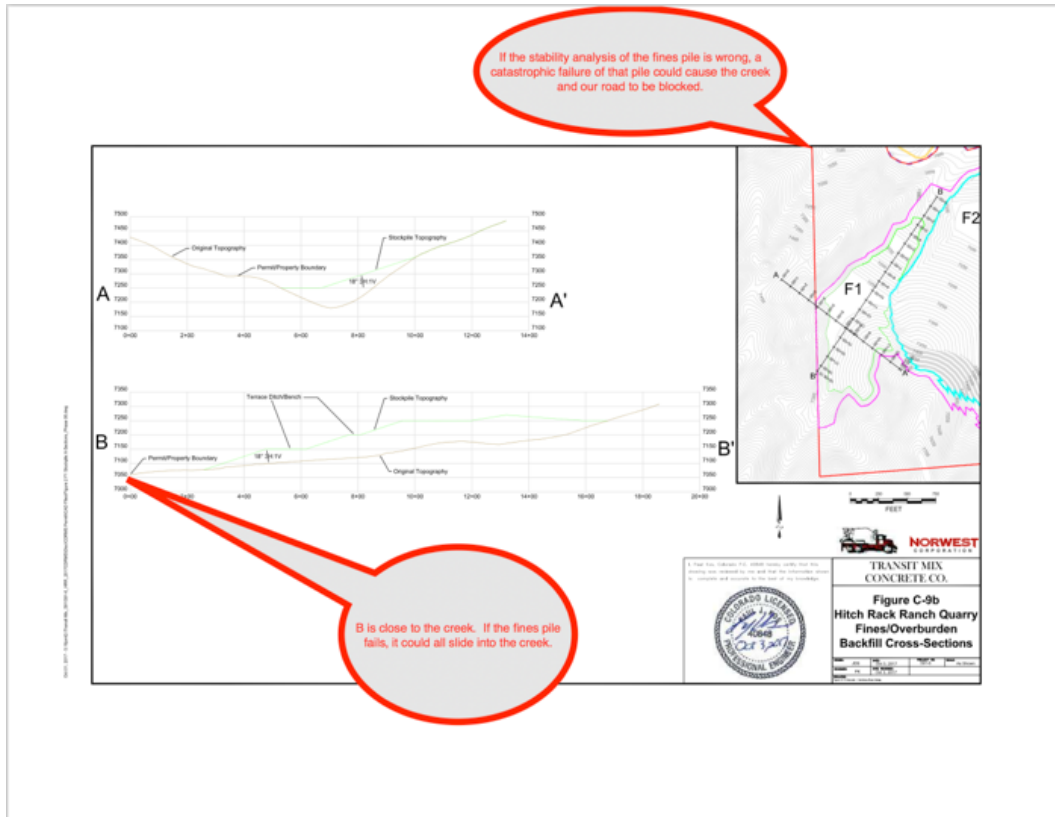
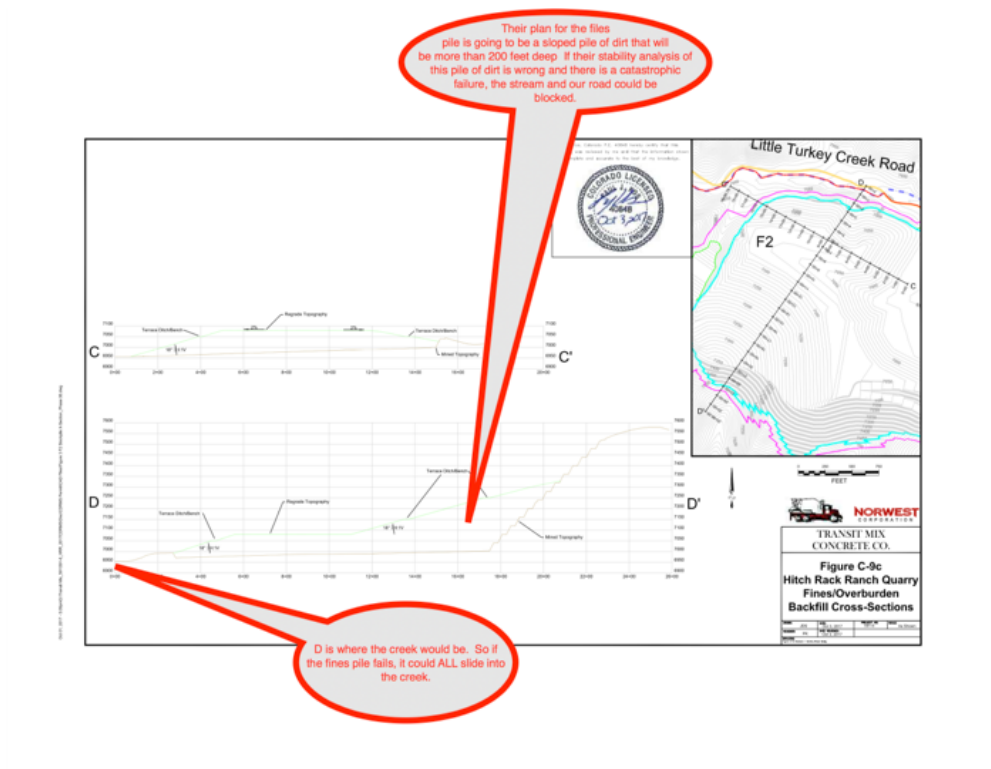
Figures C-9b and C-9C (shown on the next page) depict the proposed fines piles. Point B in Figure C-9b is at the lower end of the F1 fines pile. That pile of material will be over 100 feet deep and the lower end of it is quite close to Little Turkey Creek. Point D in Figure C-9C is at the lower end of the F2 fines pile. That pile of material will be over 200 feet deep and the lower end of it is also quite close to Little Turkey Creek.

Given the proximity to the creek and the planned depth of the fines piles, the stability of those piles will be critical to preventing landslides of material into the creek. The application includes a Stability Analysis for the Fines Pile (NORWEST, Hitch Rack Ranch Quarry Waste Stockpile Stability Analyses, dated 29 August 2017). However, we know from the historical record at Pike View Quarry that stability analyses performed by the applicant's engineers can be WRONG. If any of the stability analyses for this permit are incorrect and there is a catastrophic failure of these fines piles, there could be a landslide which could block Little Turkey Creek, which could damage the creek and Little Turkey Creek Road.

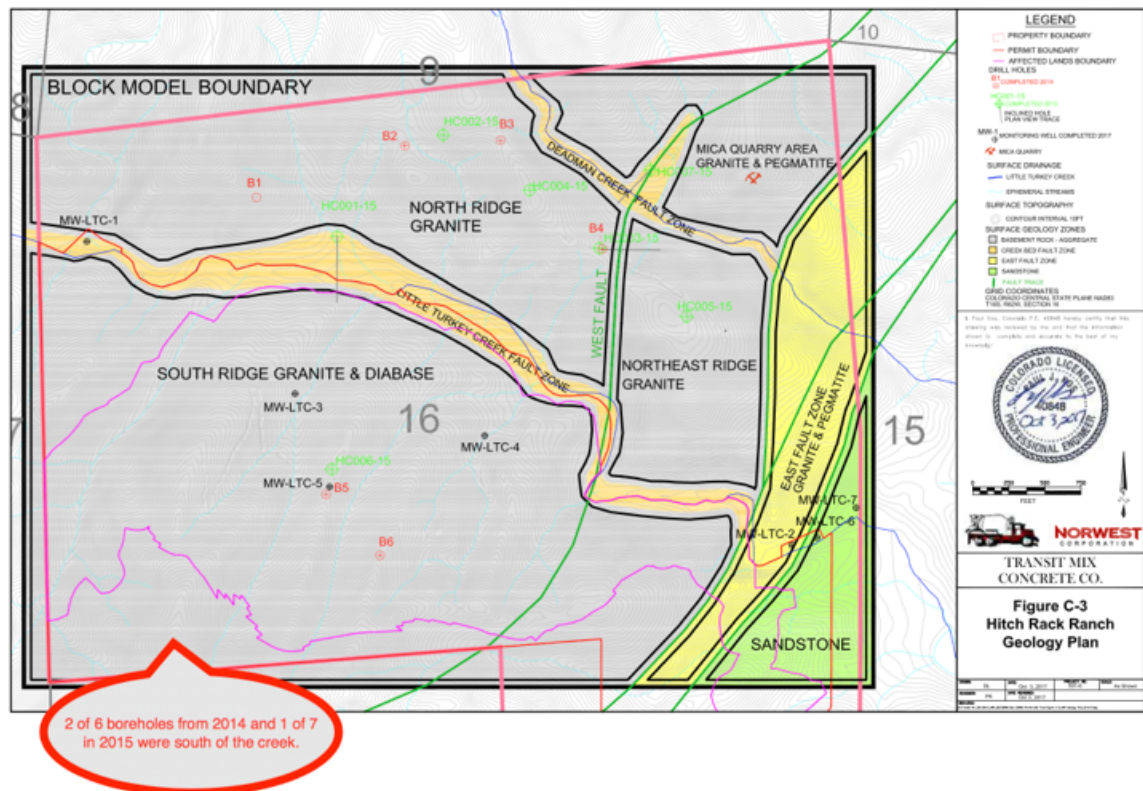
Figure C-3 (shown below) shows the locations of the test bores drilled in 2014 and 2015.

In their stability analysis for the pit walls, (NORWEST Geotechnical Pit Wall Geotechnical Assessment – Rev 0, dated Sept 11, 2017), NORWEST admits that the data collection from the 2014 drilling contained only limited geotechnical information and they therefore did not include data from those holes in their subsequent analysis. They also indicate that only 1 of 7 test bore holes completed in 2015 were drilled south of the creek. On pages 8 and 9 of their report they admit that “limited data is available for the proposed pit area but some aspects of the structural conditions are expected to be similar given the similar rock mass conditions, however additional drilling will be required to characterize the structure of the ultimate quarry pit footprint.”
