Updated version of details on objection to M2017-049

Details related to Objections to the Hitch Rack Ranch Quarry Permit Application (M2017-049)

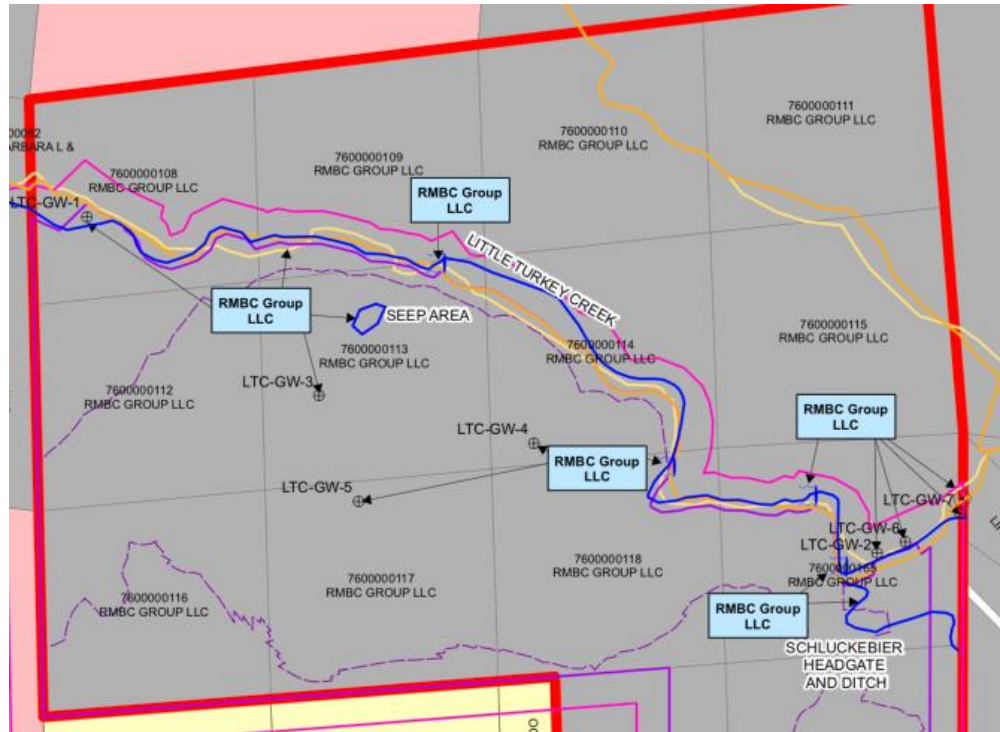
The figure on the next page is an extract from Figure C-2, as amended in the 30 October submission. It depicts the portion of the map that includes Section 16, where the majority of the mining activity will be occurring.

- 1) The map includes two different colors for roads within Section 16 (orange and yellow). There are NOT two roads.
- 2) Several segments of the line depicting the northern boundary of the permit area within Section 16 are missing. Knowing the EXACT location of the permit boundary with respect to Little Turkey Creek Road is critical to owners of the road easement.
- 3) A segment of the line depicting the northern boundary of the affected land area within Section 16 is missing. Knowing the EXACT location of the boundary of the affected lands with respect to Little Turkey Creek Road is critical to owners of the road easement.

- 4) There are numerous errors in the depiction of the locations where the road crosses the creek.
- 5) The four culverts marked as owned by RMBC Group are located within the road easement and were installed in 2013 by the Eagles Nest Association.

Some of the monitoring wells and blast monitoring equipment associated with the proposed mining operations will be located outside of the proposed affected land boundary.
- Maps within Exhibit C
 - 1) None of the maps in the application include a line delineating 200 feet from the affected lands.
 - 2) Page D-3 indicates that there will be a 100-foot buffer from the centerline of the creek. None of the maps in the application include a line delineating this offset.
- Figure C-2

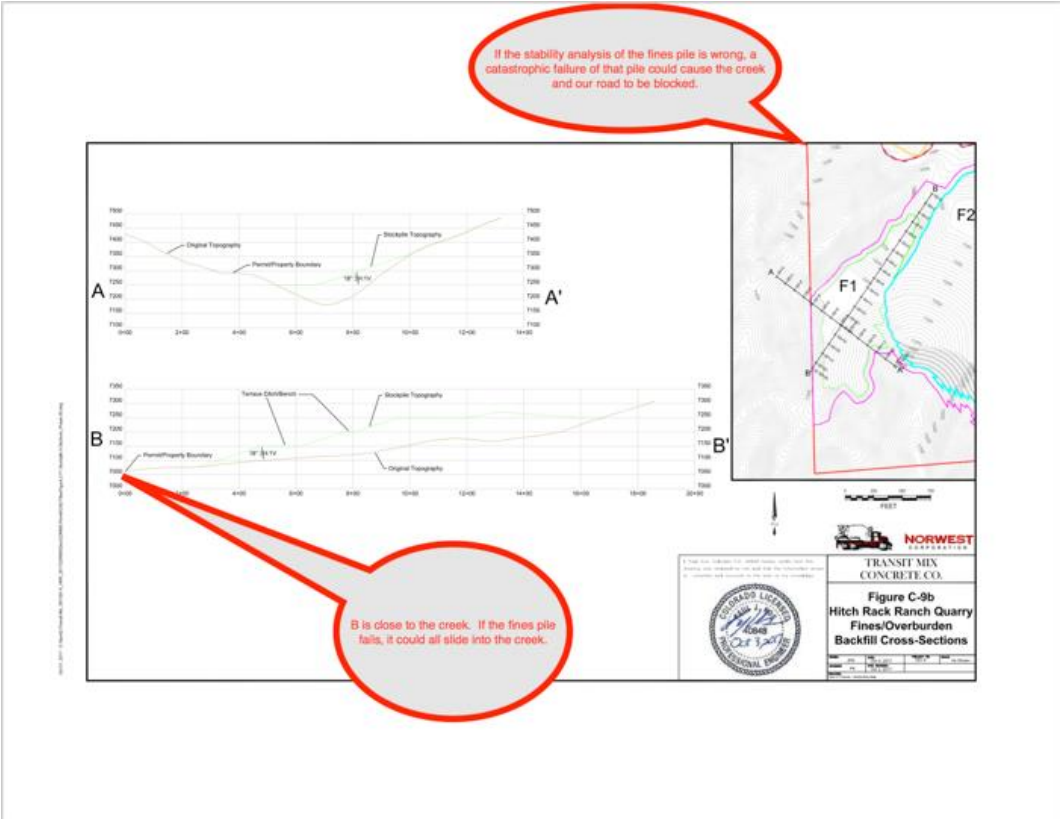
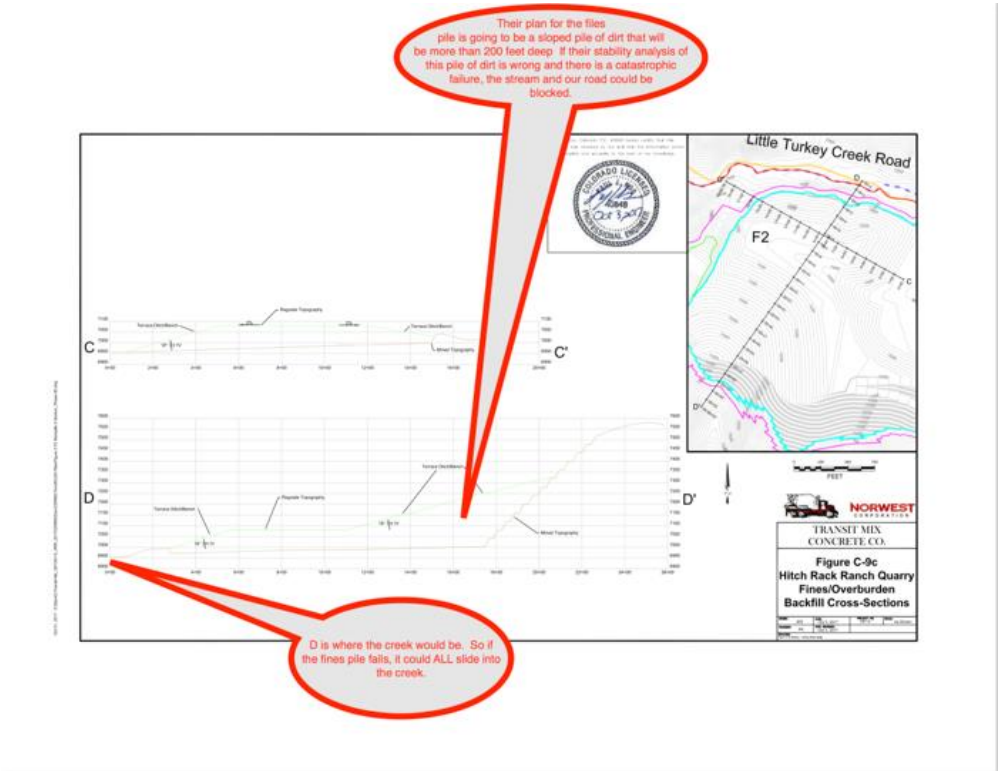
Figures C-9b and C-9C (shown on the next page) depict the proposed fines piles. Point B in Figure C-9b is at the lower end of the F1 fines pile. That pile of material will be over 100 feet deep and the lower end of it is quite close to Little Turkey Creek. Point D in Figure C-9C is at the lower end of the F2 fines pile. That pile of material will be over 200 feet deep and the lower end of it is also quite close to Little Turkey Creek.

Given the proximity to the creek and the planned depth of the fines piles, the stability of those piles will be critical to preventing landslides of material into the creek. The application includes a Stability Analysis for the Fines Pile (NORWEST, Hitch Rack Ranch Quarry Waste Stockpile Stability Analyses, dated 29 August 2017). However, we know from the historical record at Pike View Quarry that stability analyses performed by the applicant's engineers can be WRONG. If any of the stability analyses for this permit are incorrect and there is a catastrophic failure of these fines piles, there could be a landslide which could block Little Turkey Creek, which could damage the creek and Little Turkey Creek Road.

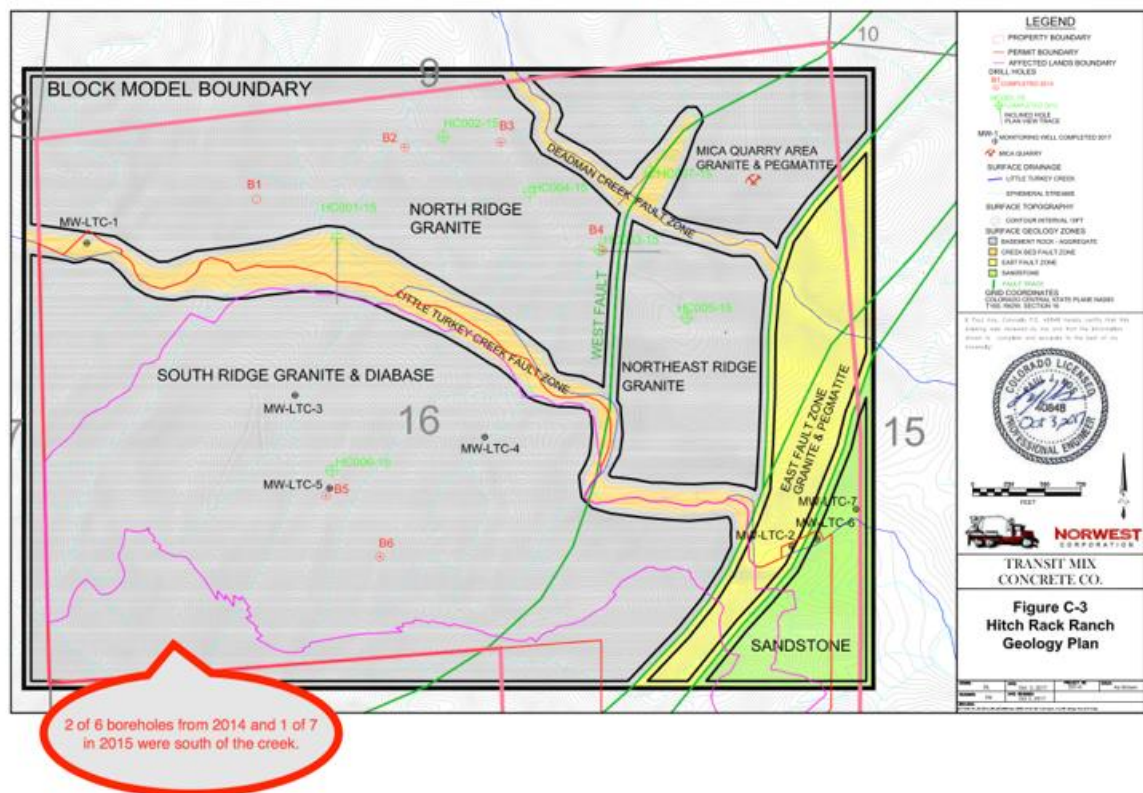
Figure C-3 (shown below) shows the locations of the test bores drilled in 2014 and 2015.

In their stability analysis for the pit walls, (NORWEST Geotechnical Pit Wall Geotechnical Assessment – Rev 0, dated Sept 11, 2017), NORWEST admits that the data collection from the 2014 drilling contained only limited geotechnical information and they therefore did not include data from those holes in their subsequent analysis. They also indicate that only 1 of 7 test bore holes completed in 2015 were drilled south of the creek. On pages 8 and 9 of their report they admit that “limited data is available for the proposed pit area but some aspects of the structural conditions are expected to be similar given the similar rock mass conditions, however additional drilling will be required to characterize the structure of the ultimate quarry pit footprint.”

In NORWEST’s analysis for the 2016 permit (M-2016-010) “Hitch Rack Ranch Pit Wall Geotechnical Assessment – Rev. B”, dated January 26, 2015 the engineer recommended: “Additional geotechnical drilling and analyses are required to confirm conditions prior to mining the area south of Little Turkey Creek.” In the transcript from the October 2016 Board Hearing, the CDRMS staff indicated “we have a commitment in the application that before they open that south pit, there’s going to be a lot more research done” (Page 8974 of the Administrative Record).
