**Division of Reclamation,
Mining and Safety**

**Re: Loveland Ready-Mix Concrete, Inc.; Knox Pit; File No. M-2017-036;
Exhibit 6.5 – Second Geotechnical Stability Exhibit Review**

Project Knox Pit

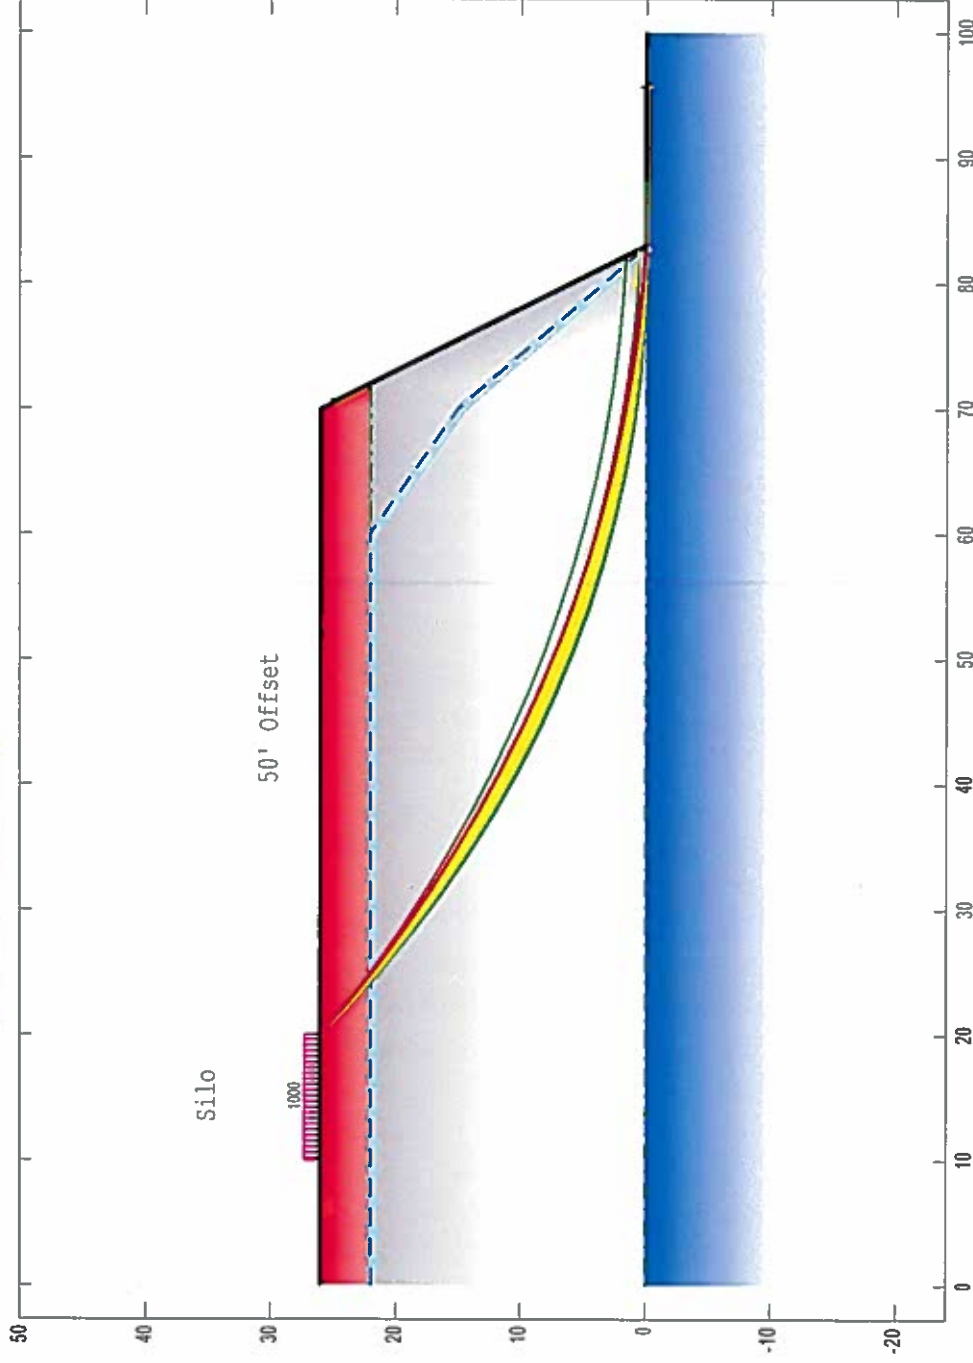
Mine Slope Analysis - 50' Offset

FoS Ranges ≤ 1.00 $> 1.00 \leq 1.20$ $> 1.20 \leq 1.40$ > 1.40

FoS Ranges

≤ 1.00 $> 1.00 \leq 1.20$ $> 1.20 \leq 1.40$ > 1.40

Material Keys

- 1: Backfill
- 2: Topsoil
- 3: Sandy Gravel
- 4: Bedrock

Pre-Reclamation Slope Stability

The Applicant's cross section was duplicated for verification. The factor of safety produced by Galena (1.35) was lower than the factor of safety produced by the Applicant's calculation (1.7). The factor of safety is greater than the required factor of safety of 1.3. Therefore, the accuracy of the Applicant's calculation is confirmed. A copy of the Galena model is attached.

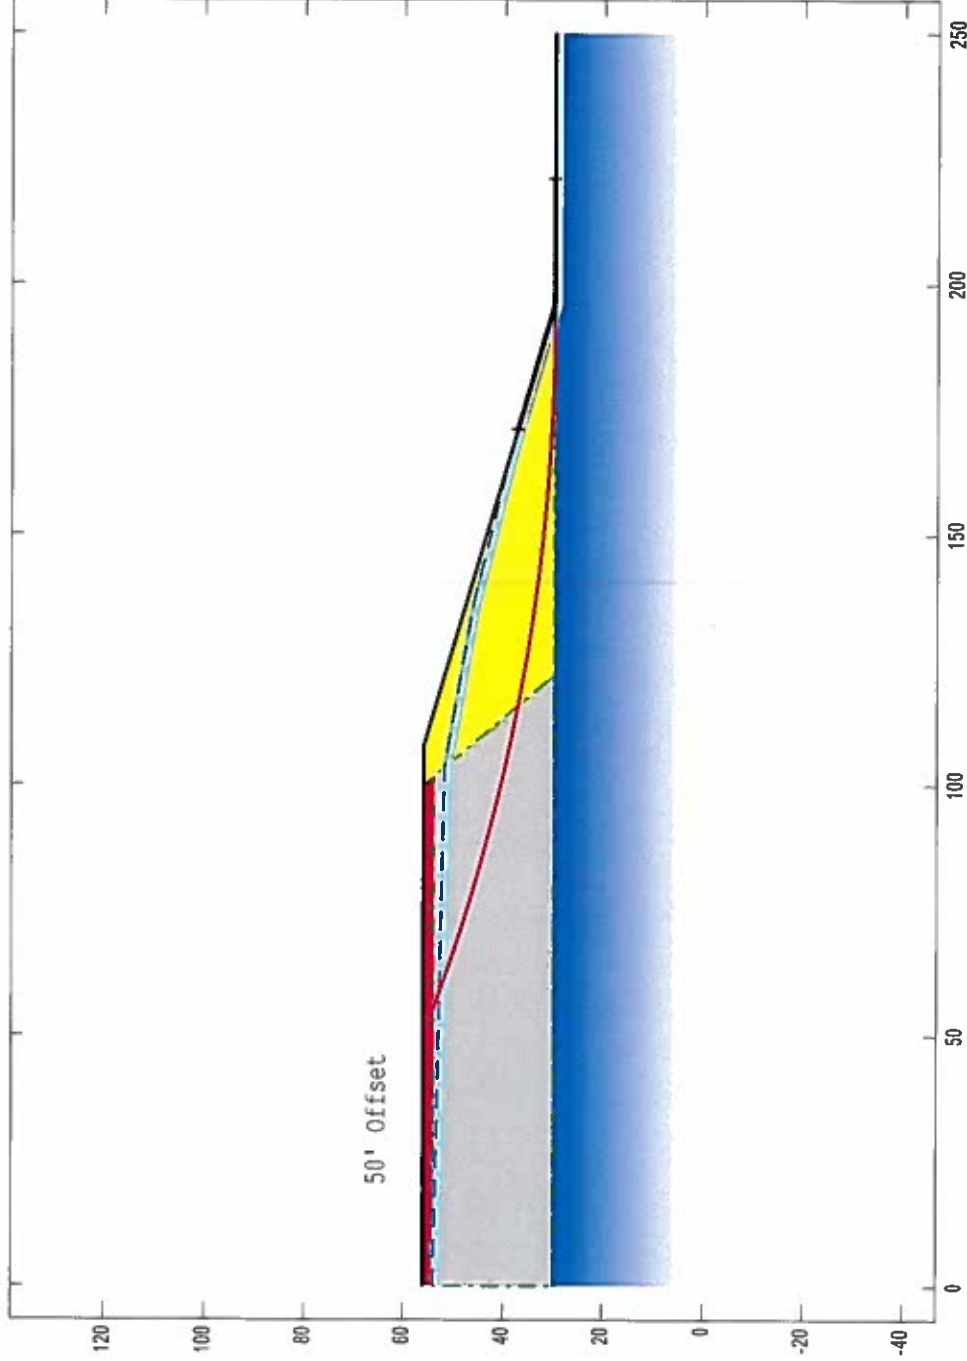
Analysis 1

Multiple Stability Analysis

Method: Bishop Simplified

Surface: Circular

Results

Critical Factor of Safety: 1.88

FoS Ranges

≤ 1.00 $> 1.00 \leq 1.20$ $> 1.20 \leq 1.40$ > 1.40

Material Keys

- 1: Backfill
- 2: Topsoil
- 3: Sandy Gravel
- 4: Bedrock

Generic Worst-Case Post Reclamation Scenario

The Applicant's cross section was duplicated for verification. The factor of safety produced by Galena (1.88) was greater than the required factor of safety of 1.3. Therefore, the stability of the cross section is acceptable. A copy of the Galena model is attached.

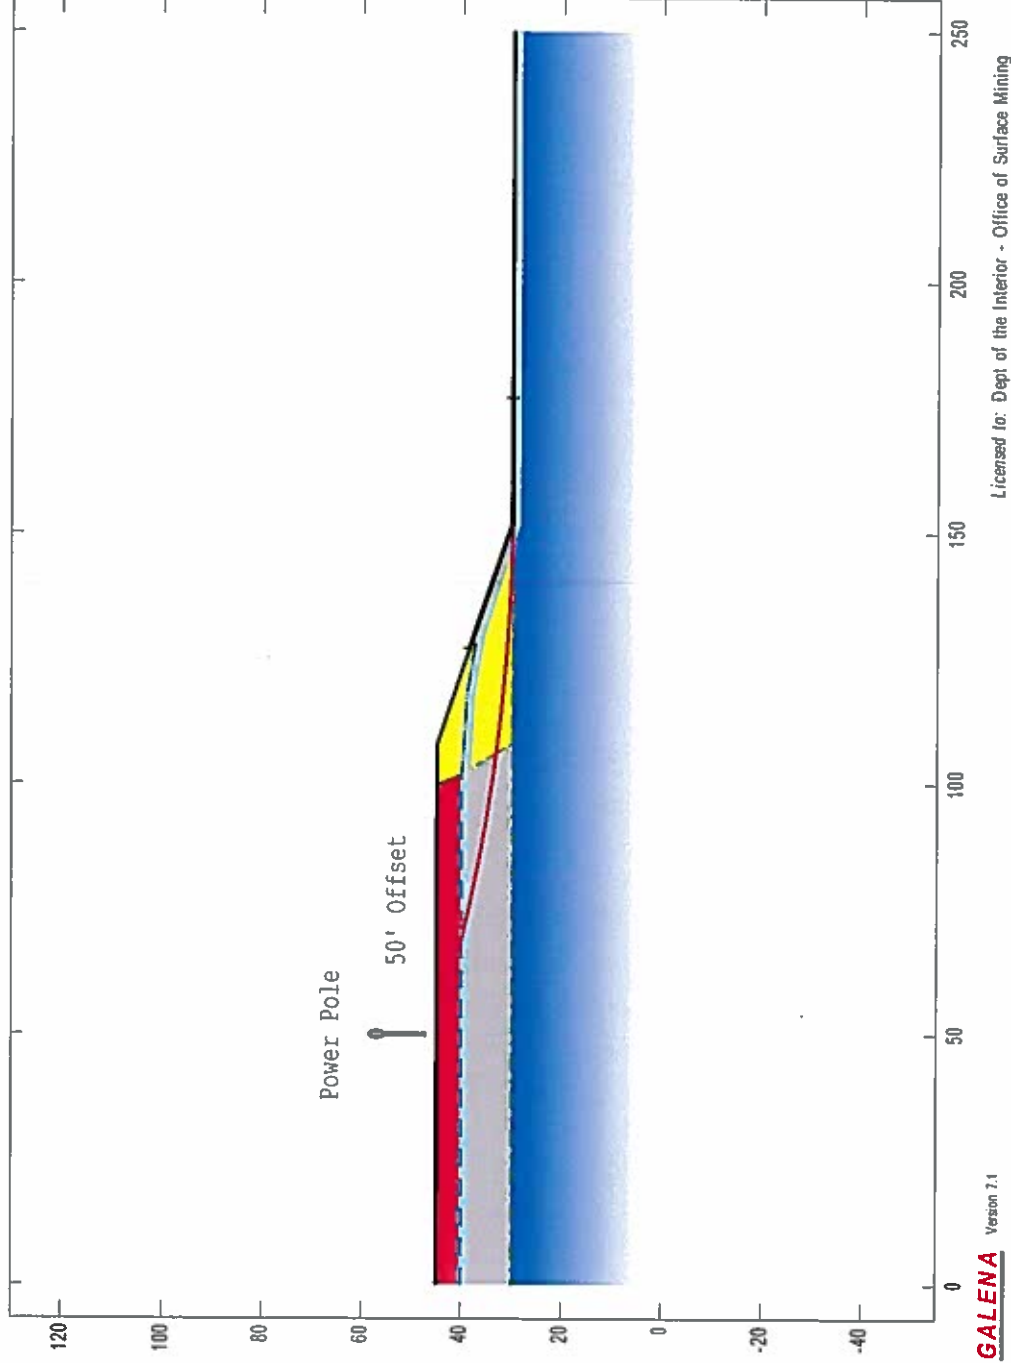
Post Reclamation Platte River Power Authority Cross-Section

Analysis 1

Multiple Stability Analysis

Method: Bishop Simplified

Surface: Circular

Results

Critical Factor of Safety: 3.28

File: C:\Users\p...l\Post Reclamation Platte River Power Authority Cross-Section 50' Offset.gmf

FoS Ranges

≤ 1.00 $> 1.00 \leq 1.20$ $> 1.20 \leq 1.40$ > 1.40

Material Keys

- 1: Backfill
- 2: Topsoil
- 3: Sandy Gravel
- 4: Bedrock

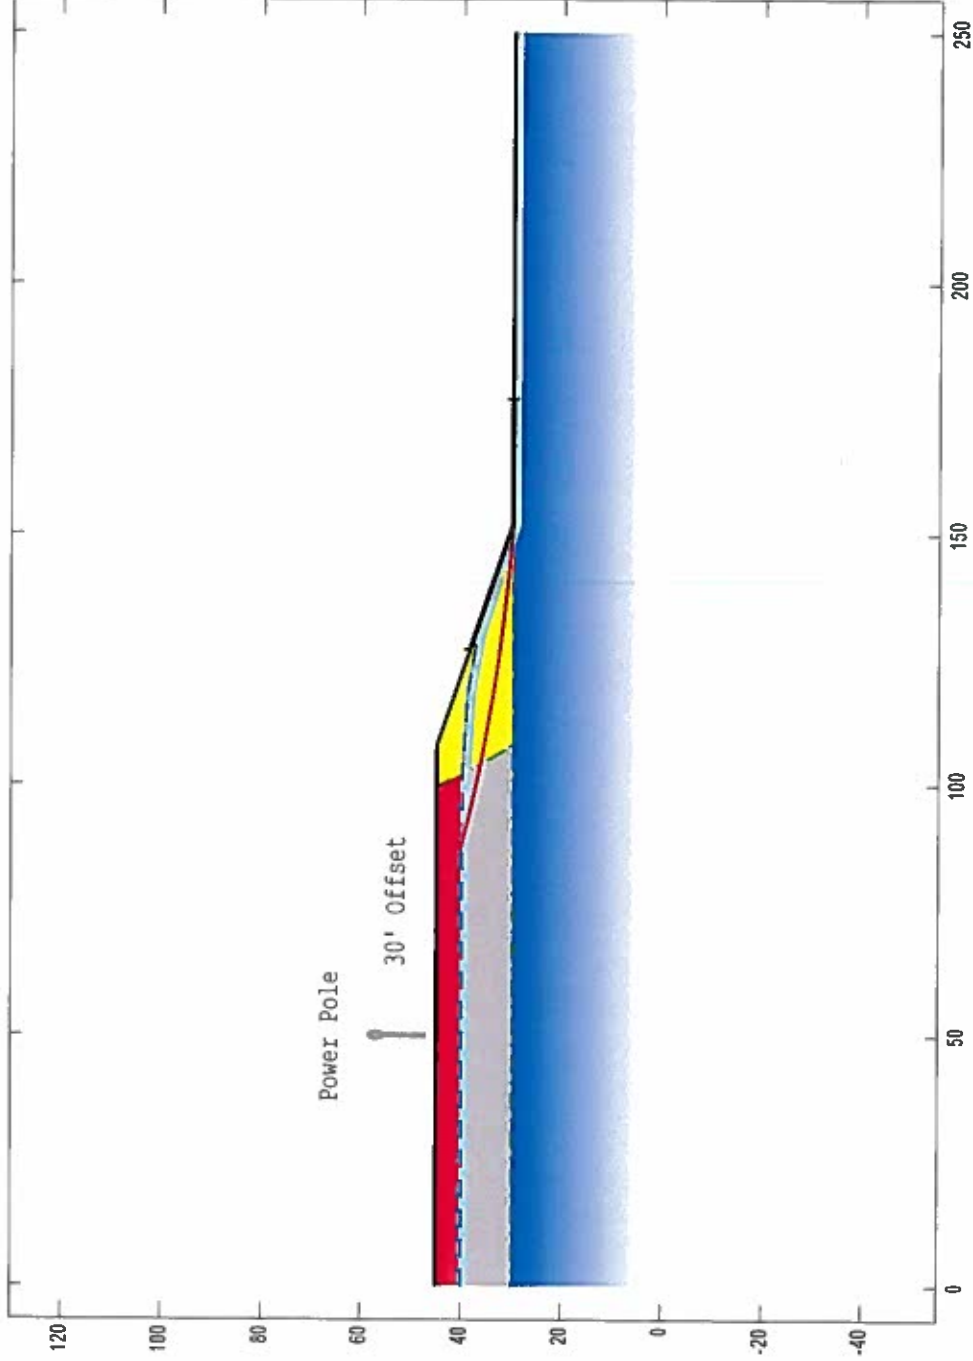
Post Reclamation Platte River Power Authority Cross-Section

Analysis 1

Multiple Stability Analysis

Method: Bishop Simplified

Surface: Circular

Results

Critical Factor of Safety: 2.51

File: C:\Users\p...Post Reclamation Platte River Power Authority Cross-Section 30' Offset.gmf

FoS Ranges

≤ 1.00 $> 1.00 \leq 1.20$ $> 1.20 \leq 1.40$ > 1.40

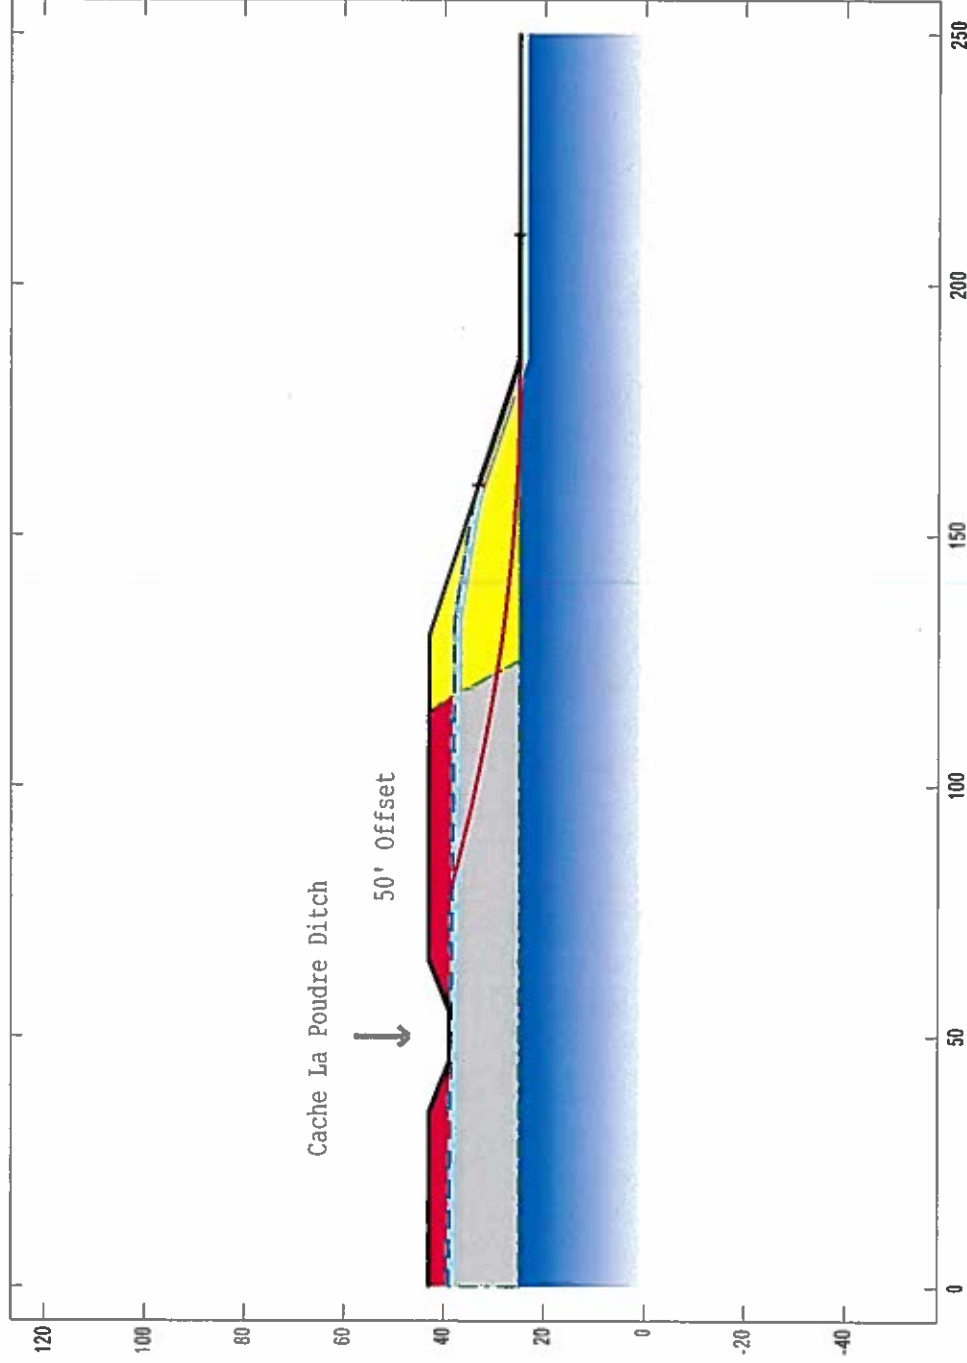
Post Reclamation Cache La Poudre Ditch Cross-Section

Material Keys

- 1: Backfill
- 2: Topsoil
- 3: Sandy Gravel
- 4: Bedrock

Analysis 1

Multiple Stability Analysis

Method: Bishop Simplified

Surface: Circular

Results

Critical Factor of Safety: 2.84

File: C:\Users\p...Post Reclamation Cache La Poudre Ditch Cross-Section 50' Offset.gml

FoS Ranges

≤ 1.00 $> 1.00 \leq 1.20$ $> 1.20 \leq 1.40$ > 1.40
