Henderson  
3 Dam Buttress

3D Post-Earthquake Stability Analysis  
with Buttress, Model Geometry  
Stage 1, Crest El. 8883 ft

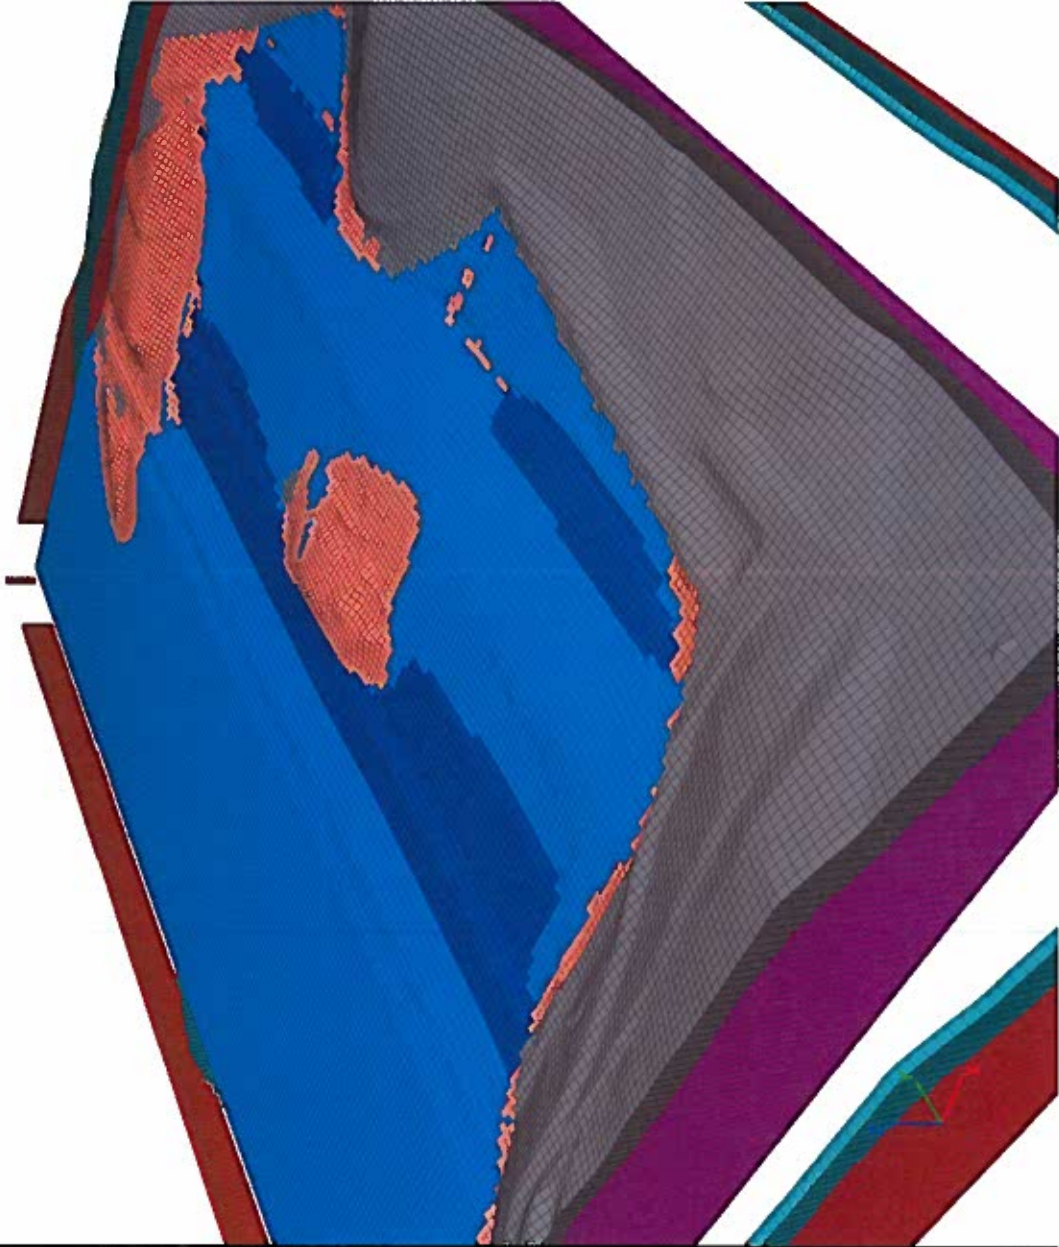
Deformed Factor: 5

| Project No.<br>60551494 | Henderson<br>3 Dam Buttress | 3D Post-Earthquake Dynamic Deformation Analysis<br>with Buttress Deformed Mesh/5 Times Exaggerated<br>@45 Sec<br>Stage 1, Crest El. 8883 ft | Figure<br>23 |
