**MINERALS PROGRAM INSPECTION REPORT****PHONE: (303) 866-3567**

<b>MINE NAME:</b> ZMK Gravel Pit	<b>MINE/PROSPECTING ID#:</b> M-1991-146	<b>MINERAL:</b> Gravel	<b>COUNTY:</b> Ouray
<b>INSPECTION TYPE:</b> Monitoring	<b>INSPECTOR(S):</b> Travis H. Marshall	<b>INSP. DATE:</b> April 20, 2018	<b>INSP. TIME:</b> 09:30
<b>OPERATOR:</b> Sako Excavation, LLC	<b>OPERATOR REPRESENTATIVE:</b> Bob Larson	<b>TYPE OF OPERATION:</b> 110c - Construction Limited Impact

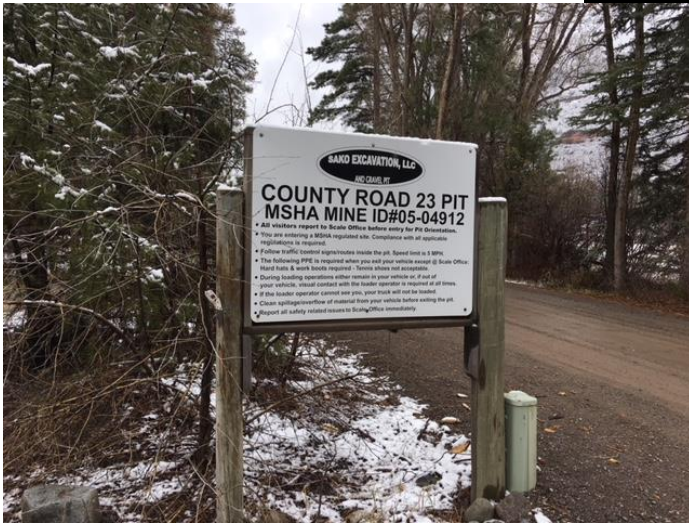
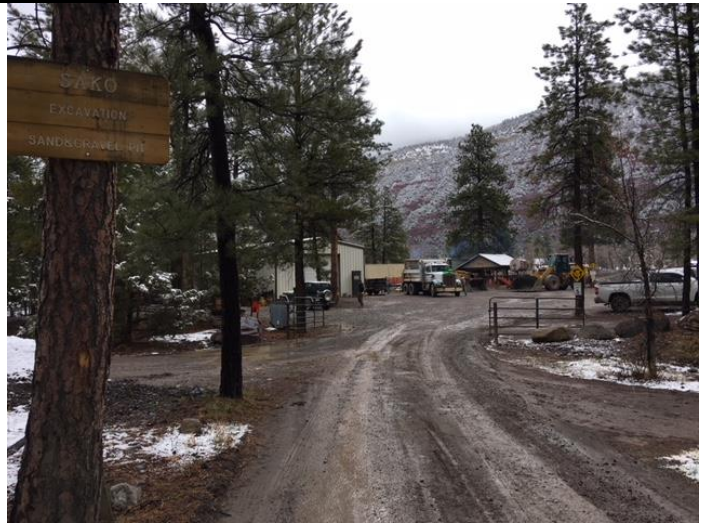
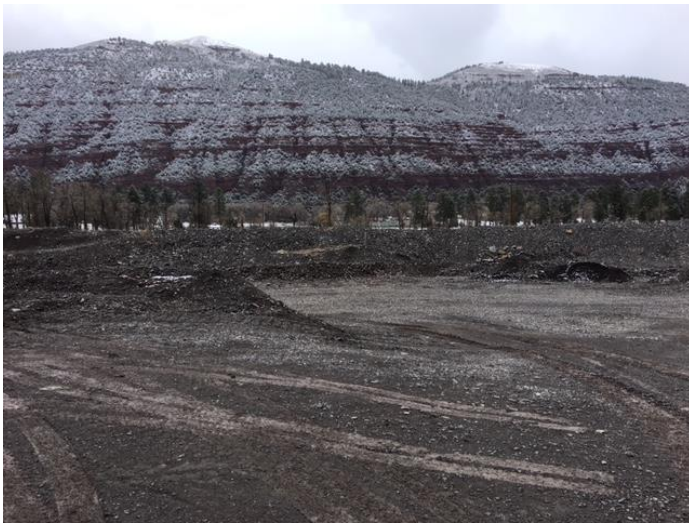
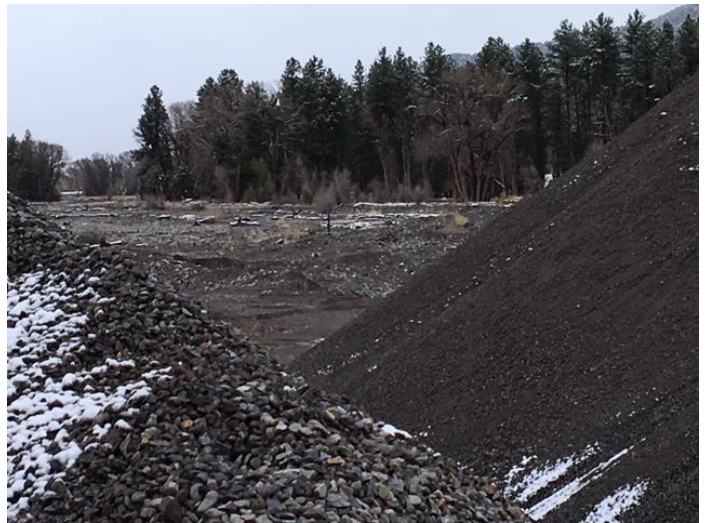
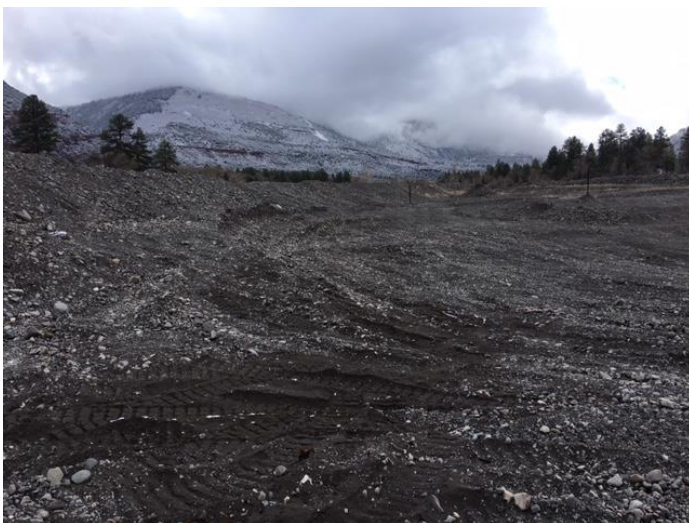
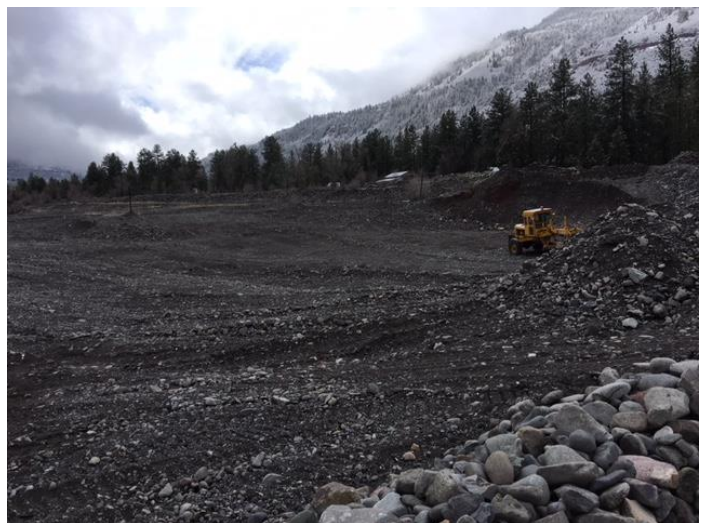
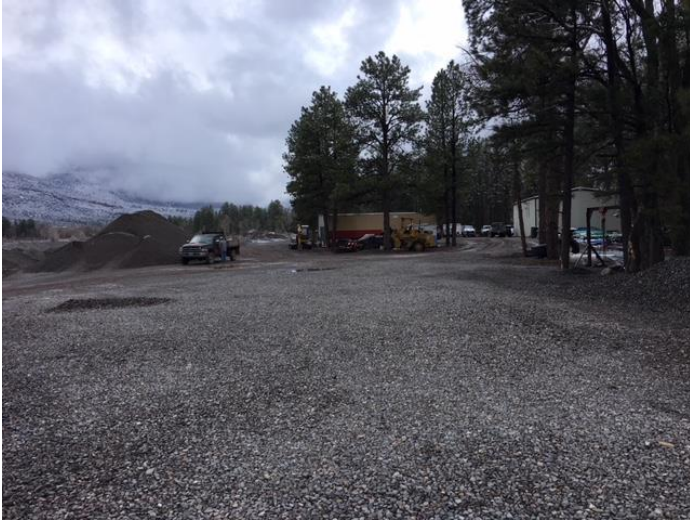
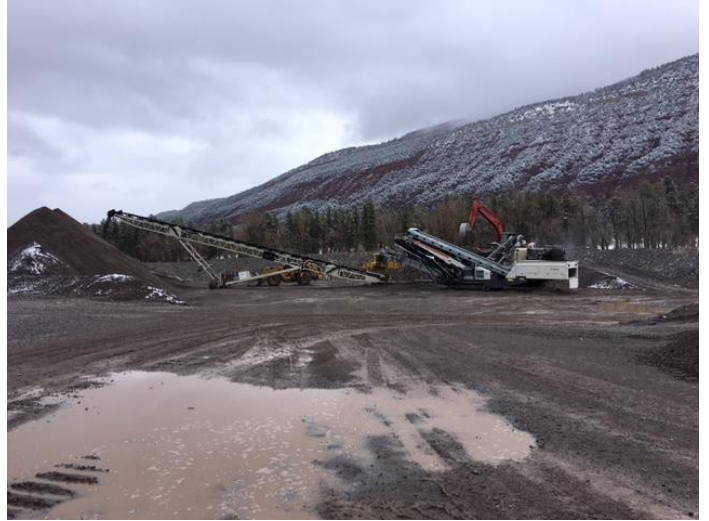
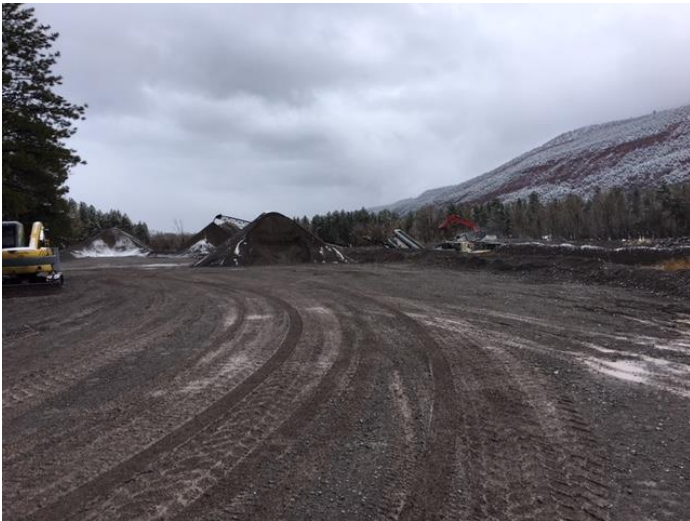
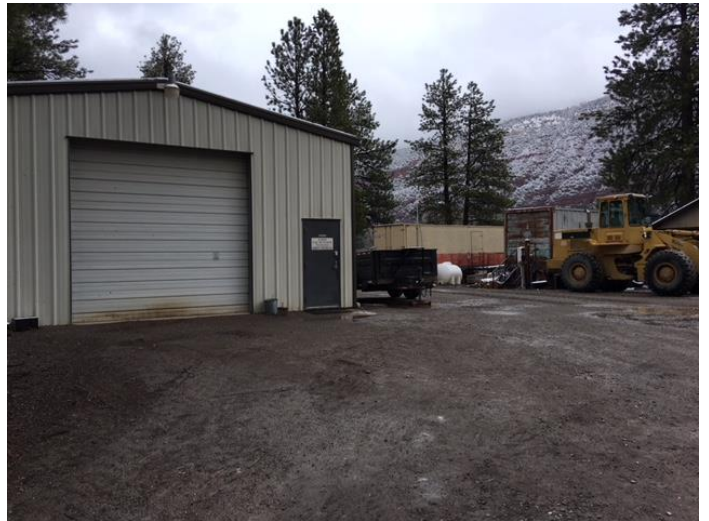
## PHOTOGRAPHS

Photos that show the conditions observed during the inspection are included at the end of this inspection report.

The mine identification sign was not posted at the entrance of the mine site. This is a problem for failure to post a mine identification sign as required by Rule 3.1.12(1). Boundary markers in the form of posts were observed around the entire perimeter of the pit.

The operation was active during the inspection. A mobile crusher was observed processing material. Various stockpiles of processed material were observed west of the crushing plant. On-highway haul trucks were observed being loaded with gravel. The overall appearance of the site appeared to be orderly and no issues other than the missing sign were observed.

The water level monitoring wells were observed. They appeared to be accessible and in properly functioning condition. Four wells are measured for water levels on a monthly basis and the results are submitted annually with the annual report.
