MINERALS PROGRAM INSPECTION REPORT
PHONE: (303) 866-3567

MINE NAME: Stone Gravel Pit	MINE/PROSPECTING ID#: M-1997-089	MINERAL: Sand and gravel	COUNTY: Montezuma
INSPECTION TYPE: Surety-Related Inspection	INSPECTOR(S): Travis H. Marshall	INSP. DATE: October 30, 2018	INSP. TIME: 10:00
OPERATOR: Daren Stone	OPERATOR REPRESENTATIVE: Kathy Stone	TYPE OF OPERATION: 112c - Construction Regular Operation	
REASON FOR INSPECTION: Surety Related	BOND CALCULATION TYPE: Complete Bond	BOND AMOUNT: \$17,232.00	
DATE OF COMPLAINT: NA	POST INSP. CONTACTS: U.S.BLM	JOINT INSP. AGENCY: U.S.BLM	
WEATHER: Cloudy	INSPECTOR'S SIGNATURE:

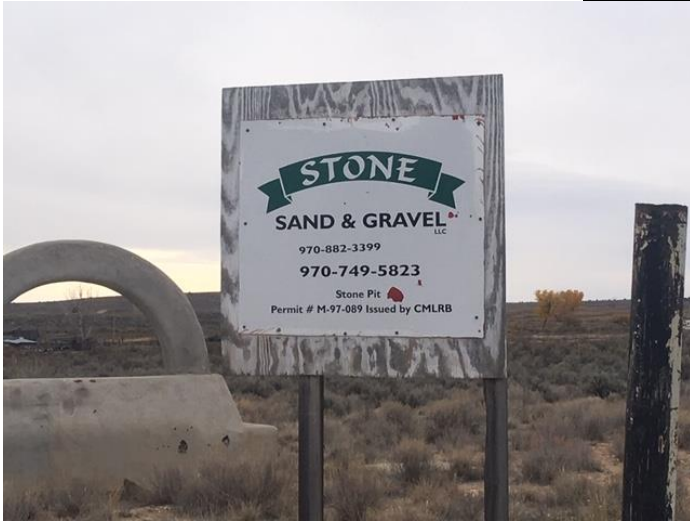
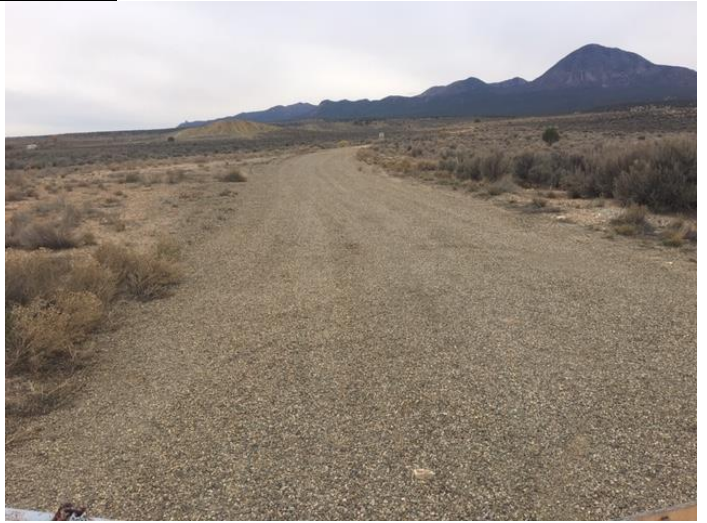
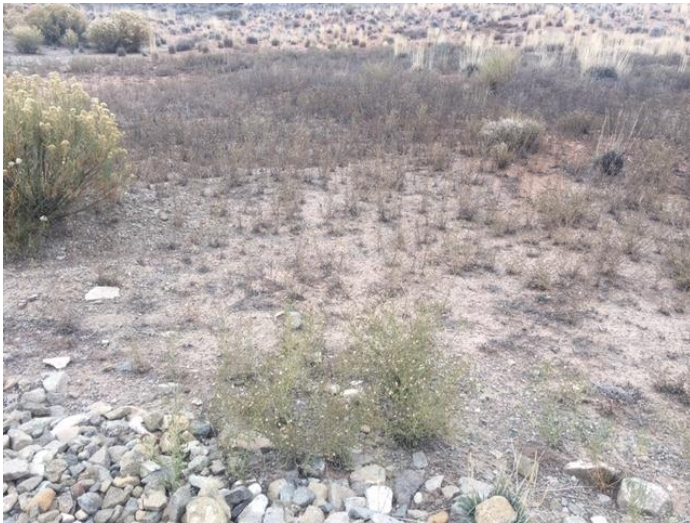
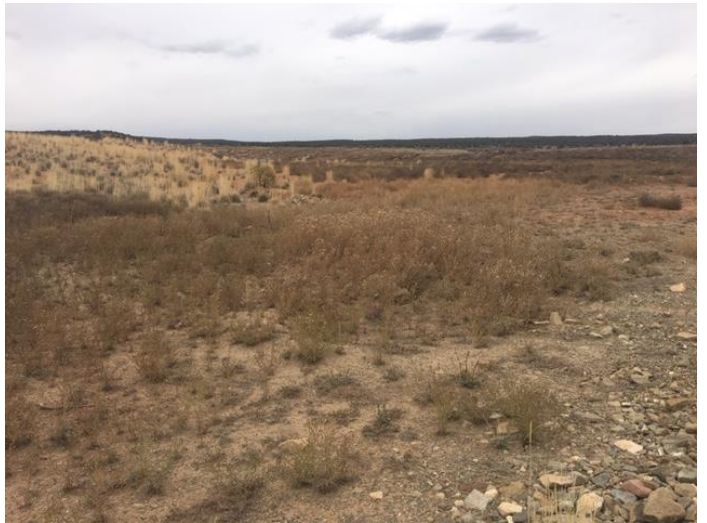
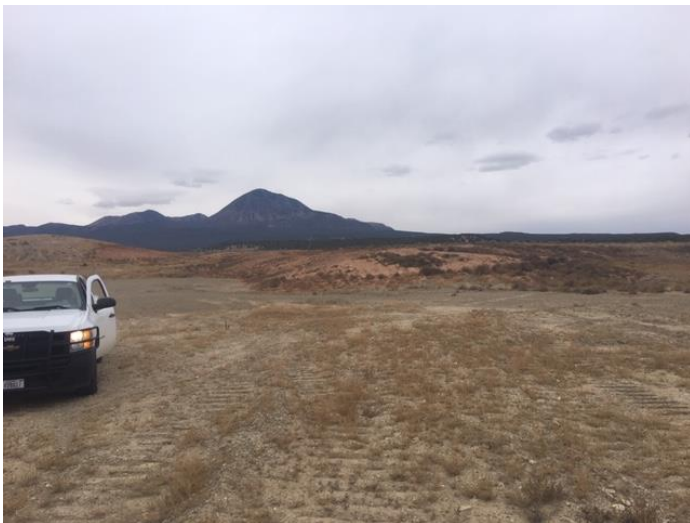
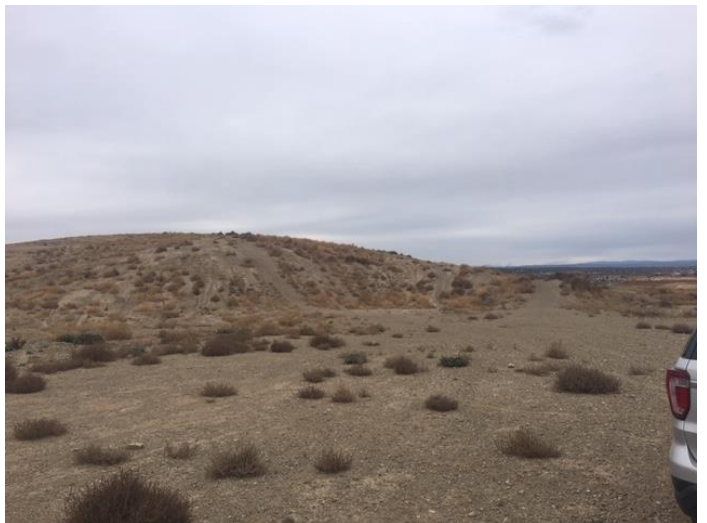
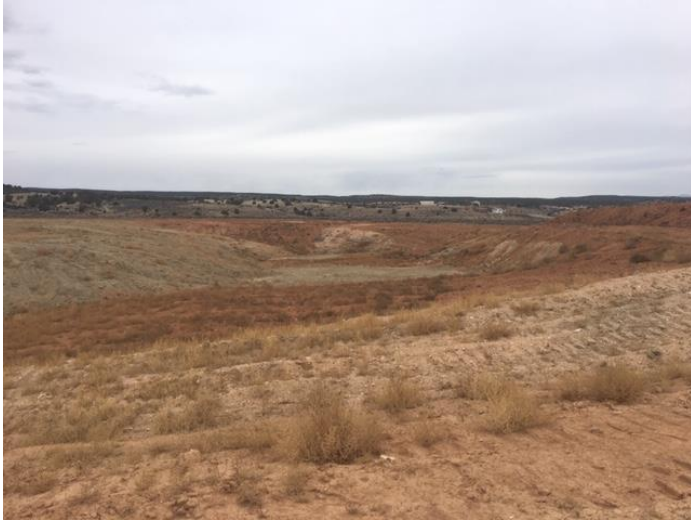
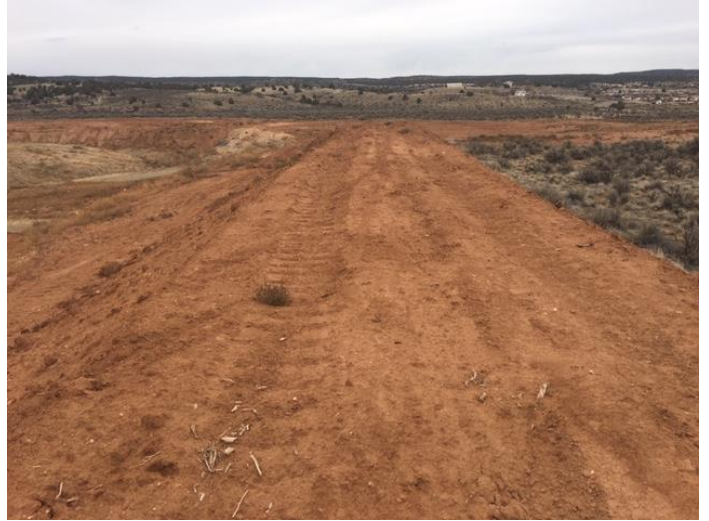
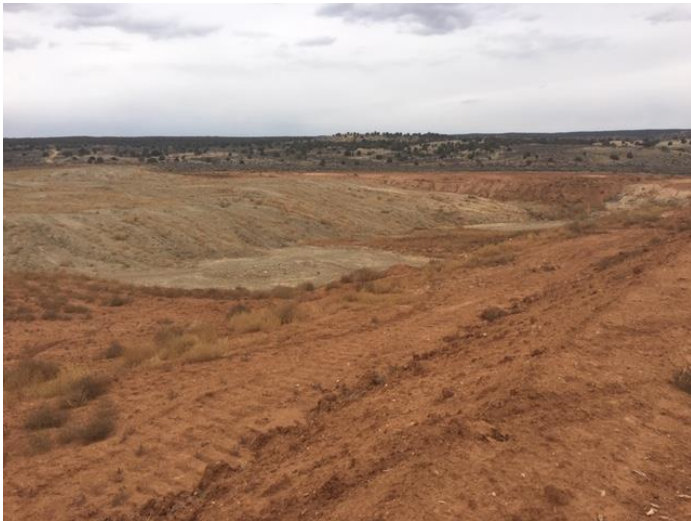
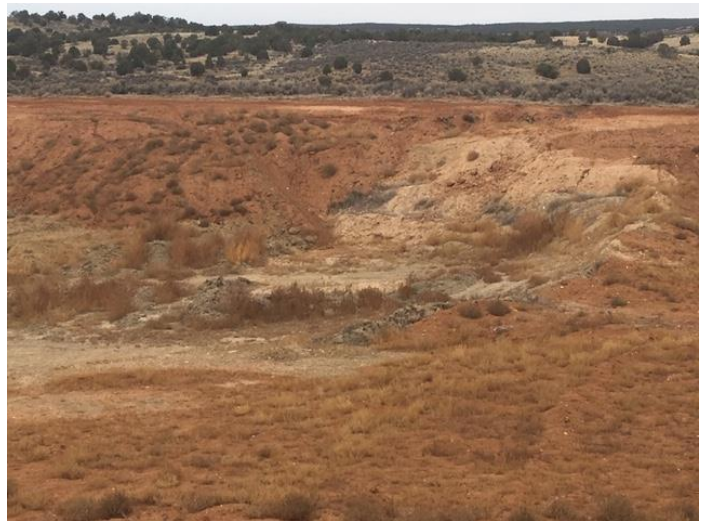
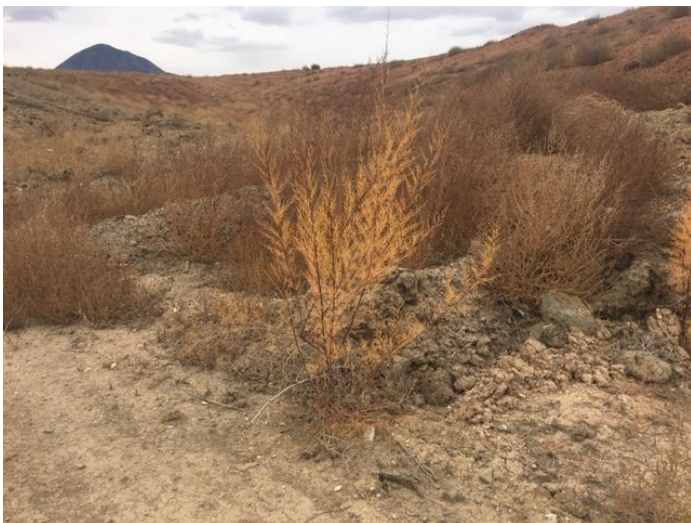
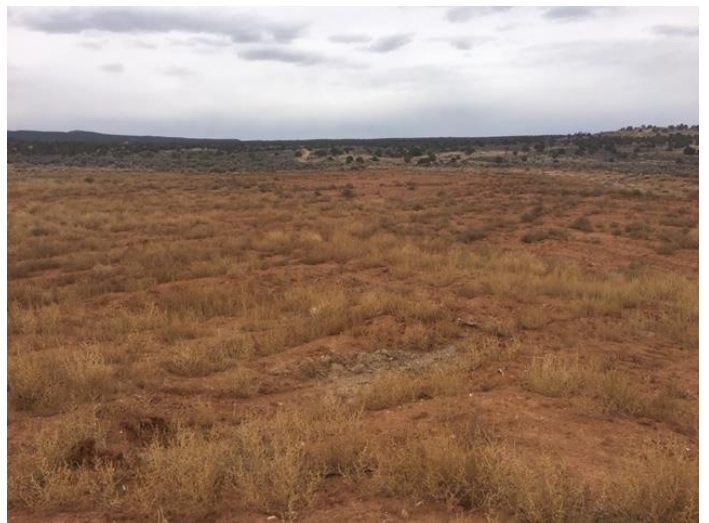
PHOTOGRAPHS

Photos that show the conditions observed during the October 30, 2018 inspection are included at the end of this report.

The purpose of the inspection was to observe the current conditions/progress of reclamation at the site. Staff was accompanied by the BLM to determine if the grading was complete. Both the BLM and Division staff agreed that the site's grading was complete and was ready for seeding.

A tamarisk and Russian knapweed was observed within the disturbance area. The knapweed appeared to have been sprayed and the tamarisk will need to be removed in order to prevent a future infestation. This is not noted as a problem at this time but is documented to be used as a tool to monitor weed control efforts during future inspections.
