## Rose Red Quarry M-2013-068

**RE: Colorado Rose Red Stone Resource, M-2013-068, AM-02 Adequacy Response 5**

## Colorado Rose Red Quarry - Surface Quarry Bench Design

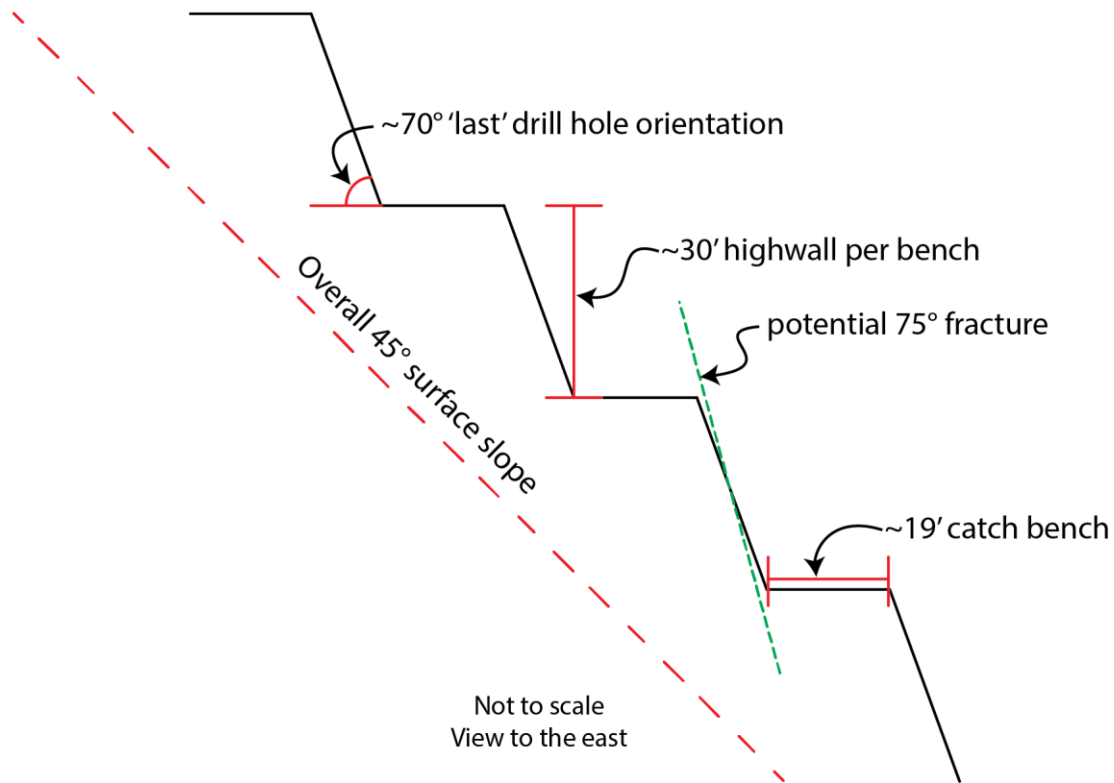
**Figure 1.** Schematic cross-section of the surface quarry operation at the Colorado Rose Red Quarry.

- e. **GLA Response 4/5:** To mitigate potential mass rock movement along the above detailed  $75^{\circ}$  south dipping fracture, the batter angle will be pushed to  $70^{\circ}$ , see the below Figure 1 cross-section. Any fractures within the pit wall cannot daylight and allow a massive block failure. The dashed green line represents a hypothetical  $75^{\circ}$  fracture – notice how rock mass above the intersection of the fracture and the face will be cleared as the final  $70^{\circ}$  batter angle is realized. Rock mass below the intersection of the fracture and the face will not experience movement as the rock mass will be contained in the catch bench. If the  $75^{\circ}$  fracture occurs along a catch bench, no failure will occur as the fracture will be constrained within the catch bench unable to daylight. By changing the batter angle to  $70^{\circ}$  the previously proposed 30 foot catch bench will now have a length of ~19 feet. This length will be more than adequate to account for mining equipment traffic. Additionally, best management practices will be utilized during every phase of surface excavation including but not limited to: highwall scaling, erection of safety berms, and potential closure of hazard areas until the hazard can be fully mitigated.
