AFS M-2014-043 Hatchery Adequacy Response

RE: Albert Frei and Sons, Inc.
Hatchery Pit - M-2014-043
Technical Revision 01 adequacy response 01

HATCHERY PIT PHASE 2 SLOPE LINER

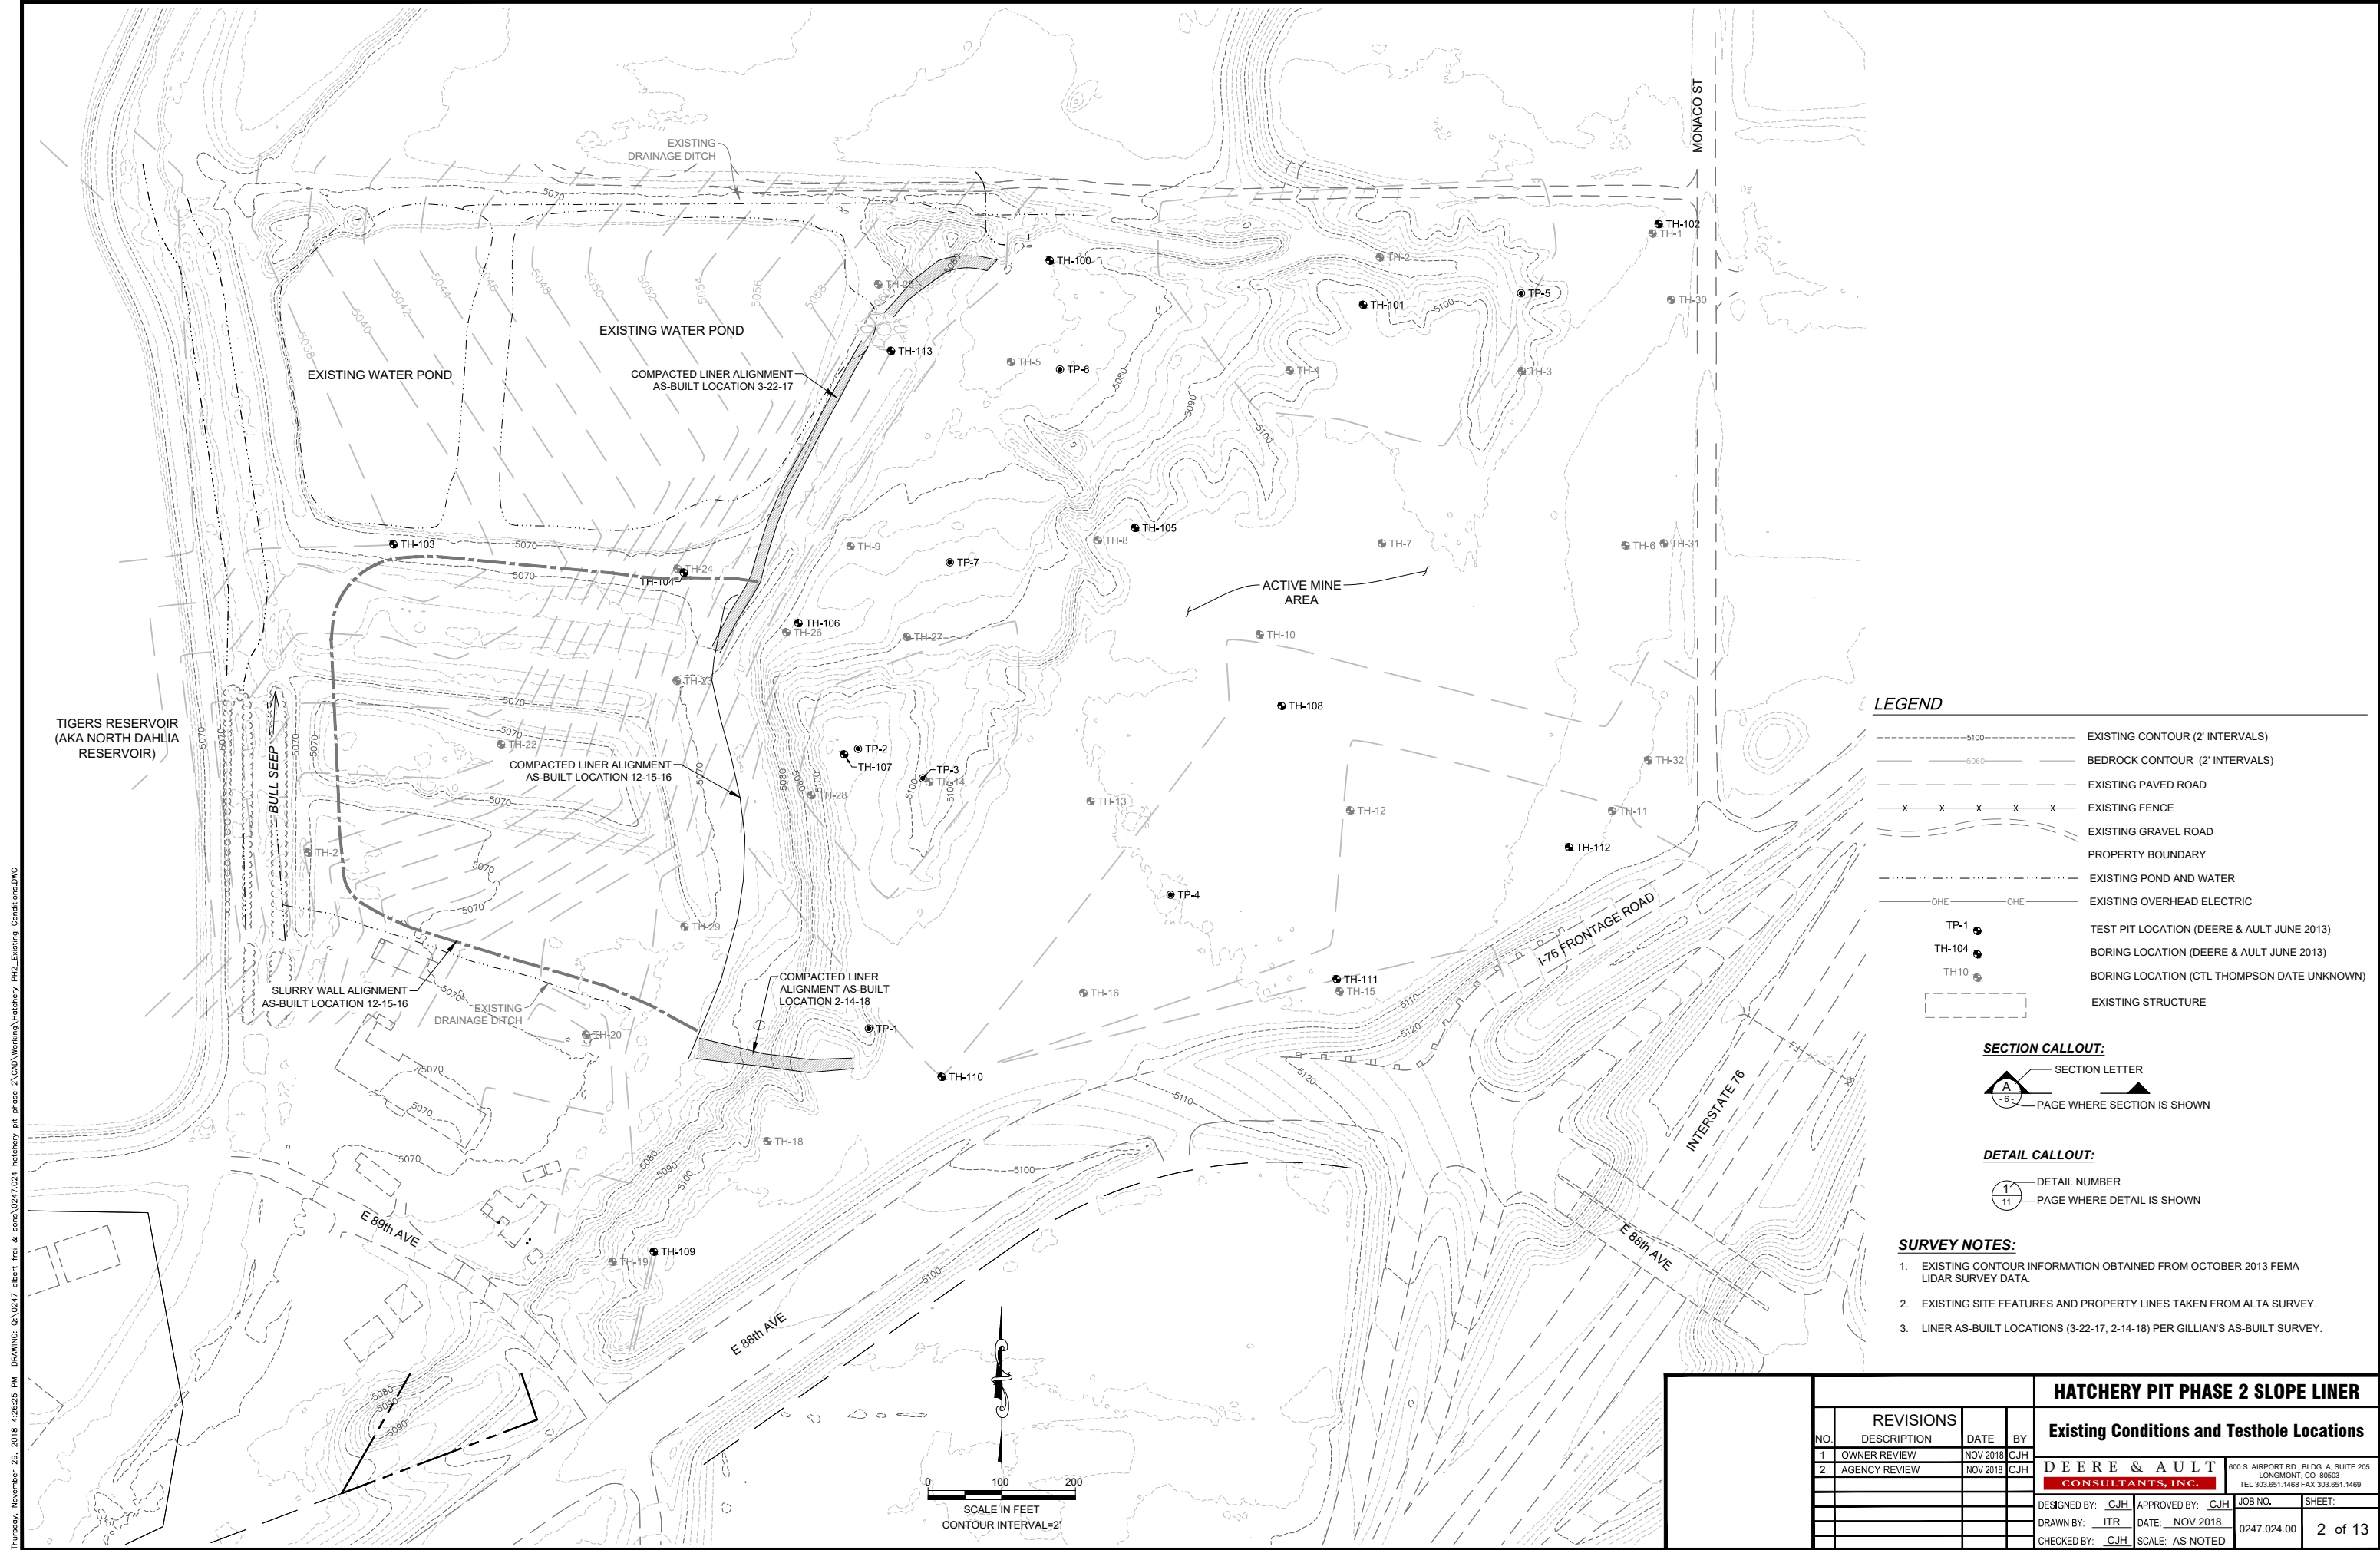
Existing Conditions and Testhole Locations

- EXISTING CONTOUR INFORMATION OBTAINED FROM OCTOBER 2013 FEMA LIDAR SURVEY DATA.
- EXISTING SITE FEATURES AND PROPERTY LINES TAKEN FROM ALTA SURVEY.
- LINER AS-BUILT LOCATIONS (3-22-17, 2-14-18) PER GILLIAN'S AS-BUILT SURVEY.

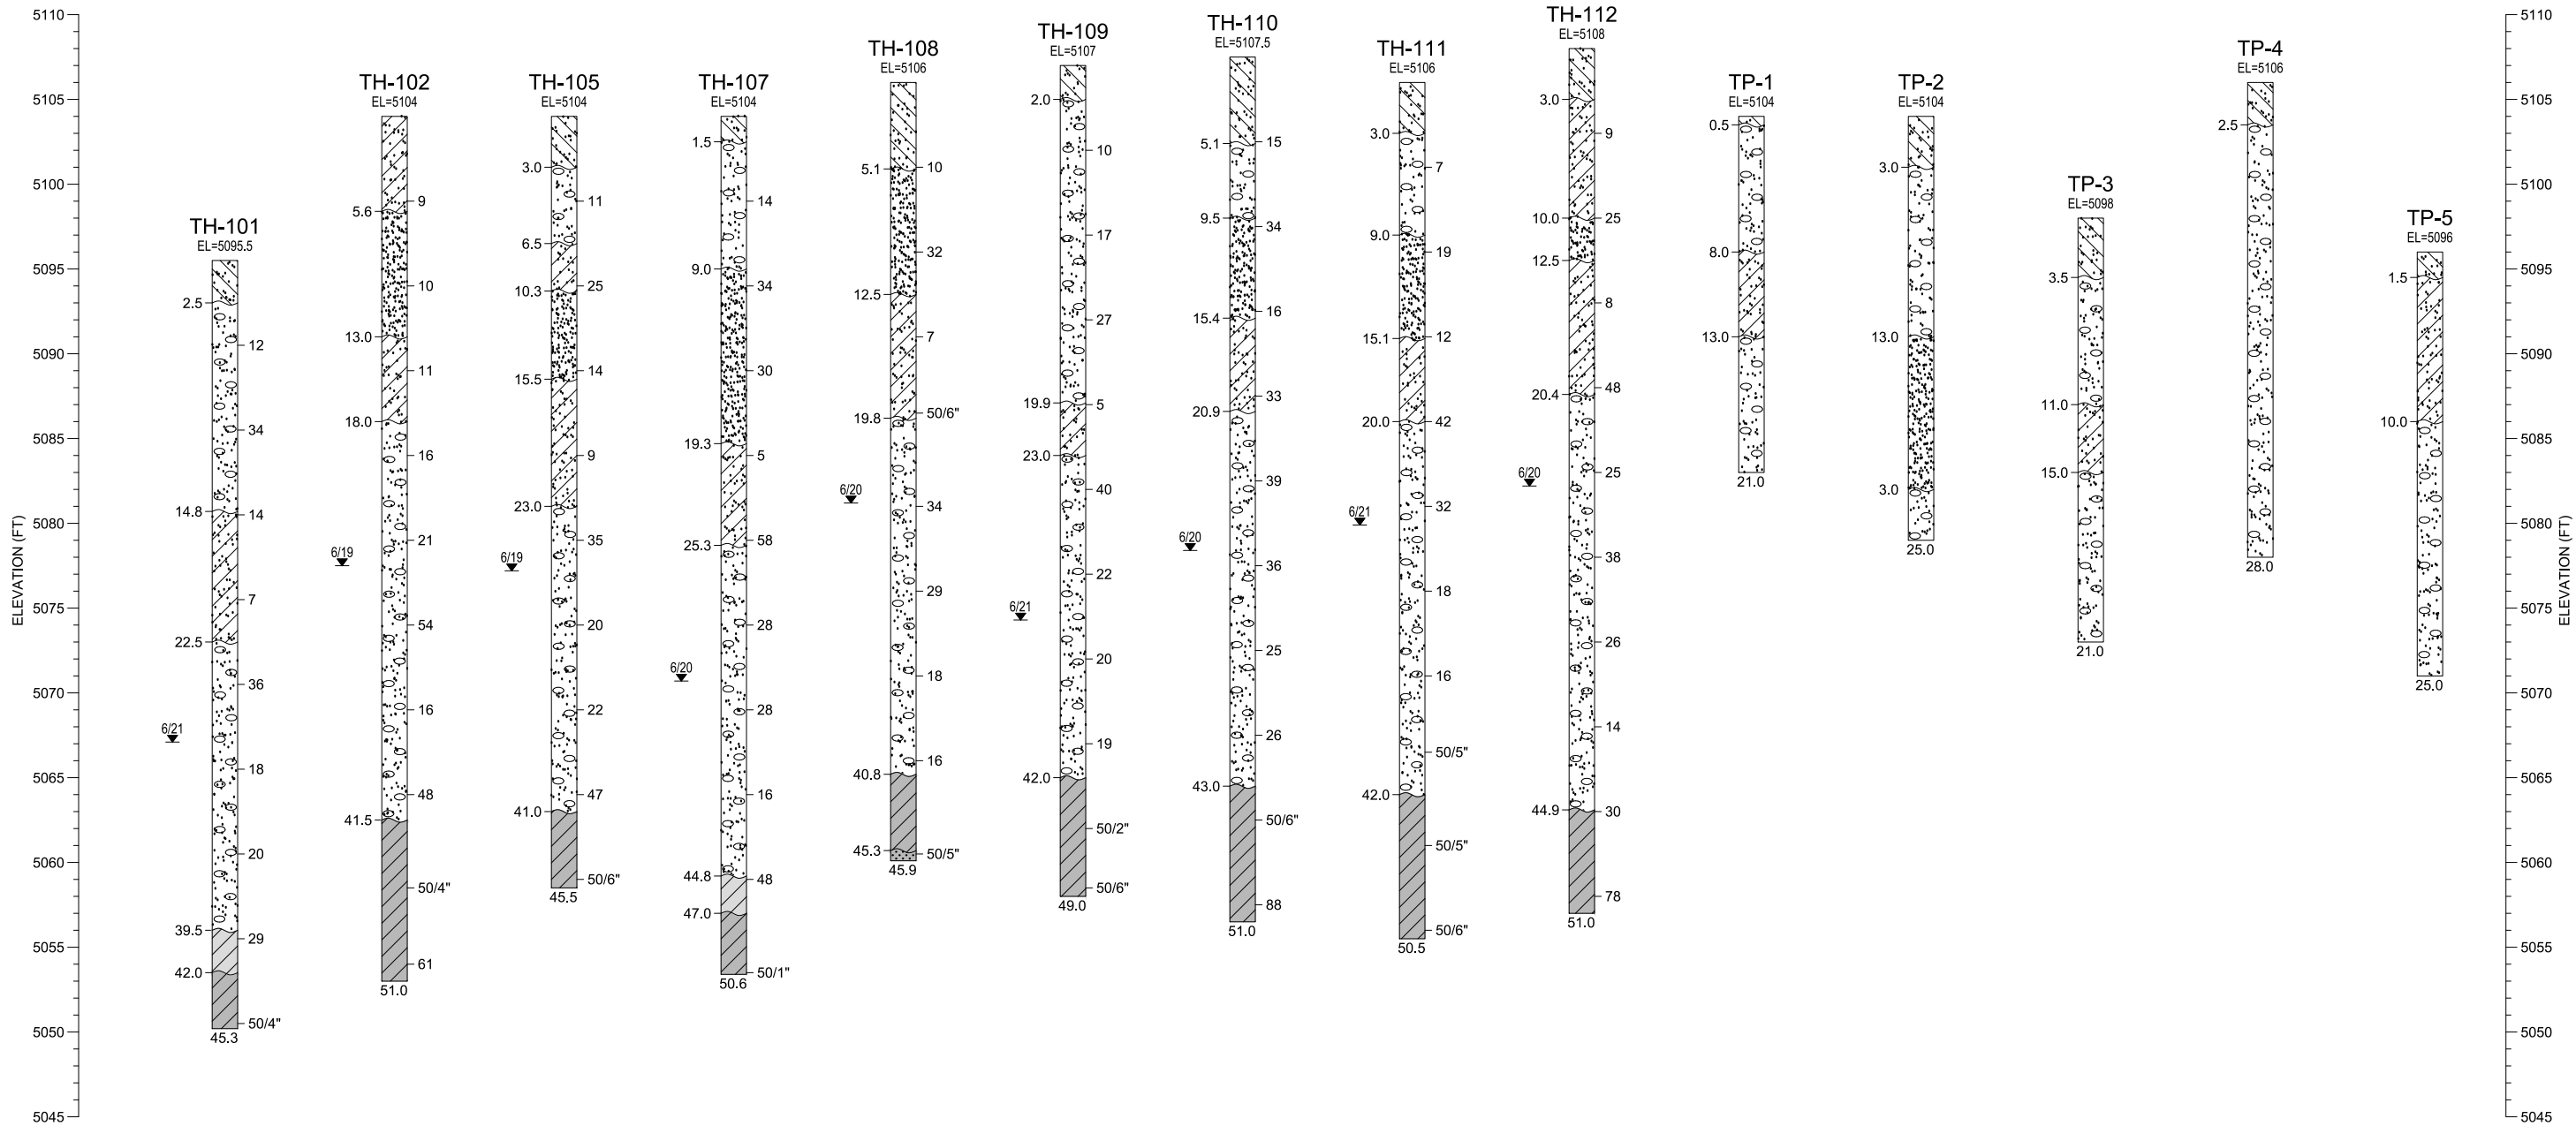
Summary Logs and Legend

- SILTY SAND: VERY LOOSE TO LOOSE, SILTY, WELL GRADED, FINE TO COARSE GRAINED SAND, SCATTERED GRAVEL, DRY, LIGHT BROWN TO DARK BROWN, NON PLASTIC, LOCAL ROOTS PRESENT

- CLAYEY SAND: VERY LOOSE TO MEDIUM DENSE, SLIGHTLY CLAYEY TO CLAYEY, SILTY, SCATTERED SMALL GRAVEL, POORLY GRADED, FINE GRAINED, SLIGHTLY MOIST TO MOIST, YELLOW TAN TO BROWN TO DARK BROWN, LOCAL IRON STAINING, LOW TO LOCAL MODERATELY PLASTIC, MUD LENS

- SAND: LOOSE TO DENSE, WELL GRADED, CLEAN, FINE TO COARSE GRAINED, SCATTERED SMALL GRAVEL, DRY, TAN TO LIGHT BROWN
- SAND & GRAVEL: MEDIUM DENSE TO VERY DENSE, SANDY GRAVEL TO GRAVELLY SAND, LOCAL COBBLES, TRACE SILT AND CLAY, WELL GRADED, FINE TO COARSE GRAINED SAND, SMALL GRAVEL UP TO 10 INCH COBBLES, ROUNDED GRAVEL AND COBBLES, SLIGHTLY MOIST TO WET, TAN BROWN TO REDDISH TAN TO LIGHT BROWN

- WEATHERED CLAYSTONE, HARD (SOILS), VERY LOW STRENGTH BEDROCK, DRY TO MOIST, TANISH BROWN TO MOTTLED BROWN, LOCAL IRON STAINING, MIXTURE OF BEDROCK COLORS, MODERATELY PLASTIC, BLOCKY

- CLAYSTONE: VERY HARD TO HARD (SOILS), VERY LOW STRENGTH BEDROCK, DRY TO SLIGHTLY MOIST, GRAY TO DARK GRAY, LOW TO MODERATELY PLASTIC, BLOCKY, SLIGHTLY WEATHERED TO FRESH NEAR BEDROCK/SAND AND GRAVEL CONTACT

- SANDSTONE: VERY HARD (SOILS), VERY LOW TO LOW STRENGTH BEDROCK, CLAYEY TO VERY CLAYEY, DRY, GRAY WITH BLACK AND WHITE GRAINS, POORLY GRADED, FINE TO MEDIUM GRAINED SAND, MOSTLY BIOTITE AND QUARTZ MINERALS, NON TO LOW PLASTIC, FRESH

9.8 APPROXIMATE DEPTH OF GEOLOGIC CONTACT
6/4 WATER ENCOUNTERED DURING DRILLING AND DATE MEASURED
23 STANDARD SPLITSPOON BLOW COUNT. NUMBER ("N" VALUE) INDICATES THE NUMBER OF BLOWS OF A 140 LB. HAMMER FREE FALLING 30 INCHES REQUIRED TO DRIVE THE SAMPLER 1 FOOT OR THE INDICATED INTERVAL. "WT" INDICATES THE SAMPLER ADVANCED WITH RESTING WEIGHT OF THE HAMMER
29.9 DEPTH OF BORING (FT)

- EXPLORATORY BORINGS WERE DRILLED BETWEEN 6-19-13 AND 6-21-13 USING A TRUCK-MOUNTED CME 55 DRILL RIG. BORINGS WERE DRILLED WITH 4.25-INCH I.D. HOLLOW STEM AUGERS.
- EXPLORATORY TEST PITS WERE EXCAVATED ON 6-21-13 USING A CATERPILLAR TRACK HOE.
- ALL EXPLORATORY BORING LOCATIONS WERE FOUND USING A HANDHELD GPS.
- LINES BETWEEN MATERIALS REPRESENT APPROXIMATE BOUNDARIES BETWEEN TYPES AND TRANSITIONS MAY BE GRADUAL.
- GROUNDWATER LEVELS WERE MEASURED AT THE TIME OF DRILLING. GROUNDWATER LEVELS MAY FLUCTUATE SEASONALLY AND DUE TO SITE MINING AND DEWATERING OPERATIONS.
- ELEVATIONS WERE ESTIMATED FROM OCTOBER 2013 FEMA LIDAR SURVEY.

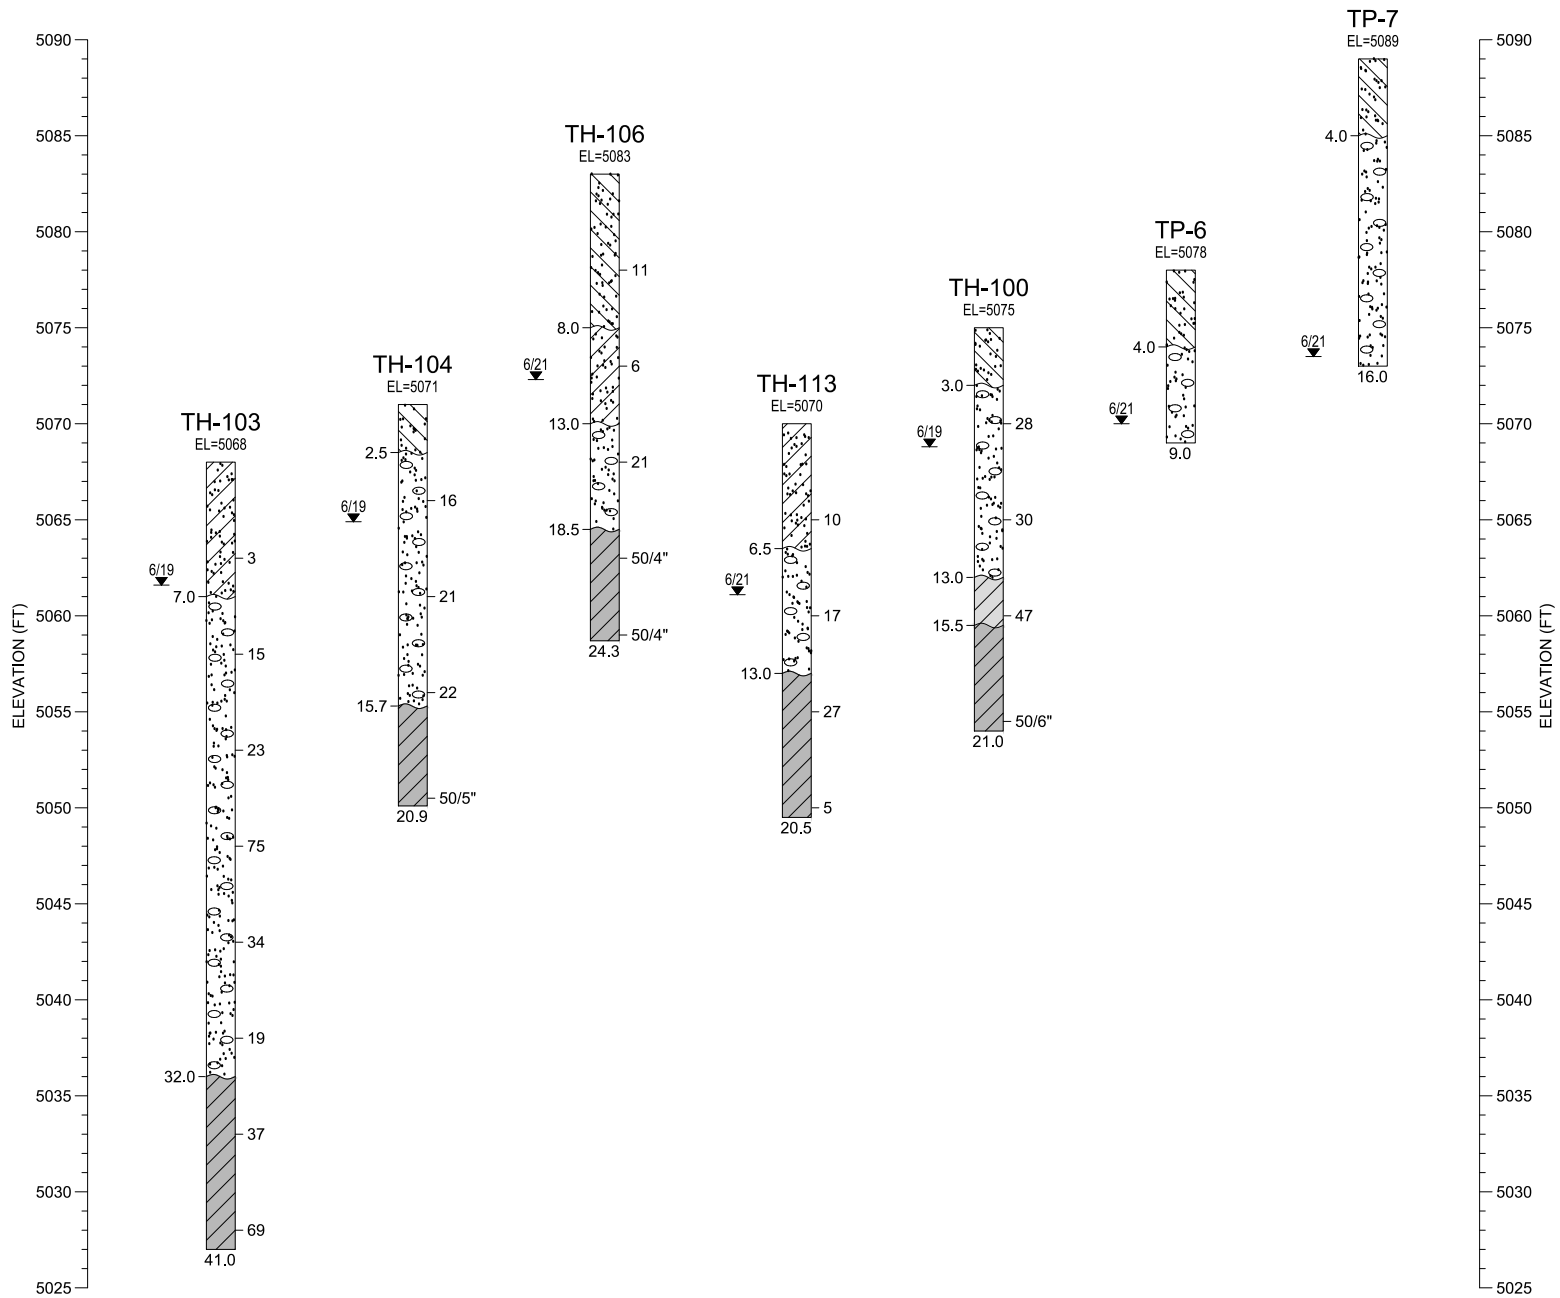
1. BORING LEGEND SHOWN ON SHEET 3.
2. EXPLORATORY BORINGS WERE DRILLED BETWEEN 6-19-13 AND 6-21-13 USING A TRUCK-MOUNTED CME 55 DRILL RIG. BORINGS WERE DRILLED WITH 4.25-INCH I.D. HOLLOW STEM AUGERS.
3. EXPLORATORY TEST PITS WERE EXCAVATED ON 6-21-13 USING A CATERPILLAR TRACK HOE.
4. ALL EXPLORATORY BORING LOCATIONS WERE FOUND USING A HANDHELD GPS.
5. LINES BETWEEN MATERIALS REPRESENT APPROXIMATE BOUNDARIES BETWEEN TYPES AND TRANSITIONS MAY BE GRADUAL.
6. GROUNDWATER LEVELS WERE MEASURED AT THE TIME OF DRILLING. GROUNDWATER LEVELS MAY FLUCTUATE SEASONALLY AND DUE TO SITE MINING AND DEWATERING OPERATIONS.
7. ELEVATIONS WERE ESTIMATED FROM OCTOBER 2013 FEMA LIDAR SURVEY.

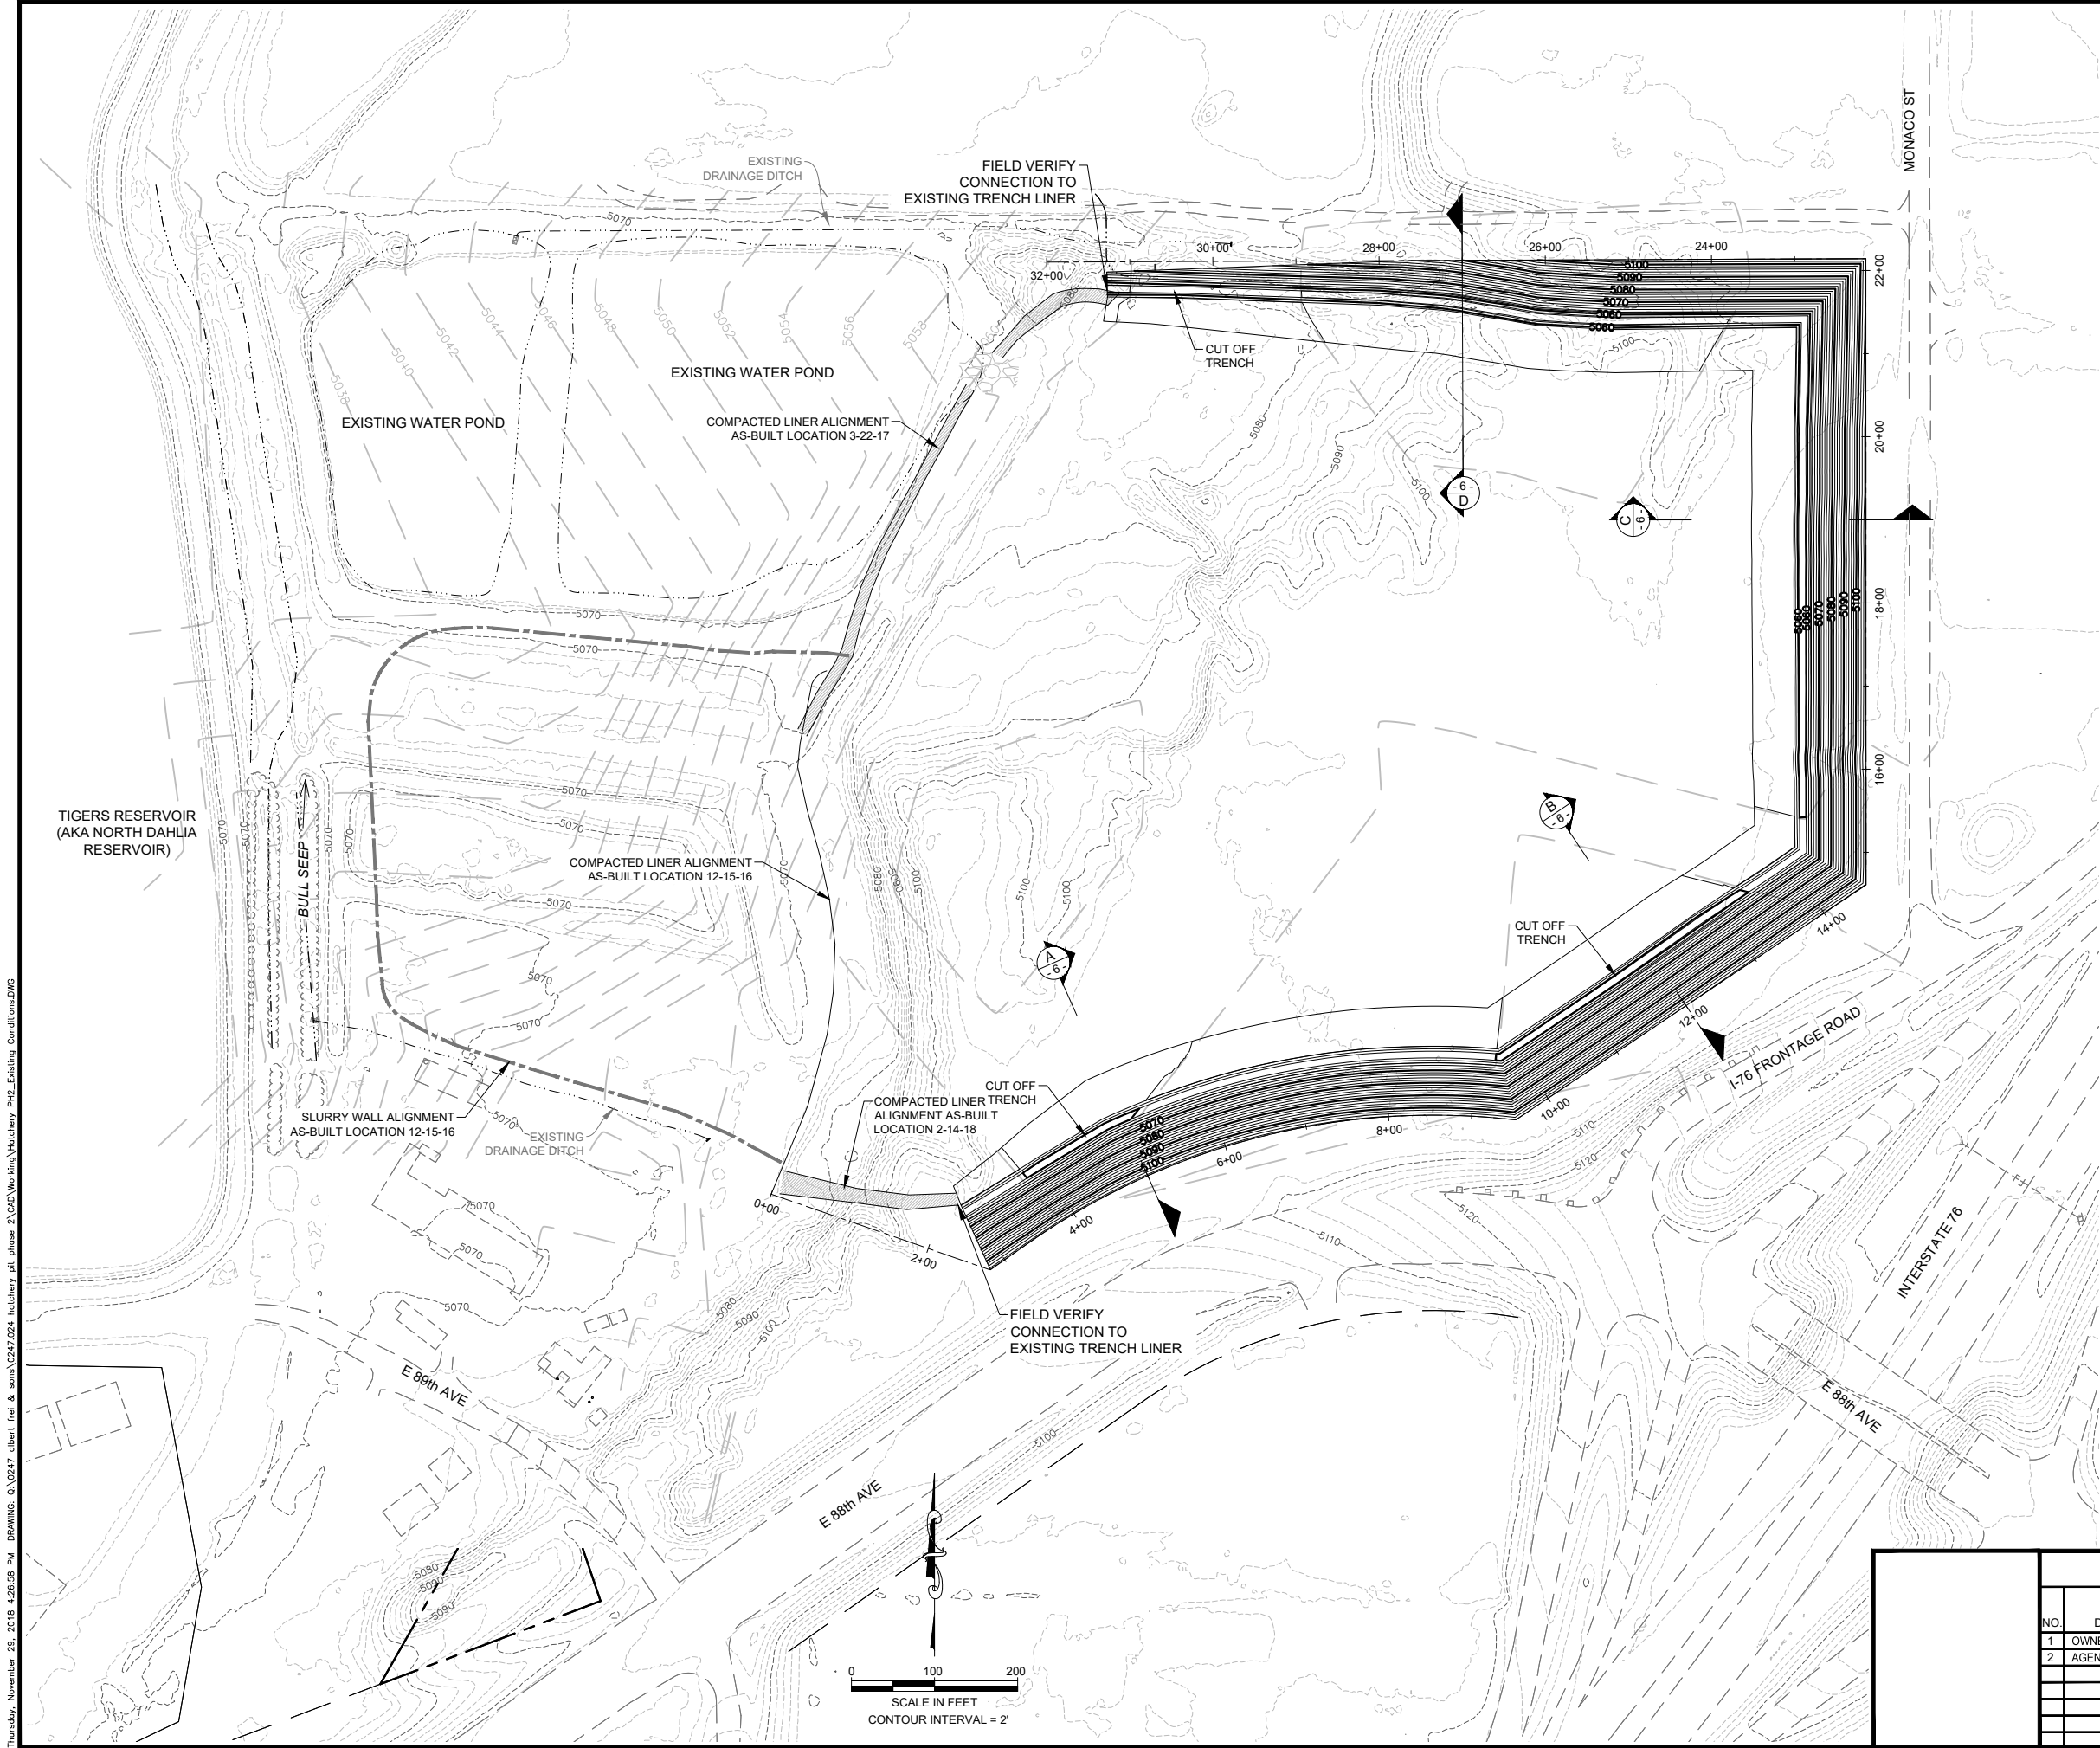
HATCHERY PIT PHASE 2 SLOPE LINER				
REVISIONS				Slope Liner Excavation Plan
NO.	DESCRIPTION	DATE	BY	
1	OWNER REVIEW	NOV 2018	CJH	DEERE & AULT CONSULTANTS, INC.
2	AGENCY REVIEW	NOV 2018	CJH	
DESIGNED BY: CJH				APPROVED BY: CJH
DRAWN BY: ITR				DATE: NOV 2018
CHECKED BY: CJH				SCALE: AS NOTED
				JOB NO. SHEET:
				0247.024.00 5 of 13

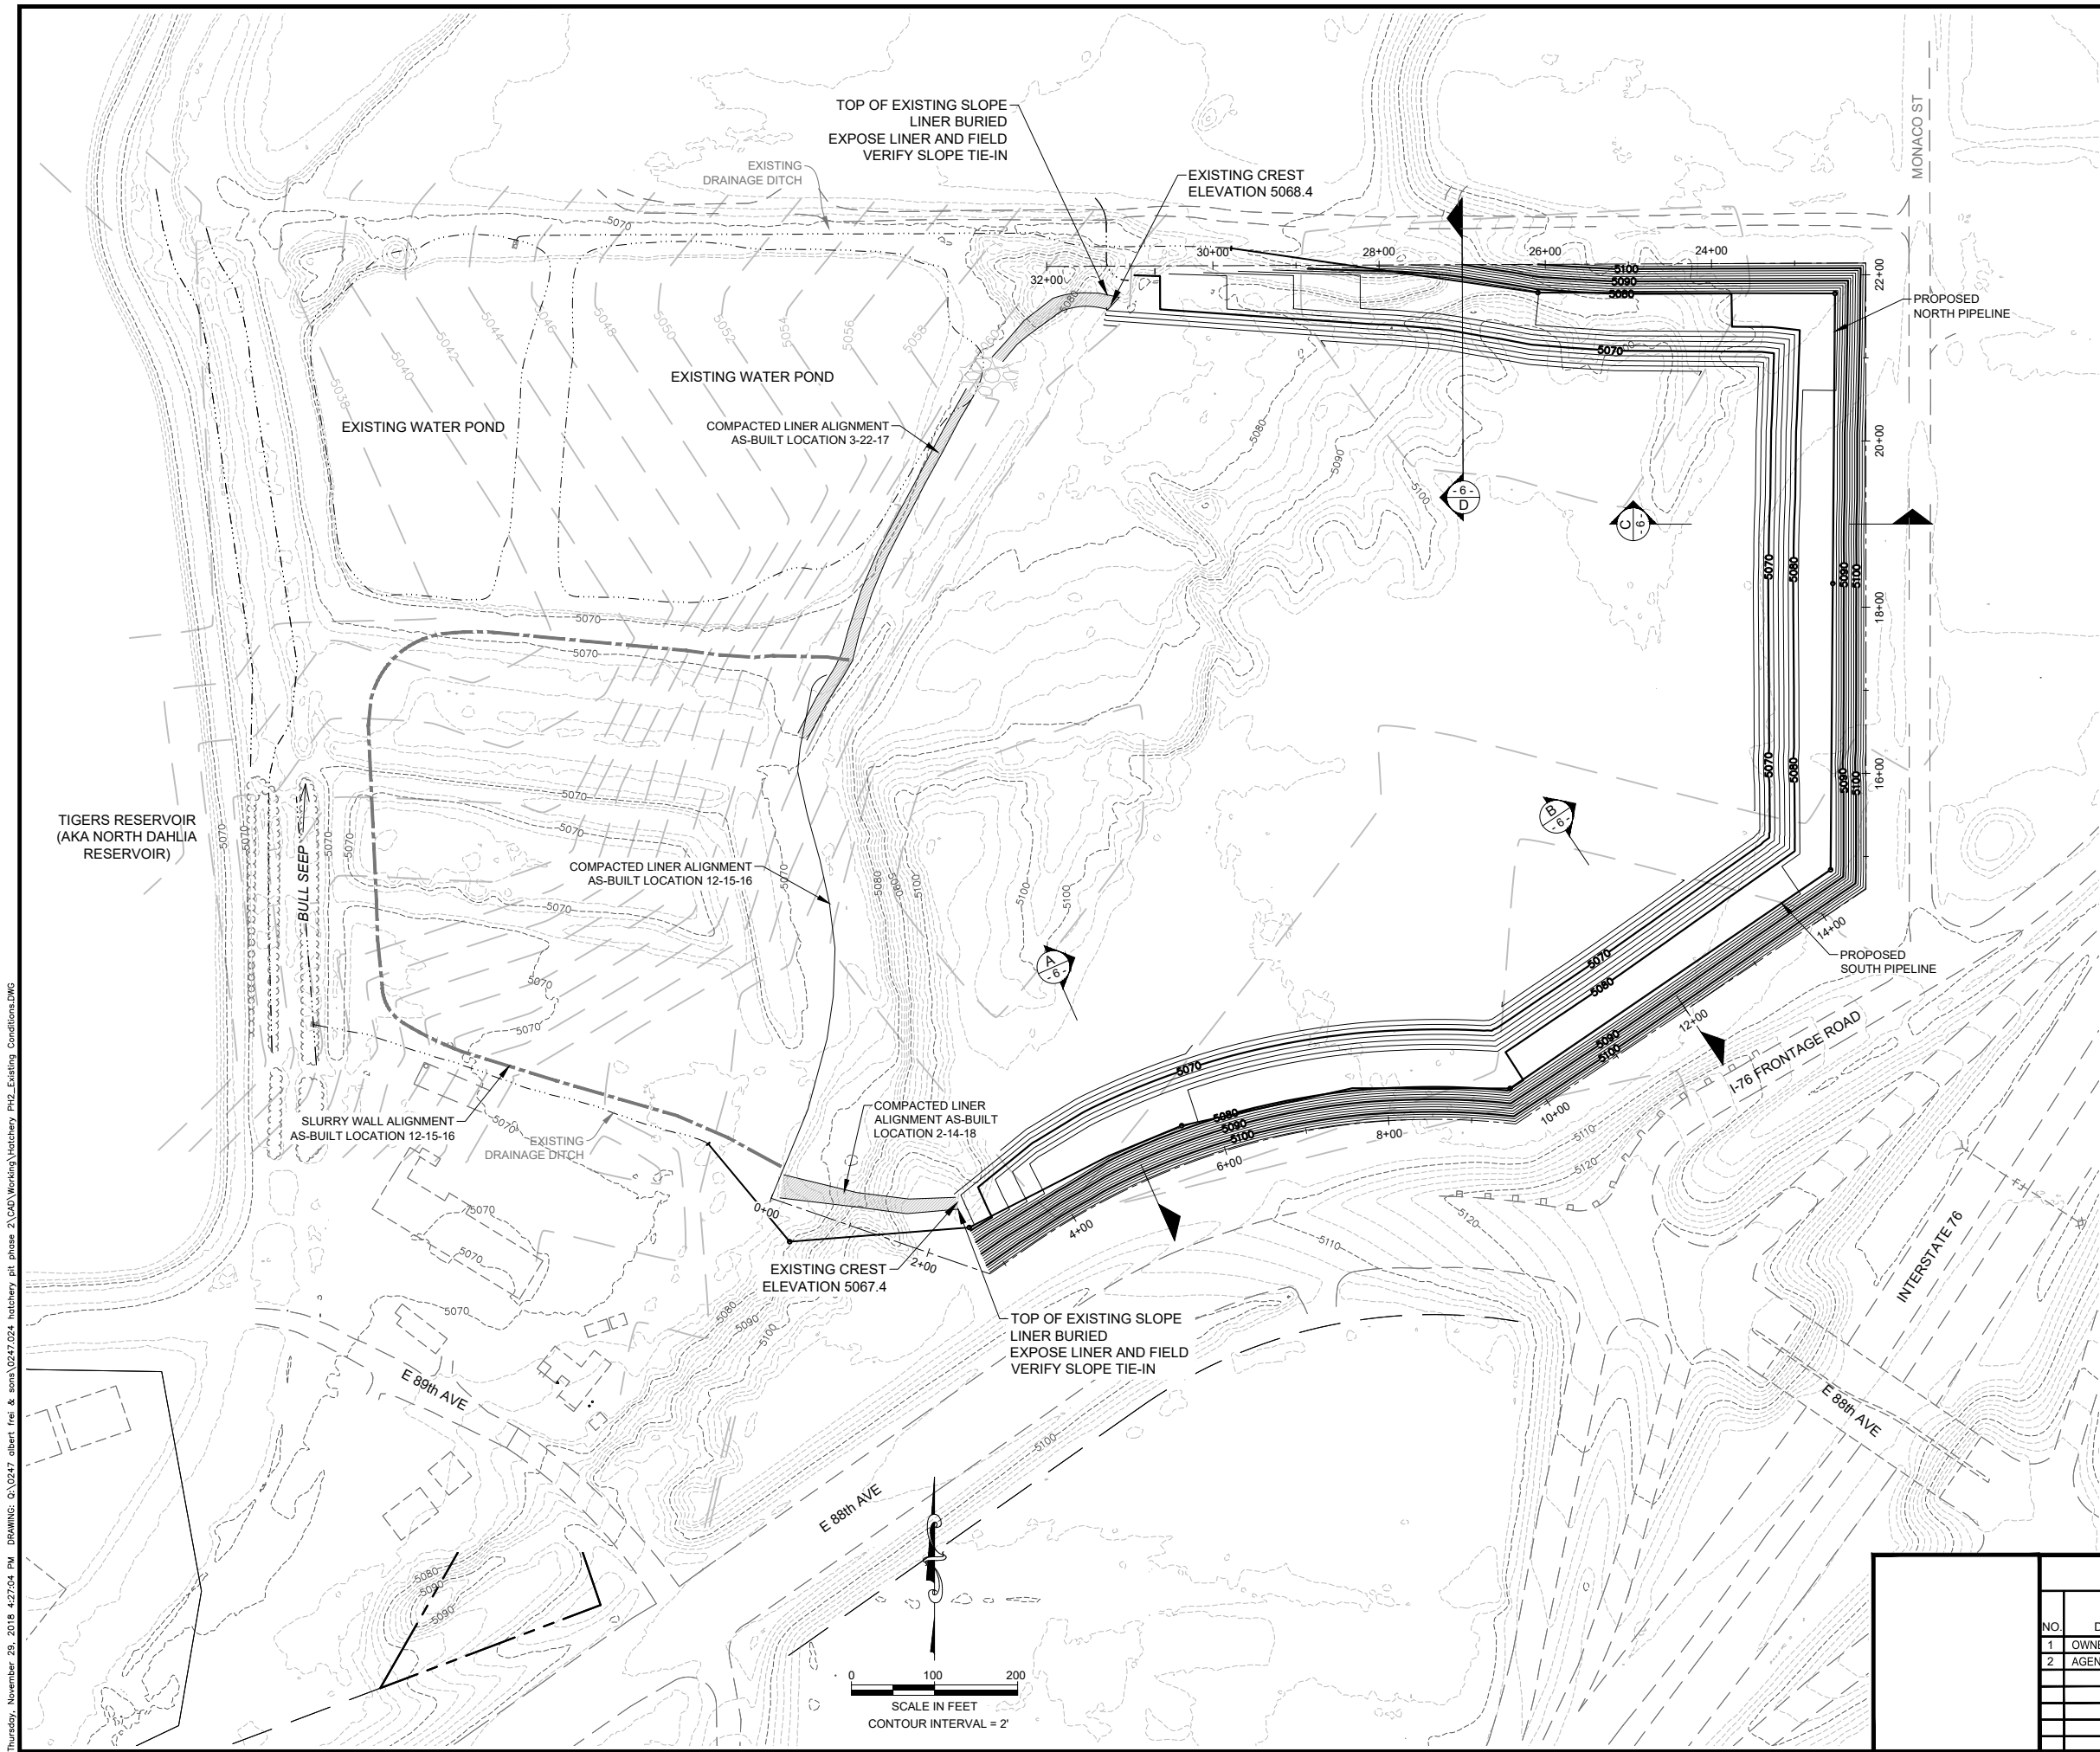
REVISIONS				HATCHERY PIT PHASE 2 SLOPE LINER			
NO.	DESCRIPTION	DATE	BY	Slope Liner Plan			
1	OWNER REVIEW	NOV 2018	CJH	DEERE & AULT CONSULTANTS, INC.			
2	AGENCY REVIEW	NOV 2018	CJH				
DESIGNED BY:	CJH	APPROVED BY:	CJH	600 S. AIRPORT RD., BLDG. A, SUITE 205 LONGMONT, CO 80503 TEL 303.651.1468 FAX 303.651.1469	JOB NO.	SHEET:	
DRAWN BY:	ITR	DATE:	NOV 2018	CHECKED BY:	CJH	0247.024.00	6 of 13
				SCALE: AS NOTED

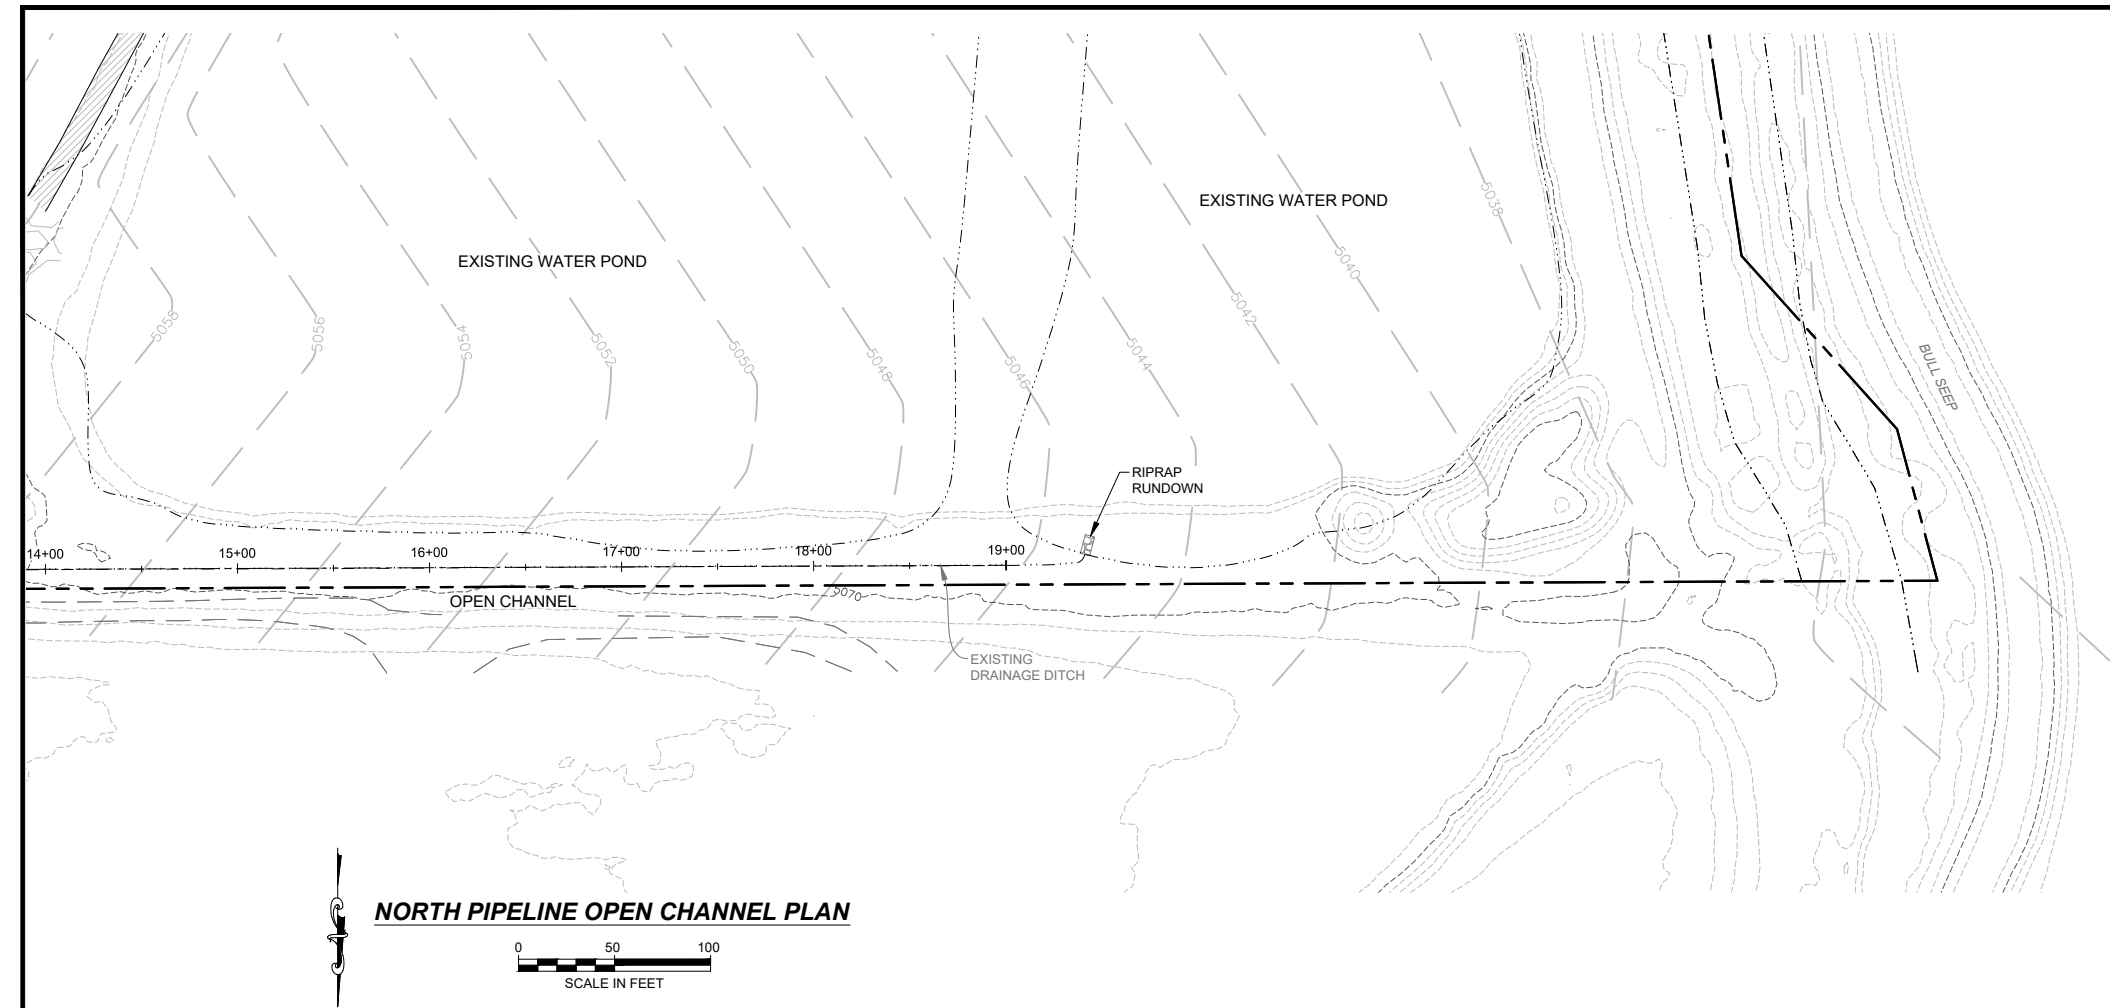
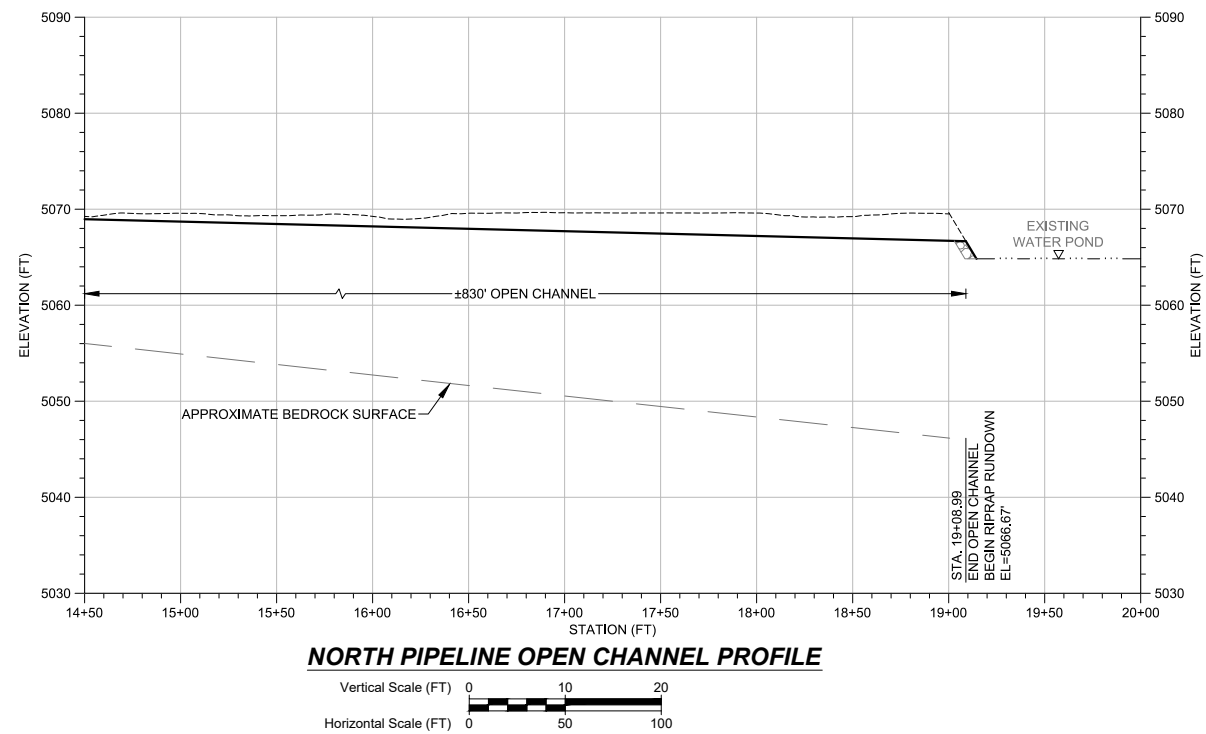
REVISIONS				HATCHERY PIT PHASE 2 SLOPE LINER			
NO.	DESCRIPTION	DATE	BY	North Pipeline Plan and Profile (2)			
1	OWNER REVIEW	NOV 2018	CJH	DEERE & AULT CONSULTANTS, INC.			
2	AGENCY REVIEW	NOV 2018	CJH				
	DESIGNED BY: CJH	APPROVED BY: CJH		JOB NO.	SHEET:		
	DRAWN BY: ITR	DATE: NOV 2018		0247.024.00	10 of 13		
	CHECKED BY: CJH	SCALE: AS NOTED
