MINERALS PROGRAM INSPECTION REPORT
PHONE: (303) 866-3567

MINE NAME: Colona Gravel Pit	MINE/PROSPECTING ID#: M-1994-005	MINERAL: Sand and gravel	COUNTY: Montrose
INSPECTION TYPE: Monitoring	INSPECTOR(S): Dustin Czaplá, Travis Marshall	INSP. DATE: June 18, 2019	INSP. TIME: 10:00
OPERATOR: Oldcastle SW Group, Inc. dba United Companies of Mesa County	OPERATOR REPRESENTATIVE: None	TYPE OF OPERATION: 112c - Construction Regular Operation	
REASON FOR INSPECTION: Normal I&E Program	BOND CALCULATION TYPE: None	BOND AMOUNT: \$165,351.00	
DATE OF COMPLAINT: NA	POST INSP. CONTACTS: None	JOINT INSP. AGENCY: None	
WEATHER: Clear	INSPECTOR'S SIGNATURE:

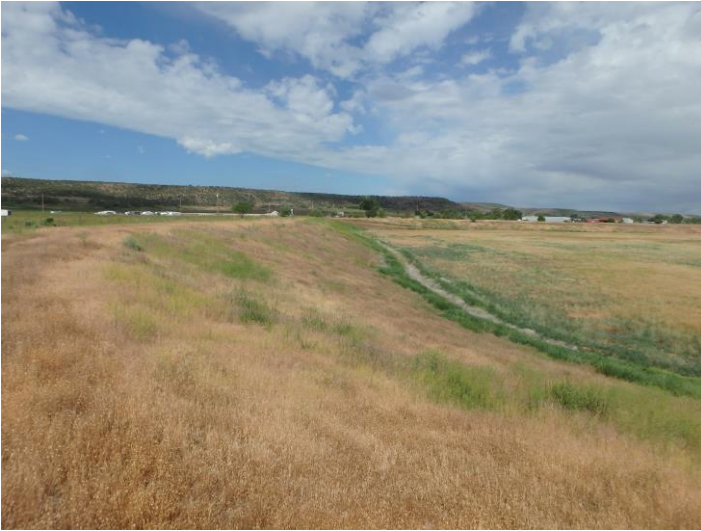
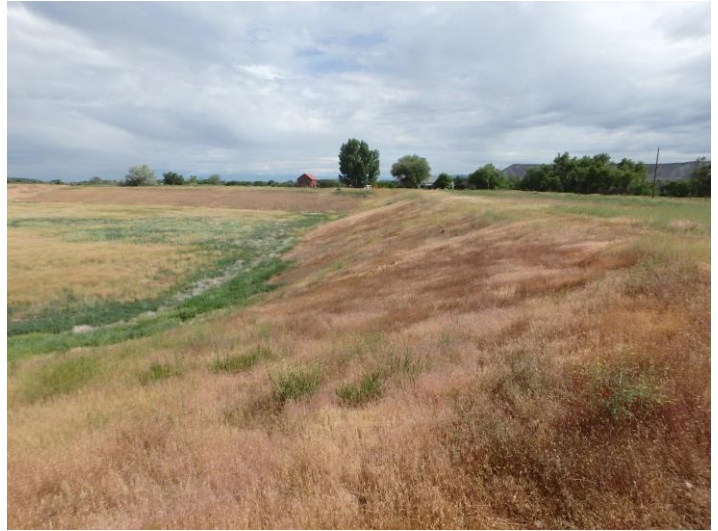
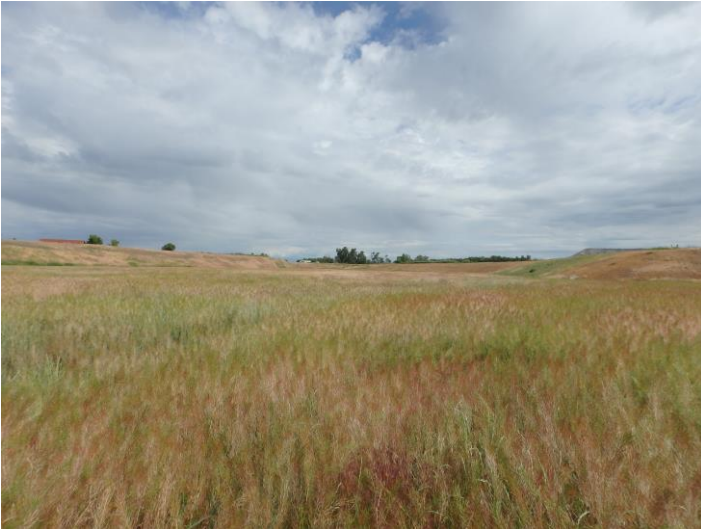
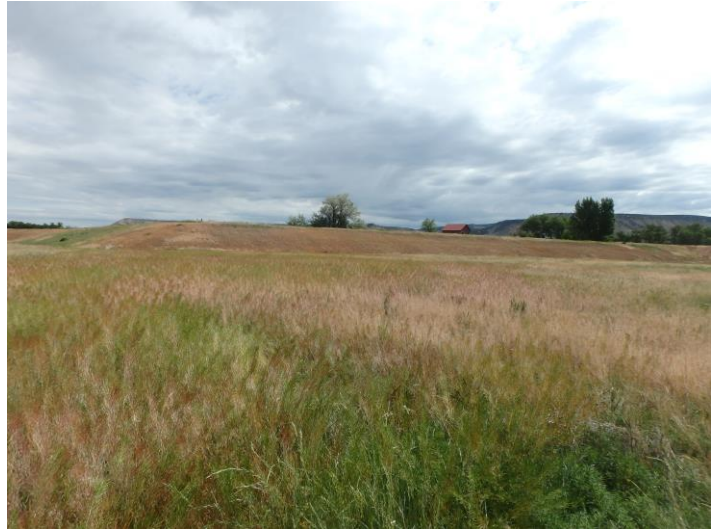
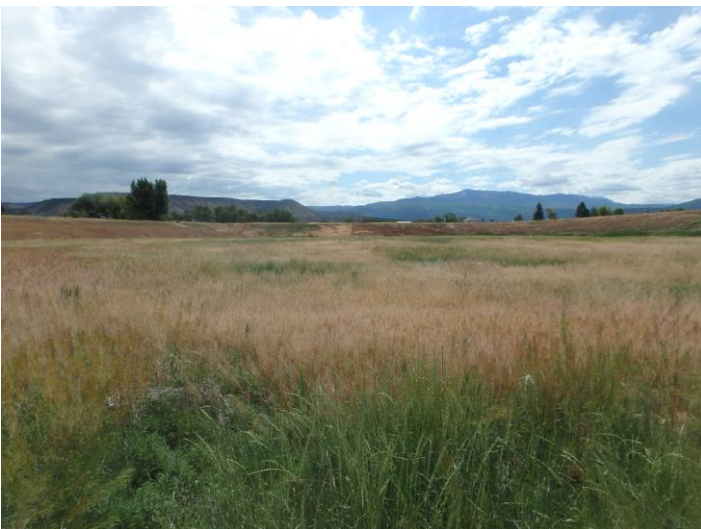
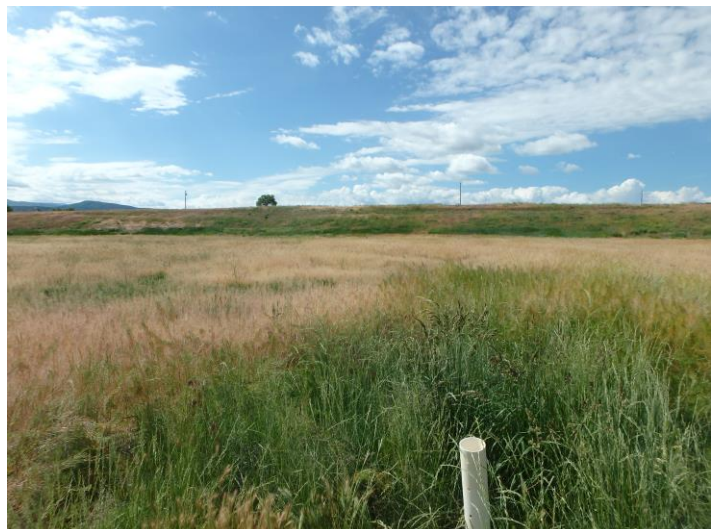
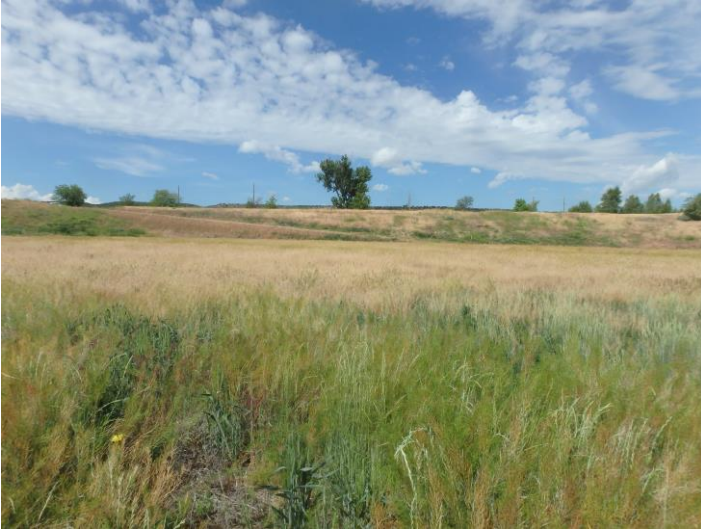
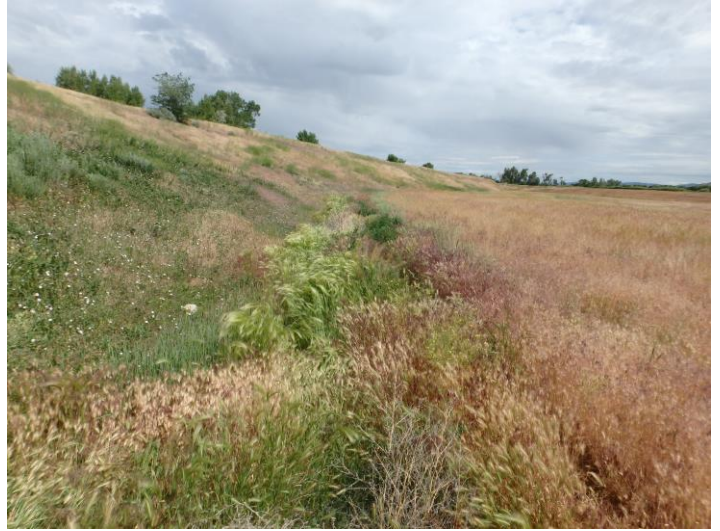
PHOTOGRAPHS

The south pit area is in final reclamation. This inspection was conducted in order to observe and monitor conditions in the south pit area in order to address landowner concerns related to groundwater infiltration through the highwalls and exposed groundwater in the pit floor. There were no seeps in the highwalls observed during this inspection. There was no exposed groundwater observed in the pit floor during this inspection. The irrigation ditches on the west and east sides, adjacent to the pit were not flowing at the time of this inspection. The irrigation ditch on the west side of the pit, adjacent to Hwy 550, was flowing. The operator has constructed a ditch running along the base of the south and west highwall slopes in order to divert any seepage water around the south pit floor to the north pit area. No water was observed in the ditch.

This inspection was conducted as part of the Division of Reclamation, Mining and Safety's (Division) normal monitoring program. A representative for the operator was not present. Photographs are included with this report in order to illustrate the conditions observed.
