**MINERALS PROGRAM INSPECTION REPORT**  
**PHONE: (303) 866-3567**

| <b>MINE NAME:</b><br>Pit No 1 | <b>MINE/PROSPECTING ID#:</b><br>M-1977-020 | <b>MINERAL:</b><br>Sand and gravel | <b>COUNTY:</b><br>Delta |

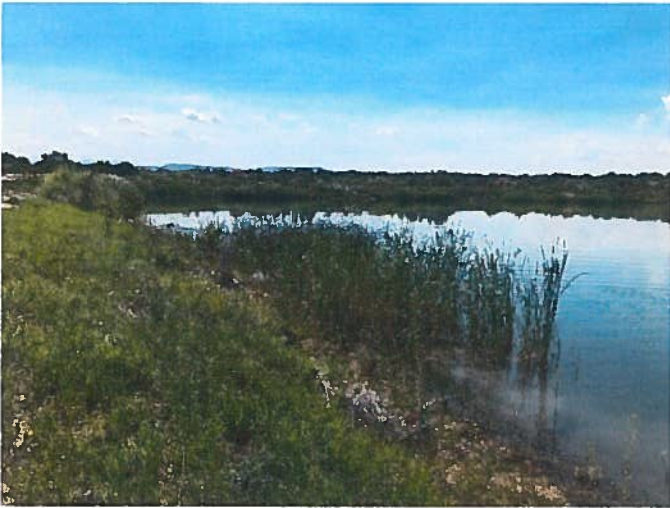
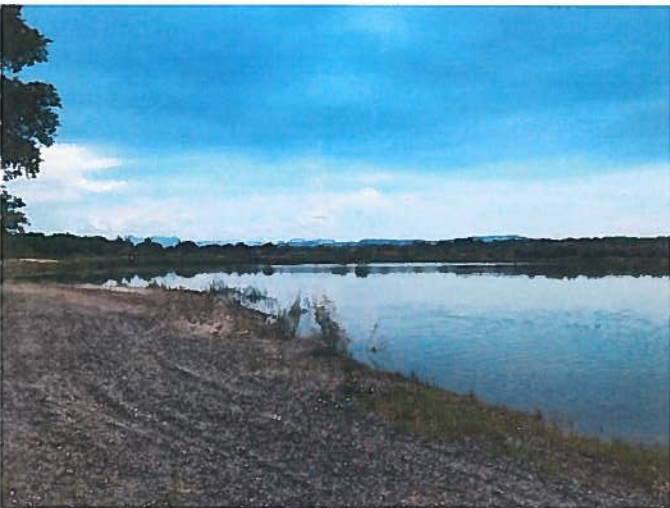
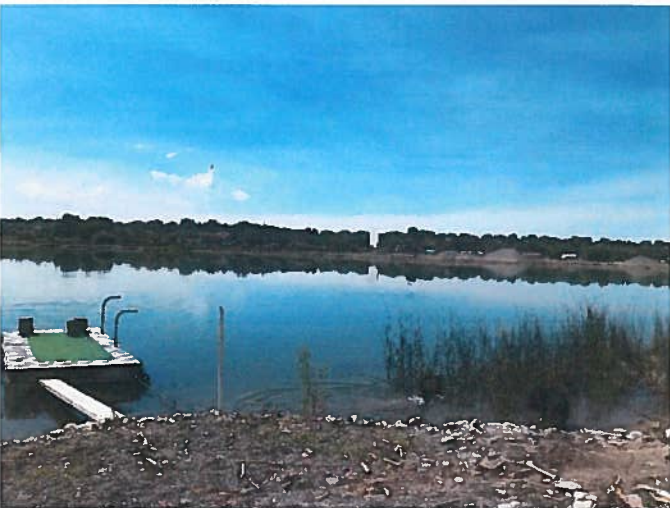
**PHOTOGRAPHS**

Tamarisk and Russian Olive have been removed from this area. Final grading is complete and in accordance with the approved reclamation plan. Topsoil has been applied to the pit slopes and seeding occurred earlier this spring. The planted grasses were observable in places, but still too immature to determine whether or not successful establishment will occur. Most of the vegetation observed consisted of volunteer species. Willows and cottonwoods are beginning to establish on the banks.

This inspection was conducted as a routine monitoring inspection. Mike Ripp with MVR Resources, representing the Operator, was present during this inspection. Photographs are included with this report in order to illustrate some of the conditions observed.
