MINERALS PROGRAM INSPECTION REPORT
PHONE: (303) 866-3567

MINE NAME: Clayton Sand and Gravel	MINE/PROSPECTING ID#: M-1999-022	MINERAL: Sand and gravel	COUNTY: Saguache
INSPECTION TYPE: Monitoring	INSPECTOR(S): Stephanie Mitchell	INSP. DATE: November 7, 2019	INSP. TIME: 10:30
OPERATOR: Eddie Clayton	OPERATOR REPRESENTATIVE:	TYPE OF OPERATION: 110c - Construction Limited Impact	
REASON FOR INSPECTION: Normal I&E Program	BOND CALCULATION TYPE: Complete Bond	BOND AMOUNT: \$7,900.00	
DATE OF COMPLAINT: NA	POST INSP. CONTACTS: None	JOINT INSP. AGENCY: None	
WEATHER: Clear	INSPECTOR'S SIGNATURE:

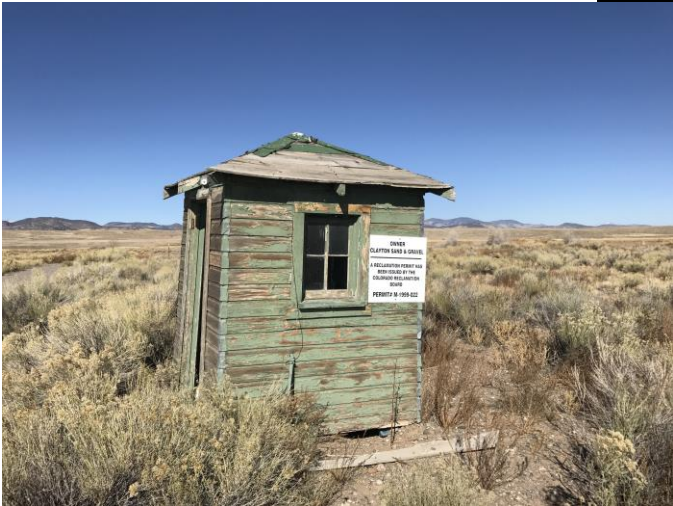
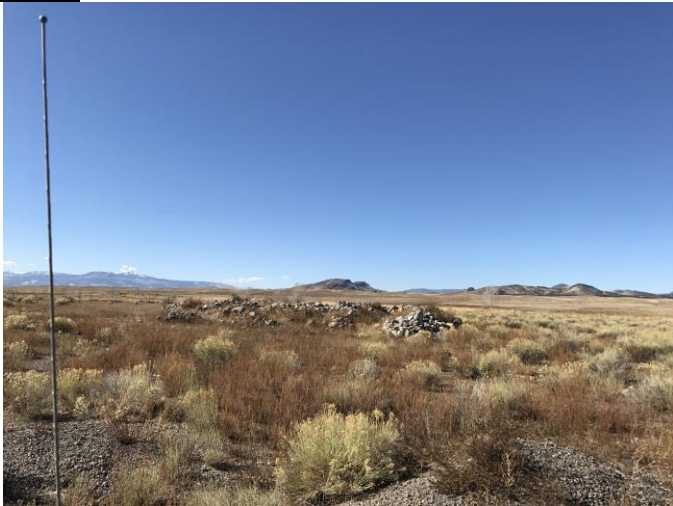
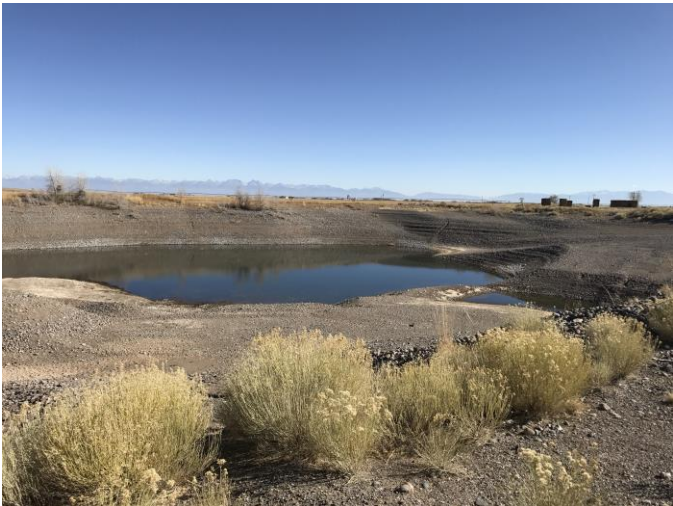
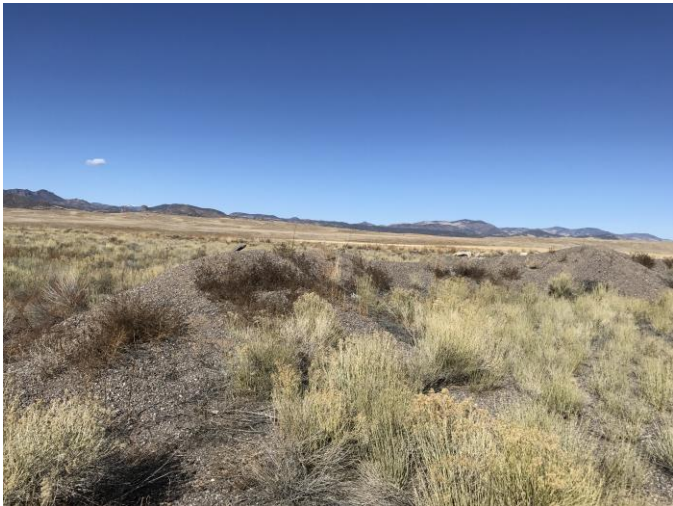
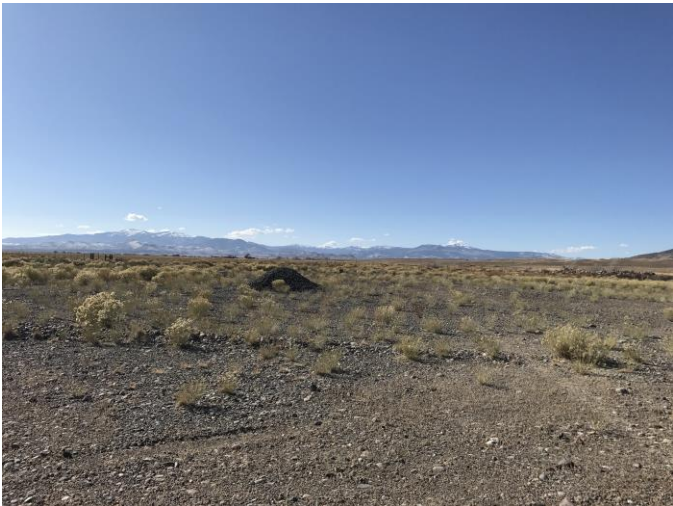
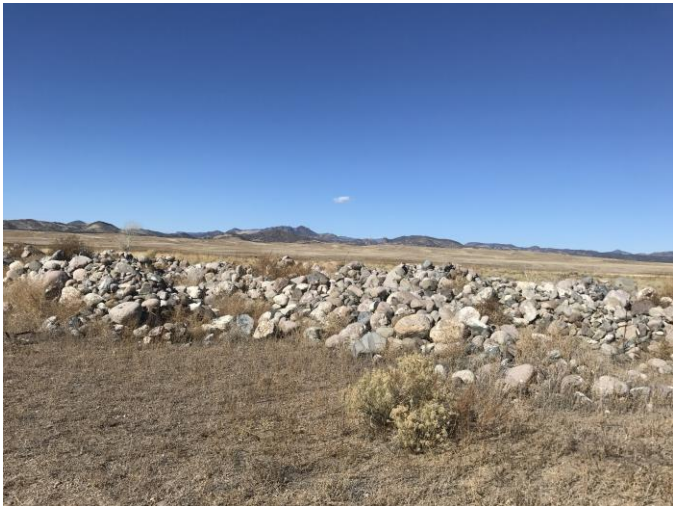
PHOTOGRAPHS

It is recommended at this time that the Operator start to reclaim (grade remaining material stockpiles, spread remaining topsoil and seed area with the approved seed mix) the remaining disturbed area. Photos showing the conditions observed during the inspection are included at the end of this report.

This is a 3.90 acre 110c mining operation for sand and gravel. A mine identification sign was in place at the entrance to the mine site. The site is stable and no disturbance was observed outside of the approved permit boundaries. The permit area acreage has been reduced over the years through acreage release requests in 2003 and 2010.
