**Re: Mountain Coal Company, LLC - West Elk Mine, CDRMS Permit No. C-1980-007
Pond and Mine Site Quarterly Inspection Reports – 4th Quarter 2019**

Attached are Mountain Coal Company, LLC's (MCC) Pond, Refuse Pile and Mine Site quarterly self-inspection reports for the 4th Quarter of 2019.

MCC added waste rock material to the RPEE during the 4th quarter, constructing lifts no more than 24". Compaction tests were conducted and the construction of the RPEE certified by John C. Poulos, P.E.

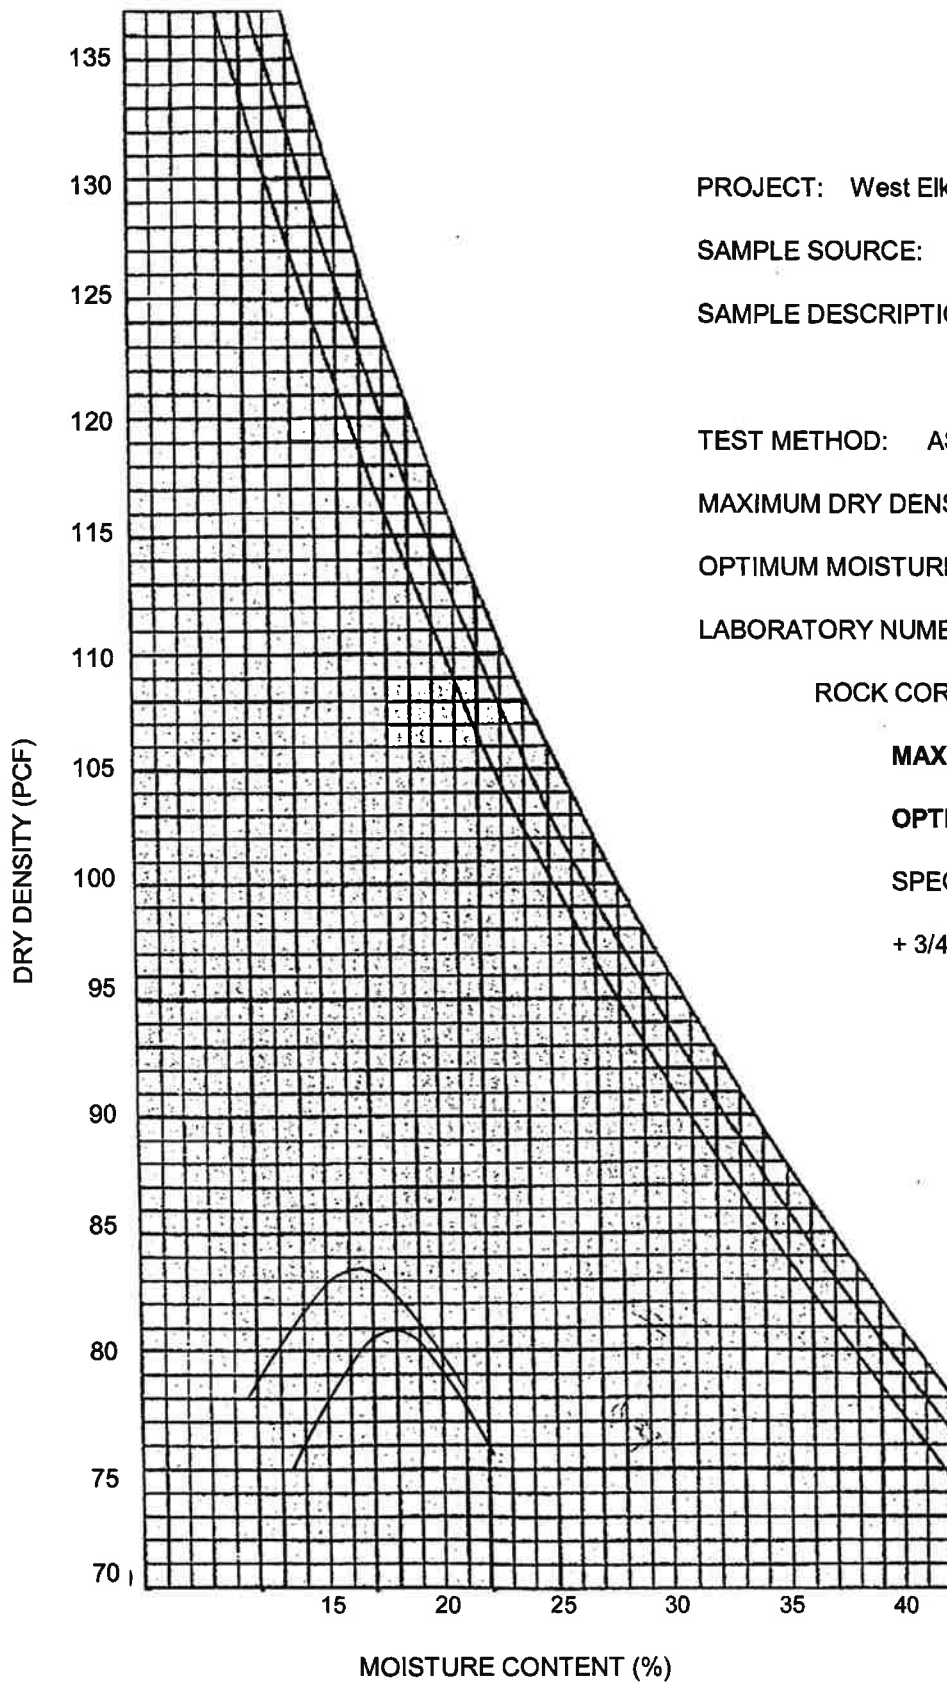
Figure: 1

PROJECT: West Elk Mine

SAMPLE SOURCE: RPEE

OPTIMUM MOISTURE CONTENT: 18.0 %

OPTIMUM MOISTURE CONTENT: 16.5%

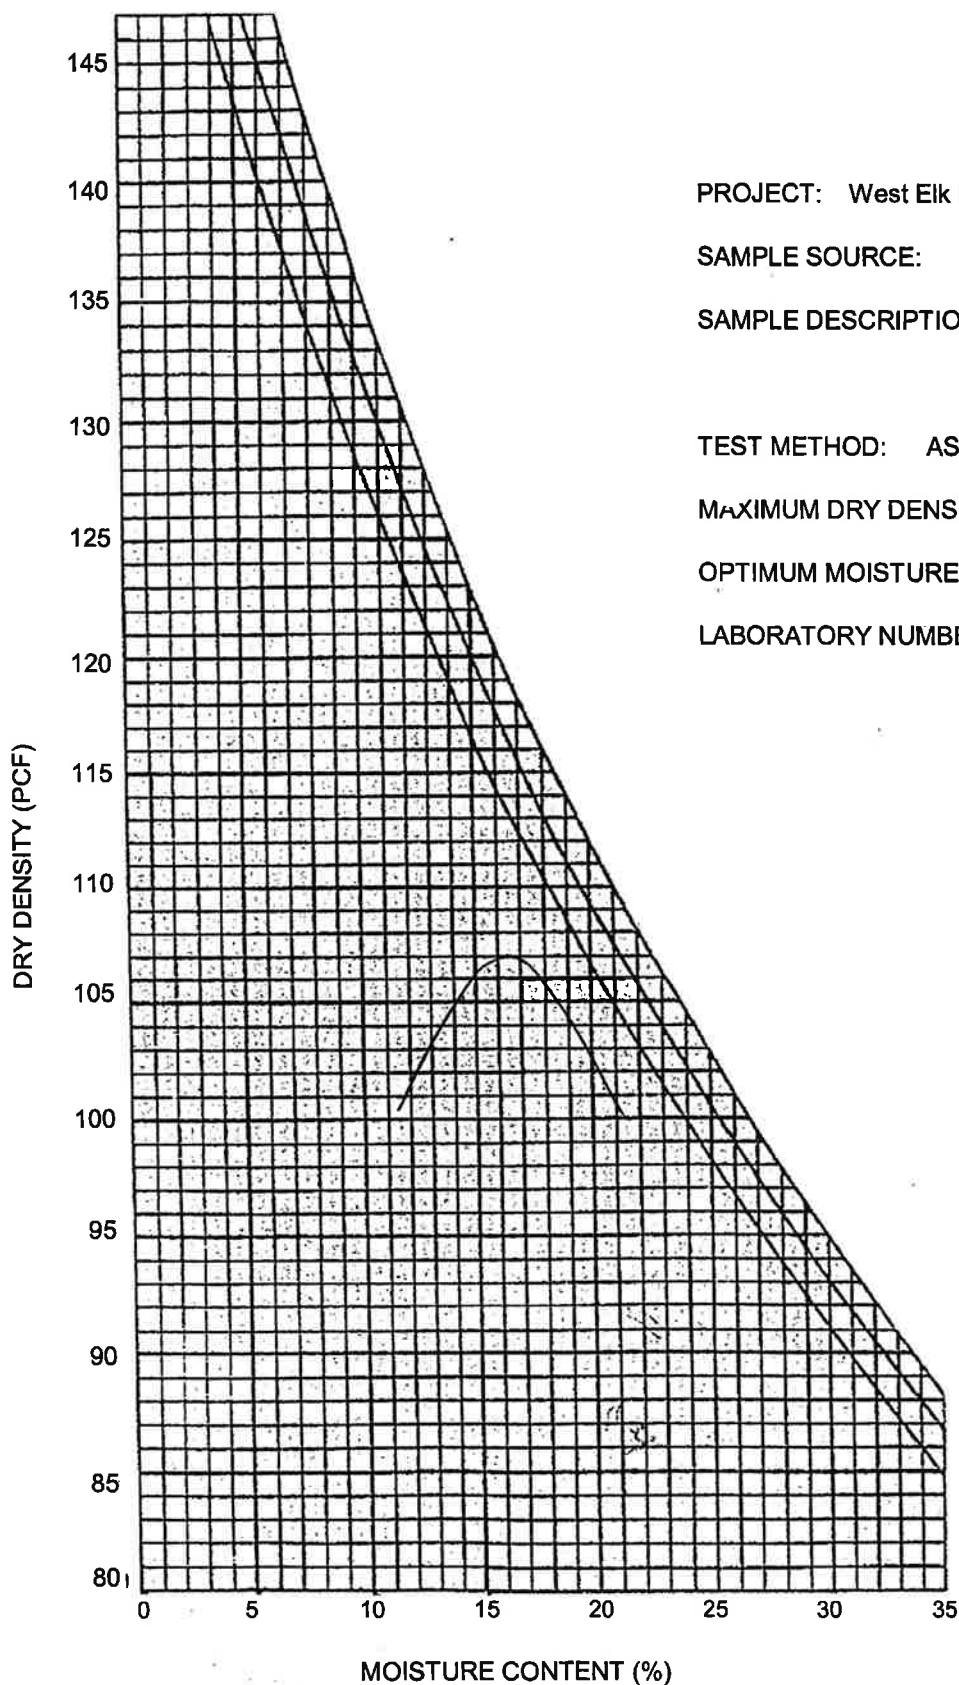
PROJECT: West Elk Mine

SAMPLE SOURCE: Cut Area

OPTIMUM MOISTURE CONTENT: 16.5 %
