- Narrative Annual Report – Provides detail to answers on annual report questions.
- 2019 Tailing Storage Facility Evaluation Letter from AECOM
- 2019 McNulty OSF Expansion As-Built Drawings
- 1 Dam Horizontal Drains – no new drains drilled in 2019
- Weed Control Data Tables

**Annual Report – 2019**  
**Climax Molybdenum Company - Climax Mine**  
**Highway 91 – Fremont Pass**  
**Climax, Colorado 80429**  
**Permit No. M-1977-493**

CLIMAX MINE  
MCNULTY OSF EXPANSION  
COVER SHEET

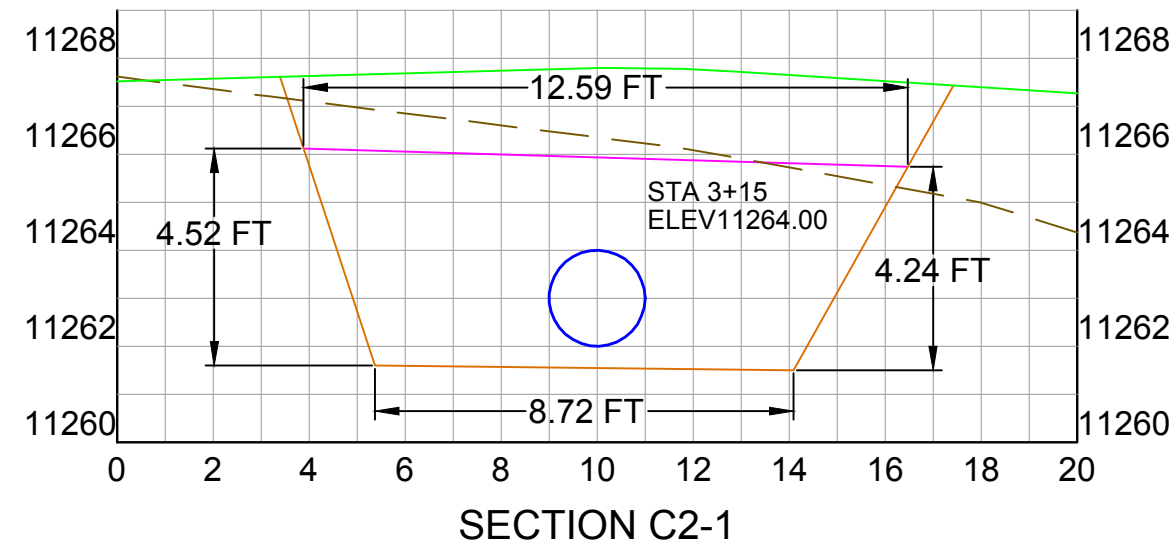
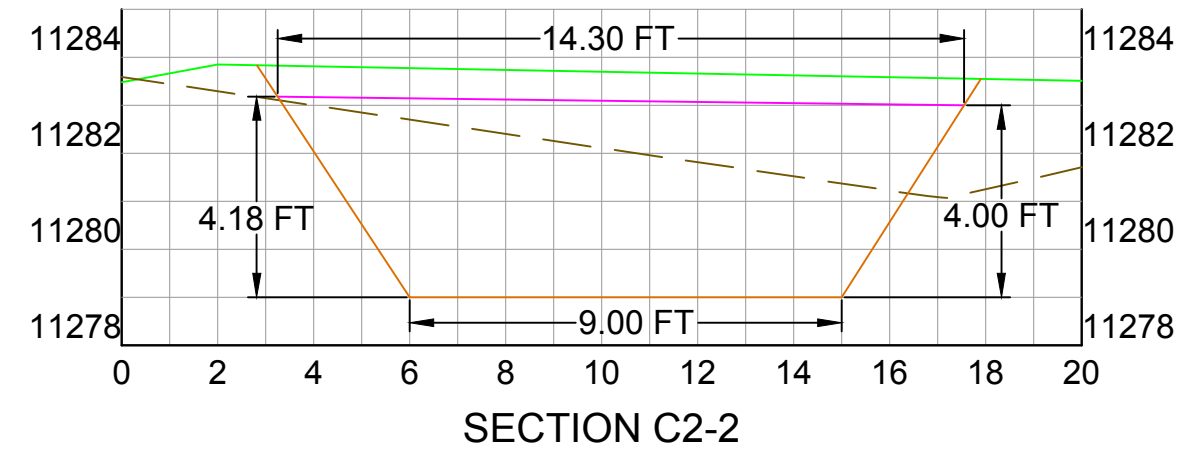
| DRAWING | MCN-AB-12 |

CLIMAX MINE  
MCNULTY OSF EXPANSION  
REACH C2 CWCS CROSS-SECTIONS
