**Re: Second Adequacy Review of Amendment Application Package AM03, Arcosa  
Lightweight - Boulder, Permit M1988-108 Response to Comments**

**ARCOSA**  
LIGHTWEIGHT BOULDER PLANT #1604  
JEFFERSON COUNTY, COLORADO

MINE GRADING MAP

EXHIBIT  
C-4

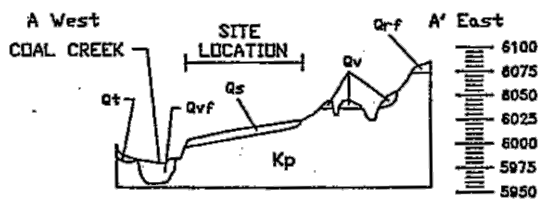
CROSS-SECTION A-A'  
VERTICAL EXAGGERATION 5X  
SURFICIAL GEOLOGIC CROSS SECTION

NOTE: A DETAILED BEDROCK GEOLOGY CROSS SECTION PROVIDED ON FIGURE D.2.

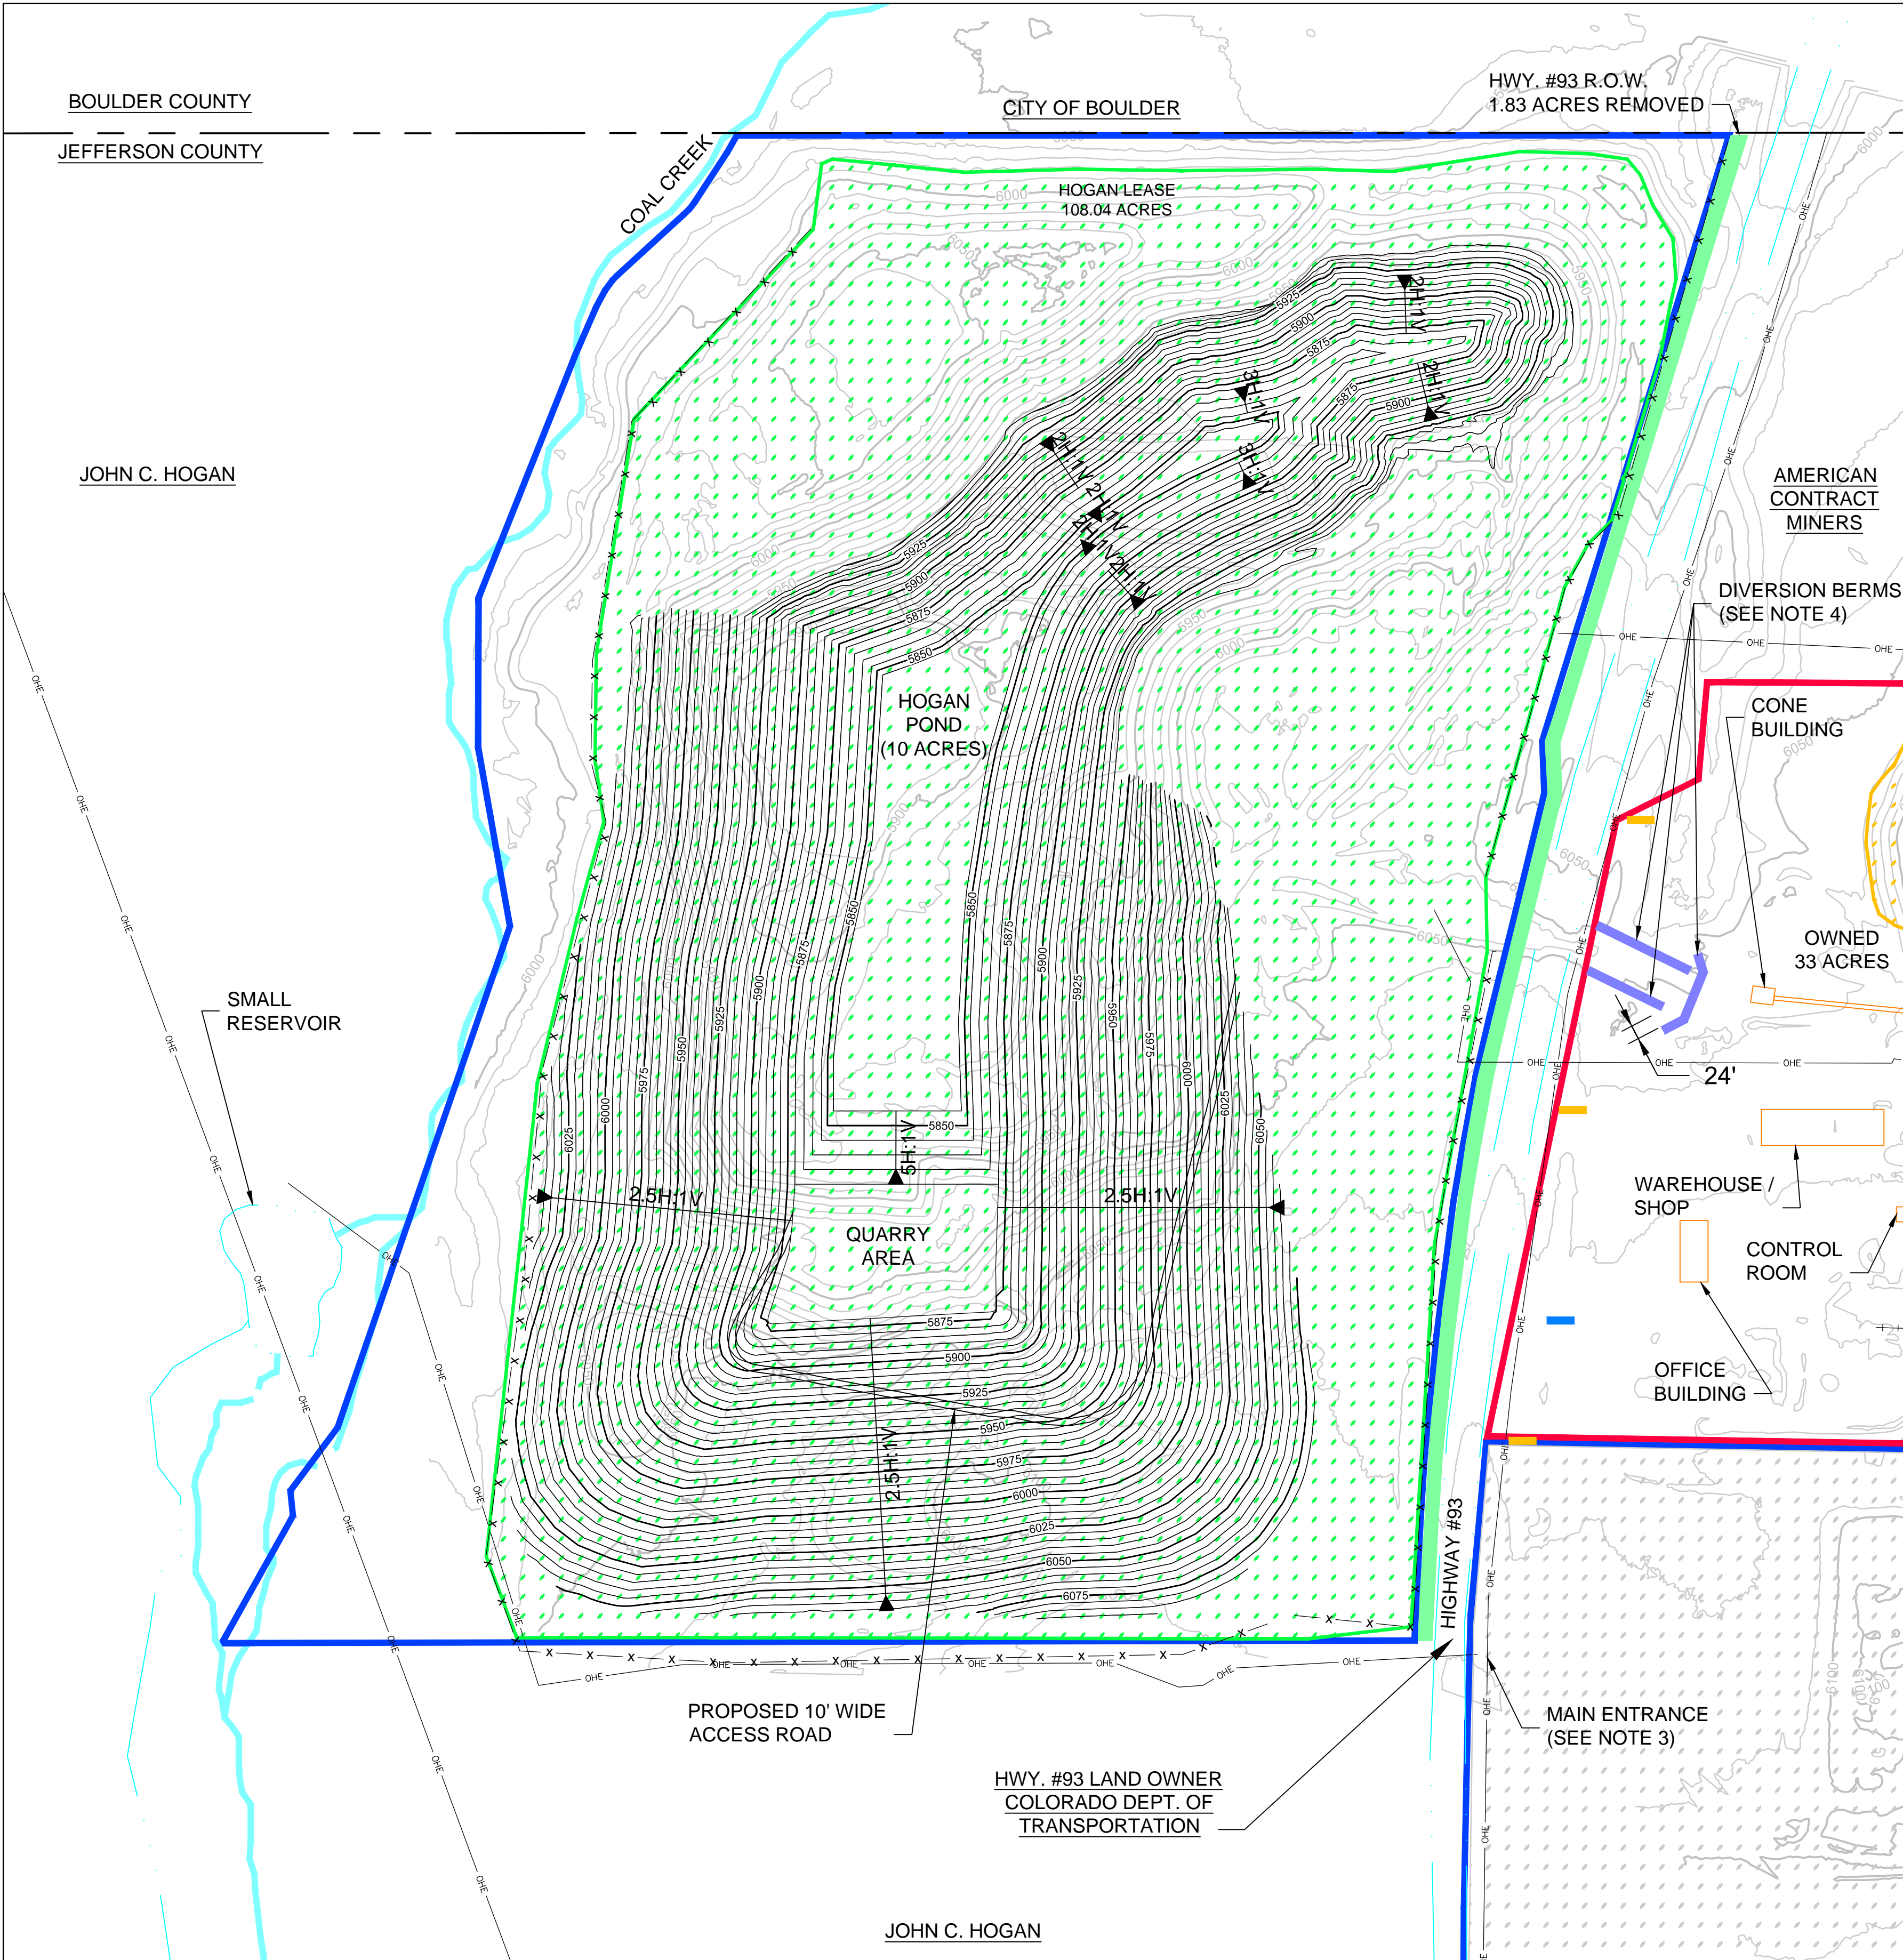
## **EXHIBIT F-2**

QUARRY AREA RECLAMATION

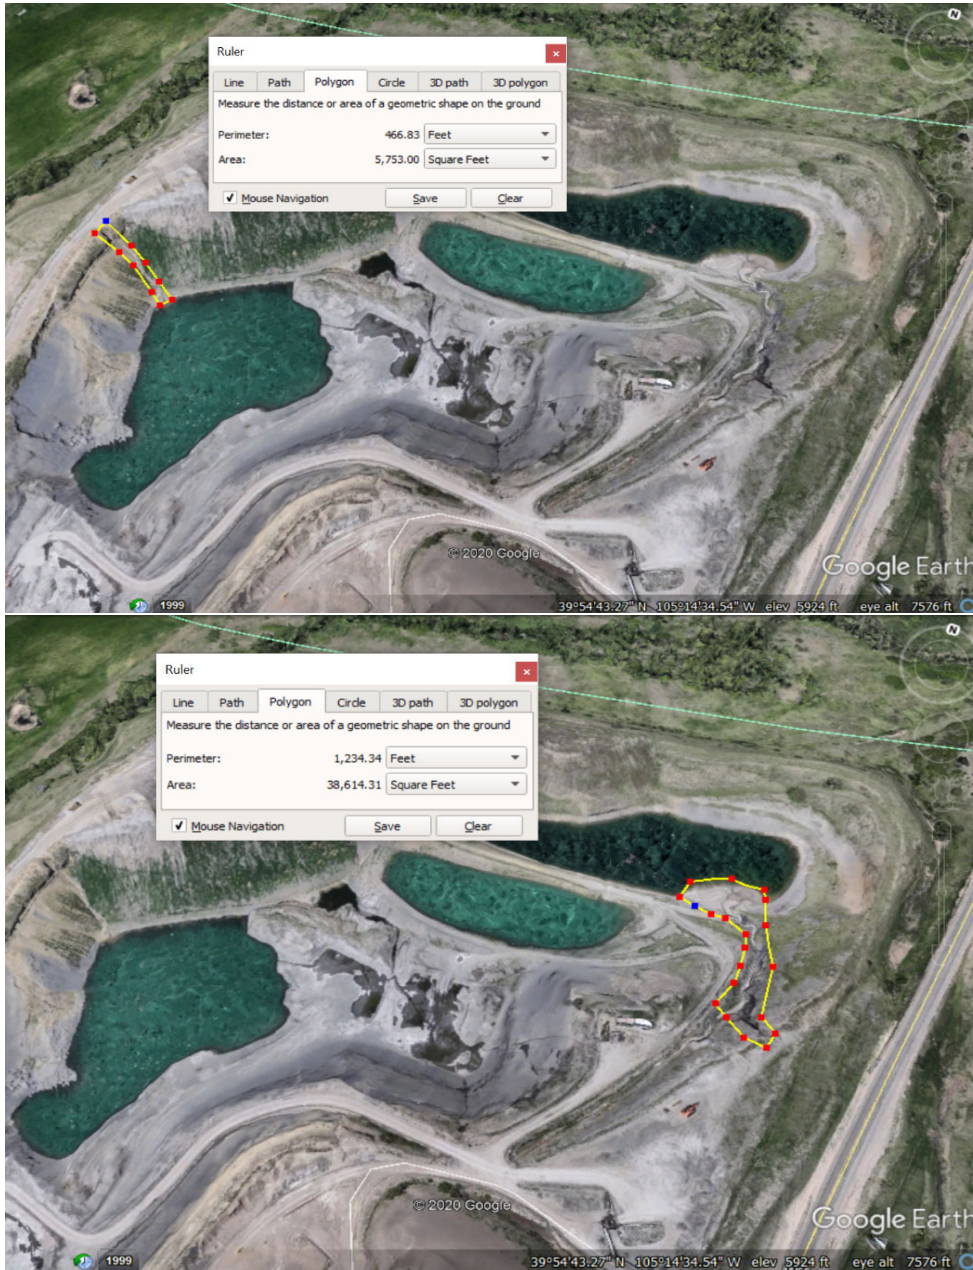
## Erosion Rill Repair Areas

### Arcosa Lightweight Facility

\*Assume erosion rill average depth is 2 feet across entire rill area.

\*\*Sediment in mine area will be removed during operations.
