**Dowe Flats Mine / M1993-041 / TR-4 / Adequacy Review #3 - Bond Estimate**

RE: Dowe Flats Quarry, Permit No. M-1993-041, Technical Revision #4, Adequacy Review No. 2 Response

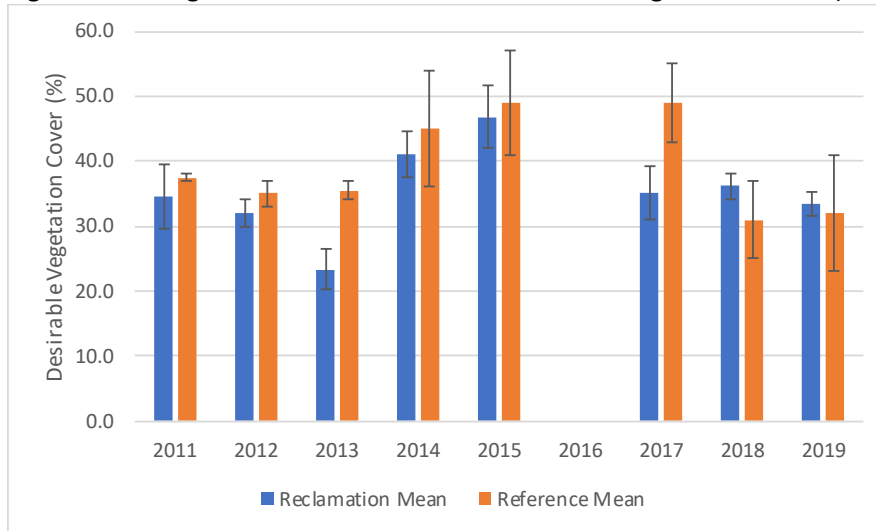
Figure 1: Average Reclamation and Reference Area Vegetation Cover (2011-2019)

- 3) The seeding failure rate of 30% is much higher than expected. The most common rate found in a review of seeding specifications is 10% which is the value we used in our estimate. CEMEX has been conducting interim vegetation monitoring on the previously completed reclamation at the Dowe Flats Quarry in most years since 2011 and comparing the data to a nearby reference area inside the permit boundary but outside the affected area. In six of the eight years of monitoring, the average desirable vegetation cover of the reclamation area samples is equivalent to or greater than the reference area (Figure 1). The vegetation cover also persists well after the first few years of growth (Figure 2). Given the success of reclamation efforts to date, we believe that the 10% failure rate in our initial calculations was more appropriate.
