**TRI-STATE GENERATION AND TRANSMISSION ASSOCIATION, INC.**
**HEADQUARTERS: P.O. BOX 33695 DENVER, COLORADO 80233-0695 303-452-6111**

**RE: New Horizon Mine (Permit No. C-1981-008)  
Technical Revision No. 9 (TR-99)  
Pond 013 Limestone Inlet**

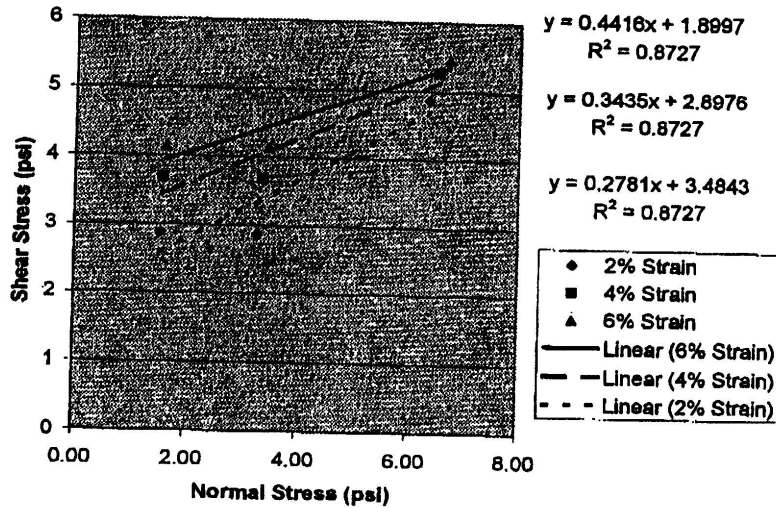
## Direct Shear Test Results

Project: Western Fuels Miscellaneous Testing Project Number: M07057MT Date Sampled: 5/7/2007  
 Location: Sample Source: TP 2 @ 0-5.5 ft Lab Sample #: 0770  
 Sample Description: Clay, Sandy, Brown Date Tested: 6/21/2007 Tested By: AC

Soil remolded to approximately 100% ASTM D698 Maximum Dry Density  
 Remolded Dry Density = 114.5 pcf Moisture Content = 12.4%

% Strain	Cohesion (psf)	Friction Angle (deg)
2	274	24
4	417	19
6	502	16

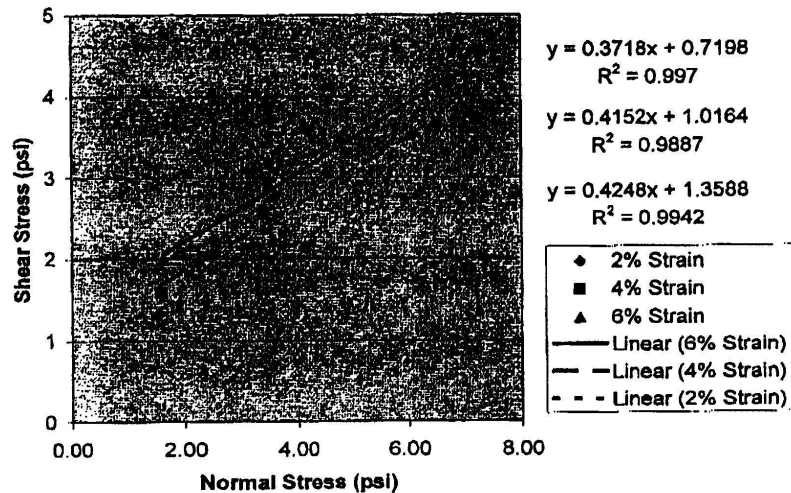
### Direct Shear Test Results

Project: Western Fuels Miscellaneous Testing	Project Number: M07067MT	Date Sampled:
Location: TP 2 @ 0-5.5 ft	Sample Source:	Lab Sample #: 0770
Sample Description: Clay, Sandy, Brown	Date Tested: 6/4/2007	Tested By: AC

Soil remolded to approximately 85% ASTM D698 Maximum Dry Density  
 Remolded Dry Density = 97 pcf      Moisture Content = 9.7%

% Strain	Cohesion (psf)	Friction Angle (deg)
2	104	20
4	146	23
6	196	23

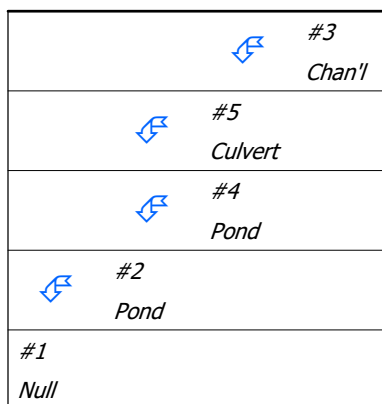
## Structure Networking:

Type	Stru #	(flows into)	Stru #	Musk. K (hrs)	Musk. X	Description
Null	#1	==>	End	0.000	0.000	Null Below Pond 013
Pond	#2	==>	#1	0.000	0.000	Pond 013
Channel	#3	==>	#5	0.000	0.000	Ditch C-9
Pond	#4	==>	#2	0.000	0.000	Continuous flow 1000 gpm
Culvert	#5	==>	#2	0.000	0.000	Culvert C177 at Sta 0+25 in C-9 Ditch

The SEDCAD printout shows the 10 year, 24 hour storm flows in Ditch C9 to be 4.65 cfs in the 10 year storm, and flowing at a velocity of 1.4 fps, well below the allowable velocity of 7 fps for the grass lined channels at these conditions.

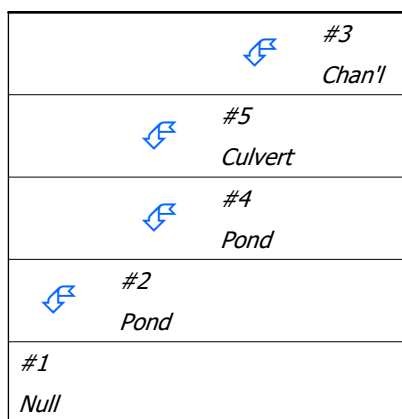
## Structure Networking:

Type	Stru #	(flows into)	Stru #	Musk. K (hrs)	Musk. X	Description
Null	#1	==>	End	0.000	0.000	Null Below Pond 013
Pond	#2	==>	#1	0.000	0.000	Pond 013
Channel	#3	==>	#5	0.000	0.000	Ditch C-9
Pond	#4	==>	#2	0.000	0.000	Continuous flow 1000 gpm
Culvert	#5	==>	#2	0.000	0.000	Culvert C177 at Sta 0+25 in C-9 Ditch

The 25 year, 24 hour storm has also been modeled as the spillway design event. For this analysis, it has been conservatively assumed that the twin 6-inch orifice holes are closed, and normal starting pool is the principal spillway elevation of 5555.0. This must be raised 0.23 feet to account for the 1,000 gpm over the riser lip. The starting pool for the 25 year spillway design storm was thus set to elevation 5555.23. The runoff combined with the constant inflow produce a total runoff volume of 9.14 ac-ft. In the attached SEDCAD printout for that storm it can be observed that the pool only rises to elevation. 5556.36, or 1.36 feet above the riser pipe overflow. As such, the routed 25 year storm does not raise the pool high enough to engage the three horizontal CMPs at El 5557.0, which are the emergency spillway.
