Henderson Response to DRMS TR-32 Geotech Review Report

RE: Climax Molybdenum Company, Henderson Mill, Permit No. M-1977-342, Technical Revision 32, Response to DRMS Geotechnical Stability Analysis Report

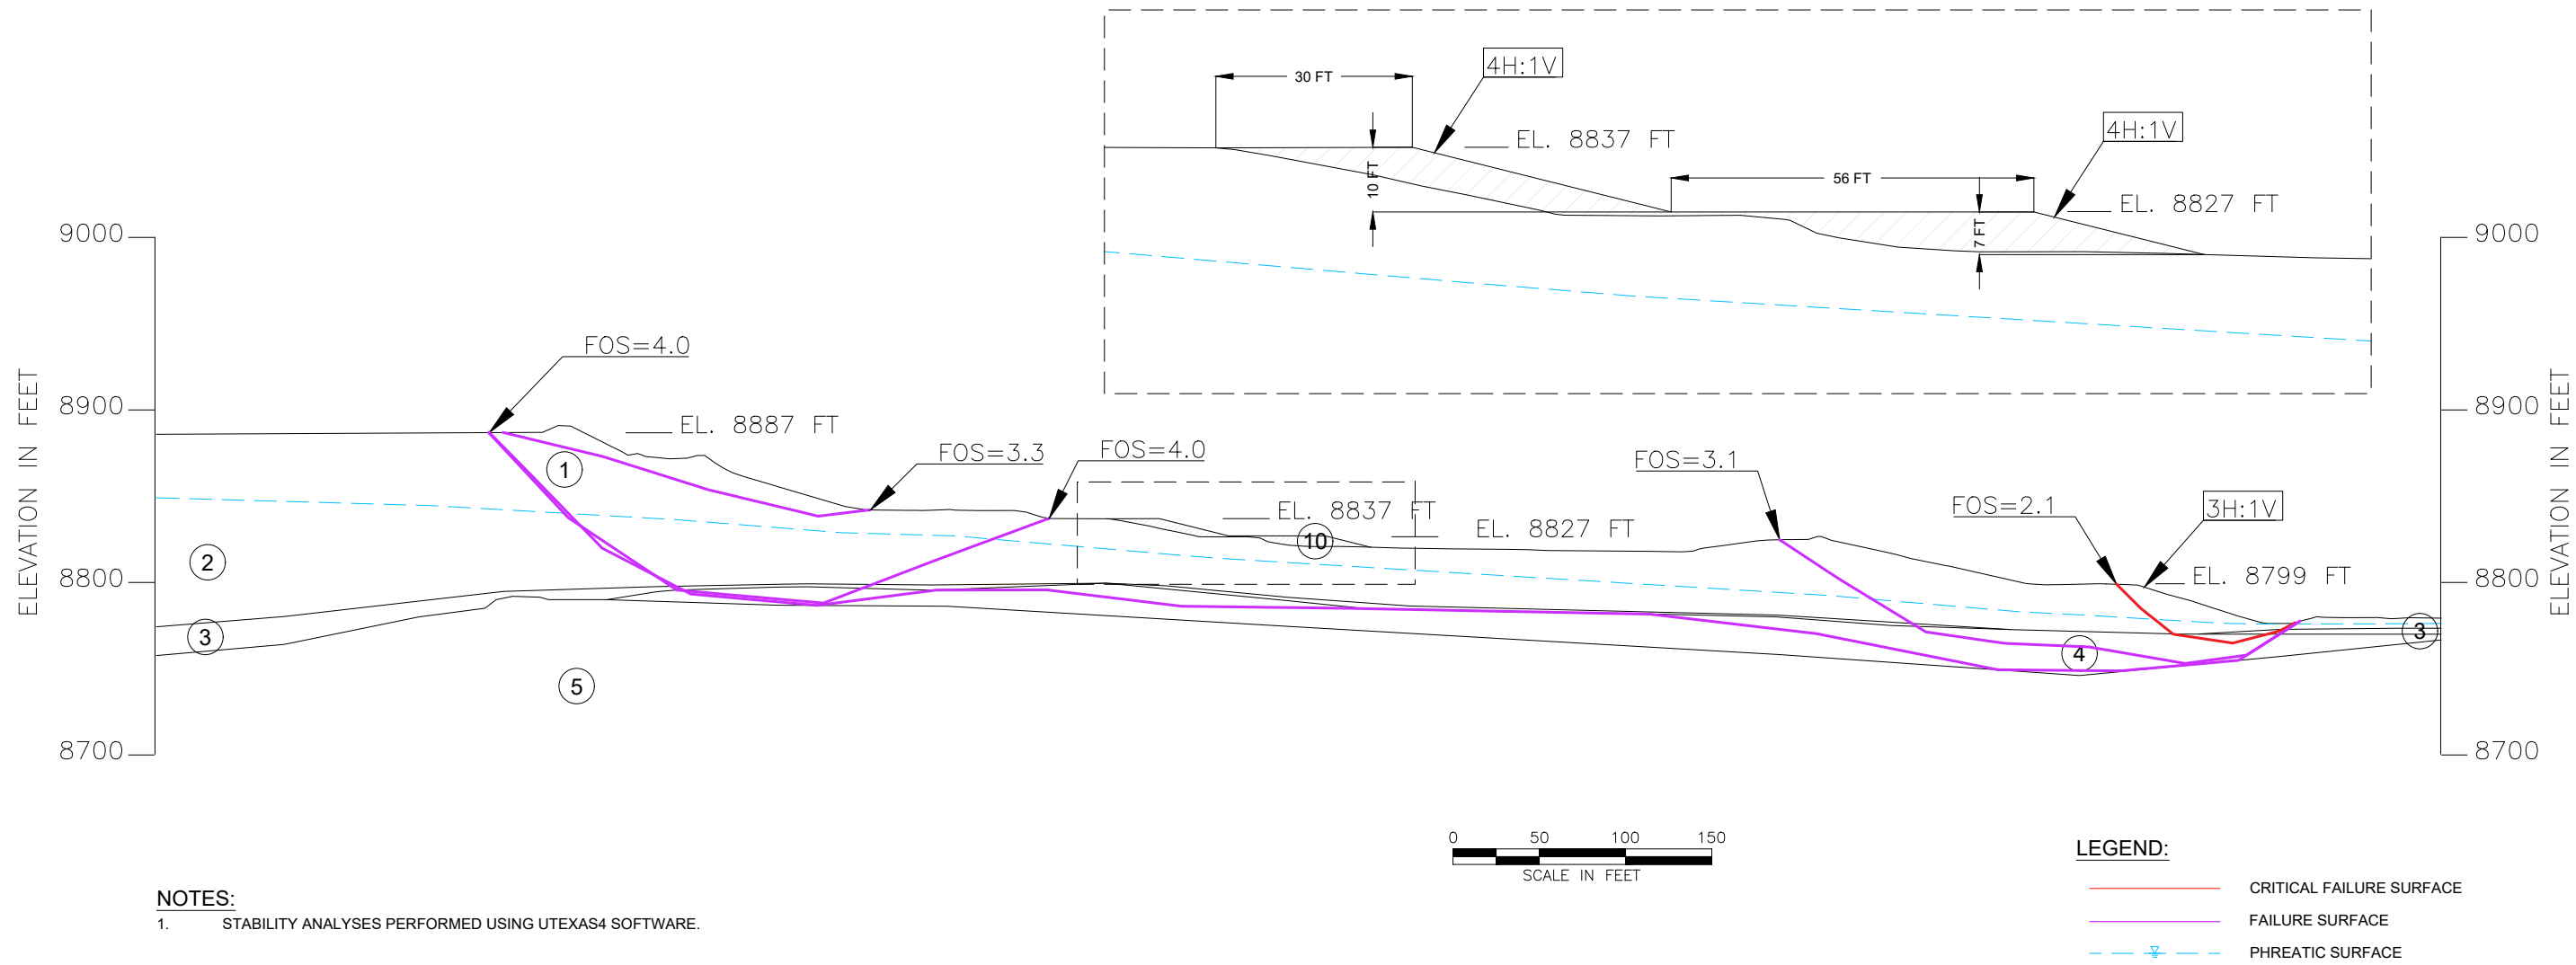
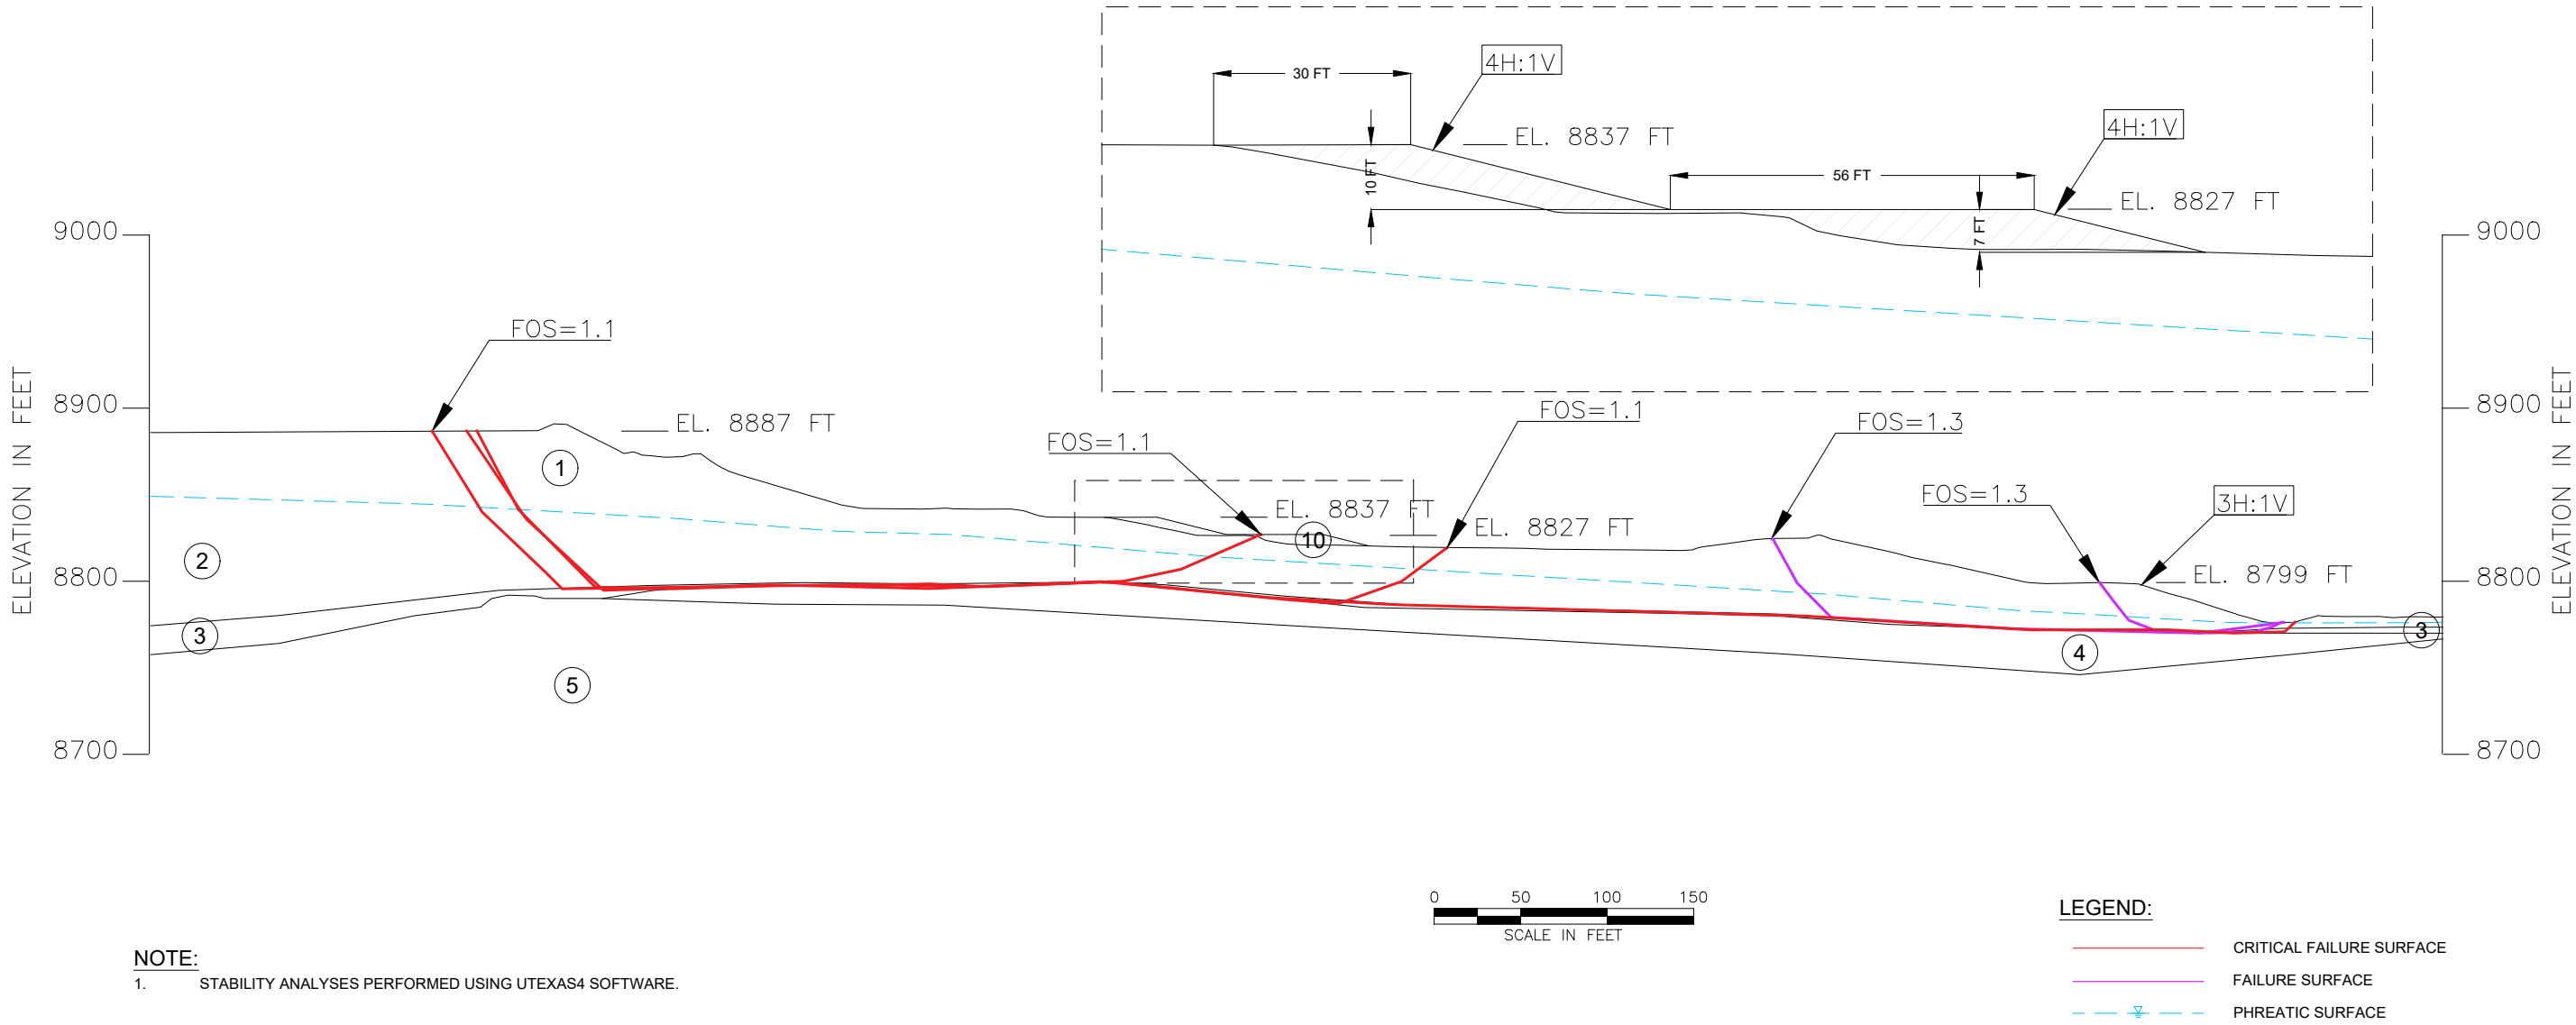
MATERIALS			
NO.	DESCRIPTION	UNIT WEIGHT (PCF)	POST-EARTHQUAKE SHEAR STRENGTH
①	UNSATURATED COARSE TAILINGS	117	C' = 0 PSF, ϕ' = 38° (Drained Strength)
②	LIQUEFIABLE COARSE TAILINGS	119	Su/p' = 0.24
③	LIQUEFIABLE FINE TAILINGS	119	Su/p' = 0.10
④	UPPER FOUNDATION	135	Su/p' = 0.27
⑤	LOWER FOUNDATION	135	C' = 500 PSF, ϕ' = 35° (Drained Strength)
⑩	BUTTRESS TAILINGS	113	C' = 0 PSF, ϕ' = 38° (Drained Strength)

were used to refine the fine tailings extent and to confirm pore pressure conditions. The CPT investigation showed that the fine tailings material located on the northern side of the original 3 Dam buttress are isolated and confirmed pore pressure conditions. An updated 2D post-earthquake loading stability analysis was completed on design section 4A with the updated fine extents. This analysis was completed using the same procedures described in the 3 Dam, Phase II Buttress Design letter report dated June 1, 2020. Figure 4 presents the updated slope stability analysis results for post-earthquake loading condition which meets the stability criteria. As a result, the proposed regrade or slope flattening of the northern original 3 Dam buttress is no longer required. Remainder of the design remains consistent with the 3 Dam Phase II submission.
