RE: Lyons Quarry; DRMS File No. M-1 977-141; Technical Revision No. 4

# Aggregate Industries - WCR, Inc.

## Lyons Quarry

Boulder County, Colorado

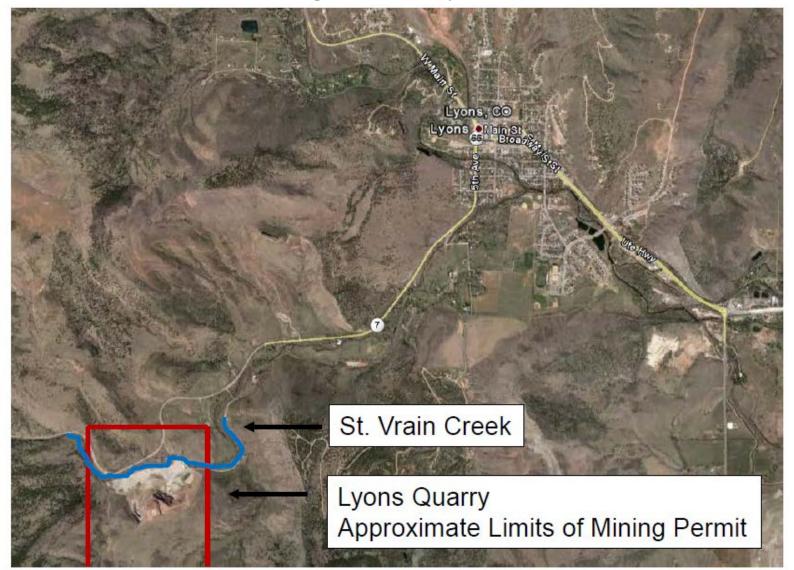
Figure 1.1 – Site Map and Location

Lyons Quarry is located southwest of Lyons, Colorado in Boulder County. **Figure 1.1,** Attachment A, shows the Lyons Quarry site just south of South St. Vrain Creek, along Colorado State Highway 7 in Sections 25 and 26 of Township 3 North, Range 71 West of the 6th Principle Meridian.

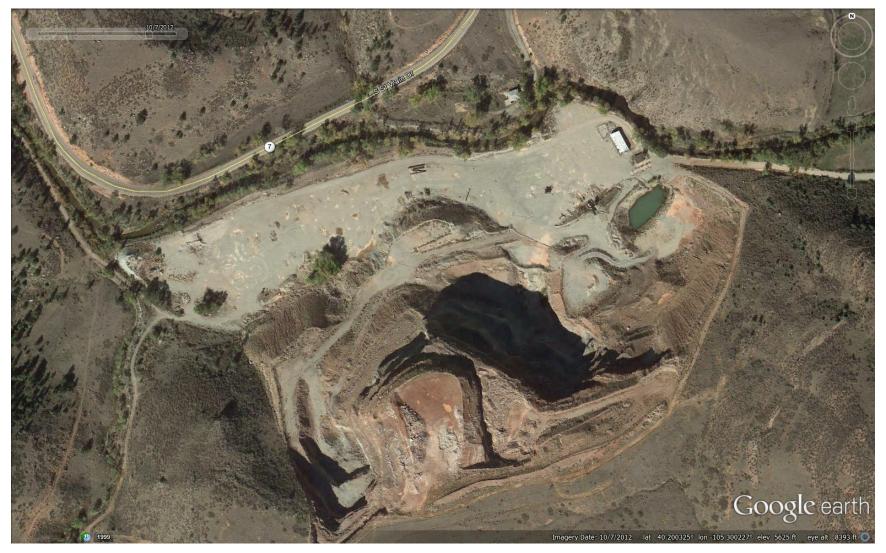
Figure 1.2 – Pre-Flood Satellite Image October 6, 2012

The floods in September 2013 changed the low-lying areas of the Lyons Quarry as up to 17 inches of rain fell over a three-day span raising the levels of the South St. Vrain Creek to 100 and 500-year floodplains (Boulder County's annual precipitation is 18 inches). The flooding washed away the access bridge that crossed the South St. Vrain from Highway 7. **Figure 1.2 and Figure 1.3**, Attachment A, display the pre- and post-flood conditions of the site as satellite images from October 7, 2012 and October 6, 2013, respectively. The extent of the flood destruction and change in creek alignment especially at the east end of the site is shown on these images.

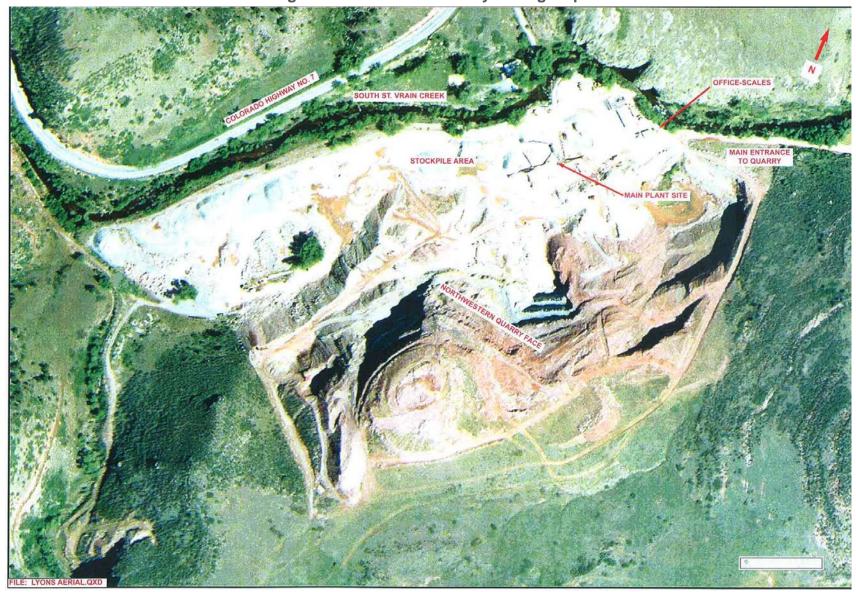
Figure 1.4 – Andesite Quarry Mining Map

Figure 1.4, Attachment A, shows the mining operations at the site in September 2002. As of

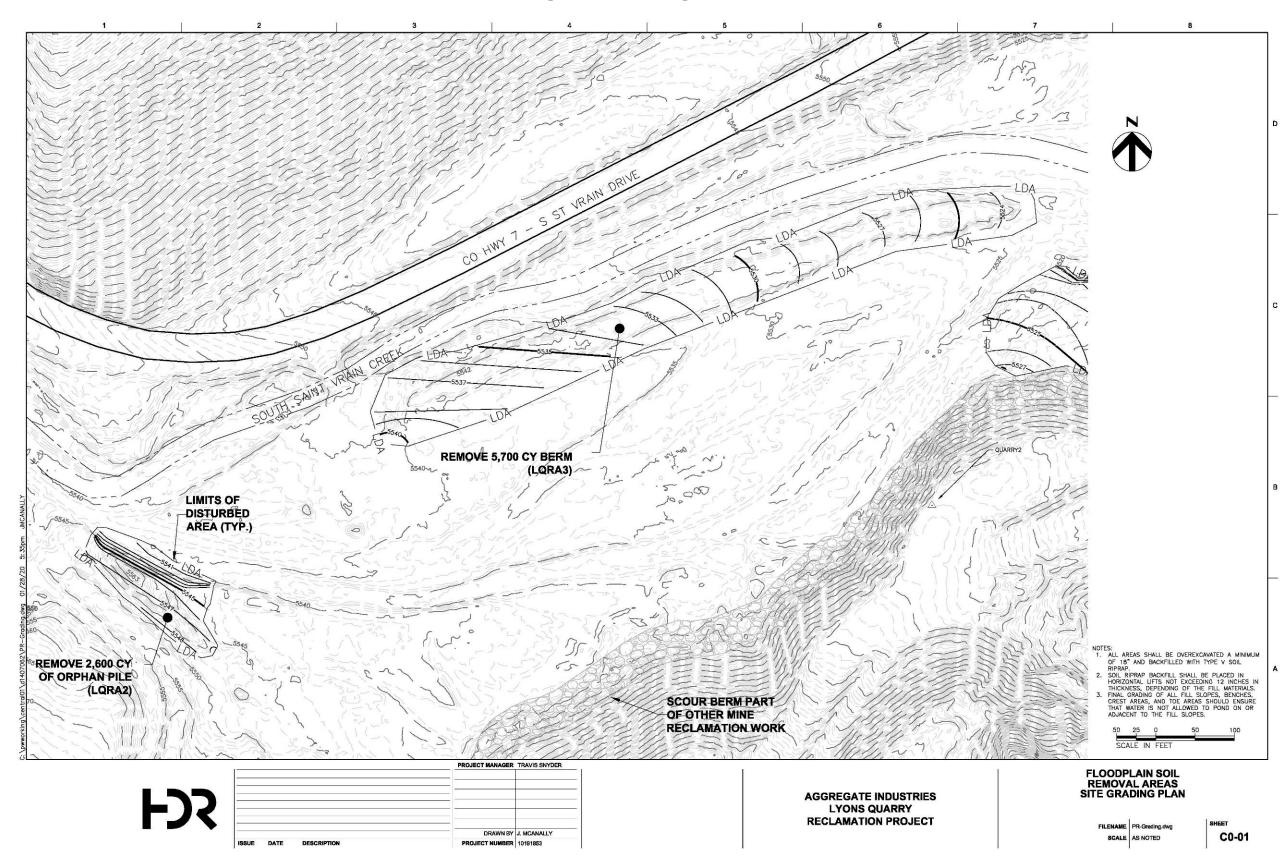
Figure B-1 – Grading Plan

The reclaimed areas will have slopes of at least 3H:1V with the exception of areas adjacent to South St. Vrain Creek which will be 1.5H:1V. All soil riprap backfill will be moisture conditioned, placed, and compacted to achieve adequate density for stability. The revised Site Grading Plan is shown in Attachment B. The slopes shown on the Site Grading Plan are verified as meeting the geotechnical specifications of the Geotechnical Stability Report in a letter signed and sealed by a qualified Colorado registered Professional Engineer, Attachment F.
