BOWIE RESOURCES, LLC
Bowie No. 2 Mine
Coal Mine Waste Bank Nos. 1, 2, & 3 Inspections –3rd Quarter 2020

On September 17th, 2020, a visual inspection of the Bowie No. 2 Mine coal mine waste banks was performed by the undersigned in accordance with Rule 4.10.2. is inspection includes Gob Pile Nos. 1, 2, and 3. Pile No. 1 is considered inactive. Pile no. 2 is located north of Bowie Road and is currently idle. Pile no. 3 is located south of Bowie Road.

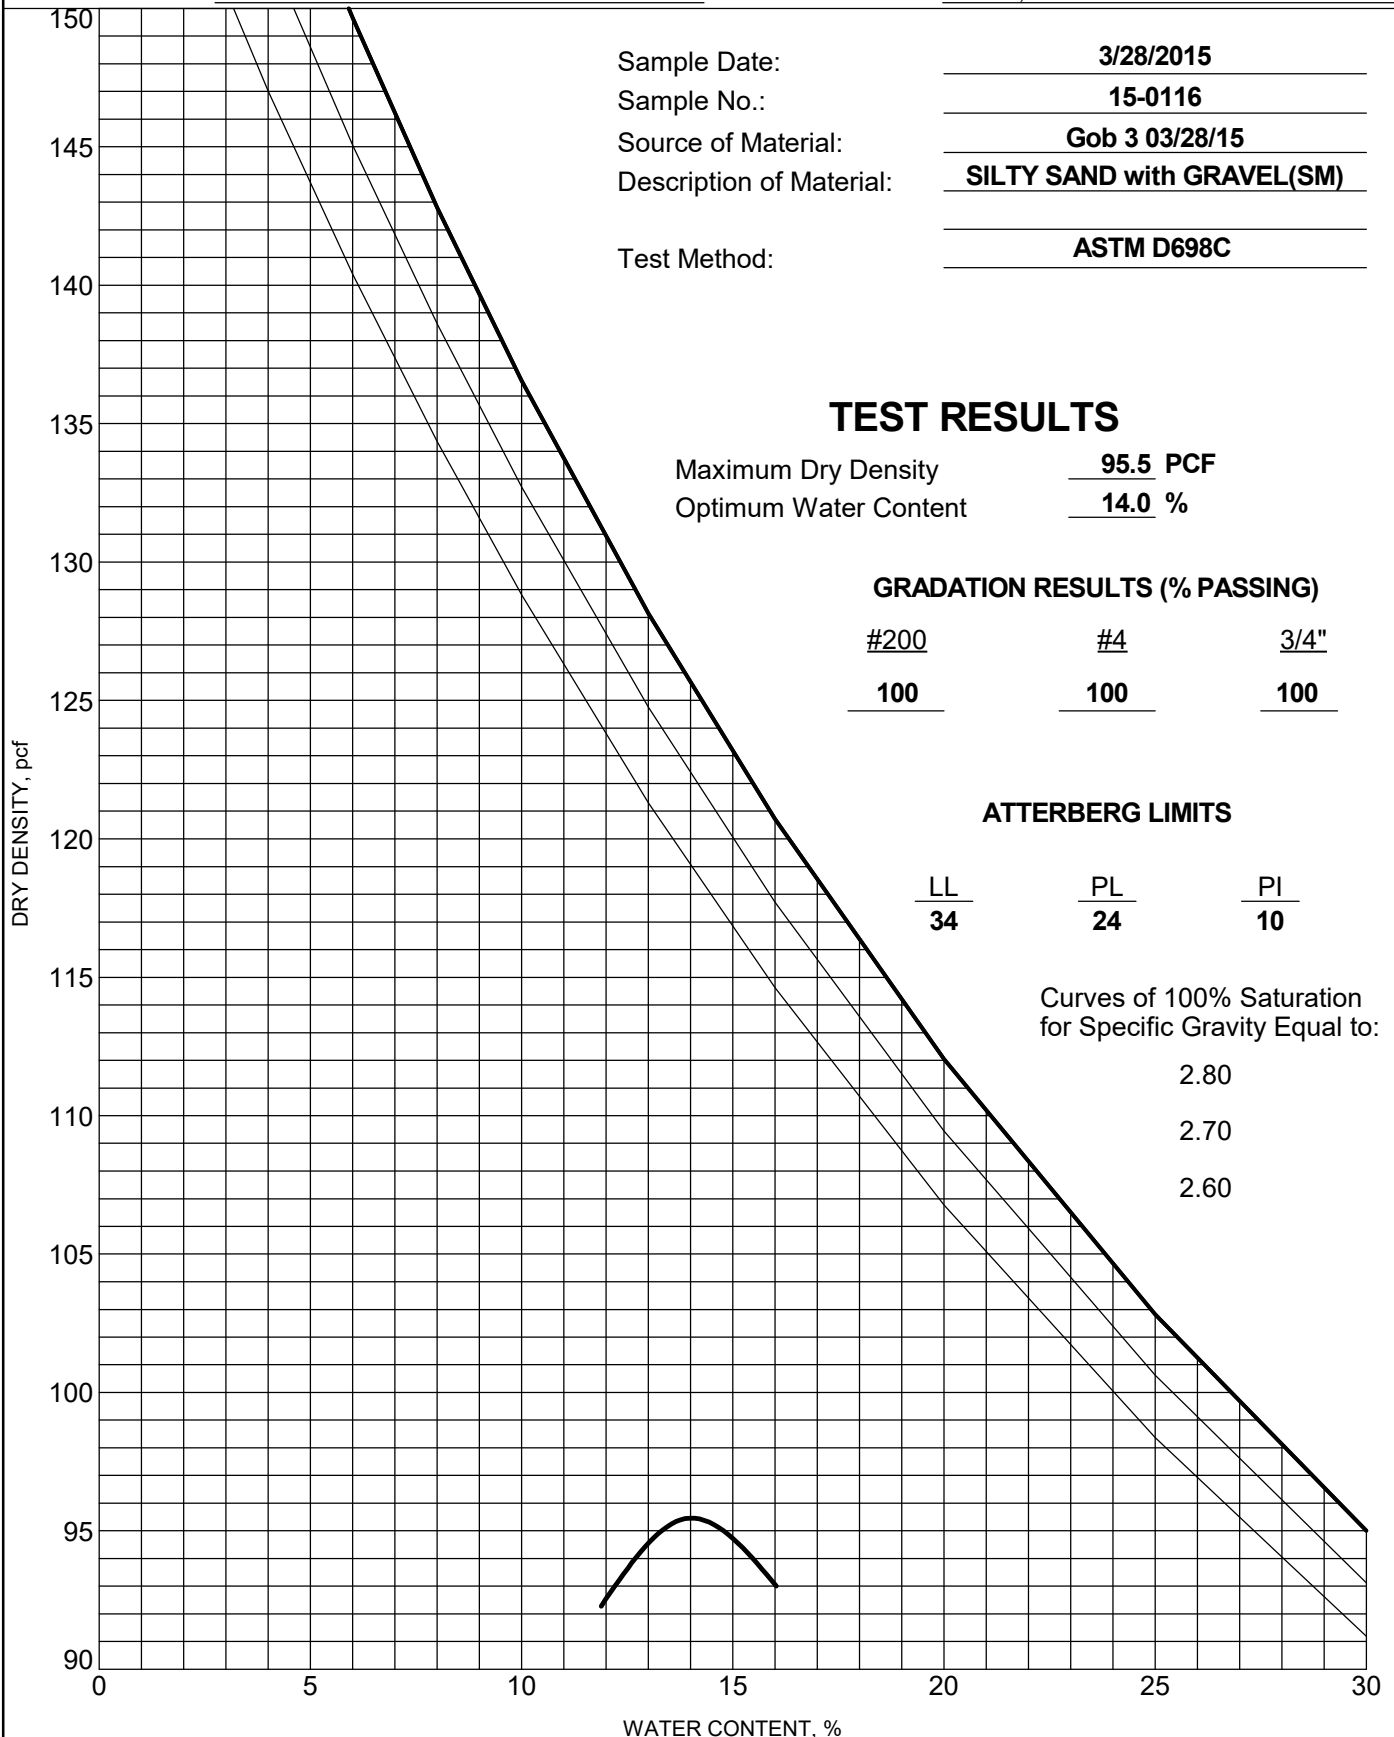
MOISTURE-DENSITY RELATIONSHIP

TEST RESULTS

Maximum Dry Density 95.5 PCF
Optimum Water Content 14.0 %
