**RE: Climax Molybdenum Company, Henderson Mine, Permit No. M-1977-342
Technical Revision No. 31, Additional 3 Dam Seepwater Return Line Cleanout Ports –
Adequacy Review Response**

3 DAM SEEPWATER CLEAN-OUT ADDITIONS AS-BUILT

A Freeport-McMoRan Company EMPIRE / PARSHALL, COLORADO 303-569-3221	TAILINGS AND WATER 3 DAM SEEPWATER CLEAN-OUT ADDITIONS COVER SHEET 5-6-9030 SHT 1 OF 5 REV.

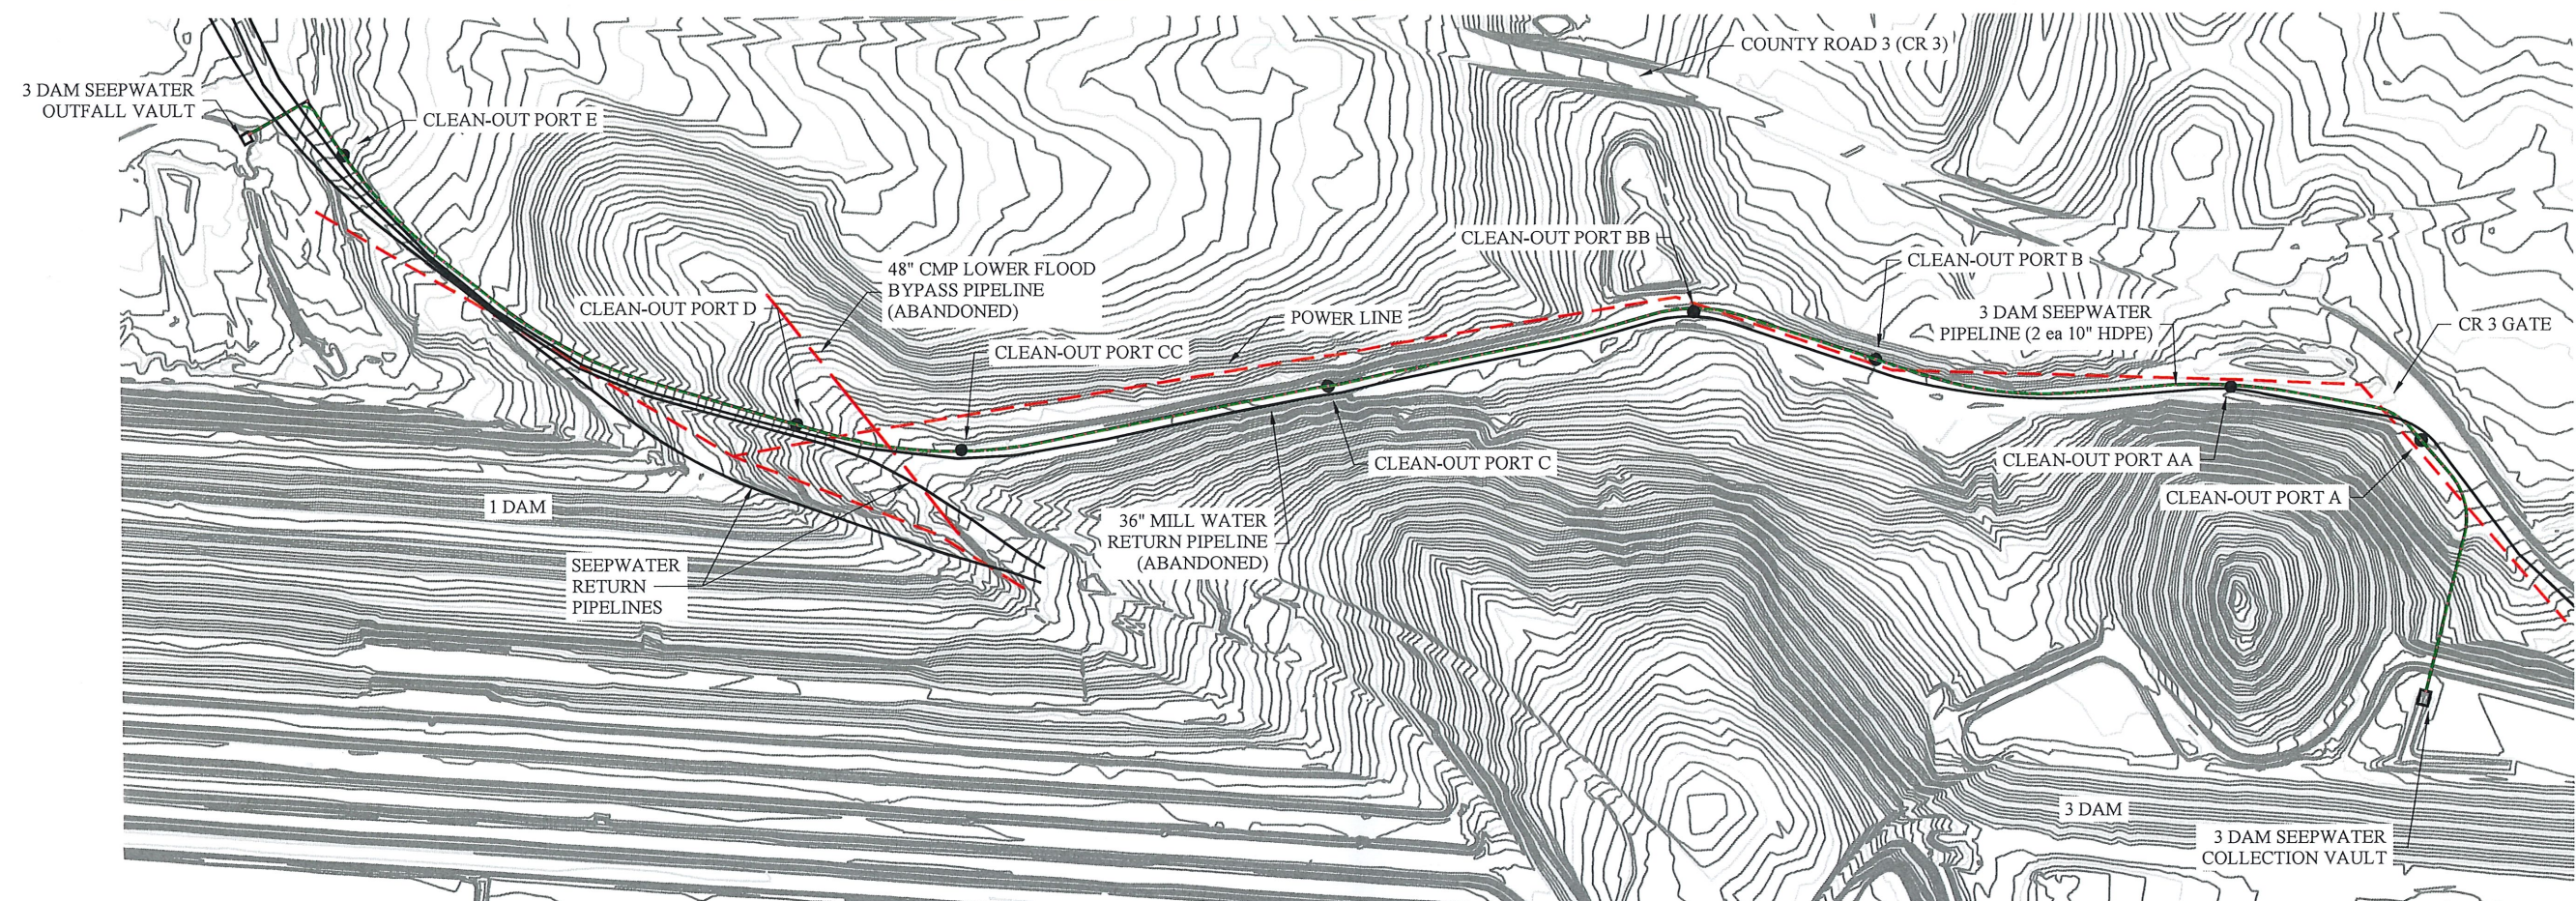
2019 CLEAN-OUT LOCATIONS		
PORT	NORTHING	EASTING
AA	193371.154	1836860.980
BB	194404.104	1836244.811
CC	195478.903	1834988.202

● PIPELINE CLEAN-OUT PORT

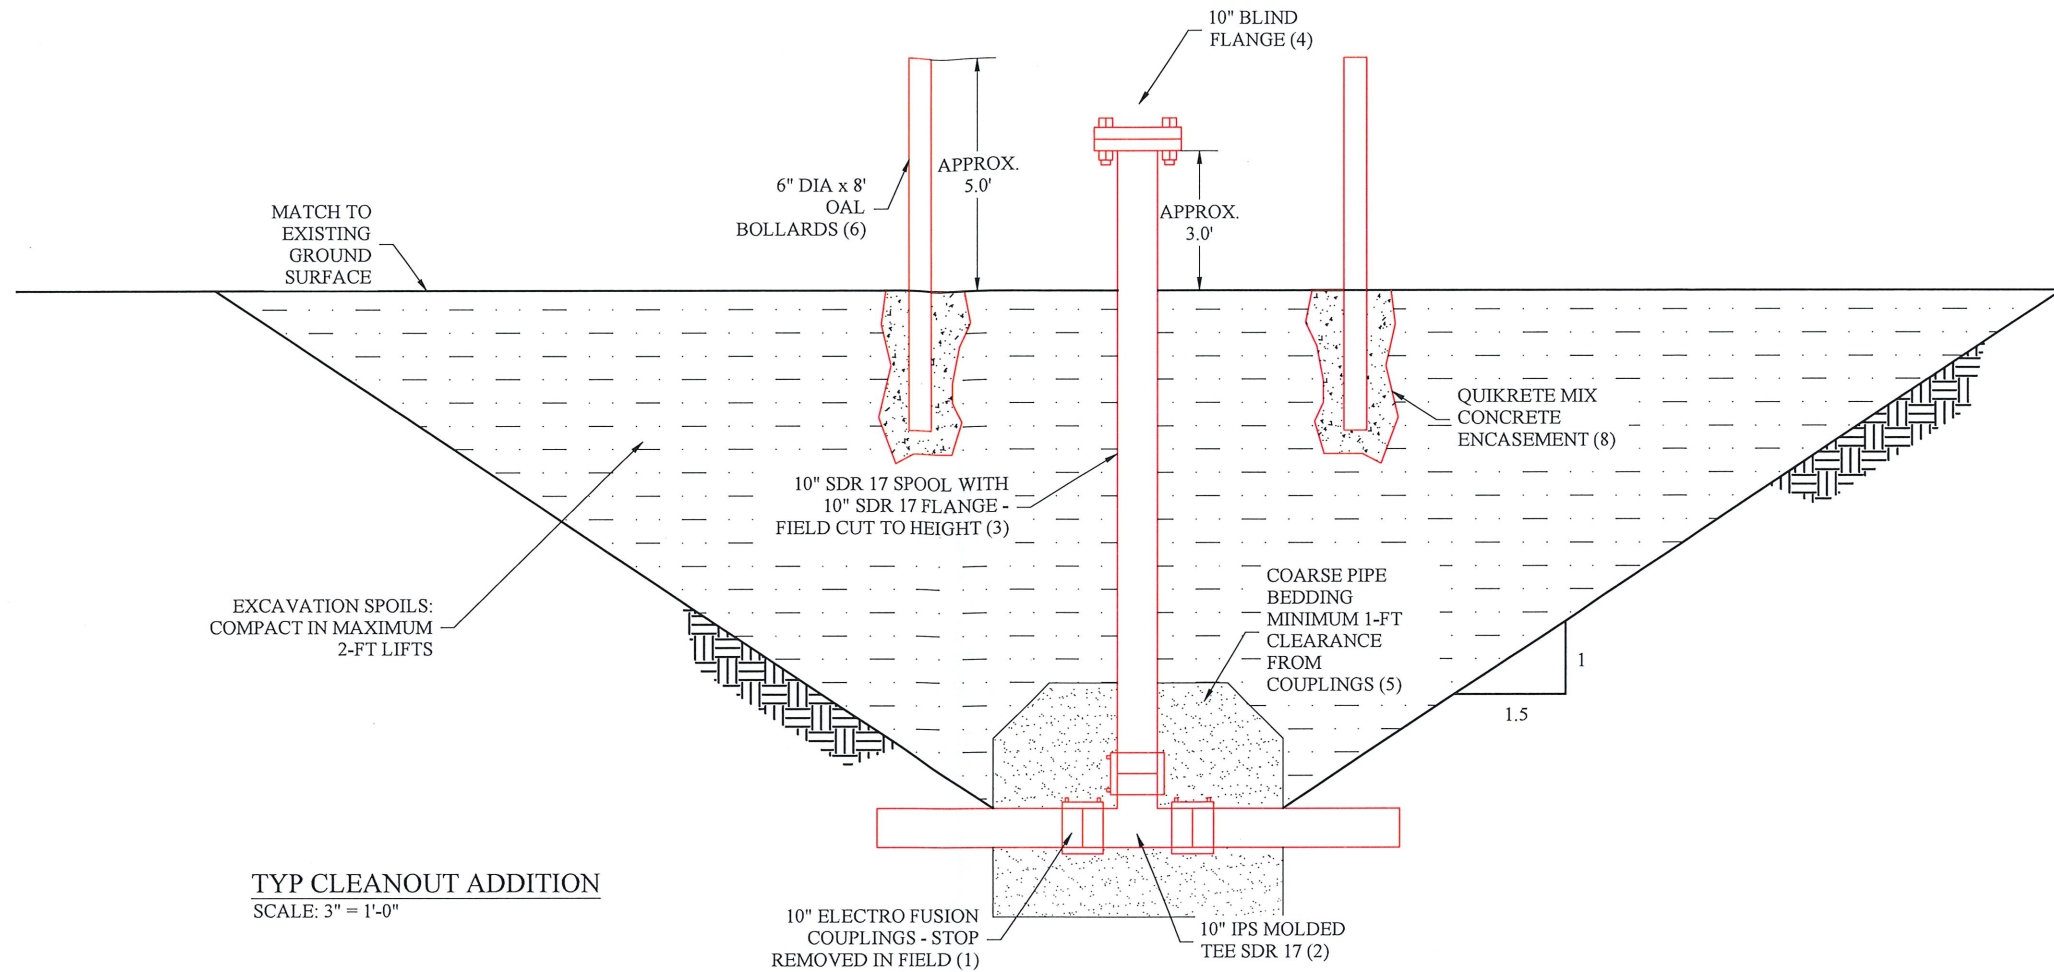
TYP CLEANOUT ADDITION
SCALE: 3" = 1'-0"

- NOTES: (UNLESS OTHERWISE SPECIFIED)
- CLEAN-OUT PORTS SHALL BE INSTALLED ON BOTH PRIMARY AND BACKUP SEEPWATER COLLECTION PIPELINES
 - BLUE STAKE PERMITTING FROM MILL ENGINEERING DEPARTMENT IS REQUIRED PRIOR TO EXCAVATION.
 - ALL COARSE PIPE BEDDING AGGREGATE MUST BE PLACED IN 18" LIFTS AND TAMPED AROUND THE PIPE.
 - ENGINEERING MUST BE CONTACTED AND APPROVE INSTALLATION PRIOR TO BACKFILL
 - EXCAVATION SPOILS MUST BE COMPACTED IN MAXIMUM 2-FT LIFTS TO GRADE. COMPACTION METHOD TO BE DETERMINED IN FIELD AND SPECIFIED BY ENGINEERING
 - UNPROTECTED TRENCH SLOPES MUST BE MADE AT 1.5:1 MINIMUM AND FOLLOW ALL FMI OPEN TRENCH POLICIES
 - EACH CLEAN-OUT ADDITION MUST BE PRESSURE LEAK TESTED FOR 24 HOURS TO MAXIMUM HEAD AND APPROVED BY ENGINEERING PRIOR TO BACKFILL
 - ALL STEEL SHALL RECIEVE ONE SHOP COAT OF RUST-OLEUM 7400 YELLOW METAL PRIMER, EXCEPT AREAS TO BE FIELD WELDED

The purpose of this letter is to state that the new cleanout access locations were constructed in conformance with the design plans and specifications. Each new HDPE cleanout was installed with a molded tee with a riser pipe to the surface and all joints connected with HDPE electrofusion couplings. Once all cleanouts were installed, a 24-hour pressure test was conducted along with visual inspections of each new joint. The pressure test was finished on September 19, 2019. Before acceptance of the test, each new fused joint was visually inspected for leaks with no leaks being found in any of the new joints. The pressure gauge at the discharge of each pipeline was verified to continually hold pressure throughout the 24-hour test. After the inspection and pressure test, the pipelines were deemed acceptable for continued use, and put back into service.
